Recommendations To Improve Energy Efficiency at the Soo Area Office, Sault Ste. Marie, MI

Larry Lister and Martin J. Savoie

REFERENCE: CERL Technical Report 99/70, *Recommendations To Improve Energy Efficiency at the Soo Area Office, Sault Ste. Marie, MI*

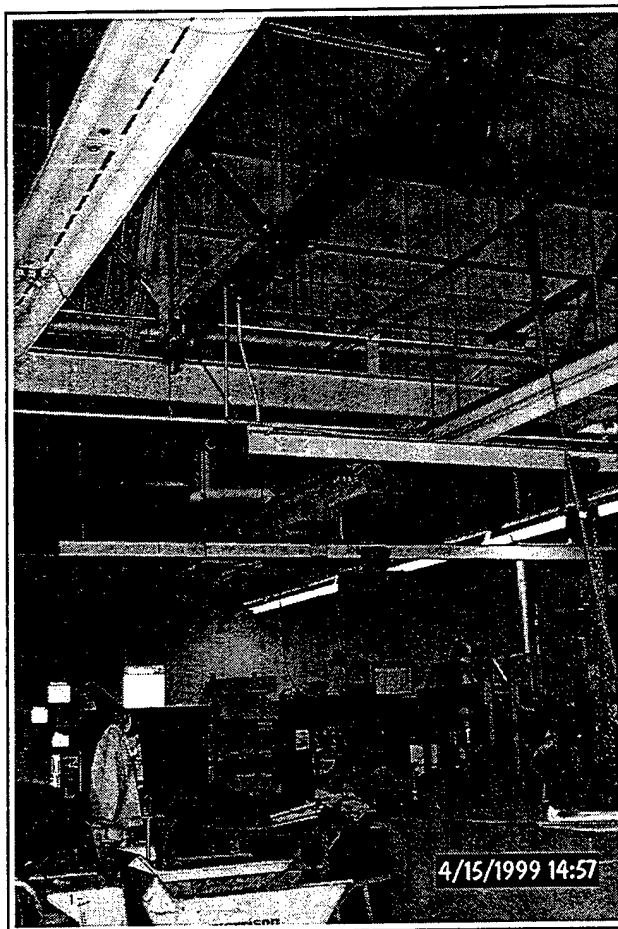
Figure 1. North warehouse lighting.

Upon failure of existing systems, replace warehouse lighting (Figure 1) with T8/electronic ballasted luminaires. The 8-ft fixtures should be replaced with 4-ft strips. It is recommended that the system be master/slave wired so that a single ballast is driving 3 or 4 lamps.

- d. Upon failure of existing systems, replace warehouse lighting (Figure 1) with T8/electronic ballasted luminaires.
2. *Buildings.* Because of the use pattern of frequently opened overhead doors, a more energy-efficient approach to space heating would be to replace the overhead steam-fed unit heaters with gas-fired infrared heaters. However, note that the cost-effectiveness of this change *may not justify the expenditure of energy conservation funding.*
