Technical Report CHL-99-19  
September 1999

# **DMS: Diagnostic Modeling System**

## **Report 2**

### **Reduction of Sediment Shoaling of the Entrance Channel at East Pass, Florida**

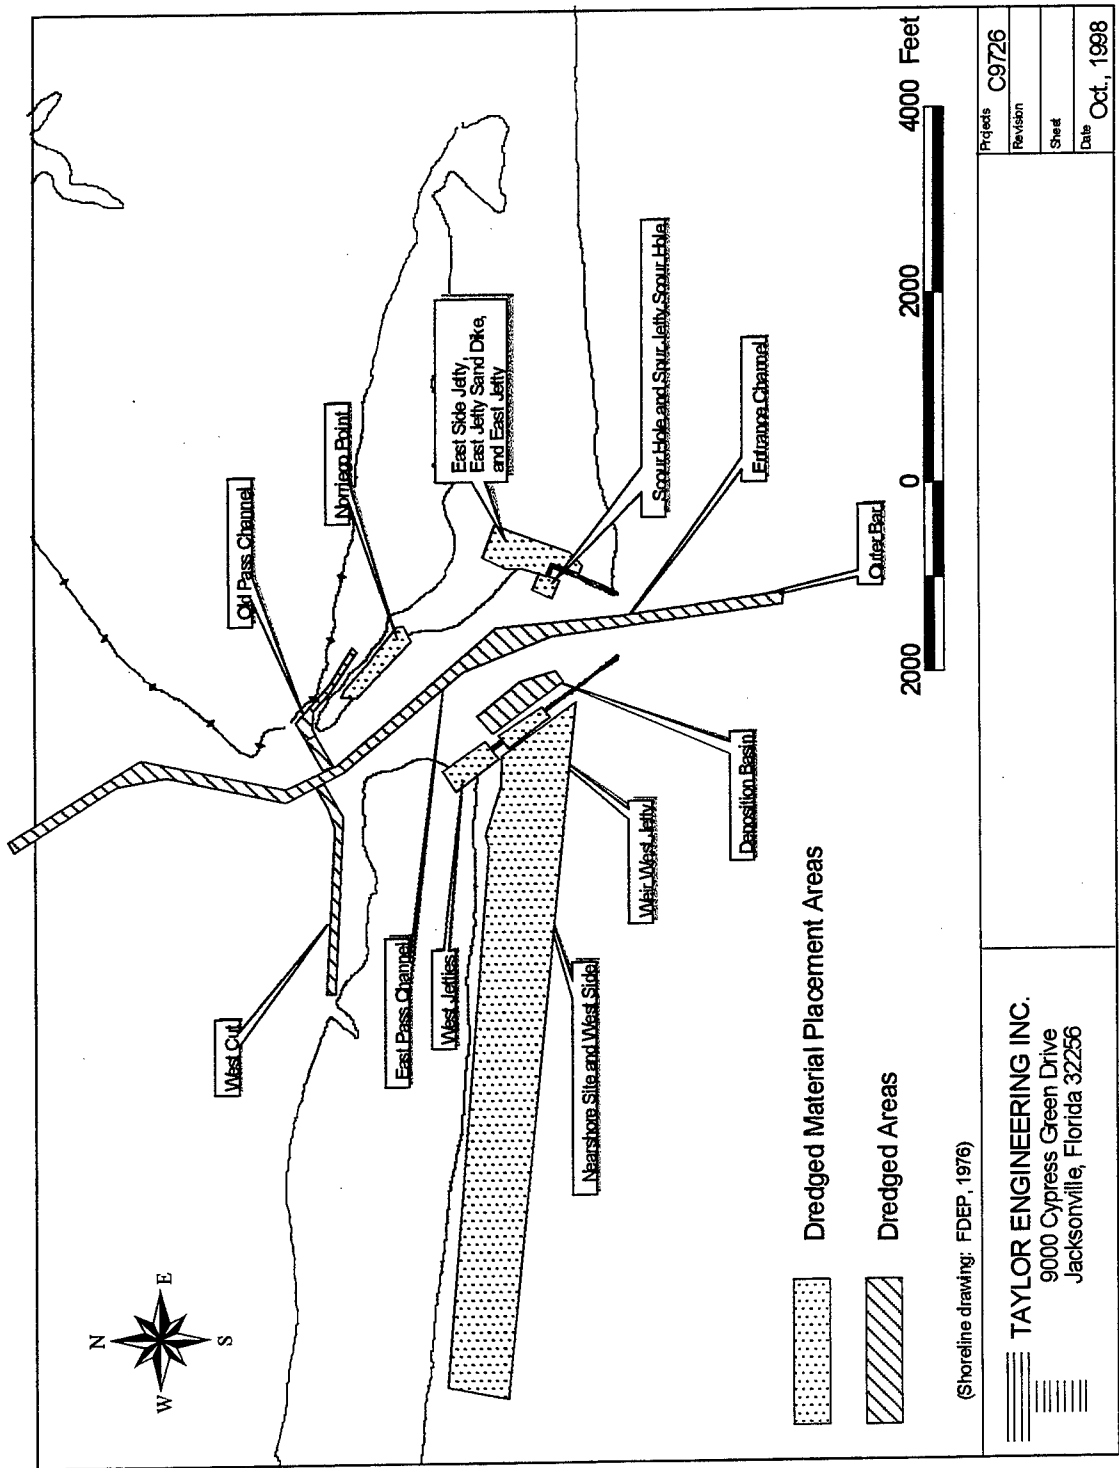
Figure 2. Dredging locations and placement sites

Between 1931 and 1995, dredging removed approximately 4 million cubic yards of sediment — about 64,000 cu yd/year — from the project channel. Figure 2 illustrates the locations of the dredge sites and disposal placement areas that encompass all dredging activity at East Pass. Figures 3 and 4 categorize the dredged and placed volumes by site. Some of the designations required considerable estimation. As is usually the case, the dredging records (especially early records) were incomplete. Figures 3 and 4 show that dredging frequency has decreased, while the magnitude of volume dredged has increased. This trend is explained by advances in economic dredging practice. Notably, before 1964, Open Water/Surf Zone designation characterized much of the dredge-material placement. Figure 2 does not denote this area because no reliable record exists of the actual placements. Also, during its early history, side-cast dredges were used to maintain the channel. Thus, the placement area depended on the maintenance location. Table 1 summarizes the dredging activity at East Pass throughout its history.

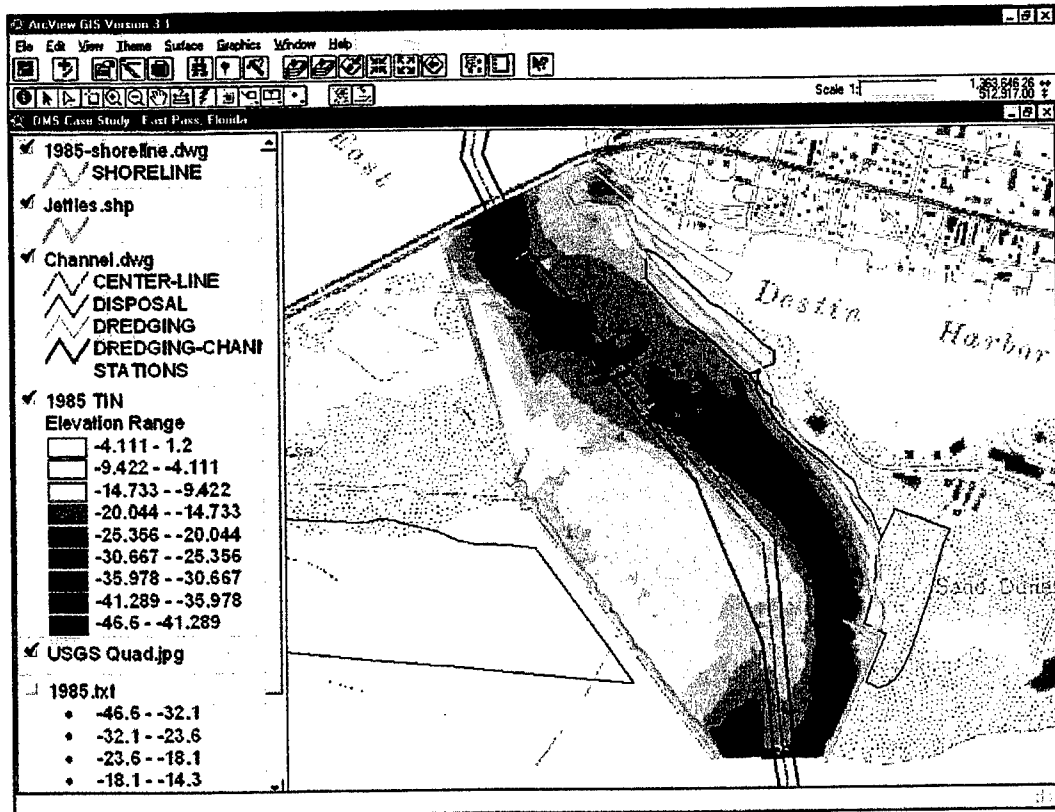
Figure 6. Example of data formats available in the DMS-Data Manager

This example illustrates some of the usable data formats in the Data Manager. First, a georeferenced image of a U.S. Geological Survey (USGS) 7.5-min quadrangle (labeled *USGS Quad.jpg*) provides the underlying base map. An AutoCad drawing (*Channel.dwg*) of the authorized channel and disposal sites has been layered on top of the base map. Above the CAD drawing, the east and west jetties are shown as an ArcView shapefile (*Jetties.shp*). Point data from a comma-delimited X,Y,Z ASCII file (*1985.txt*) were loaded into the project but not displayed. However, the point data were used to create a triangulated irregular network (TIN) to represent the surface defined by a 1985 bathymetric survey. The TIN has been color coded based on the given elevations to illustrate depths within East Pass. As this single screen shot shows, multiple data formats can now be brought together to provide a detailed view of a project.

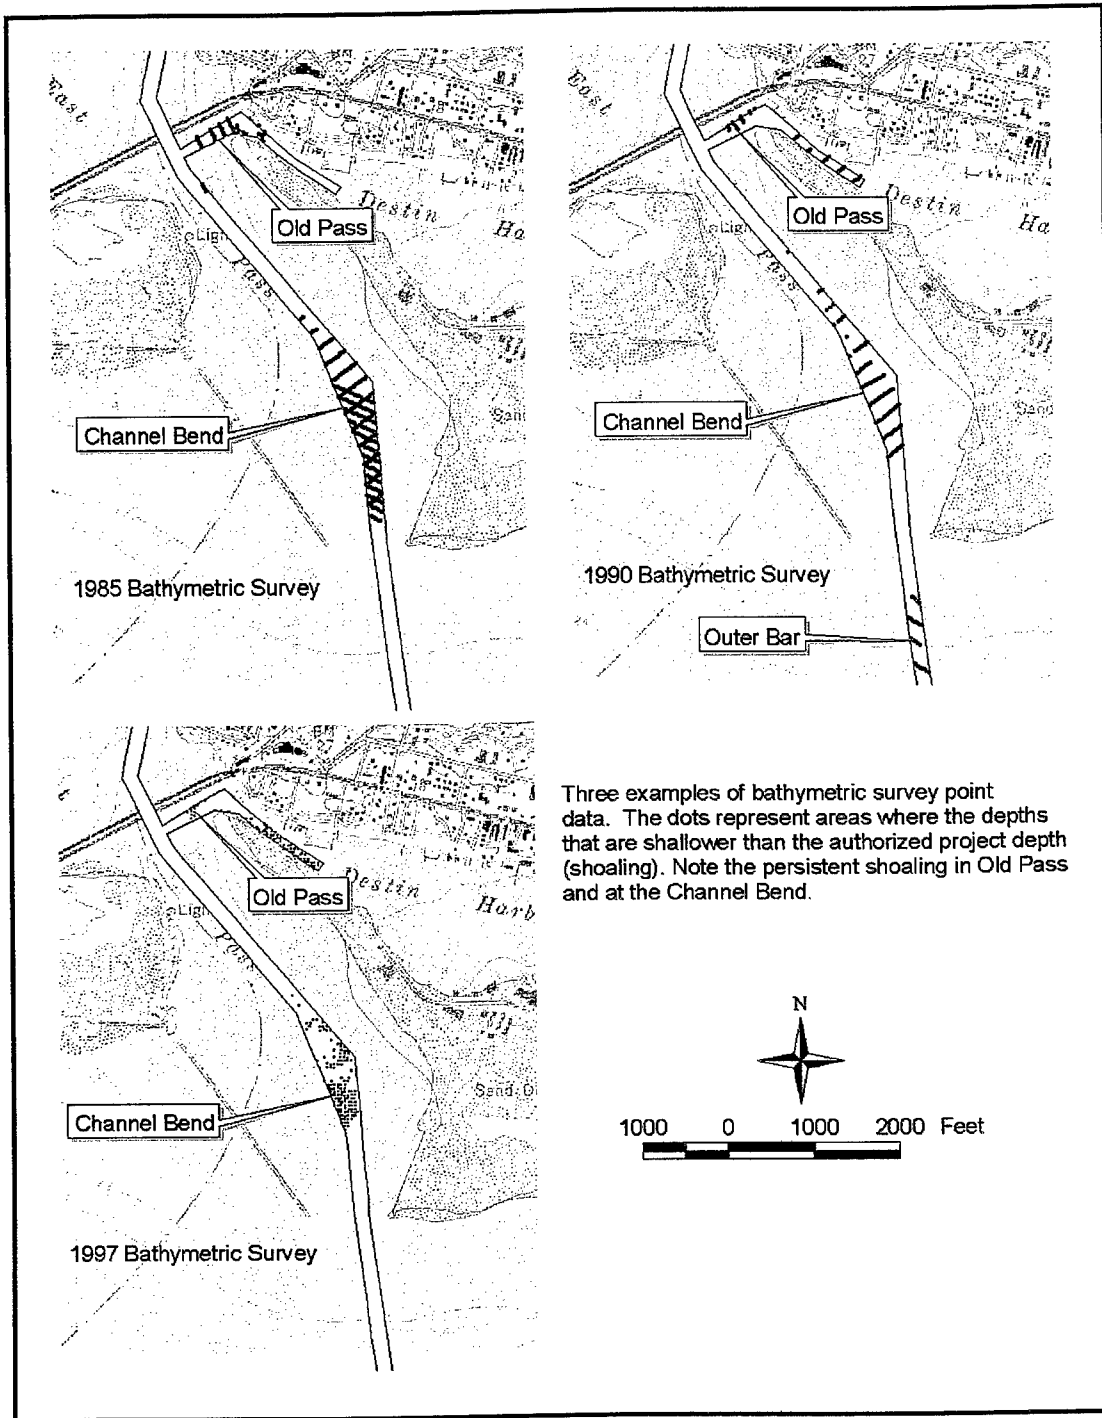
Figure 7. Bathymetric survey comparisons, 1985, 1990, 1997

Three examples of bathymetric survey point data. The dots represent areas where the depths that are shallower than the authorized project depth (shoaling). Note the persistent shoaling in Old Pass and at the Channel Bend.

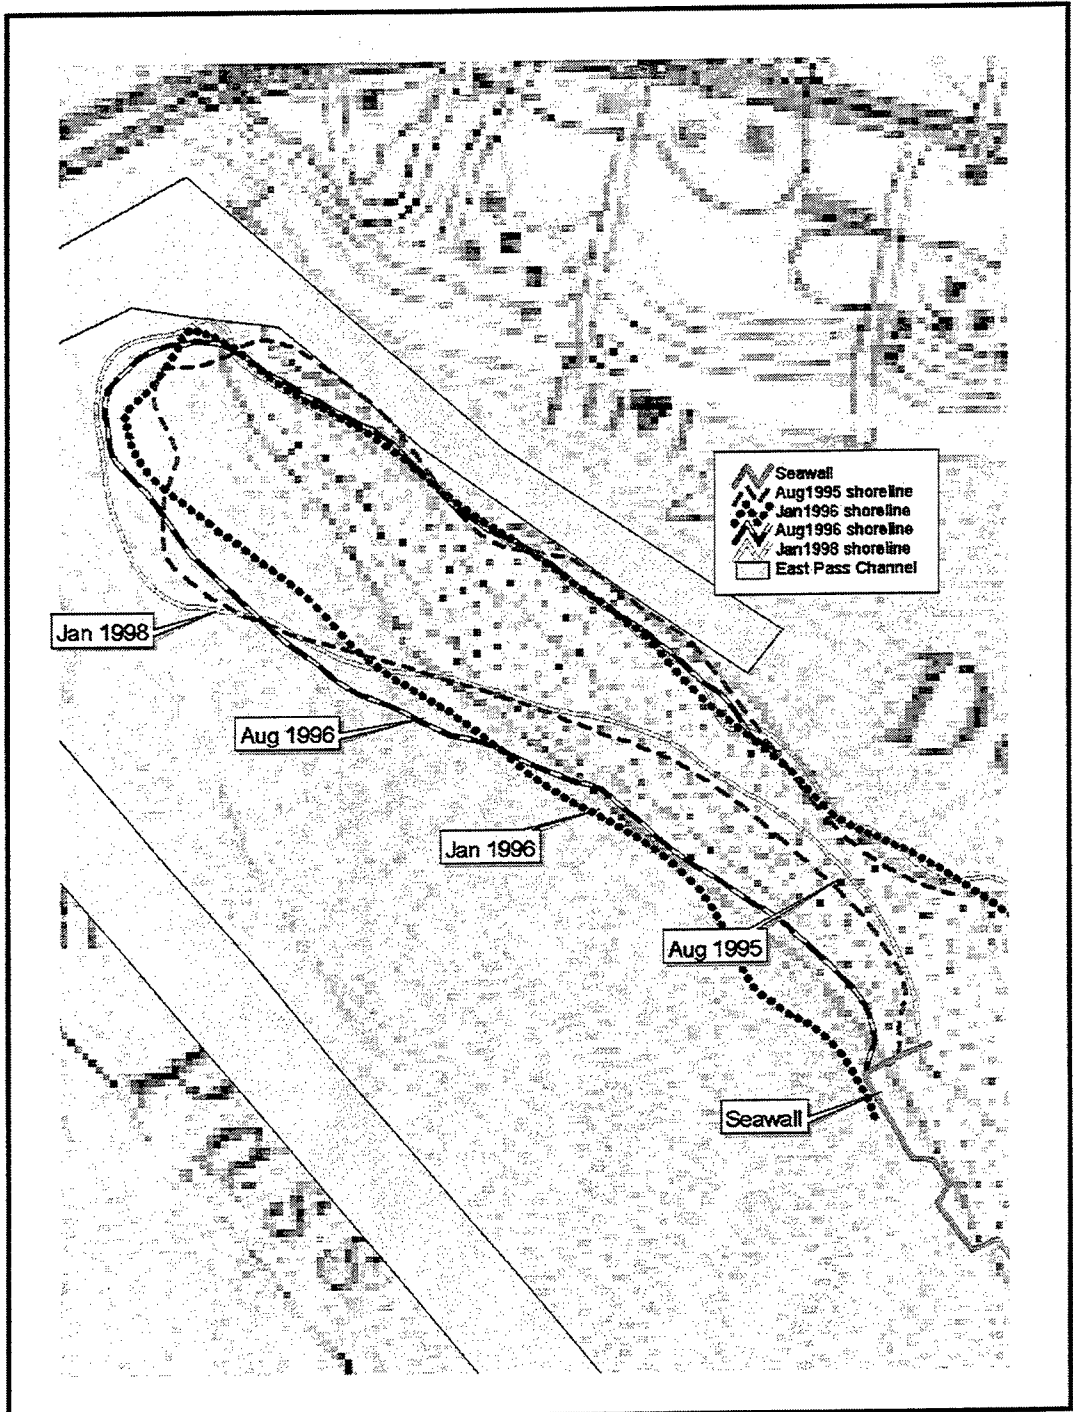
Figure 8. Norriego Point shoreline evolution

A particular area of concern to the East Pass project engineers is Norriego Point, one of several sites serving for disposal of the dredged material taken from the authorized channels. Norriego Point shelters Destin Harbor from offshore waves that propagate through the jetties into East Pass. Sand historically erodes from Norriego Point into the channels. To document the erosion of Norriego Point, Figure 8 shows four shoreline surveys taken over a 30-month period. The August 1995 shoreline shows conditions before the impact of Hurricane Opal. The January 1996 survey shows conditions following emergency Post-Opal dredging operations that placed sand on Norriego Point. The August 1996 survey shows some of the initial evolution of the shoreline position following placement. Finally, the January 1998 survey shows that the shoreline again approximated 1995 conditions. Chapters 3 and 4 investigate possible contributions that the eroding Norriego Point may have to the shoaling in the authorized channels.

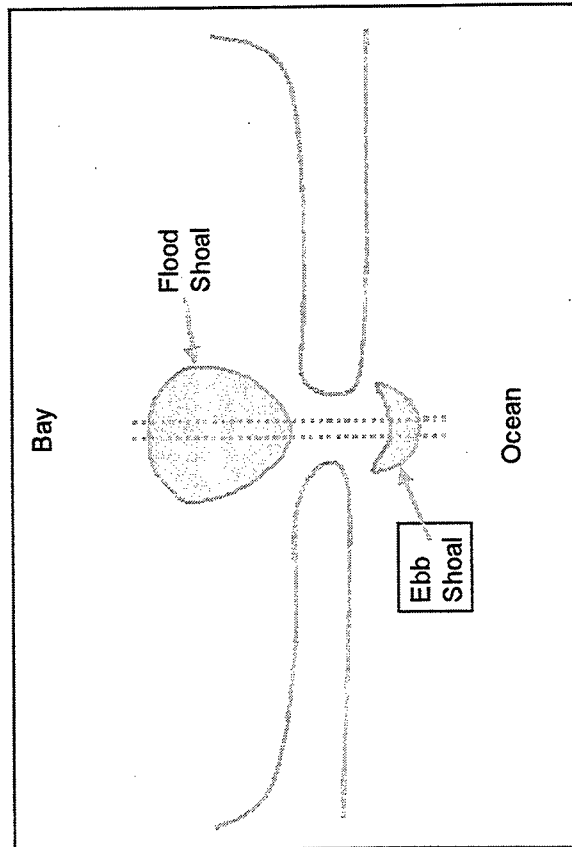
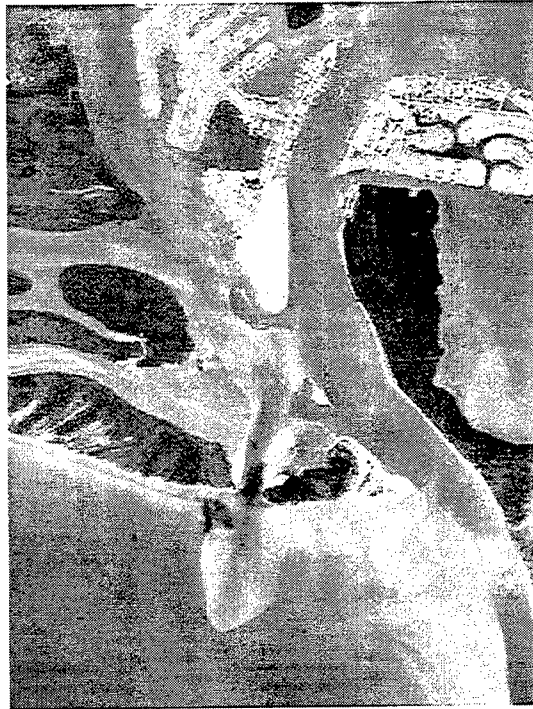
Figure 9. Example page of the DMS-Manual (*Horizontal Expansions: Expansion into Ocean – Ebb Tidal Shoal*)

**Description:** A crescent- or box-shaped shoal that forms at the seaward end of a tidal inlet. Shape of this shoal depends on the area's wave climate.

**Processes:** Wave-induced sediment transport (littoral drift) interrupted by the inlet is directed seaward by the ebb tide. Sediment settles out in the region of relative calm away from the strong currents near the inlet mouth. The decrease in velocity results from the depth-dependent horizontal spreading of the ebb jet.

**Site:** Big Marco/Capri Pass, Collier County, Florida  
 Photographed 10/13/69

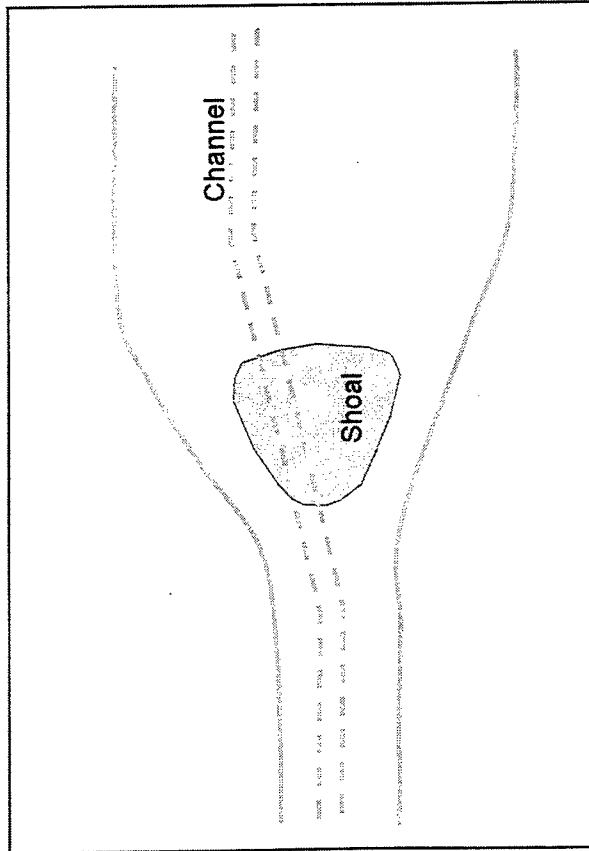
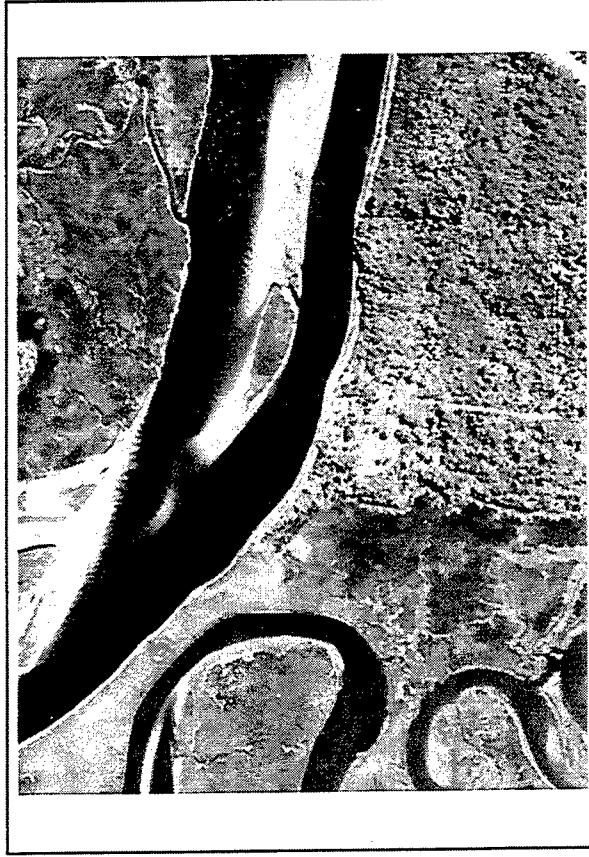
Figure 10. Example page of the DMS-Manual (*Horizontal Expansions: Areas of Shoreline Recession*)

**Description:** This shoal forms in areas of shoreline recession on either or both sides of the watercourse.

**Processes:** The transition from smaller to larger cross-sectional area is accompanied by a reduction in the flow velocity. Sediment is deposited as velocity decreases.

**Site:** Ft. George River, Duval County, Florida  
Photographed 3/9/83

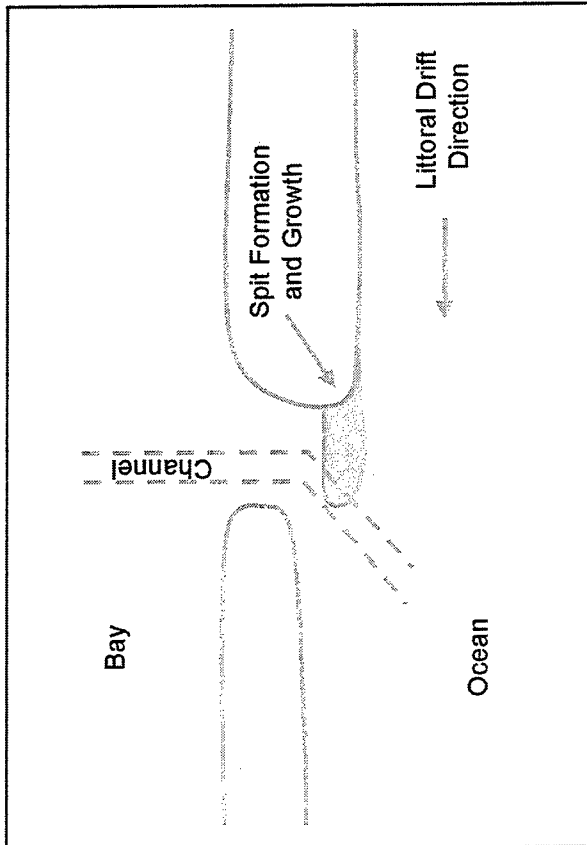
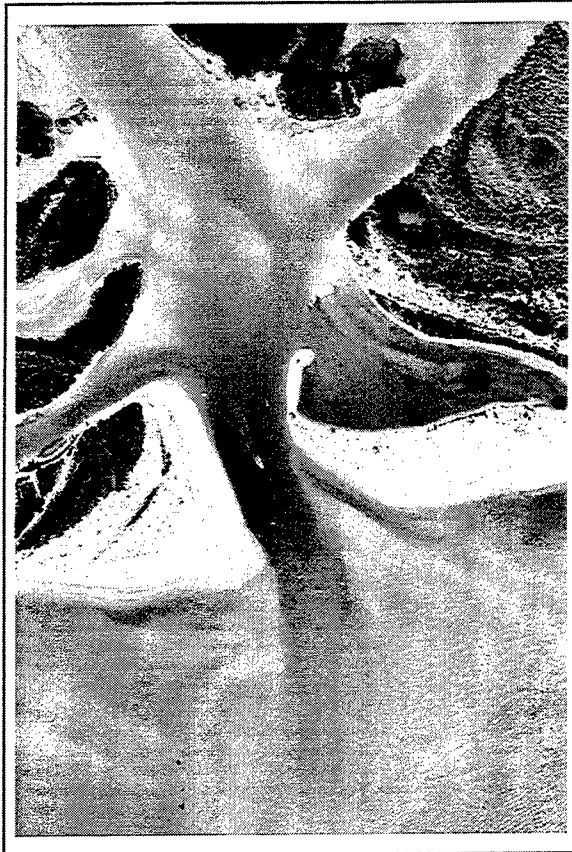
**Description:** Shoals may form and extend from areas of interruptions in the littoral drift, such as at inlets. These features grow in the direction of the littoral drift and are often manifested as subaerial spits.

**Processes:** Waves approaching a shoreline at an angle suspend and transport sediment along the shore. Where the littoral drift reaches a break in the shoreline, sand is deposited, forming a spit.

**Site:** Stump Pass, Charlotte County, Florida  
Photographed 2/15/68

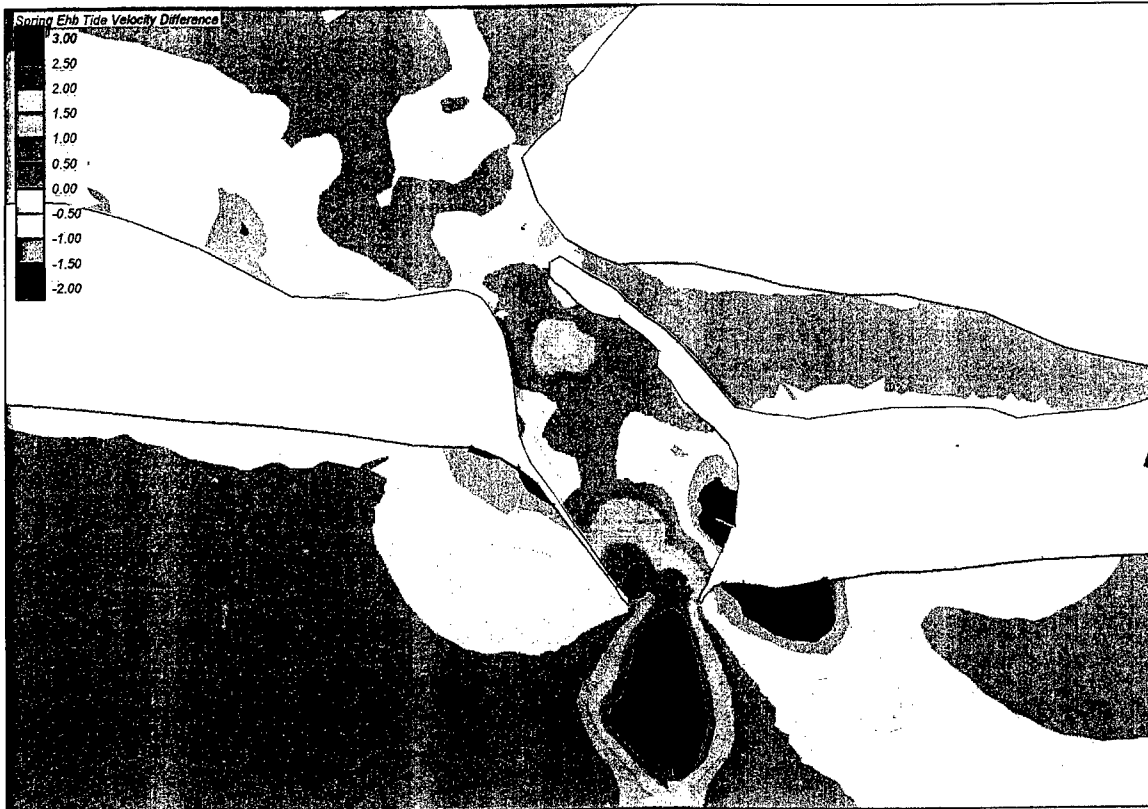
Figure 17. Example of comparison of solutions

In addition to these types of plots, graphics contours showing differences in two solution sets can provide informative comparisons. For example, Figure 17 was generated to investigate the change induced by jetty construction by plotting the difference in velocity magnitude for hydrodynamic model simulations of a 1947 bathymetry (pre-jetty construction) and a 1996 bathymetry (post-jetty construction). The plot shows the difference in spring ebb-tide velocity magnitude. Positive values (towards the blue end of the spectrum) denote increases in velocity magnitude, and negative values (towards the red end) denote decreases. Units are in feet per second.

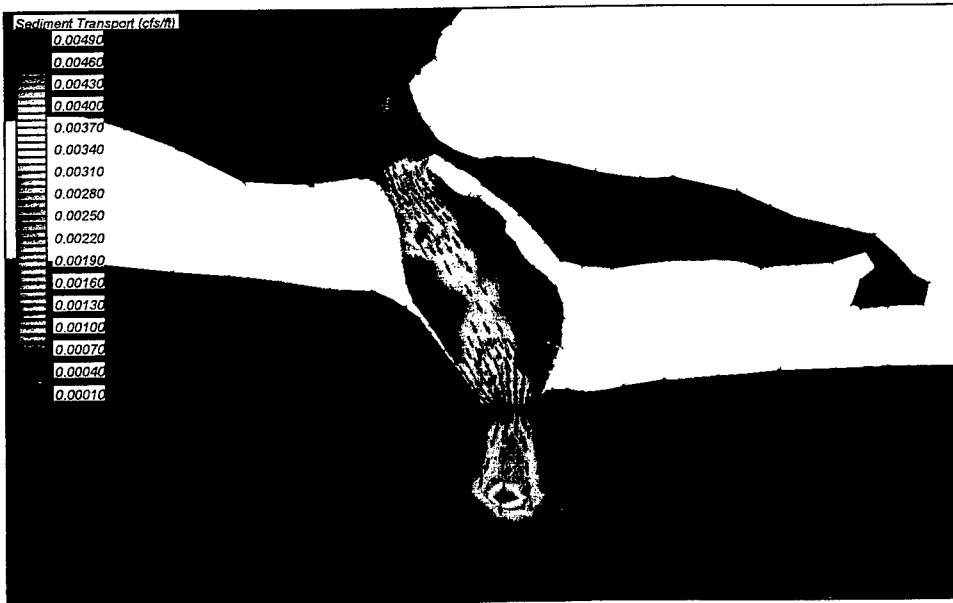
Figure 18. Example of contours of sediment transport

Application of the sediment-transport calculator produces a spatially variable scalar data set (a contour plot) of magnitude of sediment-transport rate. Interpretation of contours of sediment-transport magnitude is often difficult. One must remember that sediment-transport magnitude does not necessarily correlate to erosion or deposition. Erosion and deposition align more closely to the gradients of sediment-transport rate in the flow direction. If, for example, in a specified control volume, the sediment transport entering the volume exceeds the sediment transport leaving the volume, then most likely, the volume will contain deposition. The appropriate analogy is that of filling a bucket with a hole in the side. If water enters the bucket faster than it comes out the hole, the water level will rise (accretion). If water enters at a slower rate, then the water level will fall (erosion). The most prudent way to interpret these results is to conclude that sediment originates in areas showing sediment transport and moves in the direction of the velocity vectors. Figure 18 illustrates a contour plot of sediment transport overlaid with the water-velocity vectors.

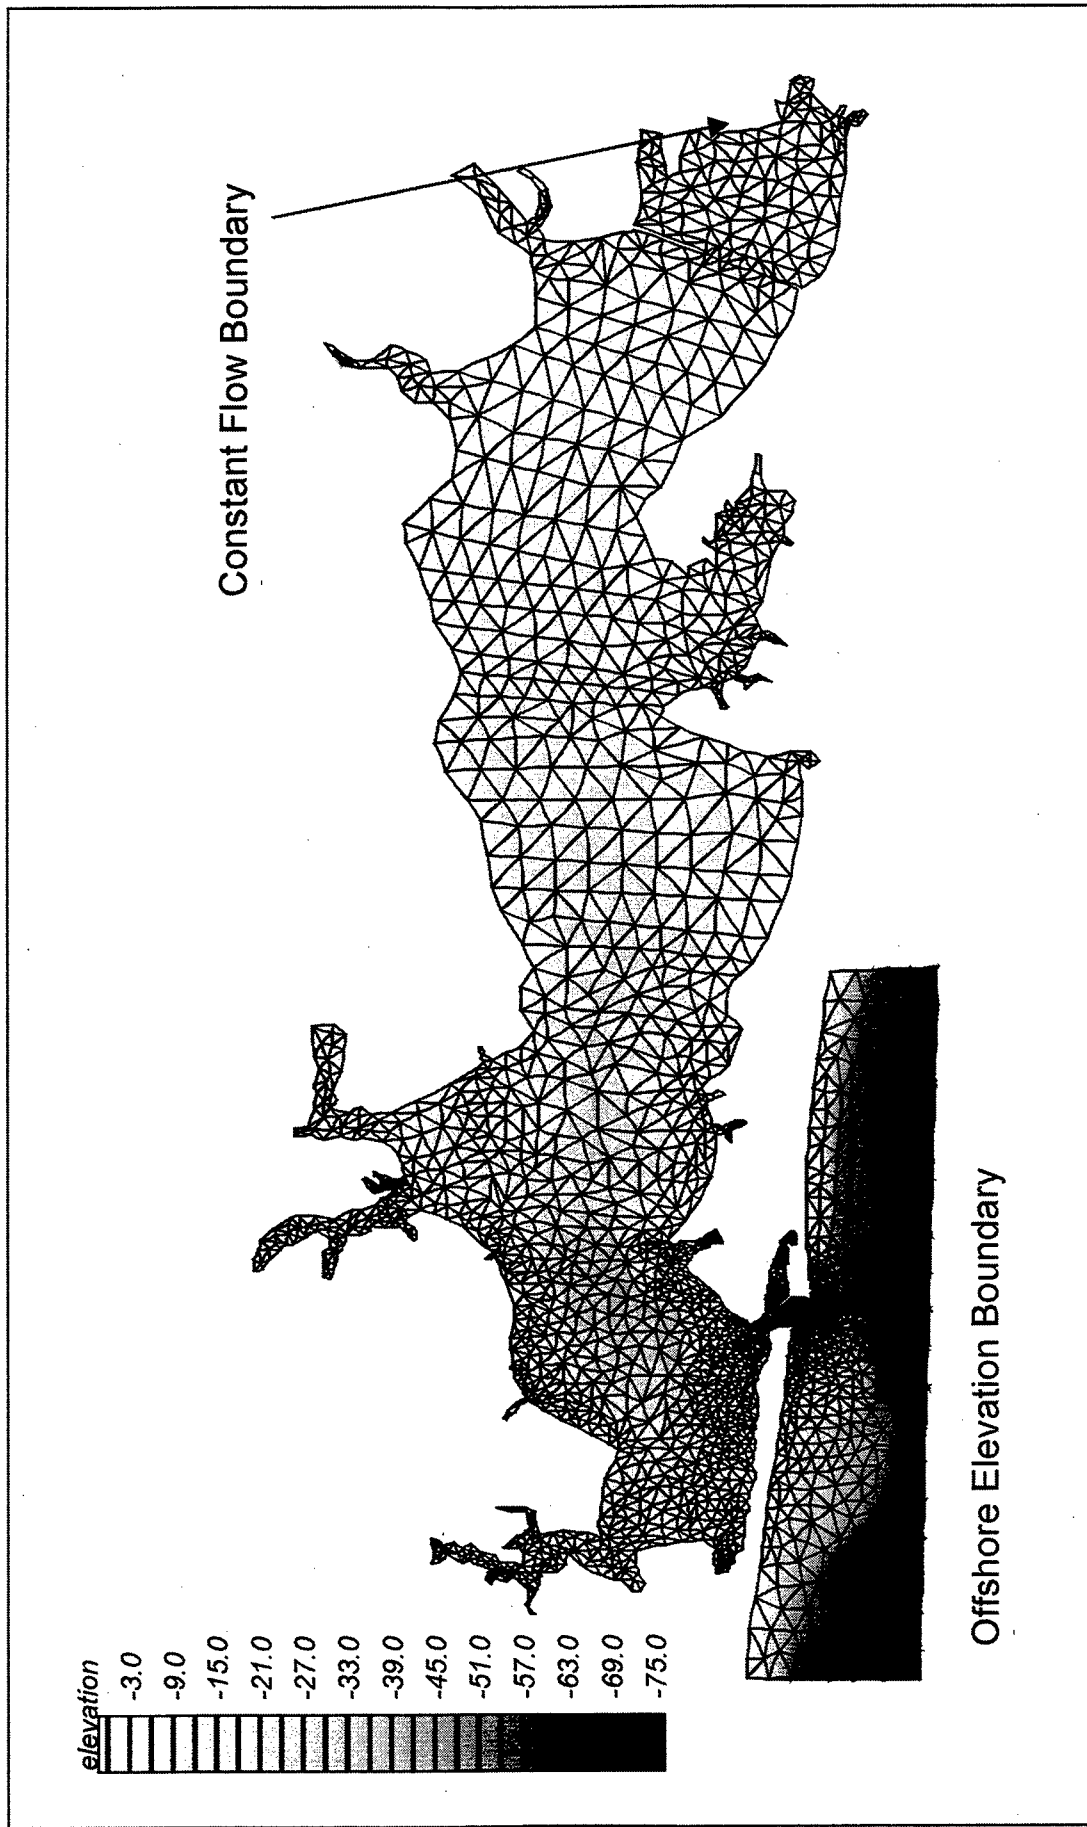
Figure 19. RMA2 solution mesh for East Pass Inlet and vicinity

Figure 19 depicts the bathymetry input to RMA2. The constructed bathymetry reflects a combination of the following hydrographic surveys, which characterize the area given in parentheses:

- 1997 USACE SHOALS Lidar Survey (Inlet Vicinity)
- 1996 USACE SHOALS Lidar Survey (Inlet Vicinity)
- 1987 NOAA Nautical Chart #11385 (Choctawhatchee Bay)
- 1995 NOAA Nautical Chart #11388 (Gulf of Mexico)

Two boundary conditions were specified for the model. Month-long tide gauge records provided the water-surface elevations at the offshore boundary located approximately 2 miles offshore. Averaged flow measurements of the freshwater influx specified the flow boundary condition situated across the Choctawhatchee River Delta on the eastern border of the bay.

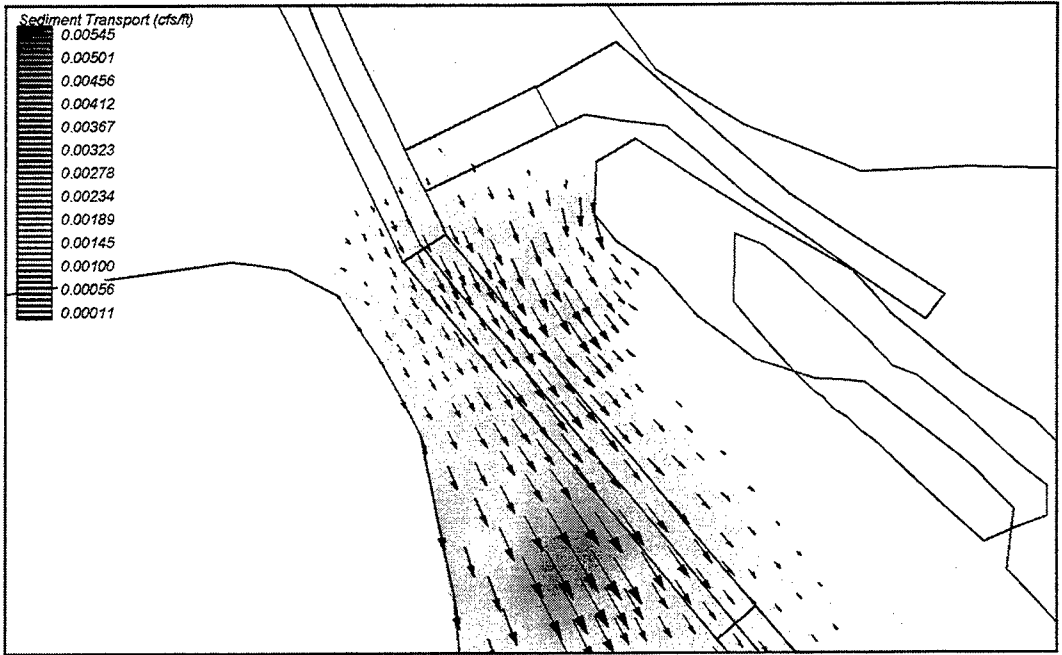
Figure 28. Sediment transport during spring flood at Old Pass

Figures 28 and 29 illustrate sediment-transport contours and vectors during spring flood and ebb near Old Pass. These figures show much less variation than the previous example. Except for a small region to the west of the area during flood (Figure 28), the contours of sediment-transport magnitude are constant (solid) in almost every area within and surrounding this shoal. Near-constant sediment-transport magnitude indicates that little sediment deposits in these areas. This result suggests a need to reevaluate the classification of this shoal. Examination of the wave climate in this area helps to clarify the classification.
