# Evaluation of NDT technologies in support of CP 140 aircraft sampling inspection

Technical Memorandum  
DCIEM TM 1999-116  
October 1999

**EVALUATION OF NDT  
TECHNOLOGIES IN SUPPORT OF  
CP 140 AIRCRAFT SAMPLING  
INSPECTION**

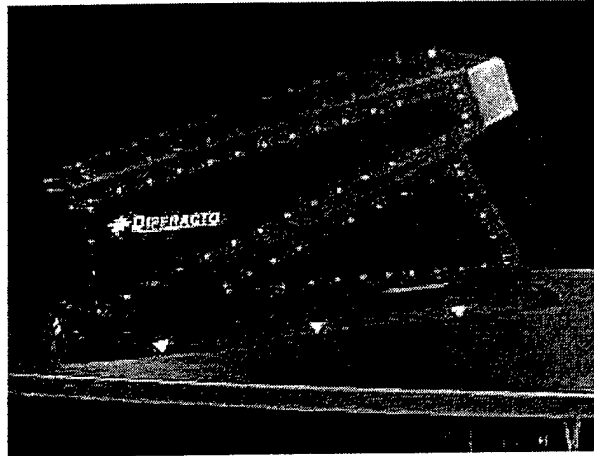
DAIS - It is a patented method of visualizing surface distortions, depressions, or protrusions as small as 10  $\mu\text{m}$  [1]. It is a real-time technique particularly applicable to rapid inspection of large surfaces. The optical set-up consists of a light source, a retroreflective screen, and the object inspected. If a flat surface with an indentation is inspected, the light striking the indentation is deflected. It then strikes the retroreflective screen at a point removed from the light rays reflected from the area surrounding the indentation. The retroreflective screen attempts to return all rays to the points on the inspected surface from which they were reflected. The screen, consisting of numerous glass beads, returns a cone of light to the surface instead. In its basic configuration, the technique is used directly as an enhancement to visual inspections.

Figure 1  
D-Sight Aircraft Inspection System from [2]

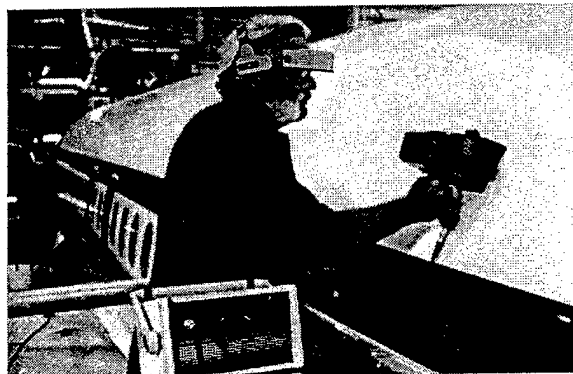
Magneto-Optic Imager (MOI) - The Magneto-Optic/Eddy Current Imager combines induced eddy current excitation with direct magneto-optic detection to produce real-time images of cracks, corrosion and other surface flaws. Disruptions of the induced currents caused by rivets, cracks, corrosion and other defects produce magnetic fields that are imaged directly by a magneto-optic sensor. The physical principle is that when a plane polarized light passes through glass in a direction parallel to an applied magnetic field, the plane of polarization is rotated [3]. Hence, a flaw would cause a variation of magnetic field and affect the images produced by the instrument.

Figure 2  
Magneto-Optic Imager from [4]
