4. TITLE AND SUBTITLE  
"Investigating the Crevice Corrosion Behavior of Coated Stainless Steel in Seawater" 5. FUNDING NUMBERS  
Contract  
N00014-97-C-0216

**INVESTIGATING THE CREVICE CORROSION BEHAVIOR OF  
COATED STAINLESS STEEL IN SEAWATER  
(Contract N00014-97C-0216)**

***FINAL REPORT***

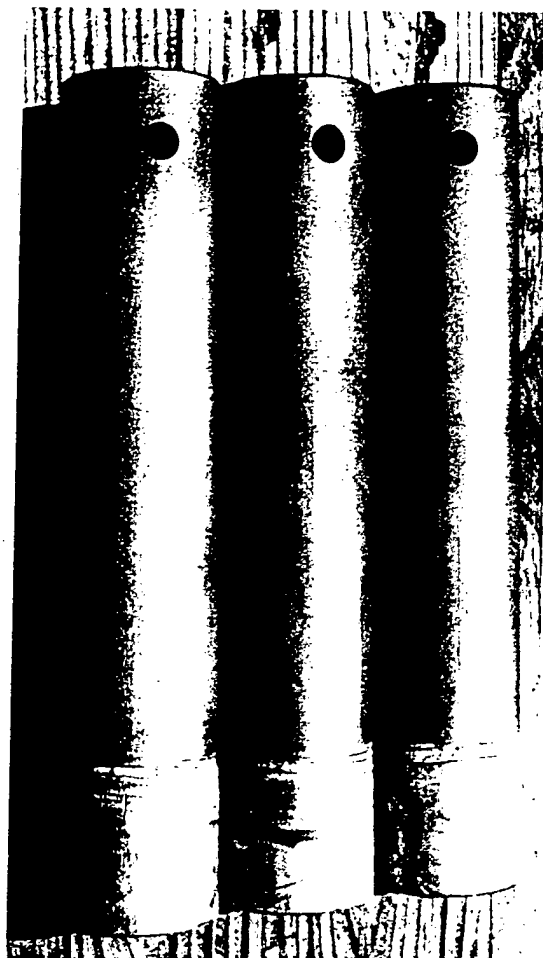
Figure 2 provides a representative view of the specimens after cleaning. The poor paint adhesion on the mill surface may have influenced the crevice corrosion process for some specimens. The paint was much more adherent to the grit blasted surfaces. For these, coating disbondment was observed only at areas affected by crevice corrosion.

*Figure 2 - Examples of crevice corrosion which developed on partially coated S31603 pipe exposed to warm seawater for 6 months. Shown triplicates of grit blasted pipe specimens with brush-applied epoxy paint on 20% of OD surface.*

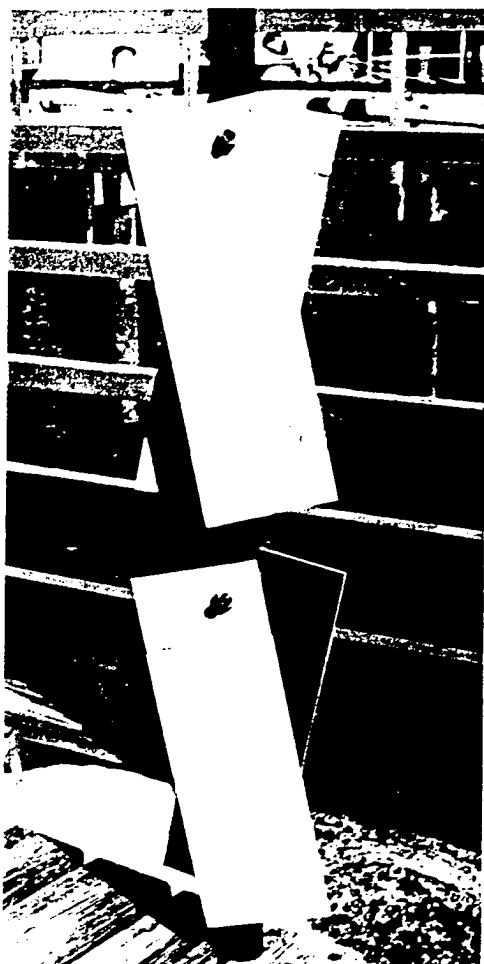
Figure 3 - Pre-test view of partially coated stainless steel sheet specimens (same coating system as in Figure 1).

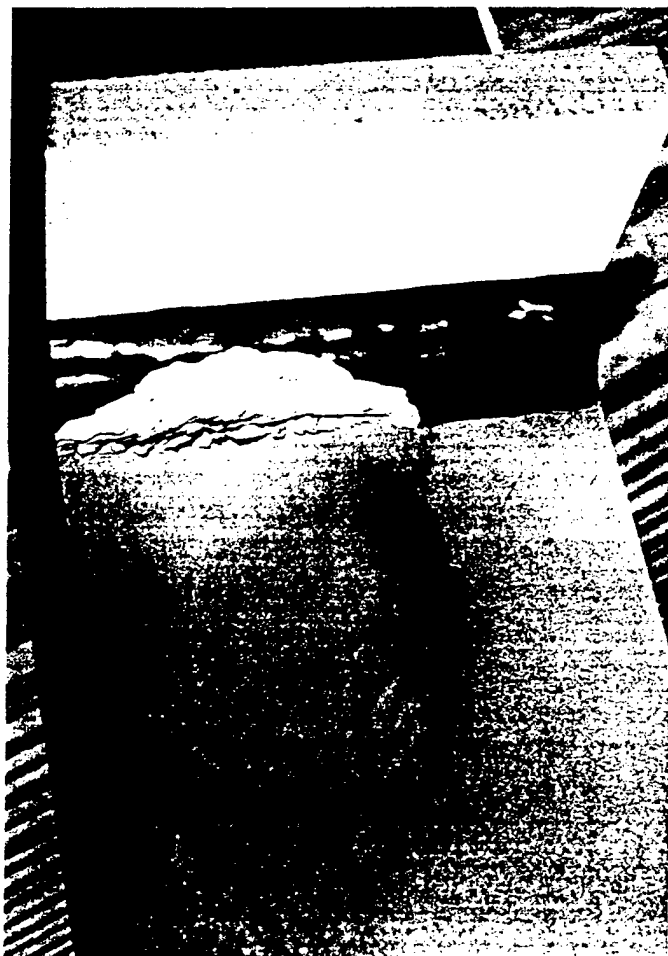
more than that found at the S20910 sites. In each case, the alloy N06625 weldment was also attacked. While not quantified by depth measurement, the weld attack shown, for example, in Figure 7 was significant. For the above nine specimens, base metal-heat affected zone depth of attack near the weld toe ranged from 0.12 mm to 2.77 mm (max.). Eighty percent of the sites measured  $\geq 0.50$  mm. The average maximum value and standard deviation value for the preceding were 1.37 mm and 0.82 mm, respectively.

*Figure 7 - Example of crevice corrosion affecting weld metal (N06625) used for joining N08367 cruciform specimen and exposed to warm seawater for 60 days.*

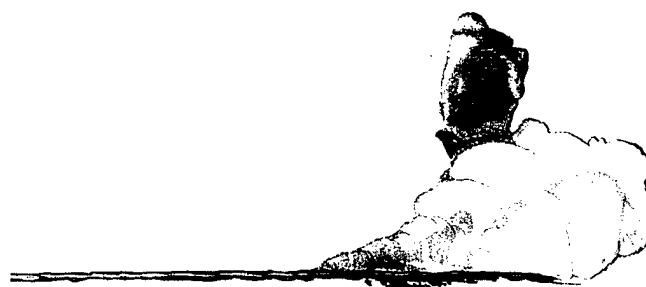
Figure 20.2  
Attack at scribe site on epoxy coated  
S20910 panel (blasted surface)
