# A TRIDENT SCHOLAR PROJECT REPORT

NO. 265

**The Use of Thermal Spraying to Enhance the  
Bonding Characteristics of a Urethane Coated Propeller**

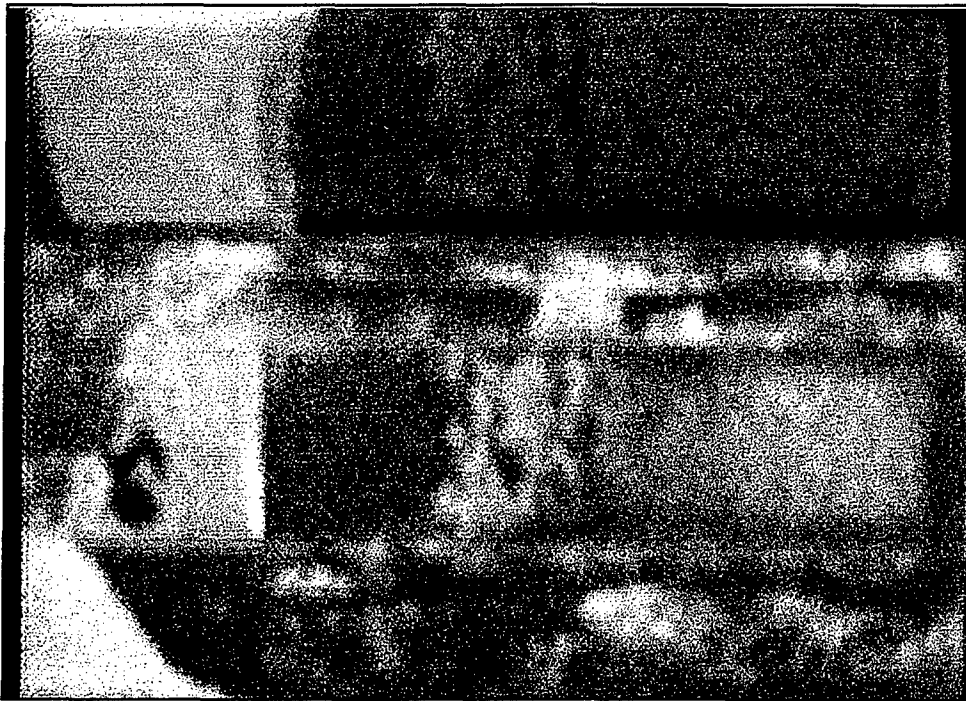
**Figure 30 - typical view of a peel surface which failed between the paint and NAB interface during the 90-degree peel test.**

The visual verification that the paint remained adhered to the thermally sprayed coating indicates that the mechanical bond between the paint - NAB interface was still sufficiently strong, and that the failure occurred within the thermally sprayed coating.
