AFWAL-TM-85-246-FIMN

EXPERIENCES WITH A SIMPLE
SKIN FRICTION BALANCE DESIGN

BY
E. L. WHITE
AEROMECHANICS DIVISION
FLIGHT DYNAMICS LABORATORY
WRIGHT-PATTERSON AFB, OHIO

NOVEMBER 1985

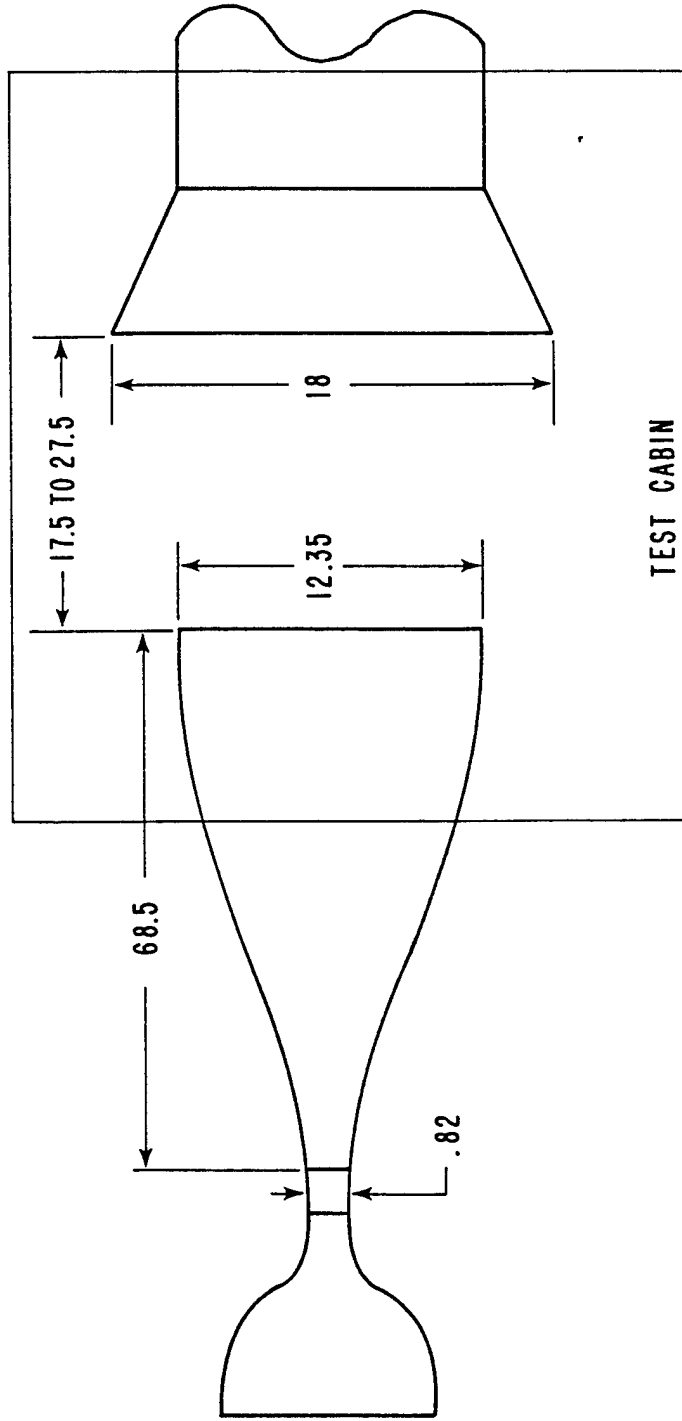
FIGURE 1

M=6 HIGH REYNOLDS NUMBER FACILITY

P_0	T_0	RN/FT.
PSIA	$^{\circ}R$	—
700	1100	10×10^6
2100	1100	30×10^6

The first tests with a VRA balance were performed in the M=6 High Reynolds Number Facility (HRNF) which operates at a stagnation temperature of 1100 degrees R. The overall length of this balance was 1.75 IN. It was mounted about 17 inches aft of the leading edge of a flat plate. A model support system injected the model into the flow after supersonic flow was established. There was no provision for mechanical vibration damping of the balance. The calibration factor was furnished with the balance. The test data was primarily recorded by Hewlett-Packard X-Y recorders. A slow speed digital recording system was also used. The first series of runs showed that vibration damping was required. A zero shift occurred in the output signal when the test cabin pressure dropped after establishing flow and before the flat plate was inserted into the flow. The output was also too low to obtain any reasonable resolution or accuracy. Bench tests were performed and it was found that the zero shift was due to the drop in test cabin pressure.

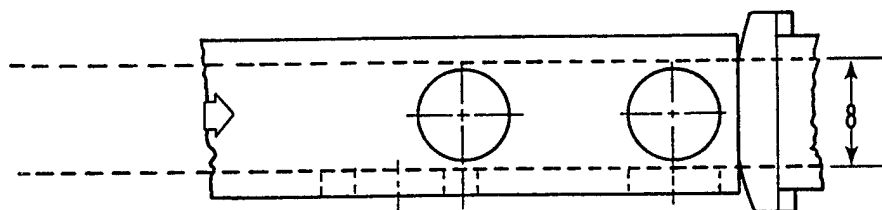
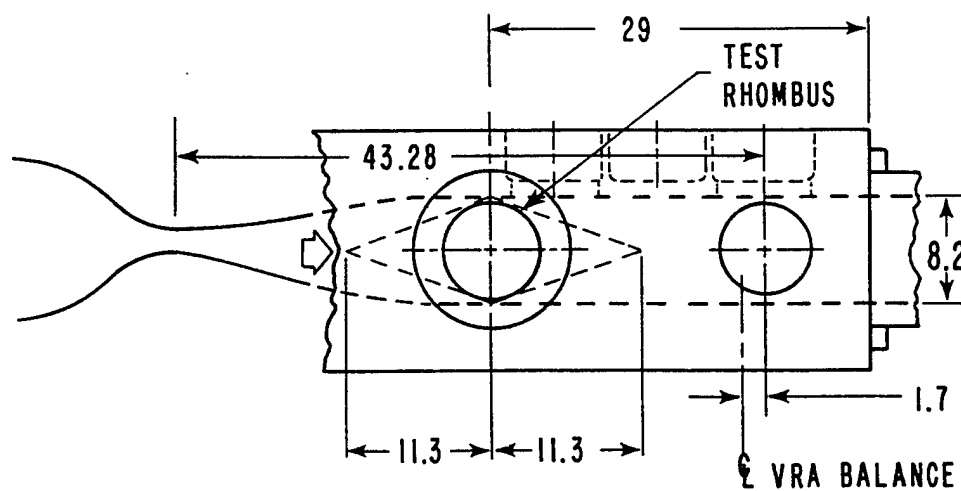
FIGURE 2

M = 3 HIGH REYNOLDS NUMBER FACILITY

P_0	RN / FT.
PSIA	—
50	10×10^6
600	100×10^6

NO T_0 CONTROL

TUNNEL TOP VIEW

TUNNEL SIDE VIEW

The balance was installed in the bottom wall of the tunnel as shown in Fig 2. Test runs were made at a series of total pressures (P_0) and at the various pressure levels, incremental changes of ± 20 psi were made to check the resolution capability of the balance. Normal run times were between 2 and 3 minutes in duration. In addition to the mechanical vibration damping provided by the silicone oil, the recorded signal was improved by using electronic filtering particularly at the higher stagnation pressures. At $P_0 = 560$ psia with the bandwidth reduced to 10 Hz, the noise was 3.5 percent peak-to-peak of the DC signal. The balance output signal followed the stagnation pressure very well (Fig 5).

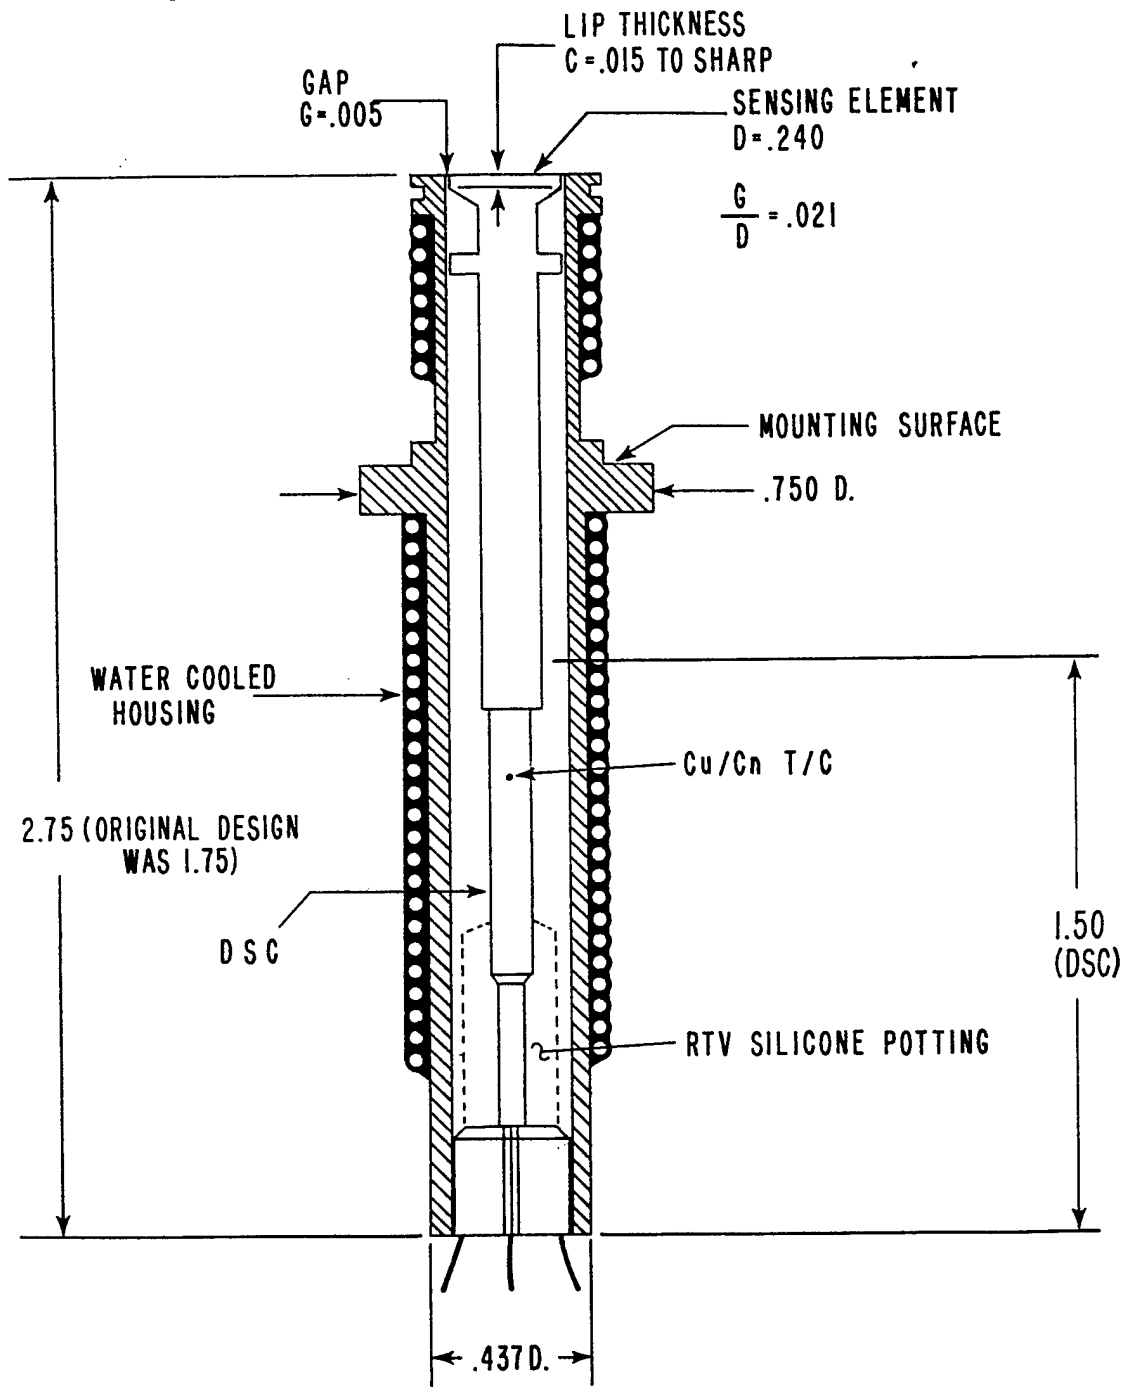
FIGURE 3

VRA SKIN FRICTION BALANCE

The Virginia Research Associates (VRA) skin friction balance design (Fig 3) is based on the Kistler-Morse Deflection Sensor Cartridge (DSC). It consists of a cantilever beam with two silicon crystals glass-fused to the beam. The two crystals are wired as the active elements of a wheatstone bridge. The claimed performance of the DSC shows excellent linearity, repeatability, thermal stability, and hysteresis characteristics (\leq metal foil strain gage). Thermal sensitivity variation is about three times greater (.01 percent of full scale/degree F) than for a metal foil strain gage. The maximum rated full scale deflection of the end of the DSC beam is $\pm .015$ IN. The original version of the VRA design

The balance (Fig 3) consists of a water cooled housing which provides for a press fit with the base of the DSC. The sensing element is press fit on the other end of the DSC and made flush with the top of the housing. The gap between the sensing element and housing is .005 inch.

At this point it was decided to try an extended length version of the balance design in an attempt to get the output to a more acceptable level. The effective length of the beam was doubled by extending the length of the sensing element and balance housing. The extended length design is shown in Figure 3. To simplify the installation and testing, the M=3 HRNF was used for this test. The thermal environment is also less severe since the total temperature goes from ambient to -40 degrees F.

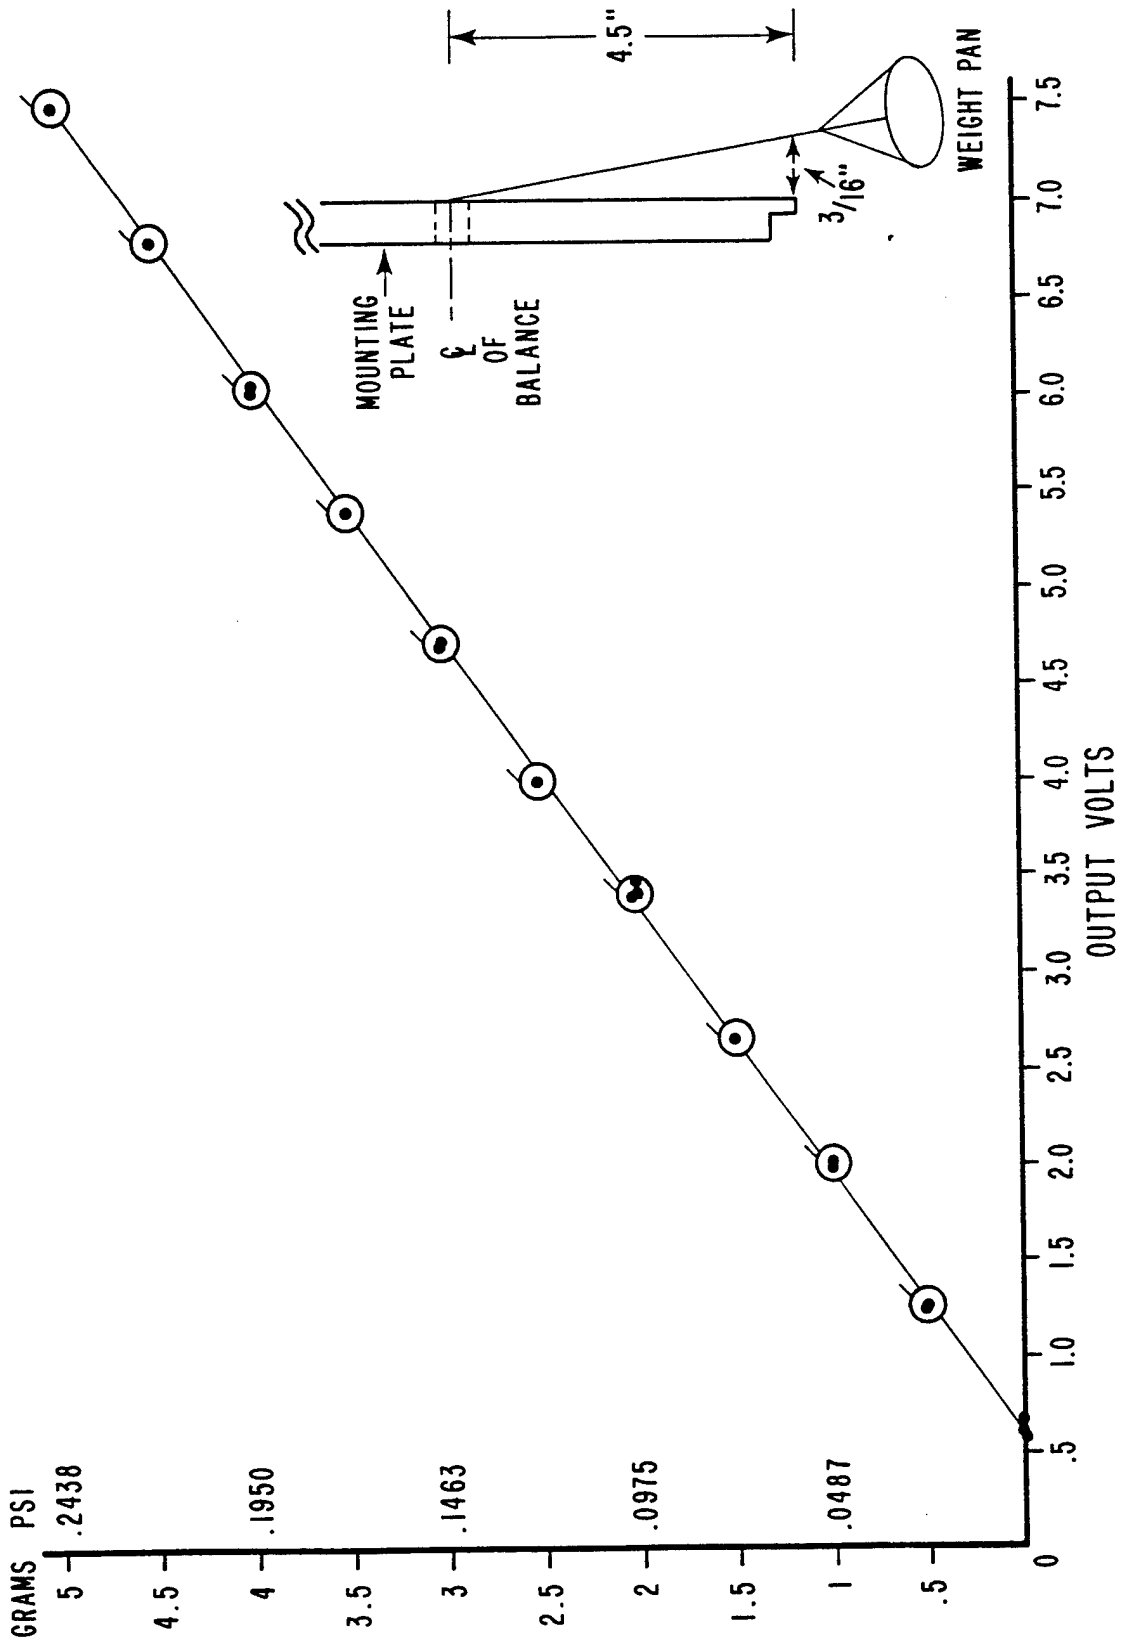
FIGURE 4

FORCE CALIBRATION OF VRA SKIN FRICTION BALANCE

The balance was calibrated with gravity loading and a linear and repeatable plot was obtained (Fig 4). The balance housing was then filled with 30,000 centistoke silicone oil and pressure and temperature effects evaluated. Before consistent pressure effect data could be obtained the silicone oil had to be thoroughly outgassed. The balance output varied as the gas bubbles worked their way through the fluid. The pressure was maintained below the lowest expected wall static pressure until there was no more variation in the balance output. Pressure effects on this damped balance were much less than for the original balance. The shift in the output of the extended length balance when the pressure is reduced to the lowest expected wall pressure (2 psia), is one percent of the full scale shearing stress of 0.1 psi (max shearing stress measured in M=3 HRNF). Since the first tests with this balance were planned for the M=3 facility, below ambient temperature effects were checked. Gaseous CO₂ was directed at the exposed surface of the balance to simulate the decreasing wall temperature in the M=3 facility. A thermocouple inside the balance housing monitored the temperature. The temperature effect due to cooling with CO₂ on the surface was about 0.5 percent/degree F based on a full scale shearing stress of 0.1 psi.

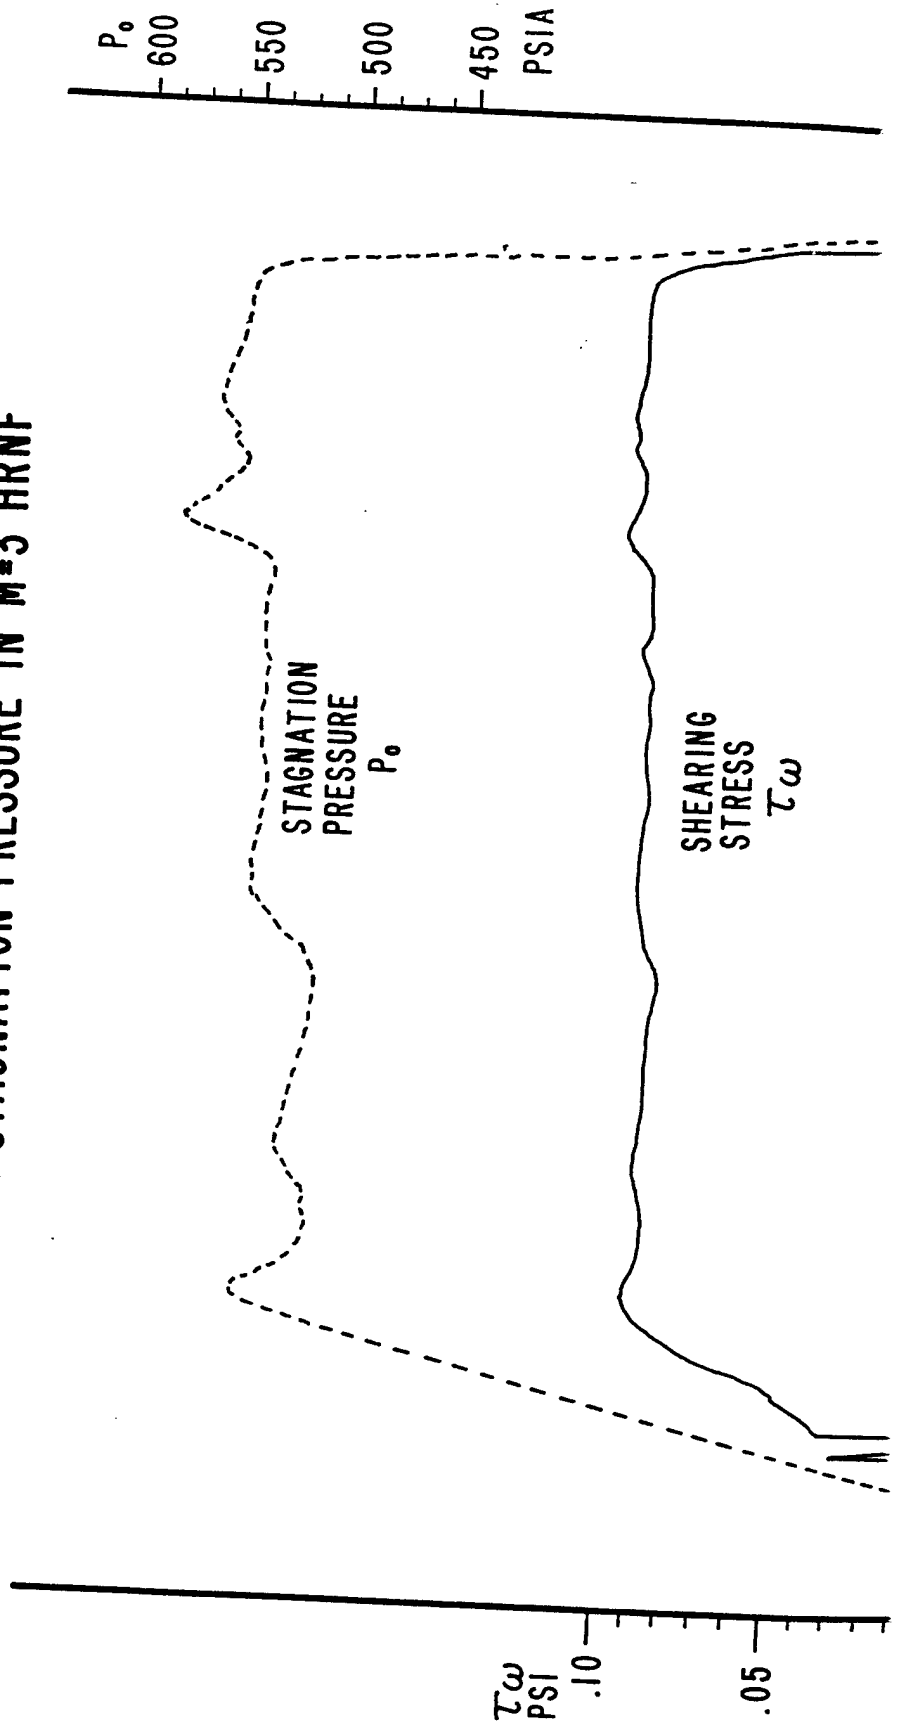
VARIATION OF MEASURED SHEARING STRESS
WITH STAGNATION PRESSURE IN M=3 HRNF

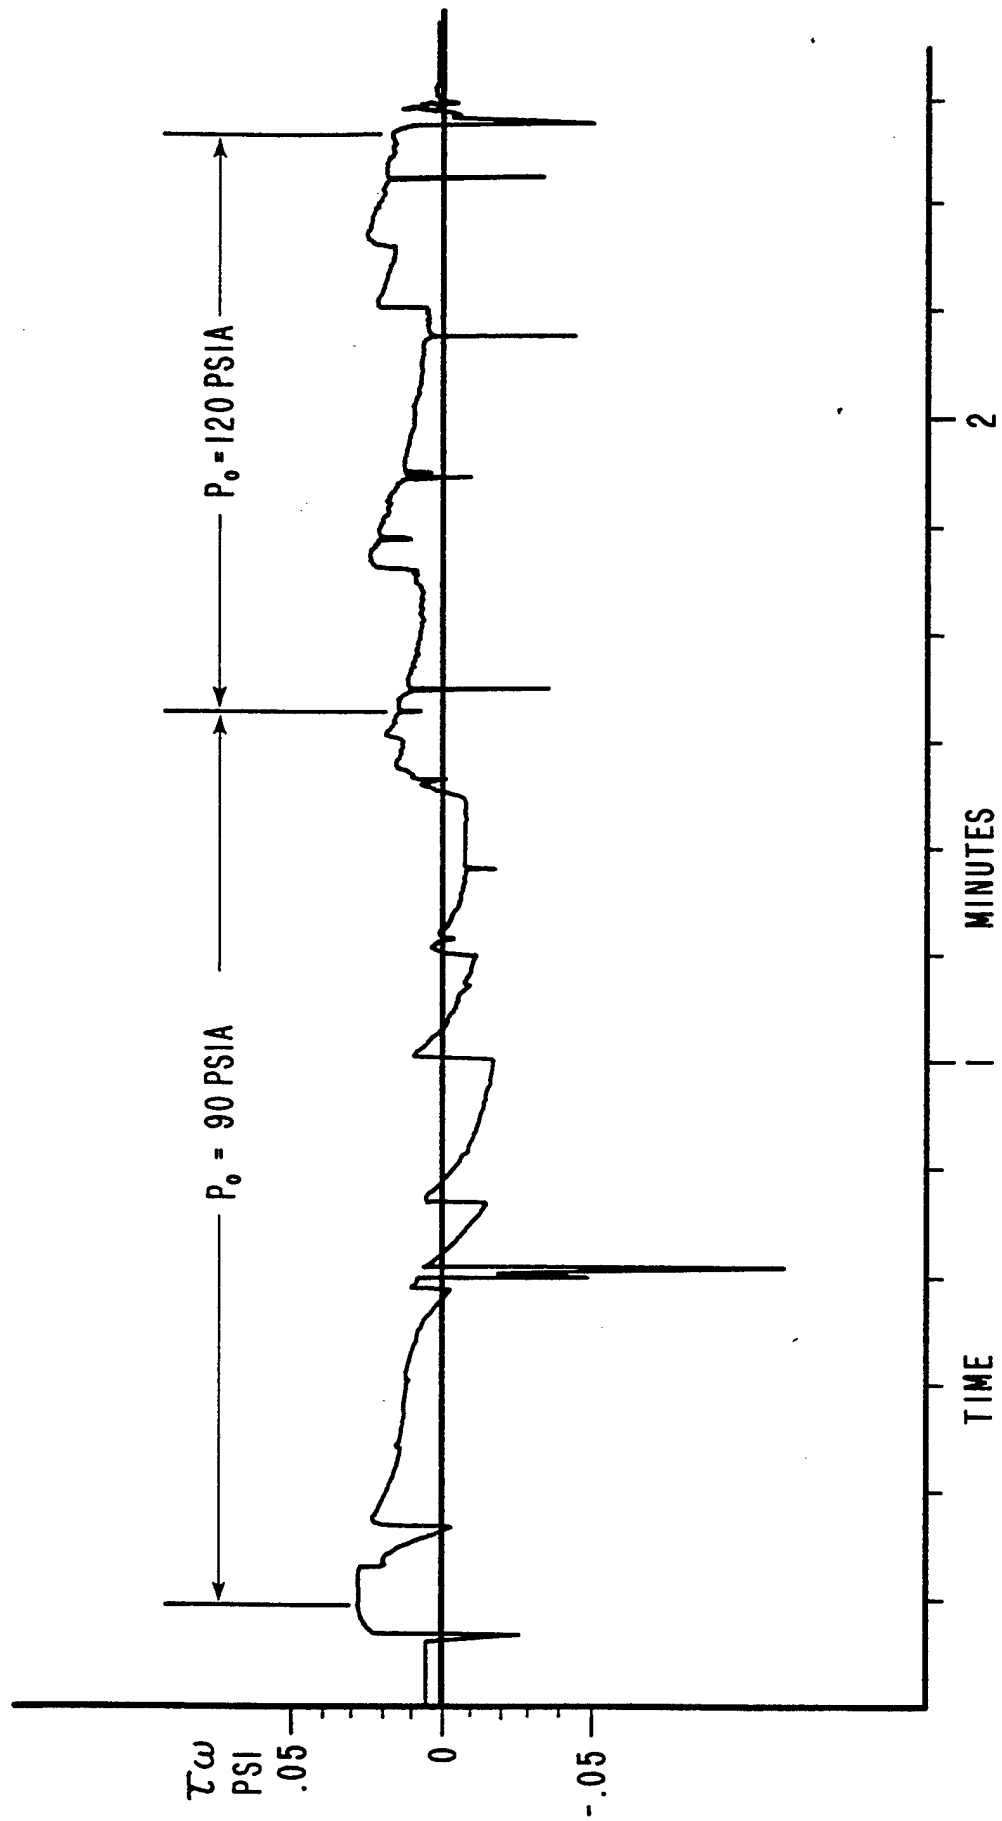
FIGURE 6

RESPONSE OF VRA BALANCE WITH SILICONE OIL

Below a stagnation pressure of 200 psia, a problem developed which made the balance data practically useless. A random variation of the output signal was observed which did not correlate with the stagnation pressure (Fig 6). To check for a possible flow problem at these pressures and at this particular tunnel station, a Kulite high frequency response surface mounted pressure transducer was mounted at the side of the balance and schlieren was set up to observe the flow at the wall. There was no correlation of the Kulite output with the balance output and the schlieren showed nothing unusual. The only thing unusual was oil streaks on the downstream side of the balance gap. The behavior of the data and the oil streaks suggest that droplets of oil are being pumped out of the balance through the gap. As a droplet works its way through the gap, a negative load is applied to the sensing element which results in the data signal shifting negative and when the droplet exits the gap, the signal goes positive. Other droplets are following and the cycle repeats.

Below $P_0 = 200$ psia the data from the oil damped balance is questionable since it was very erratic at times (Reference Figure 6) and even though the data was reasonably steady at times, it is suspect.

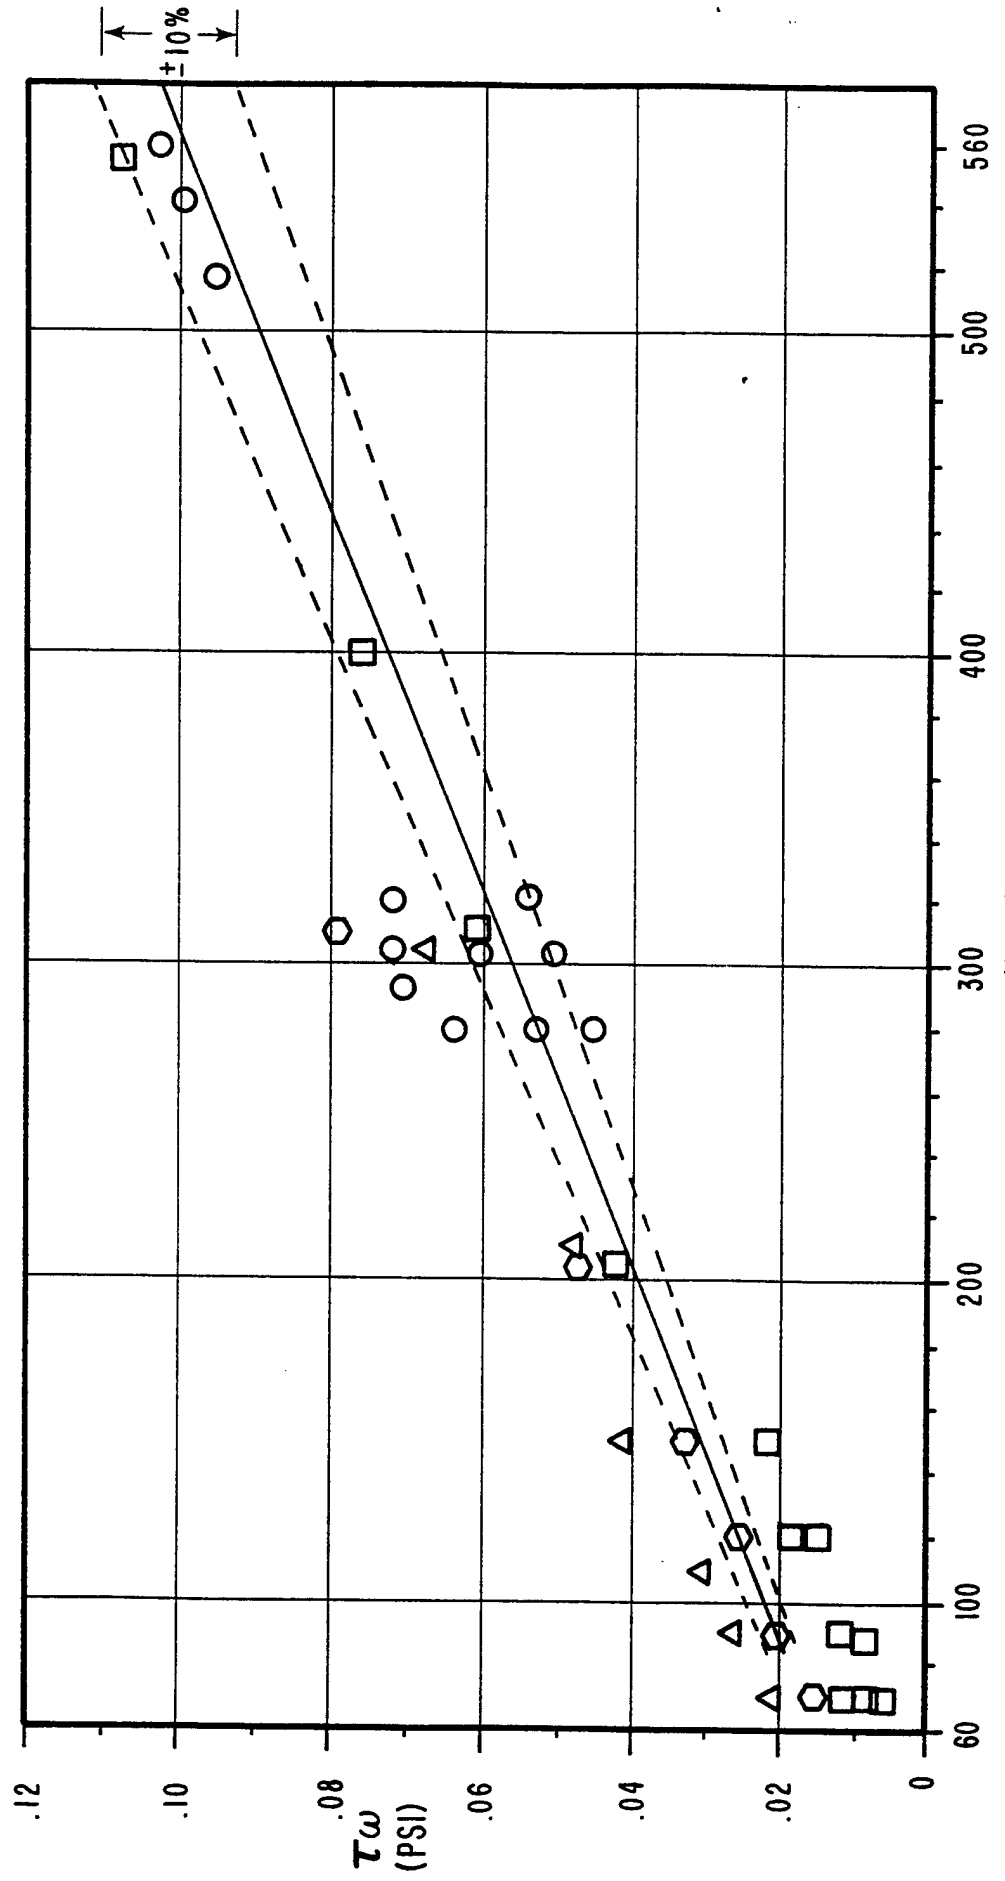
FIGURE 7

VRA SKIN FRICTION BALANCES NRS. 1 & 2 EVALUATION

M = 3 HIGH REYNOLDS NUMBER FACILITY

- 30K CS OIL
- 100K CS OIL
- △ OIL FLUSHED
- ◊ NO OIL

FROM EMPIRICAL EXPRESSION BY A.W. FIORE (1)

Numerous runs of representative data are plotted on Figure 7. The data is compared with a curve derived by A. W. Fiore which is based on measurements by Fiore and others at a nominal Mach number of 3 and a near adiabatic wall with zero pressure gradient (Reference 1). Above $P_0 = 200$ psia, the data recorded when the balance was filled with 100,000 centistoke silicone oil follows the line very well. However only one run was made in this pressure range and it is noted that two other runs with 30,000 centistoke oil also follow the line well.

Since the misalignment of the dry balance (no oil) was not discovered until after the test, there is insufficient data to explain the different slope. The data represents two runs and is linear. The most important feature of this data is the lack of any evidence of erratic balance output.

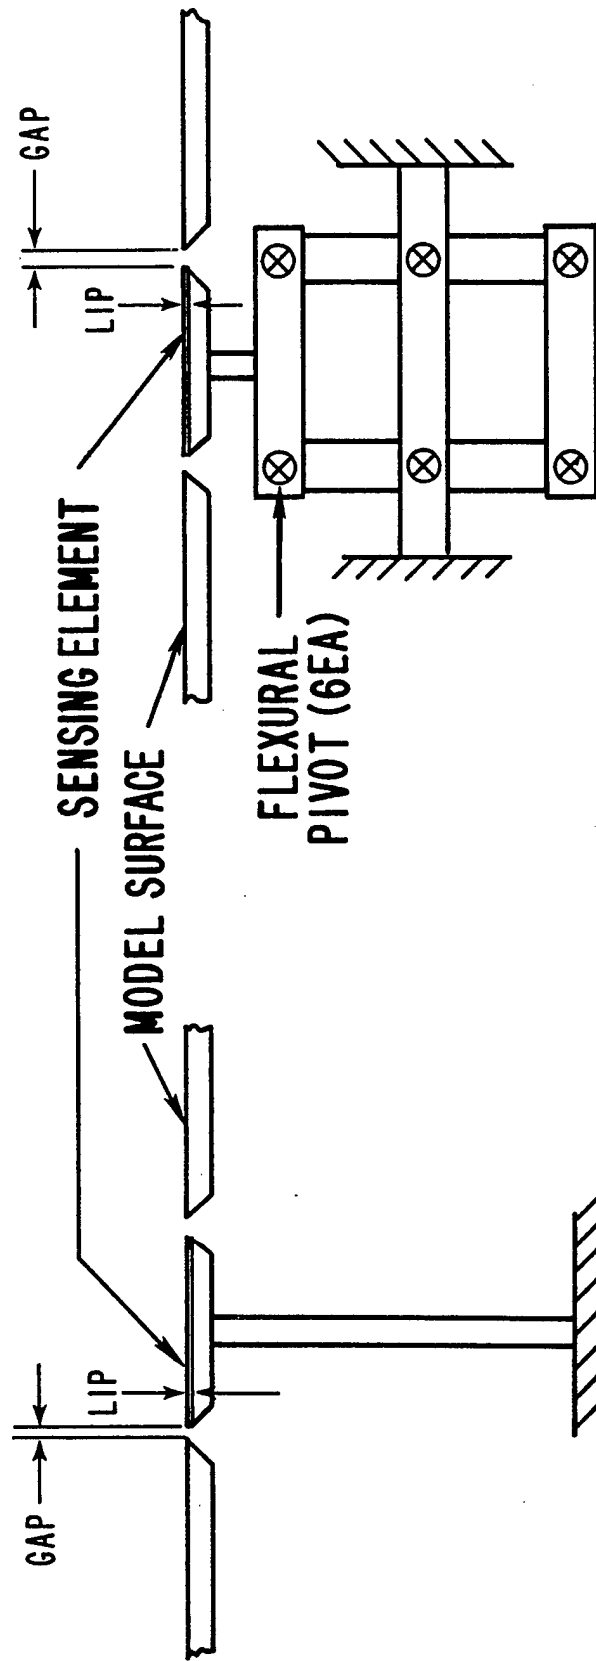
DIRECT MEASUREMENT SKIN FRICTION BALANCES

BASIC DESIGNS

CANTILEVERED OR PIVOTED BEAM
VRA

OSCILLATING DOUBLE
4 BAR LINKAGE
NASA - LRC

The search is continuing for a smaller balance design. At the present, a shortened version of the NASA-Langley design is being prepared for testing. The basic housing diameter is the same as the Kistler balance but the overall length, although shorter than the NASA design, is longer than the Kistler design. The NASA design incorporates all of the recommendations of Allen.
