**INFLUENCE OF LOADING FREQUENCY  
ON THE ELEVATED TEMPERATURE  
FATIGUE BEHAVIOR OF FIBER-  
REINFORCED CERAMIC COMPOSITES**

Report for the period 10-1-97 to 9-30-98  
Contract # F49620-98-1-0018

John W. Holmes  
Principle Investigator  
Department of Mechanical Engineering and Applied Mechanics

## **Influence of Stress Ratio on the Fatigue Life of a Silicon-Carbide Fiber Reinforced Ceramic Matrix Composite**

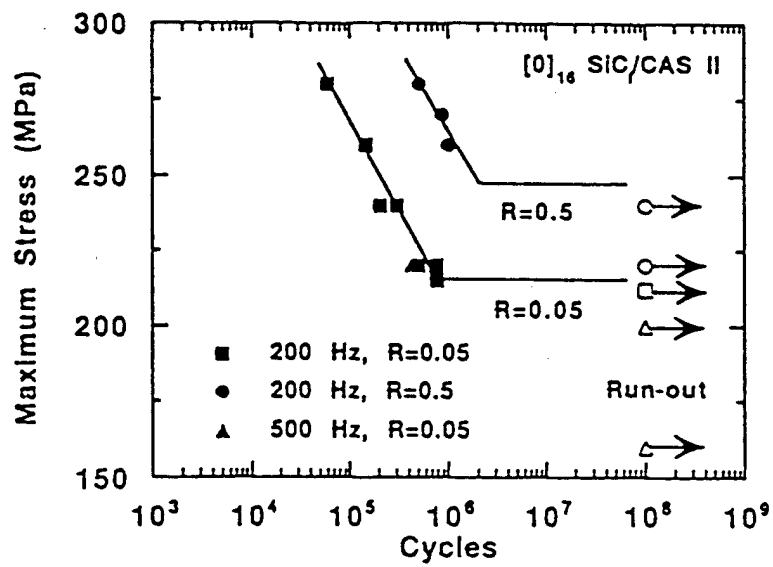
- 2) The S-N curve (relationship between the maximum applied stress and the number of cycles to failure) for  $R = 0.05$  and  $R = 0.5$ . Both fatigue life and the fatigue limit (defined as run-out for  $10^8$  cycles) increases with increasing stress ratio ( $\sigma_{\max} = 240$  MPa).

The S-N curve, constructed from the experimental data, is shown in Fig. 2 for the two stress ratios examined ( $R = 0.5$  and  $R = 0.05$ ). Several points should be noted. First, an increasing R-ratio resulted in a longer fatigue life. Such a trend has also been found for

other CMCs<sup>14,15</sup>. Second, distinct fatigue limits (defined here as run-out for  $10^8$  cycles at 200 Hz) exist for both stress ratios. Third, the fatigue limit increased from 212 MPa at  $R = 0.05$  to 240 MPa at  $R = 0.5$ .

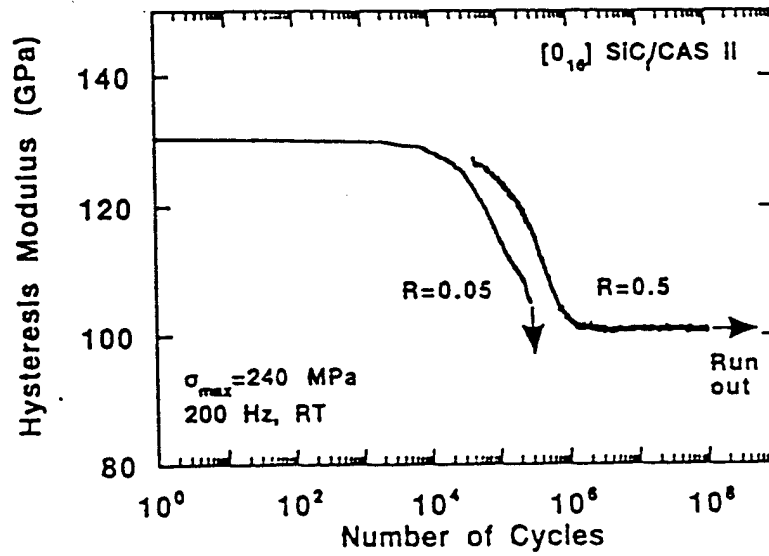
- 3) Hysteresis modulus as a number of cycles for two specimens loaded with identical maximum stress (240 MPa) at two stress ratios ( $R = 0.05$  and  $R = 0.5$ ).

For the two stress ratios, Fig. 3 shows the evolution of the hysteresis modulus,  $\bar{E}$ , as a function of the number of cycles,  $N$  ( $\sigma_{\max} = 240$  MPa). Both specimens experienced a significant modulus decrease. The modulus of the specimen subjected to  $R = 0.5$  reached a steady-state value that approximately  $2 \times 10^6$  cycles. The modulus of the specimens subjected to  $R = 0.05$  decreases also, but the specimen fails before a steady-state value is attained. Note, that the value of  $\bar{E}$  immediately prior to failure ( $R = 0.05$ ) is higher than the run-out value at  $R = 0.5$ . Thus, as with crack spacing, modulus cannot be used as a predictor of fatigue failure.

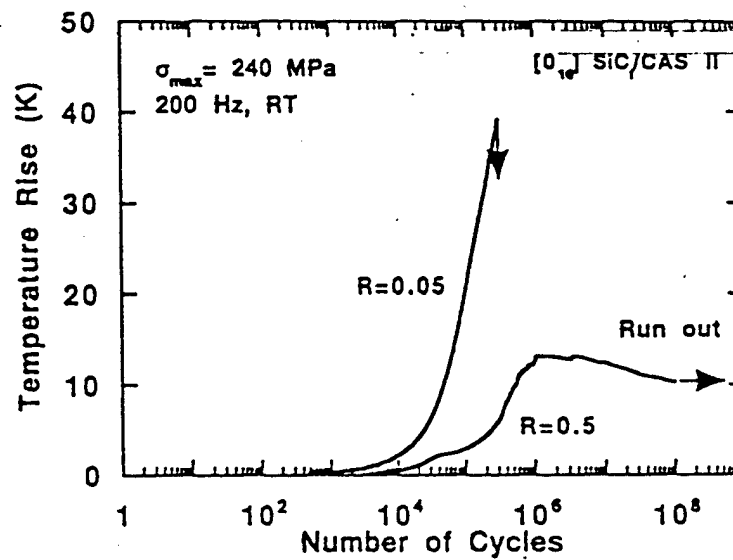
- 4) The evolution of temperature rise of cyclically loaded specimens. The maximum stress is identical for the two specimens (240 MPa), but their stress ratios are different ( $R = 0.05$  and  $R = 0.5$ )

Figure 4 shows the temperature rise curves for tests conducted at  $R = 0.05$  and  $R = 0.5$ . The temperature rise was largest for the specimen subjected to the largest stress range

(smallest R-value), see also Table I. Similar results have been obtained by Cho *et al.* <sup>16</sup>. For specimens that did not fail within  $10^8$  cycles, the temperature increased in the early stages of cycling, reached a maximum, and decreased thereafter. In contrast, nearly all specimens that failed during cycling failed while the temperature was still rising.
