**Hot/Wet Environmental Degradation  
of Honeycomb Sandwich Structure  
Representative of F/A-18:  
Discolouration of Cytec FM-300  
Adhesive**

DSTO-TN-0263

**Airframes and Engines Division  
Aeronautical and Maritime Research Laboratory**

## Executive Summary

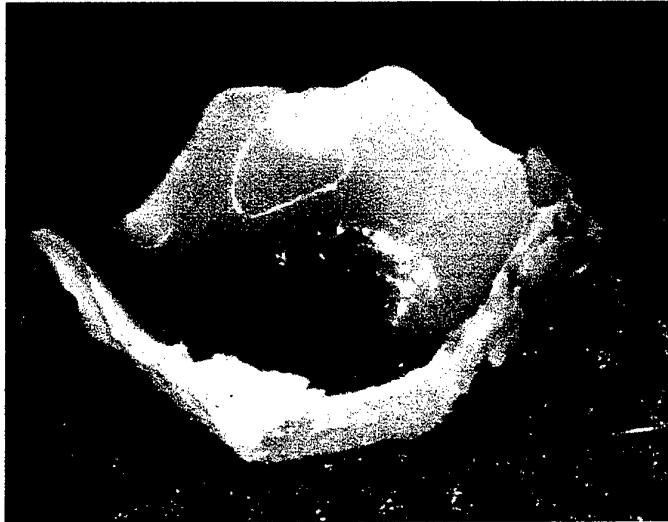
Figure 6 A sample of cured fillet adhesive showing a discoloured green film at the surface.

Cytec FM-300 adhesive discolours at the surface to a light green colour if exposed to even small quantities of air during curing. The air contained in honeycomb cells of honeycomb during curing at 175°C is sufficient to cause this discolouration. Provided the interior of honeycomb sandwich structures are maintained dry after initial manufacture, the colour of the fillet adhesive layer should appear a green colour as shown in Figure 6.

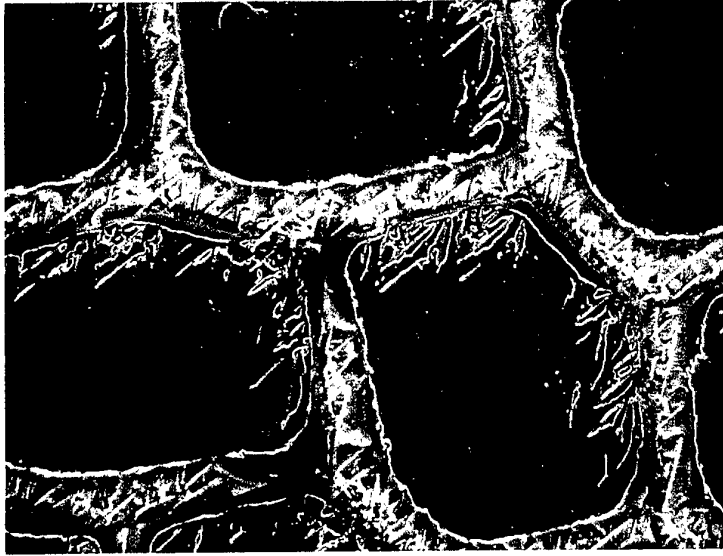
Figure 8 View looking down on a cured FM300 bondline located between the honeycomb core and face-sheet. The honeycomb has been pulled off from the skin during mechanical testing revealing the fillet tear-out areas (appearing a blue colour compared to the air discoloured green areas).

**Hot/Dry - 175°C** FM-300 adhesive film is cured at a temperature of 175°C for 60 minutes. During the curing process, the adhesive forms fillets that bond the honeycomb core to the skin as seen in Figure 9. The small quantities of air contained in the honeycomb cells during panel bonding causes the adhesive to change colour to a light green colour. This discolouration is restricted to a thin layer at the surface of the adhesive and is probably due to oxidation of the adhesive pigment. If a tensile test is used to pull the skin off from the honeycomb core subsequent to the curing process, these discoloured areas of adhesive will appear as small hexagons as seen in Figure 8. The discoloured hexagonal areas are separated by channels of fillet tear-out which appear blue. The blue areas are starved of air during bonding as they are pressed between the honeycomb foil and skin and should therefore be of a colour similar to that shown in Figure 5.
