Application of a Landscape Evolution Model to Gully Management and Reclamation on Military Lands: Fort Carson, CO Case Study

Annual report submitted to the Army Research Office

Daniel B. G. Collins, Gregory E. Tucker¹, Nicole M. Gasparini, and Rafael L. Bras

March, 2000

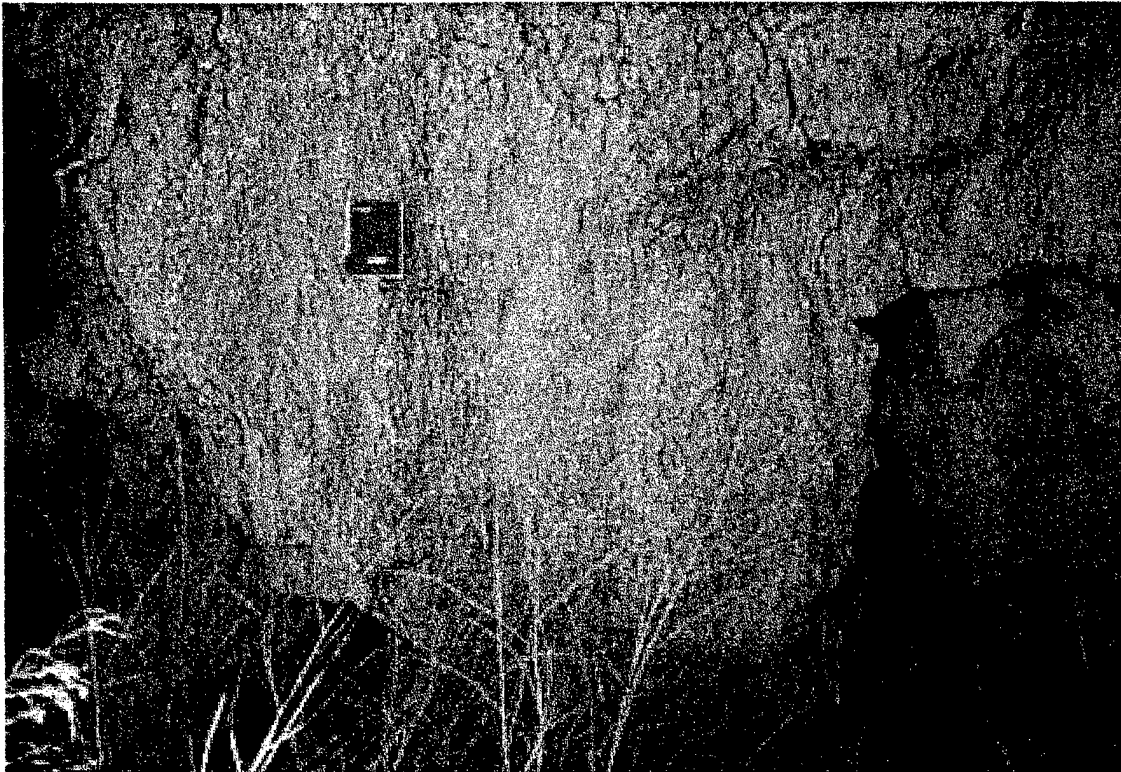
Figure 4.1

Tunnel erosion and cracks on a vertical side wall in PCMS.

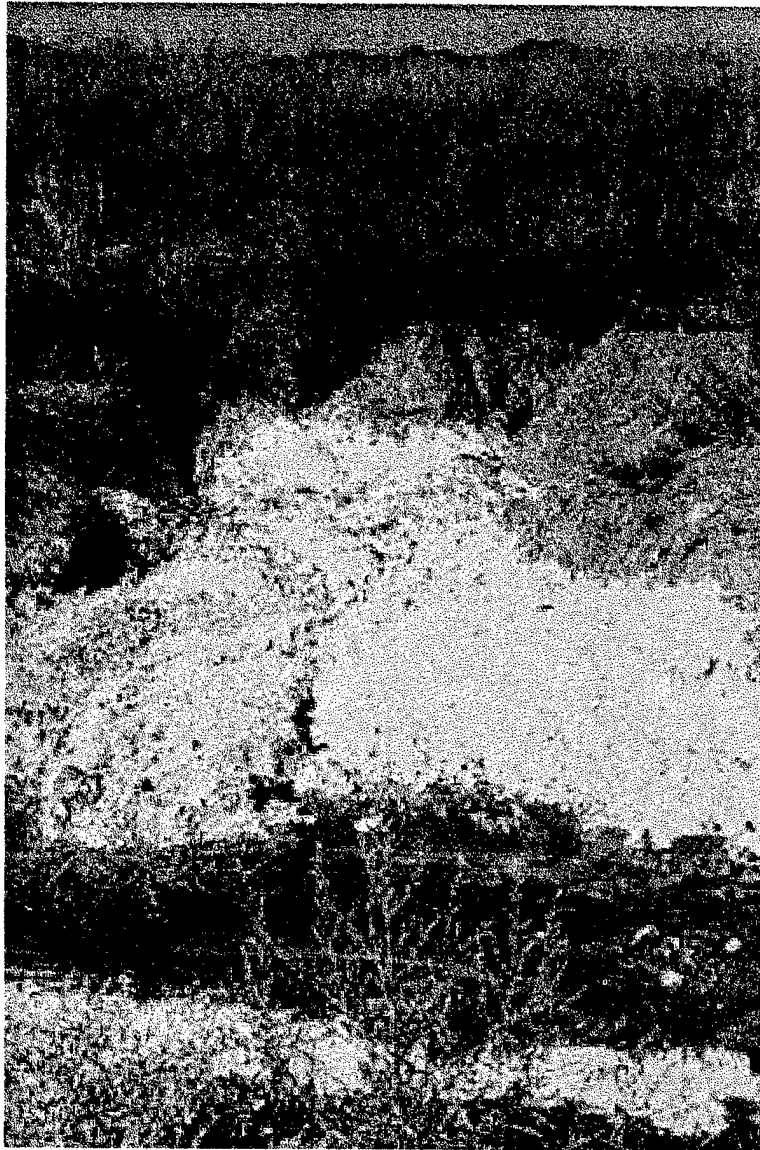
Figure 4.2

White salt deposits signifying seepage on a small gully's side wall, Fort Carson.
This gully is a failed rehabilitation attempt, where the banks were smoothed,
sediment check dams put in place, and the sculpted area revegetated.

Of the various rehabilitated gullies viewed at PCMS and Fort Carson, there were both successes and failures. Different modes of restorative methods had been adopted (Figure 4.10); bulldozing side slope material into the channels, raising the channel bottom elevation; bulldozing side material out, thus maintaining the same gully floor elevation; introducing rip-rap to the head and/or side walls; and revegetating headcuts and side walls. The successful gullies were those whose replanted vegetation had time to mature sufficiently, reported as generally three years, before a significant storm event, which would wash away younger vegetation. Gullies whose side walls had been pushed outwards seemed also to be more resilient to subsequent gully erosion. Of the failures, some had undergone extensive erosion during a single storm (Figures 4.2 and 4.7).

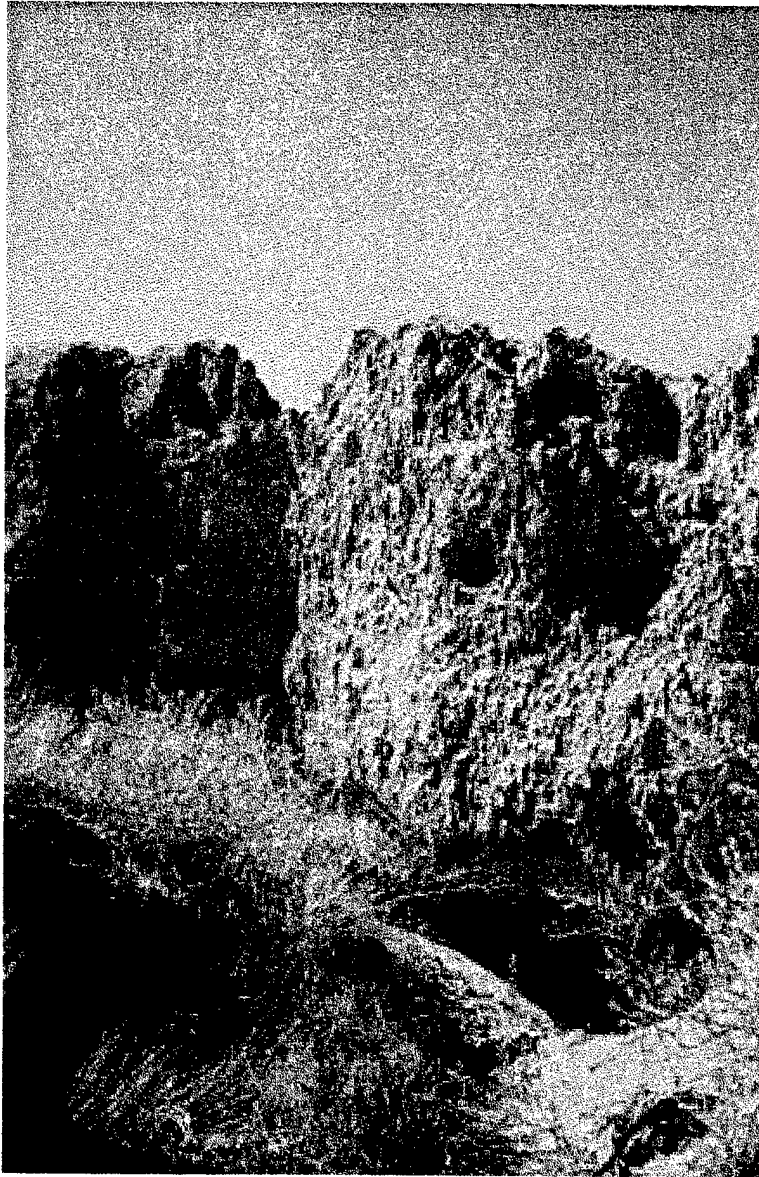
Figure 4.4

The side walls ranged in slope from a gentle incline to vertical; most were steep. Planform undulations ranged in scale from centimeters to meters. Side wall features included cracks, rills, trickle conduits, seepage faces, and tunnels (Figure 4.1). Seepage faces, observed in fewer than 50% of the sidewalls, were evident by regions of salt deposition. A few gullies had salt-lined rills emerging from their gently-sloped side walls (Figure 4.2). Salt deposits were observed both at the feet of vertical walls (Figure 4.3) and further up their sides. Slump debris was observed at the bottom of walls (Figure 4.5), but so too was its absence; neither situation was noticeably more common. Absence and presence of debris piles was observed in both the same gully system and also on opposite sides of the same channel. In PCMS, one side wall was being undercut by a chute (Figure 4.4).

Channelized chute undercutting a bank. The side wall is about 2 m high. The channel is being diverted by a large mound. This site was a few meters from the branch's head.

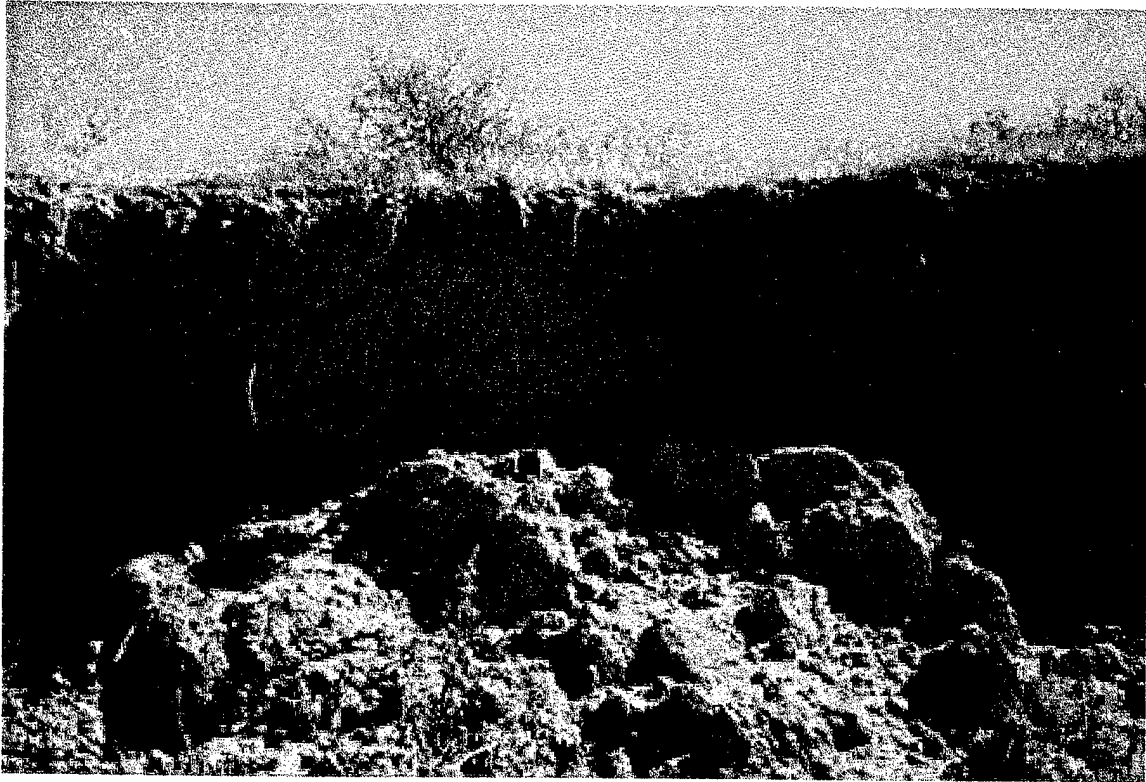
Figure 4.5

Slump debris at the side of a channel, PCMS. The remaining wall is essentially vertical, with a slight overhang induced by the root mat.

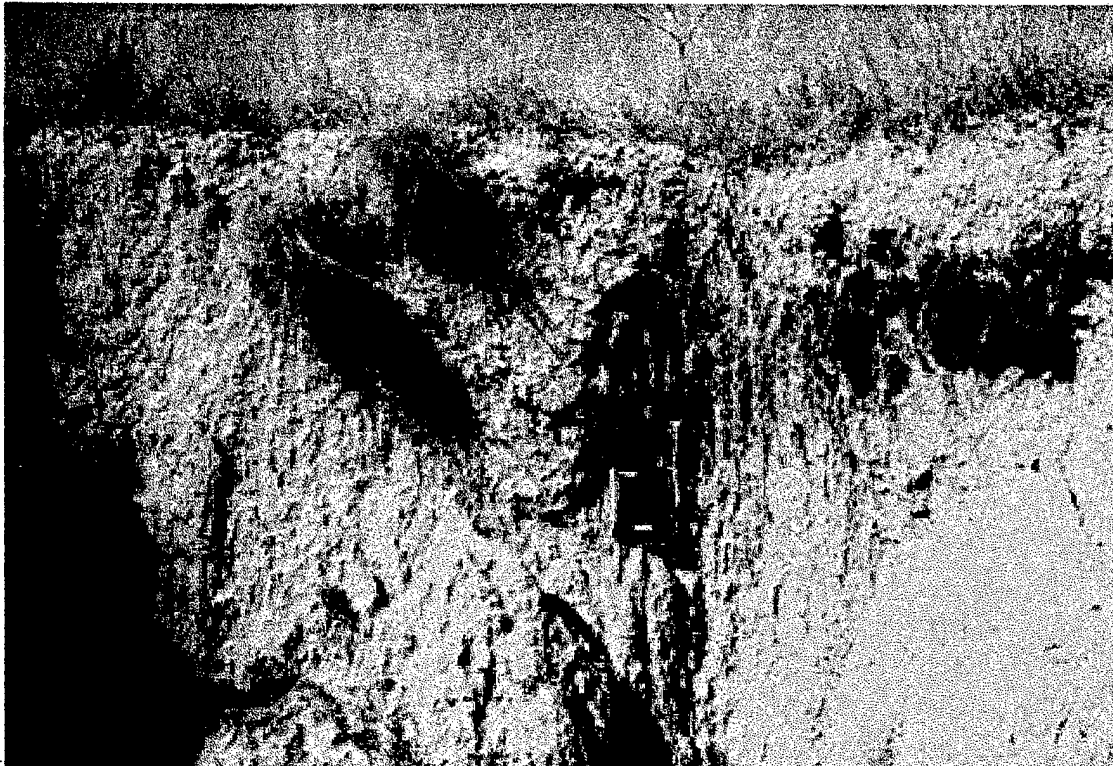
Figure 4.8

Vertical gully head being supported by a root mat, PCMS. Roots can be seen hanging from the bottom of the upper soil layer, which remains intact.

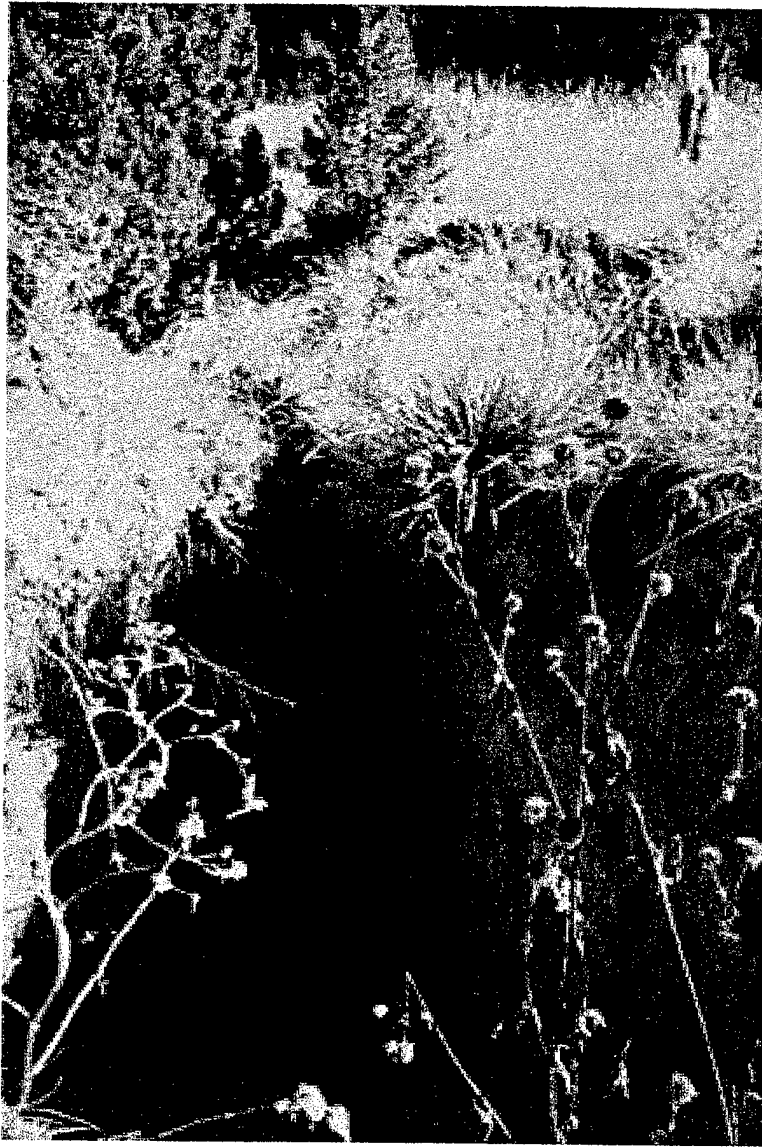
Figure 4.9

Gully head pinned by roots of the tree in the top-left of the image. Just below the tree, the 0.5 m deep, narrow channel drops 4.5 m to a rectangular gully. Tree roots were hanging from the soil below. Inside the gully the soils were damp. Despite the sizable drop, there was no obvious plunge pool at the base.
