**Navigation Study at the Approach  
to Lock and Dam 24,  
Upper Mississippi River**

**Hydraulic Micro Model  
Investigation**

Technical Report M2

Final Report - January 1998

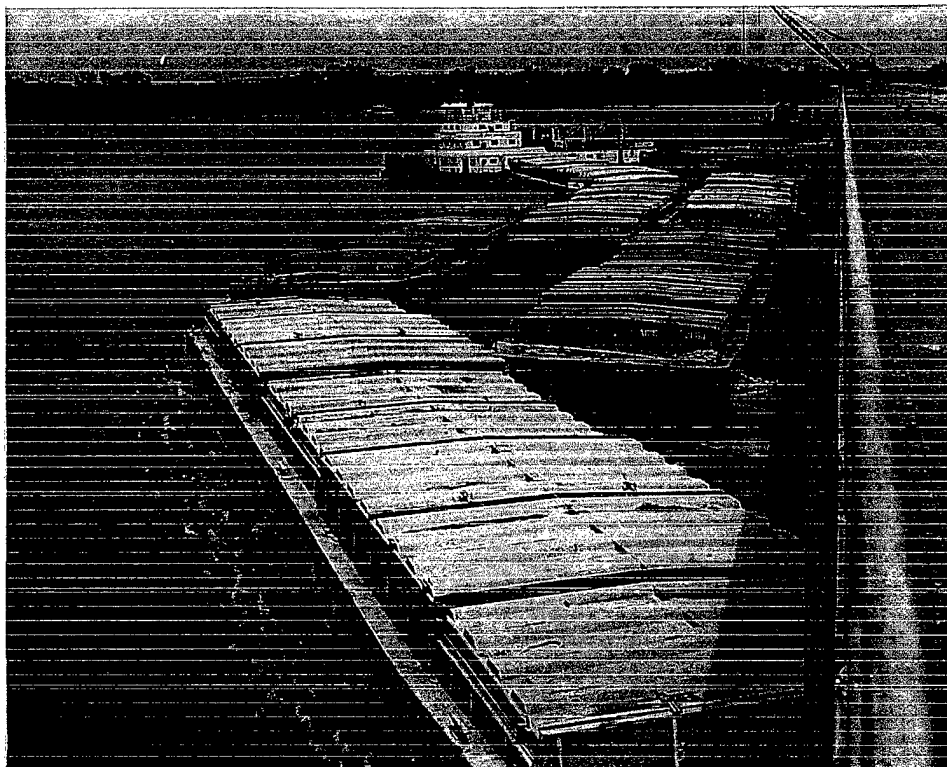
Another cost associated with the outdraft problem was transportation delays caused by the closure of the lock due to repair of the miter gates from collisions. Plate 7 shows the consequences of an outdraft induced accident at Lock and Dam 24. An unscheduled half-day lock closure for repairing a leaf gate was estimated to increase transportation costs approximately \$220,000. A two-day unscheduled lock closure for repair was estimated to increase transportation costs approximately \$2,760,000. The greatest cost would result from an accident that causes major damages to the miter or tainter gates, resulting in a loss of pool. The minimum closure due to this occurrence was estimated to be 14 days with navigation delays estimated at approximately \$82,163,000.

Accident Aftermath Due to Outdraft- Several Barges  
Against The Dam and Damage to the Miter Gates

Downbound tows frequently require the services of a helper boat during most river conditions to enter the lock chamber. A helper boat assists the tow by pushing its "head-of-tow" against the landwall while the tow pilot positions the stern towards the right descending bankline. Plate 3 is a plan view aerial diagram describing the process of a tow entering the lock chamber with the assistance of a helper boat. Plates 4, 5, and 6 are photographs displaying the sequence of events. If the towing company chooses not to use the helper boat, the tow pilot must align or check his "head-of-tow" into the landwall several times with the help of lock personnel. If the tow strikes the riverwall, barges may become separated and carried into the gate openings (Plate7).

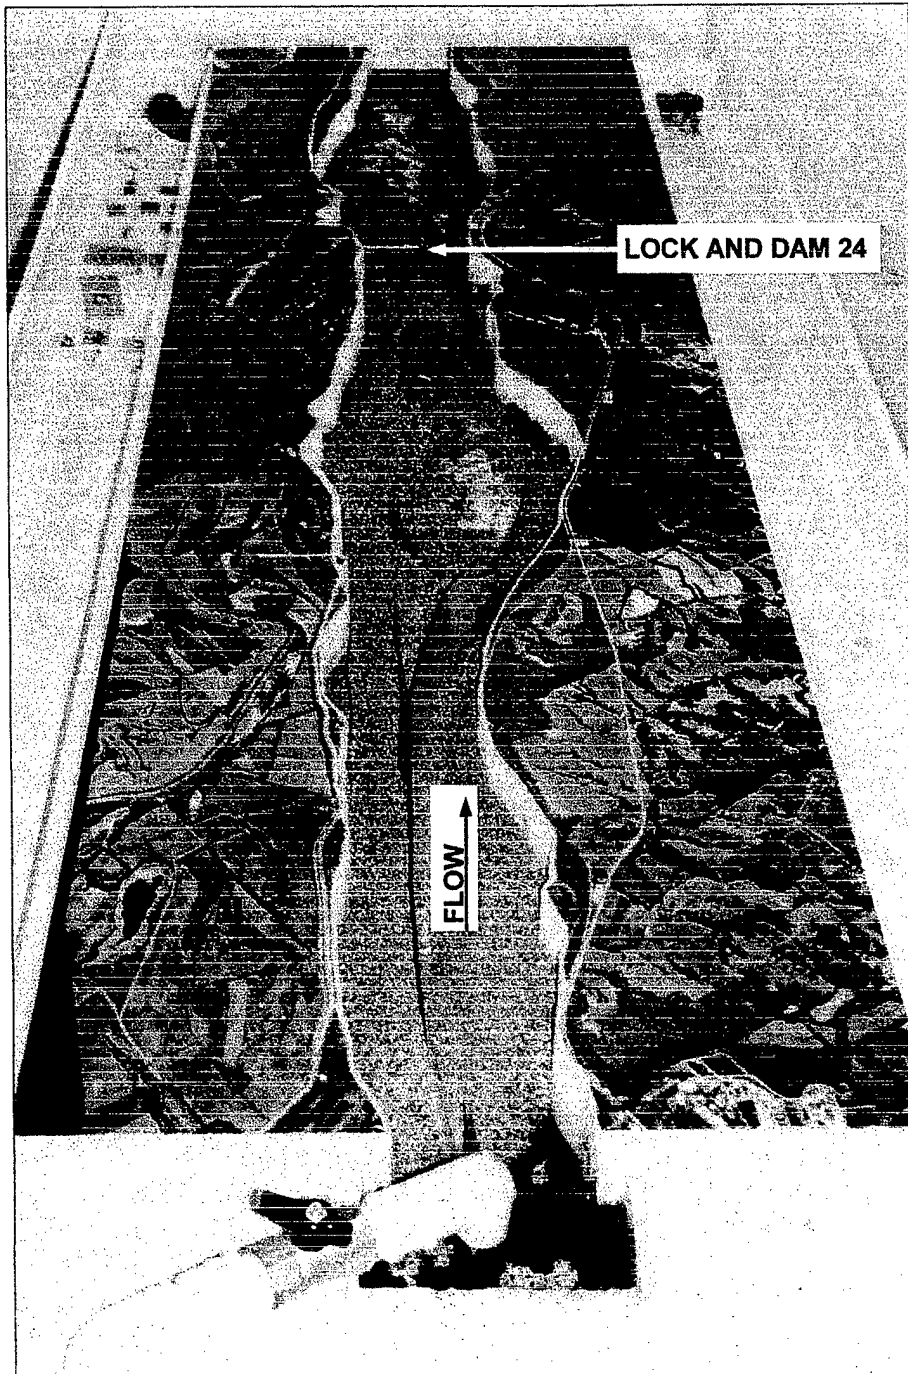
**15**

Plate 15 is a photograph of the Lock and Dam 24 hydraulic micro model used in this study. The scales of the model were 1 inch = 800 feet, or 1:9600 horizontal and 1 inch = 50 feet, or 1:600 vertical for a 16:1 distortion ratio. This distortion supplied the necessary forces required for the simulation of sediment transport conditions similar to the prototype (2). The bed material used was granular plastic urea, Type II, with a specific gravity of 1.23.

The model was constructed according to 1994 aerial photography of the study reach. The physical lock chamber was fabricated out of sheet metal, while the dam was constructed out of oil based clay. The tainter gates were not placed in the model because the study only examined open river conditions. Stage was monitored by a staff gage and a three-dimensional digitizer. Resultant bed configurations (bathymetry) were measured and recorded with a three-dimensional digitizer with a computer interface.

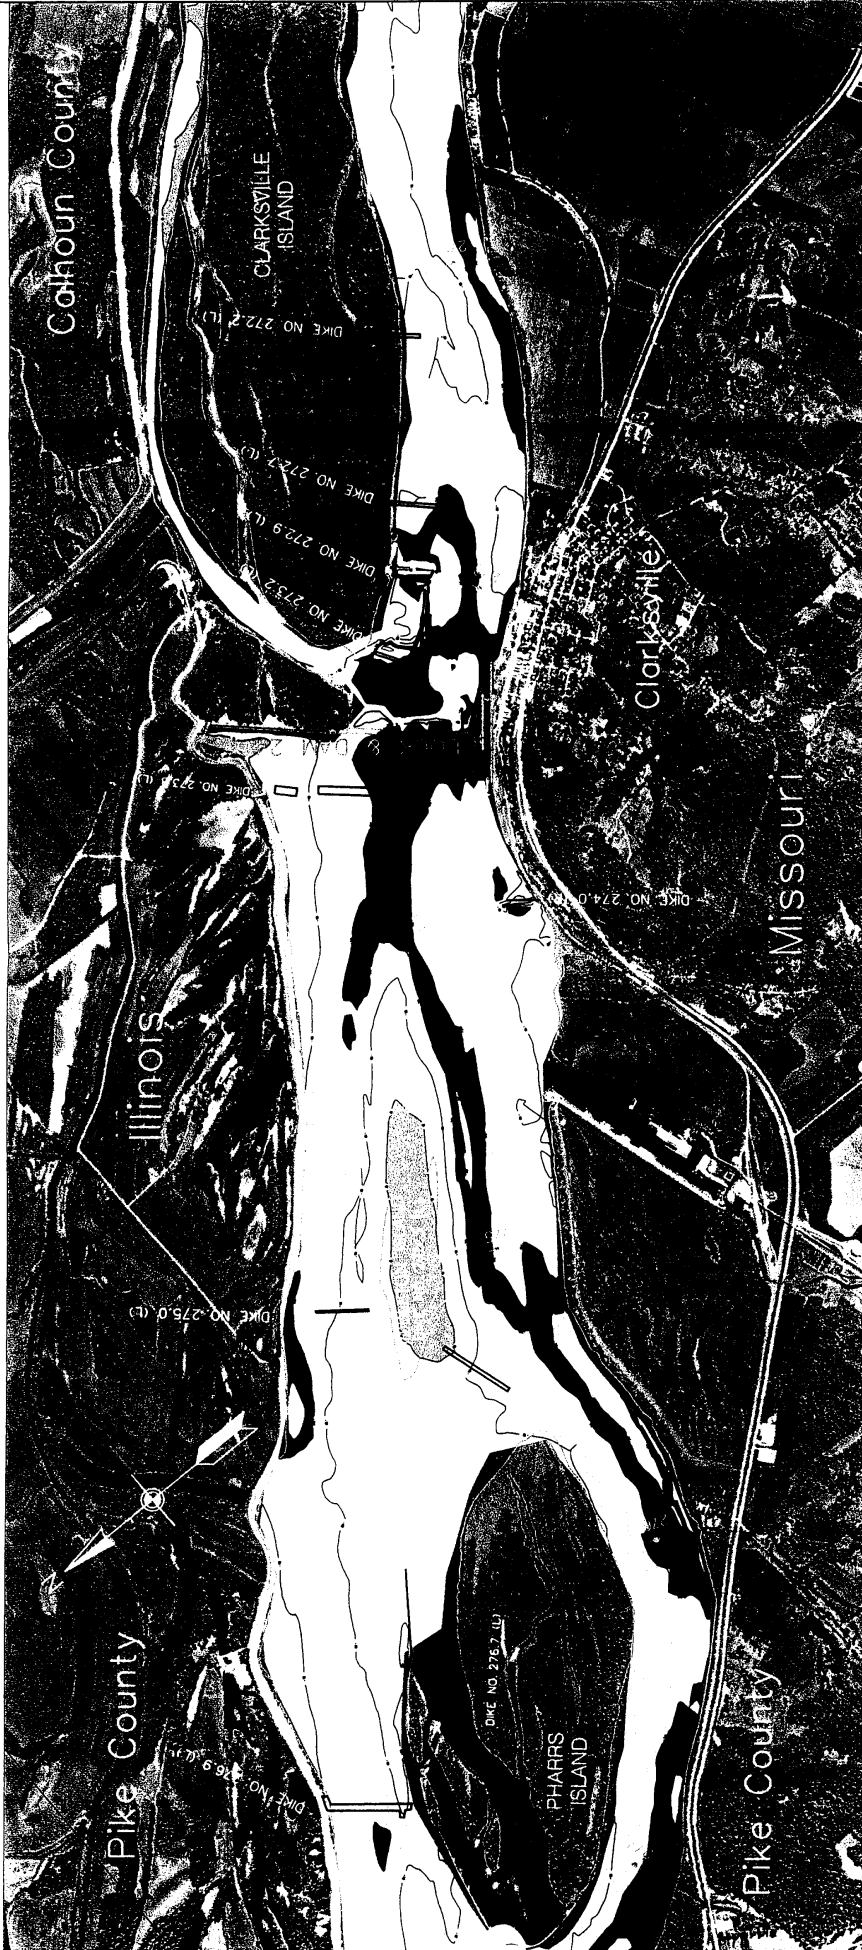
Plate 25 shows the resultant bed configuration of the micro model base test. This survey served as the comparison survey for all future design alternative model tests. The base test was developed by simulating steady flow or open river conditions until bed stability was reached.

Generally, the bathymetric trends established in the micro model were very similar to the trends observed in the historical prototype surveys. The only major noted difference was the location of the scour hole pattern below the dam. The scour had a tendency to occur further downstream in the model as compared to the prototype.
