Technical Report M3

**SIDE CHANNEL SEDIMENTATION STUDY OF THE  
MISSISSIPPI RIVER  
MARQUETTE CHUTE/CAPE BEND  
RIVER MILES 51 TO 47**

**HYDRAULIC MICRO MODEL INVESTIGATION**

December 1997

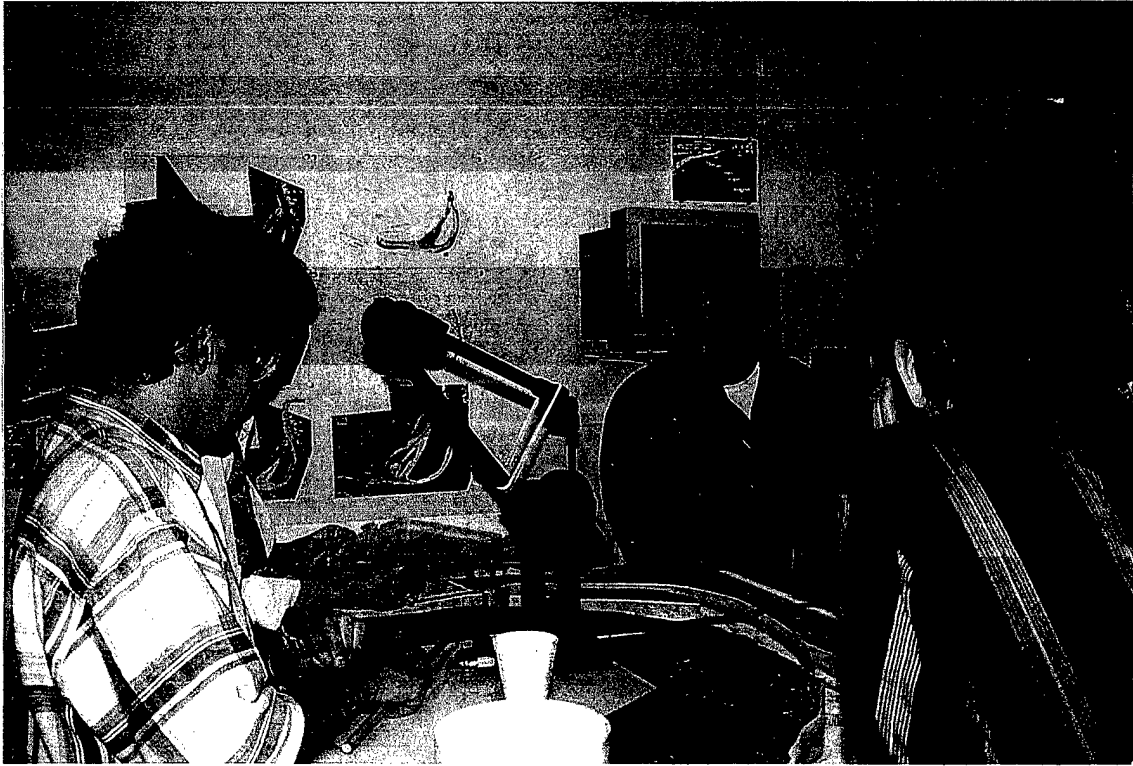
| | PLATE NO<br>1 |

| PREPARED BY R. HETRICK<br>CHECKED BY R. DAVINSON<br>DATE 4 AUGUST 1997 | MARQUETTE CHUTE MICRO-MODEL STUDY<br>MISSISSIPPI RIVER MILES 47.0 - 53.0<br>Photograph of Engineers and<br>Biologists Formulating Ideas on the<br>Marquette Chute Micro Model |

A team of cooperating federal and state agencies assembled at the U.S. Army Corps of Engineers Applied River Engineering Center (AREC) in St. Louis, Missouri to formulate and conceptualize measures to enhance and/or restore the side channel at Marquette Island (Plate 1). A variety of environmental design alternatives were submitted. The main goal was to evaluate the positive impacts of these alternatives, if any, on the resultant bed configuration (sediment transport response) and flow patterns within the Mississippi River study reach. Creating desirable biological diversity while at the same time ensuring a reliable navigation channel was the major challenge of this study.

Finally, it should be noted that the innovative ideas set forth in this study were developed as a result of a cooperative effort between all of the aforementioned agencies. "Hands on" experimentation at the Applied River Engineering Center (Plate 1) enabled both biologists and engineers to formulate design alternatives and conduct experiments in the micro model.

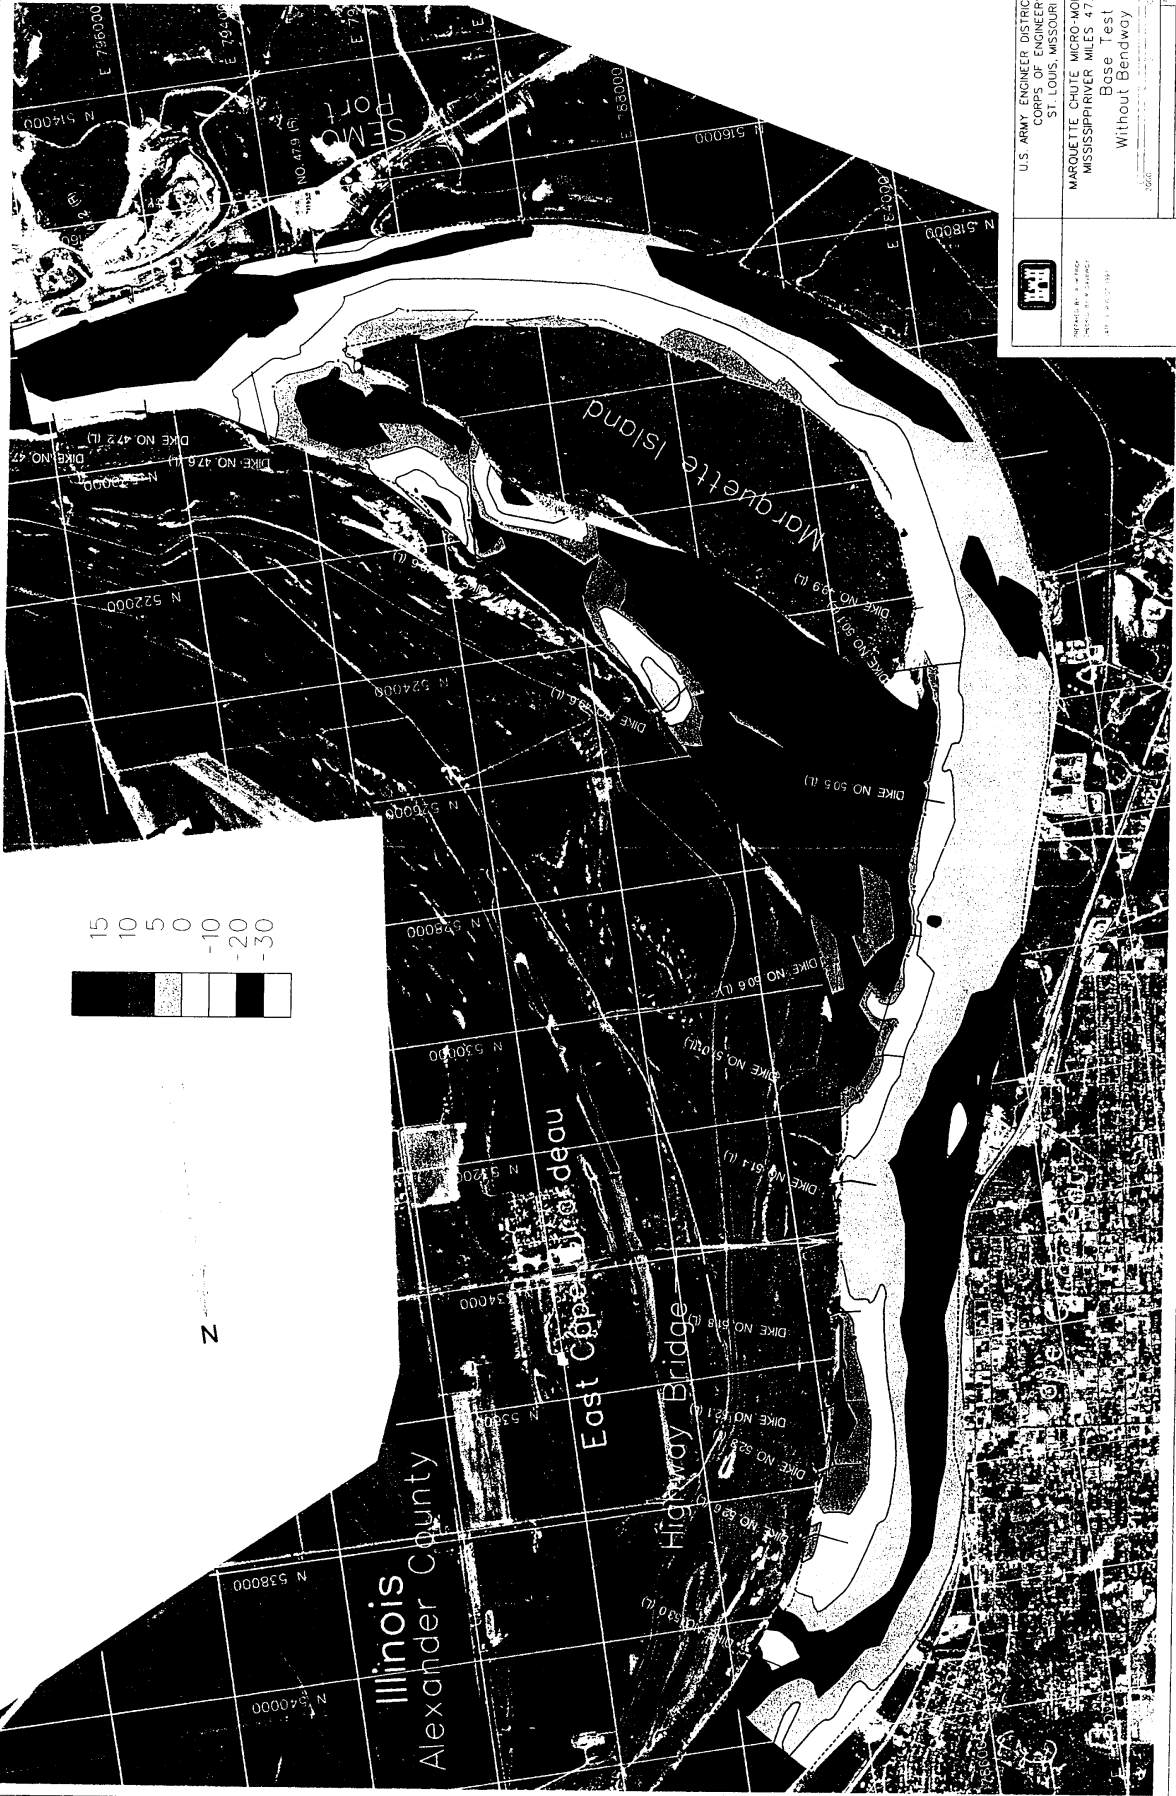
MARQUETTE CHUTE MICRO-MODEL STUDY  
 MISSISSIPPI RIVER WEIRS 47.0 - 53.0  
 Base Test  
 Without Bendway Weirs

Plate 14 shows the resultant bed survey of the base test without the bendway weirs. In the beginning of the study reach, the thalweg developed off the left descending bank. A scour hole was observed below dike 53.0(L). A crossing developed from

approximately river mile 52.8 to 52.1. The thalweg remained off the right descending bank throughout the rest of the study reach. Scour was also present near mile 51.4 on the right bank and below the apex of the bend near the diversion channel at mile 48.9. The last major area of scour observed in the model occurred off the tip of dike 47.9(R), just below SEMO port. A bar developed on the left descending bank from mile 52.8 to 51.8. A second bar developed at mile 51.3, outside the upper closure structure of Marquette Chute and continued downstream to the end of Marquette Island.

The model also showed very similar trends in the chute as compared to the prototype. There was a small scour hole inside the upper end of the upper closure structure near the existing notch. The deep section of the chute followed the Illinois side of the chute downstream toward the existing hardpoint. A scour hole was observed at this dike. Along the upper end of Marquette Island, a very high bar developed. This bar was vegetated in the prototype. Below the existing hardpoint, the "channel" crossed to the island side of the chute. There was a deep scour hole below the lower closure structure. Below the scour hole, there was a bar that extended through the remainder of the chute toward the confluence with the main channel. The only area in the model that did not accurately reflect the prototype was the area just above the lower closure structure. In the model, there was a large scour hole that formed that was not evident in the prototype. However, this scour hole remained constant throughout all tests. It is believed that this anomaly did not significantly effect the results of any of the tests.

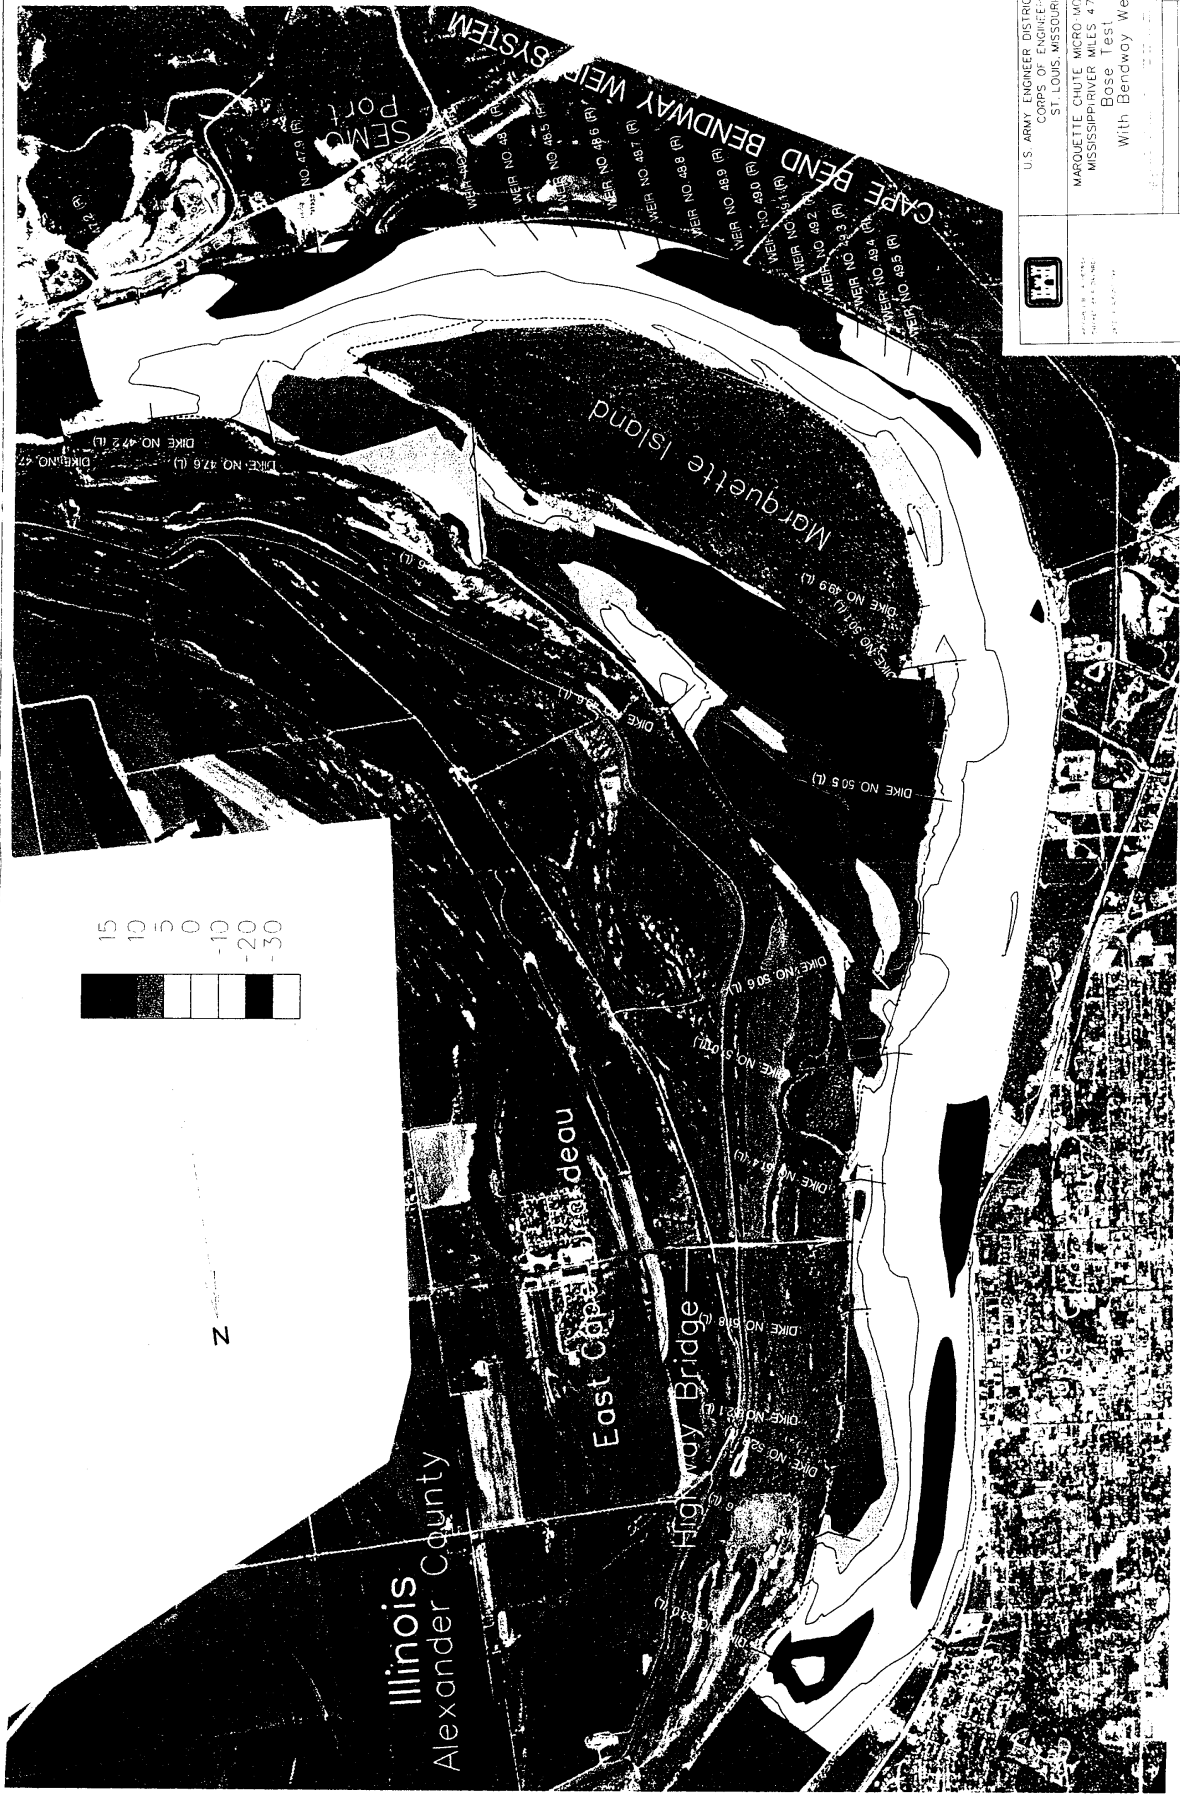
MARQUETTE CHUTE MICRO MODEL STUDY  
MISSISSIPPI RIVER MILES 47.0 - 53.0  
Bose Test  
With Bendway Weirs

Plate 15 shows the resultant bed survey of the base test with the Bendway Weirfield added. As with the original base test, the model displayed favorable results when compared with the prototype data. The side channel showed no significant changes as compared the original base test. In addition, the main channel showed no significant changes with the exception of the bendway weirfield. In this area, the right bank appeared to have caught additional sediment. The point bar also receded approximately 75 feet when compared to the base test without the weirs.

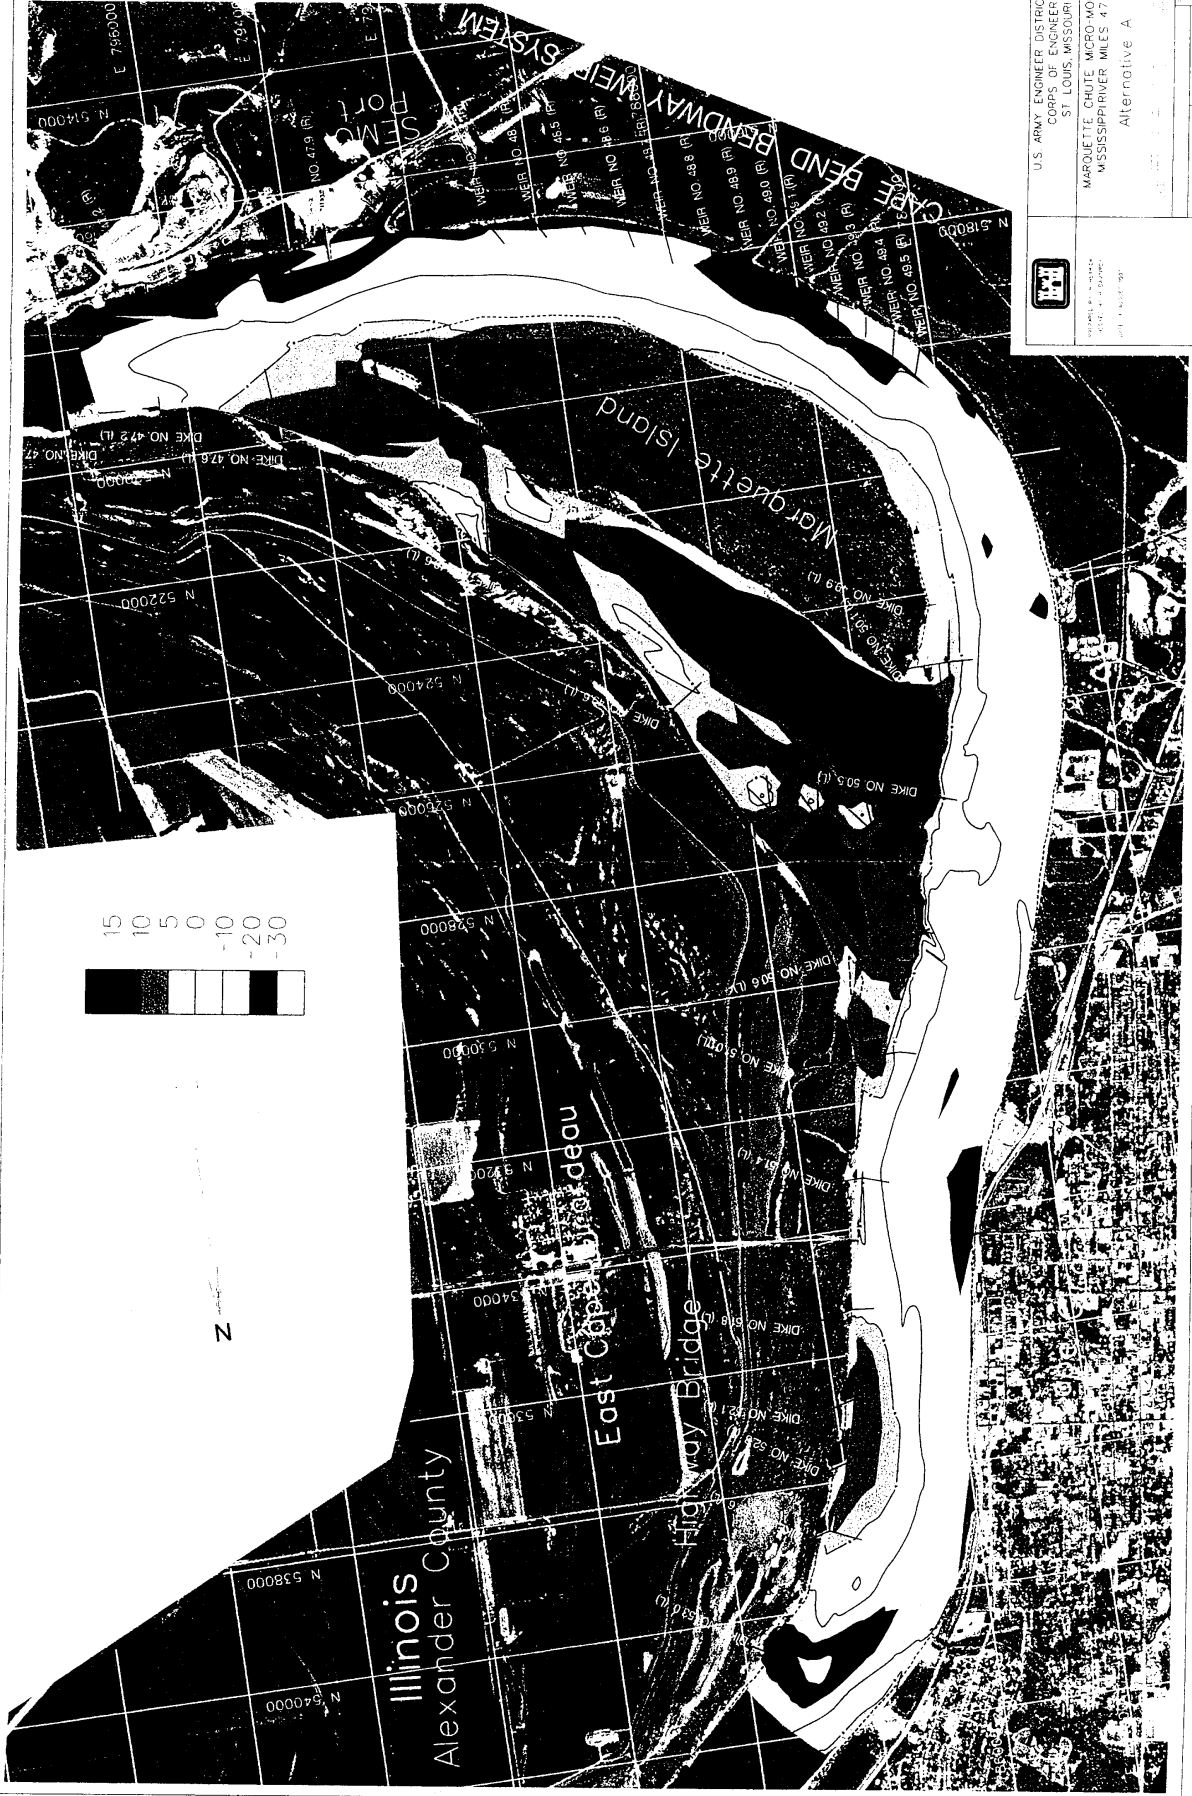
Plate 16 is a plan view contour map of the resultant bed configuration of Alternative A. Results indicated that a marginal amount of deepening occurred near the chevrons (5 to 10 feet), the scour was very local, and had little if any effect on overall deepening of the side channel. The scour hole immediately downstream of Dike 49.6L shallowed approximately 10 feet due to the material being moved by the chevrons. The rest of the side channel remained relatively unchanged.

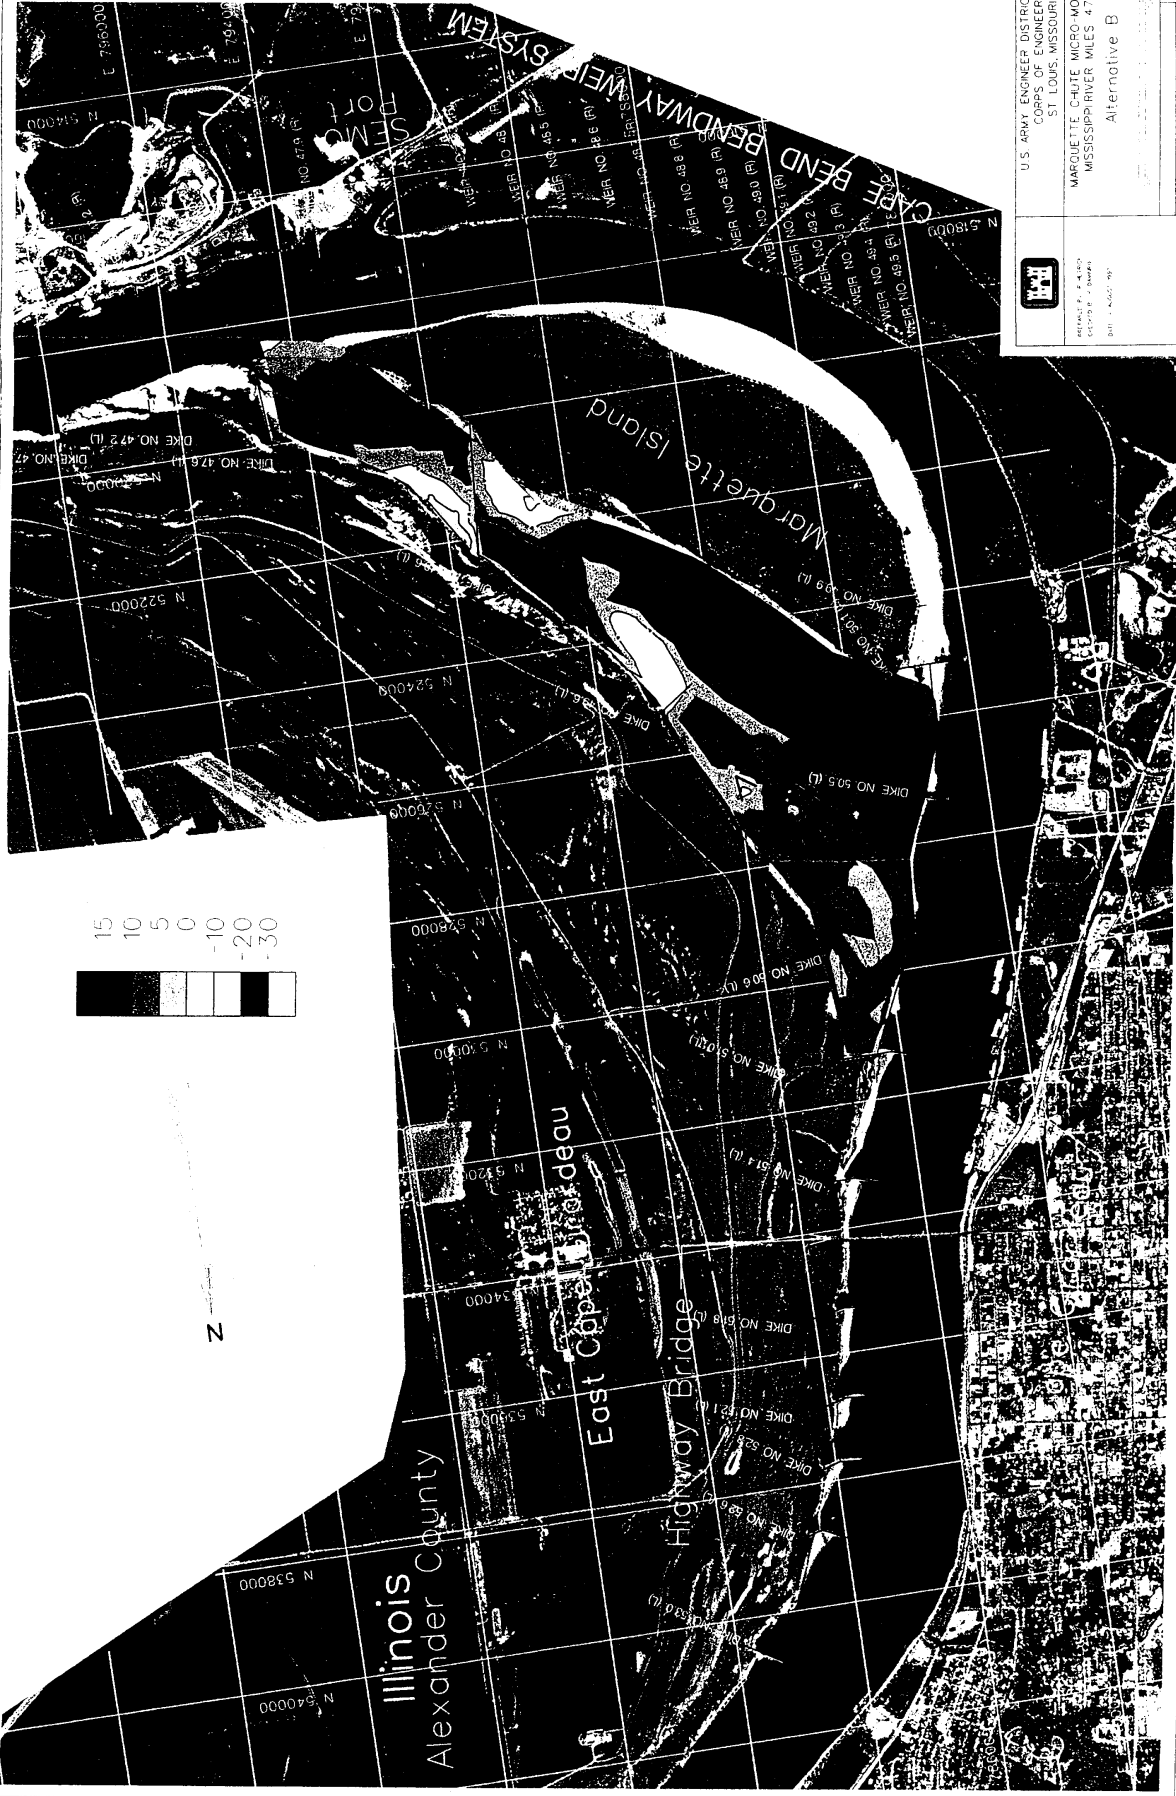
Alternative B

Plate 17 is a plan view contour map of the resultant bed configuration of Alternative B. Results indicated that between Mile 50.6L and Dike 49.6L, an overall deepening of the side channel occurred. Depths increased 5 to 10 feet in this region. Between Dike 49.6L and Dike 47.6L, the channel shallowed 5 to 10 feet. Shallowing was also noticed directly downstream of all river structures, and was observed in the model to be a direct result of the localized displaced sediment lost from the upstream chevron field.

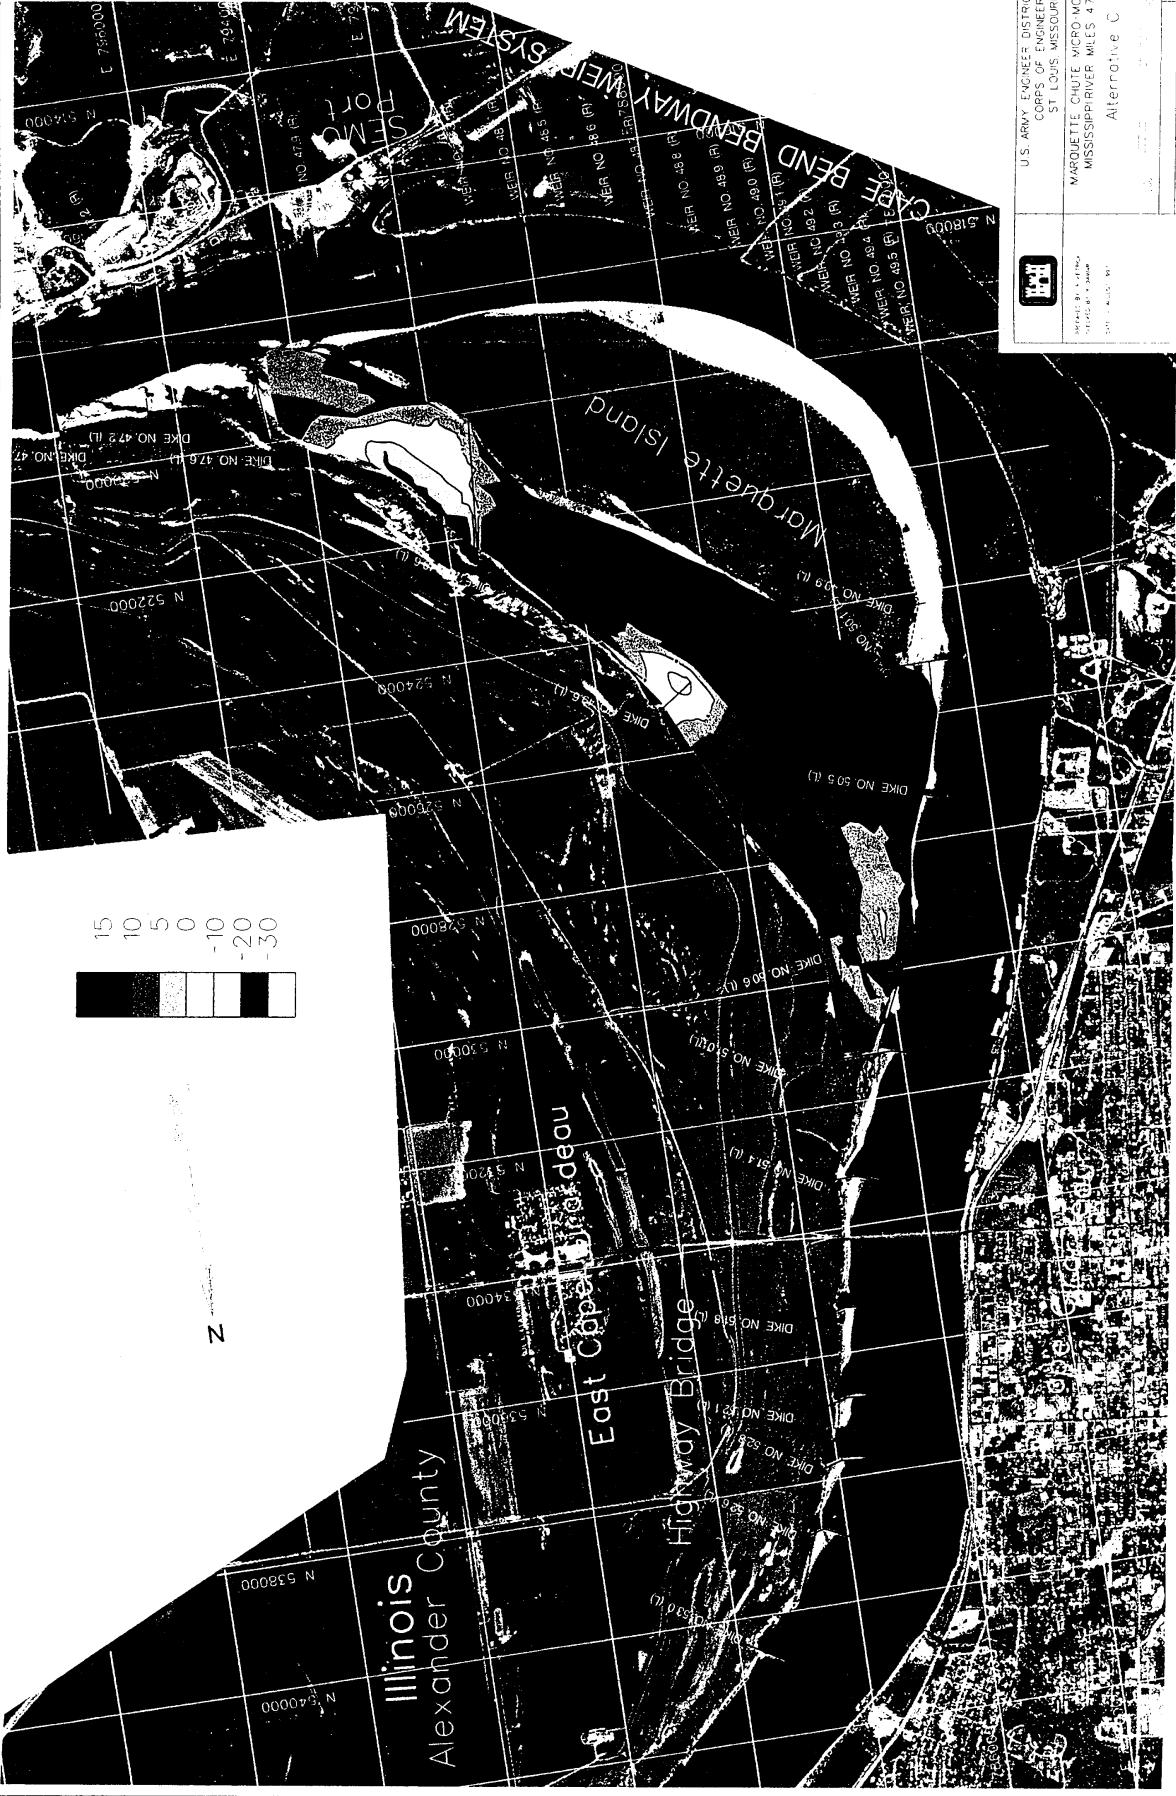
Alternative C

Plate 18 is a plan view contour map of the resultant bed configuration of Alternative C. Results indicated the chevrons had no effect on side channel depth. The scour holes downstream of Dikes 49.6 L and 48.6 L became slightly deeper as compared to the base test.

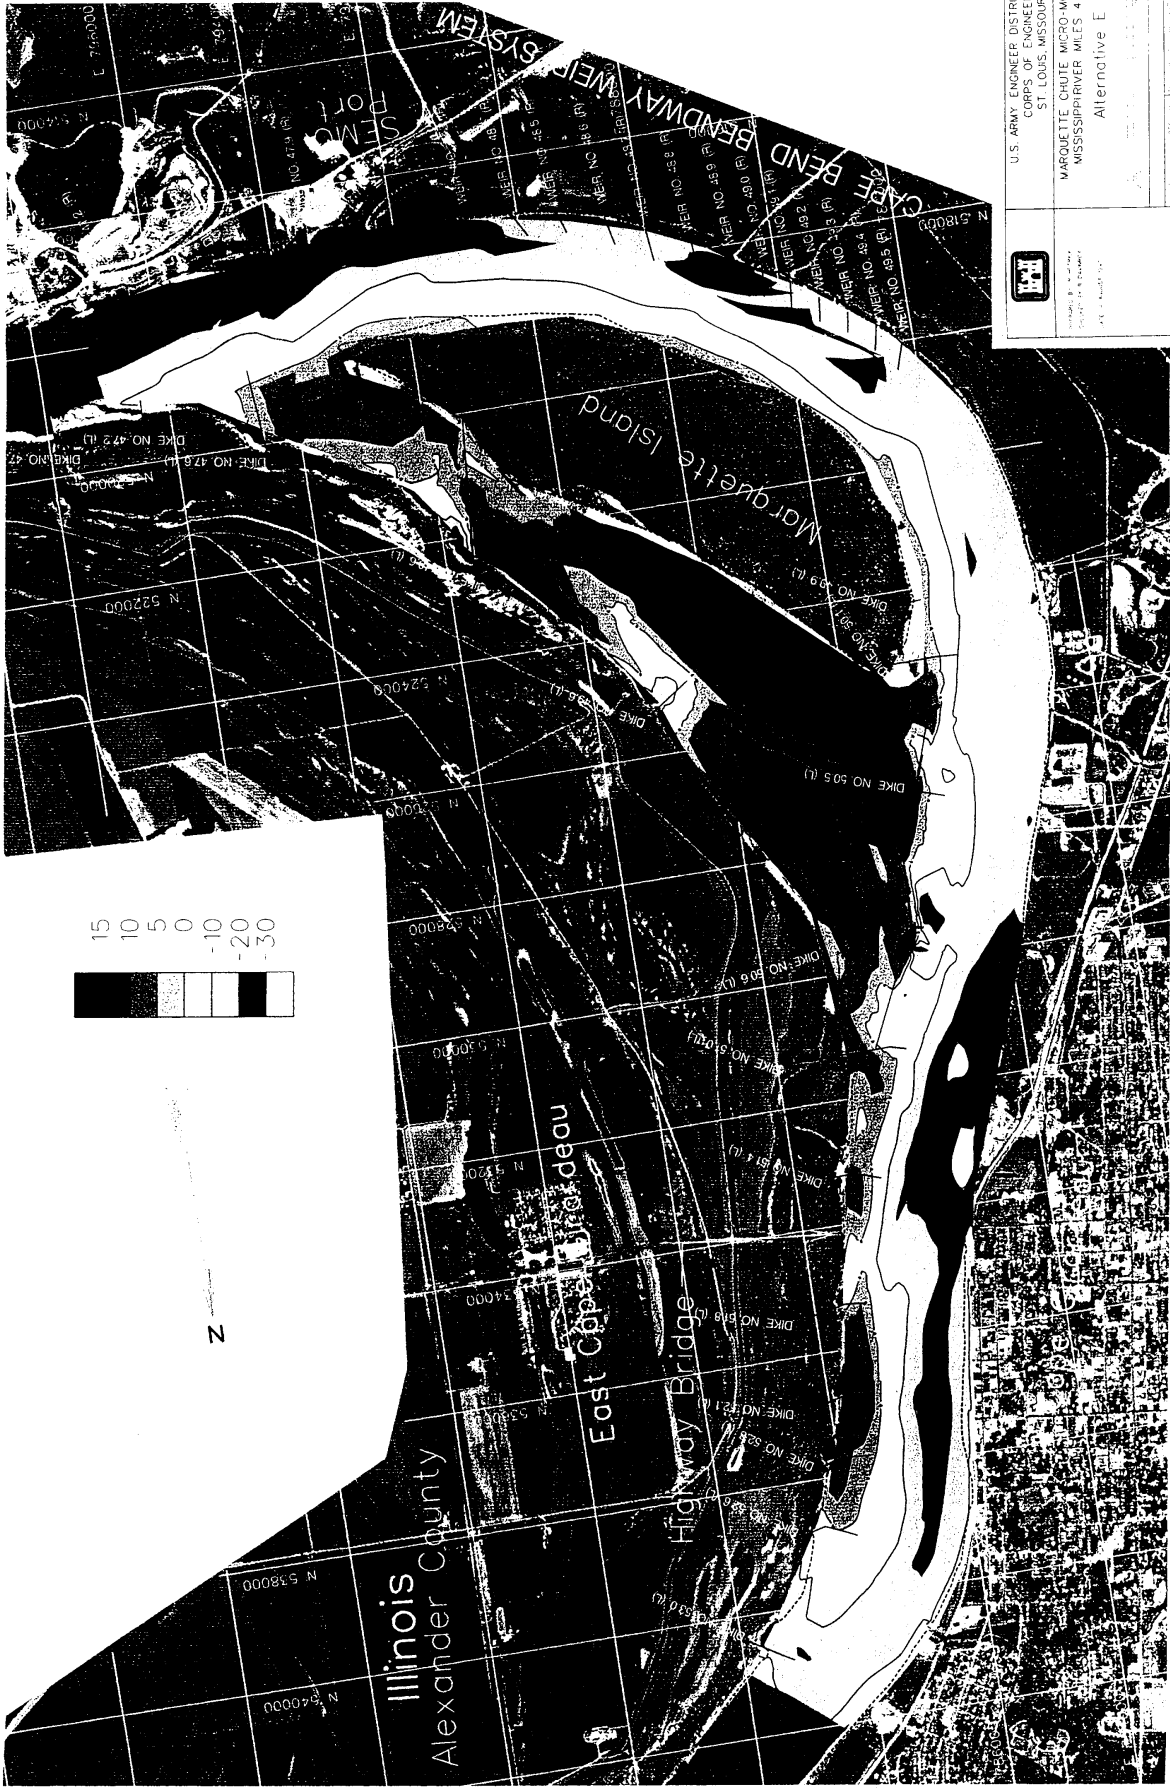
U.S. ARMY ENGINEER DISTRICT, ST. LOUIS  
 CORPS OF ENGINEERS  
 ST. LOUIS, MISSOURI  
 MARQUETTE CHUTE MICRO-MODEL STUDY  
 MISSISSIPPI RIVER MILES 47.0 - 53.0  
 Alternative E

Plate 20 is a plan view contour map of the resultant bed configuration of Alternative E. Results indicated that both the side channel and navigation channel remained relatively unchanged. Some minor increases in depth were experienced locally at the new downstream notch, but the scour hole created was very marginal in depth (5 to 10 feet). The rest of the side channel remained mostly unchanged.

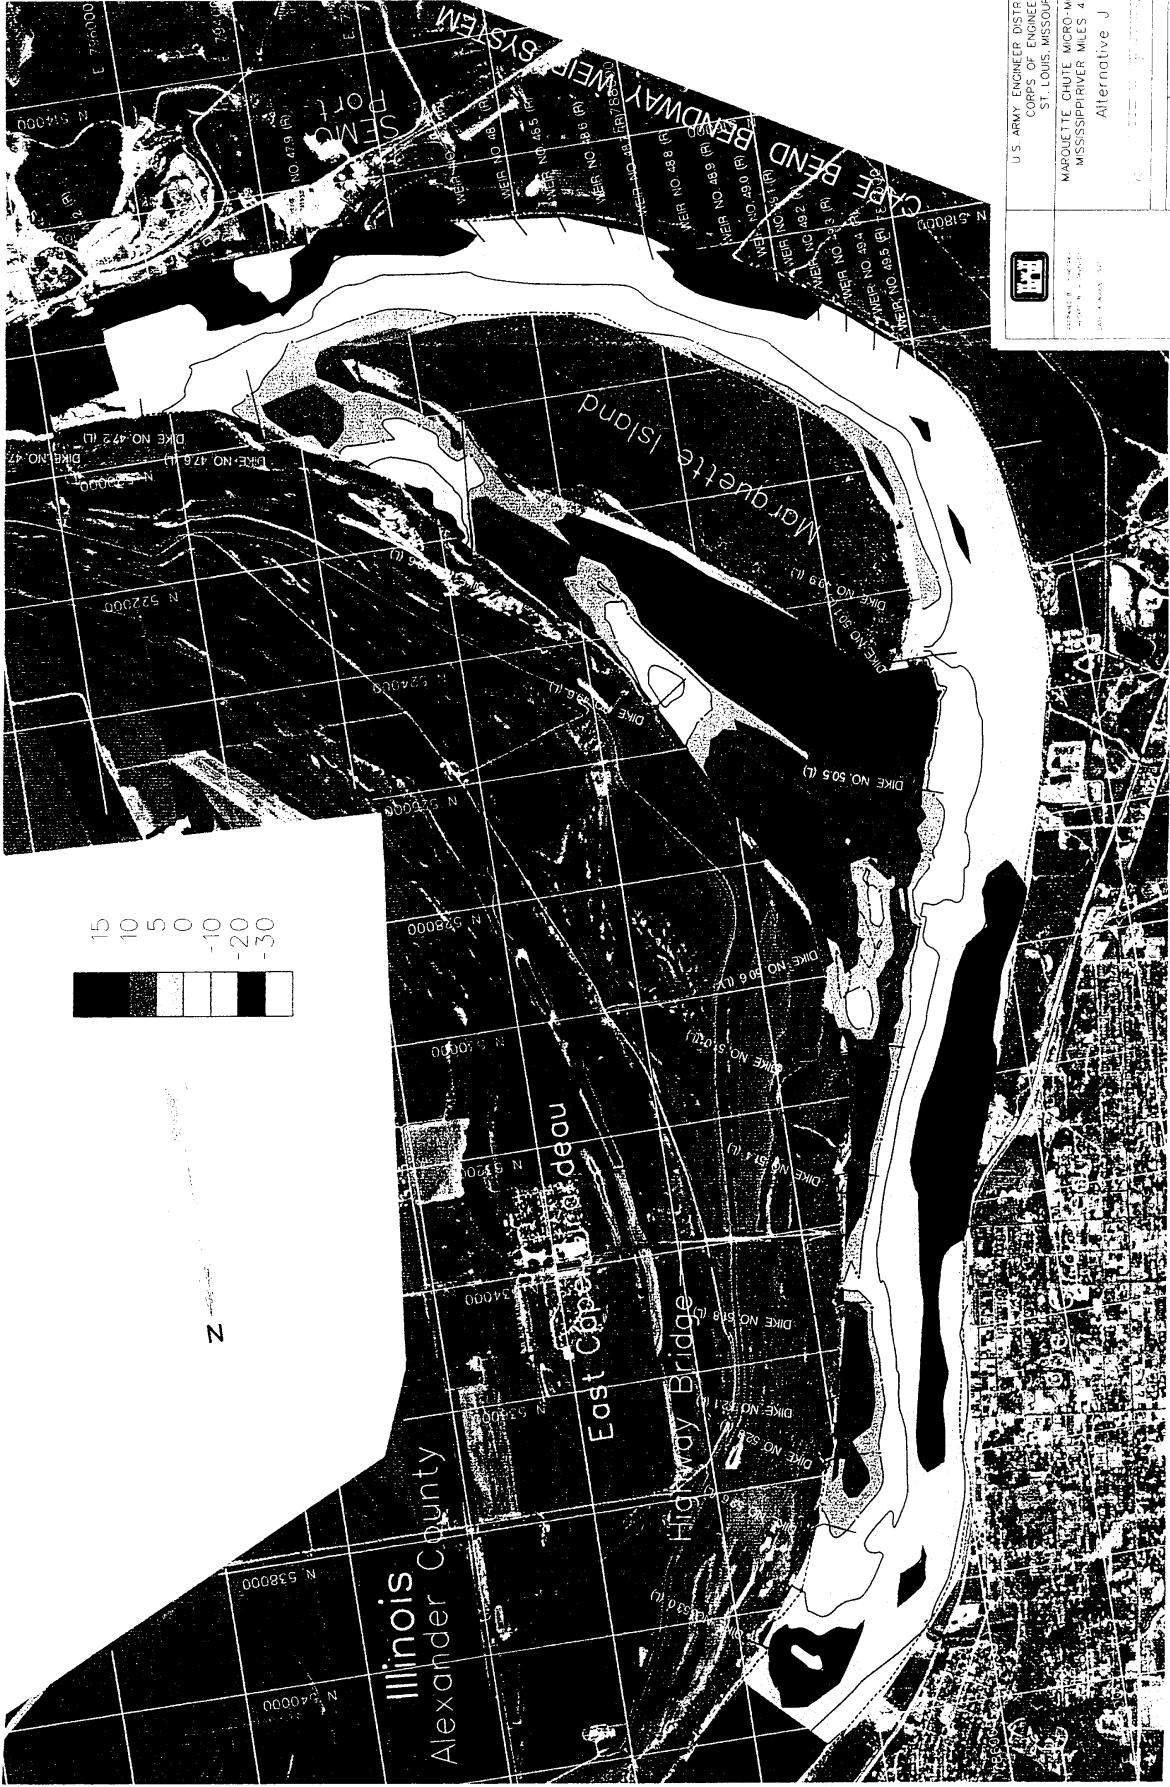
MARQUETTE CHUTE, MICRO-MODEL STUDY  
 MISSISSIPPI RIVER, MILES 47.0 - 53.0  
 Alternative J

Plate 25 is a plan view contour map of the resultant bed configuration of Alternative J. Notching the upper closure structure caused some light scouring (5-10 feet) immediately behind the closure structure. The changes also caused some deposition (5-10 feet) between Dikes 52.1L and 51.8L, and around Dikes 51.4L and 51.0L in the main channel. Noticeable scour in the centerline of the main channel between river miles 52 and 51 was observed. A scour hole also developed between Dikes 47.9R and 47.8R. The changes caused some scour around the outside of the bend from Dike 47.9R to the end of the study reach. The scour area around Dike 48.6L in the side channel increased slightly, and some small areas at the end of the side channel increased slightly in depth.

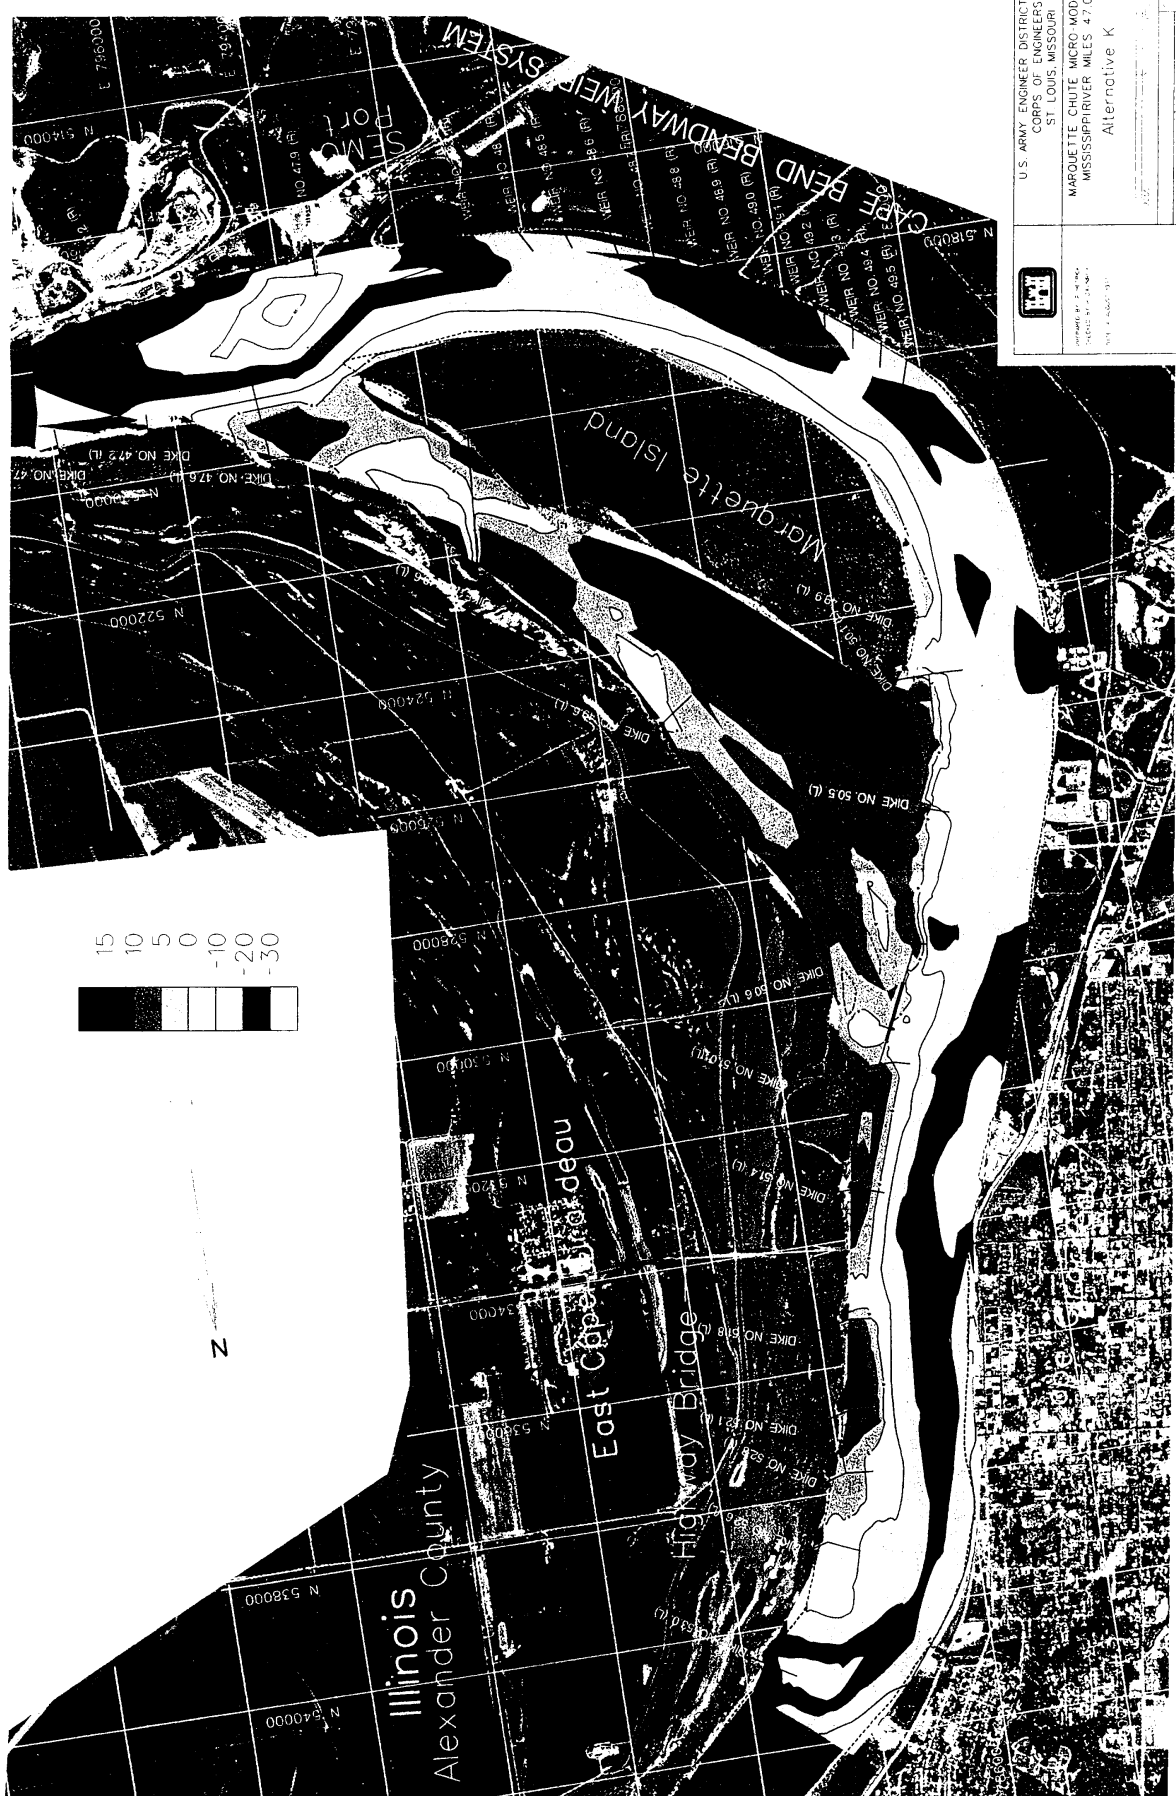
MARQUETTE CHUTE MICRO MODEL STUDY  
 MISSISSIPPI RIVER, MILES 47.0 - 53.0  
 Alternative K

Plate 26 is a plan view contour map of the resultant bed configuration of Alternative K. A large amount of scour was observed throughout the length of the main channel after notching the upper closure structure. Scouring also occurred around the outside of the

bend near Dikes 47.9R and 47.2R. The changes also caused uniform deposition of approximately five feet through most of the side channel. Localized scour was noted around the notched closure structure, as expected.

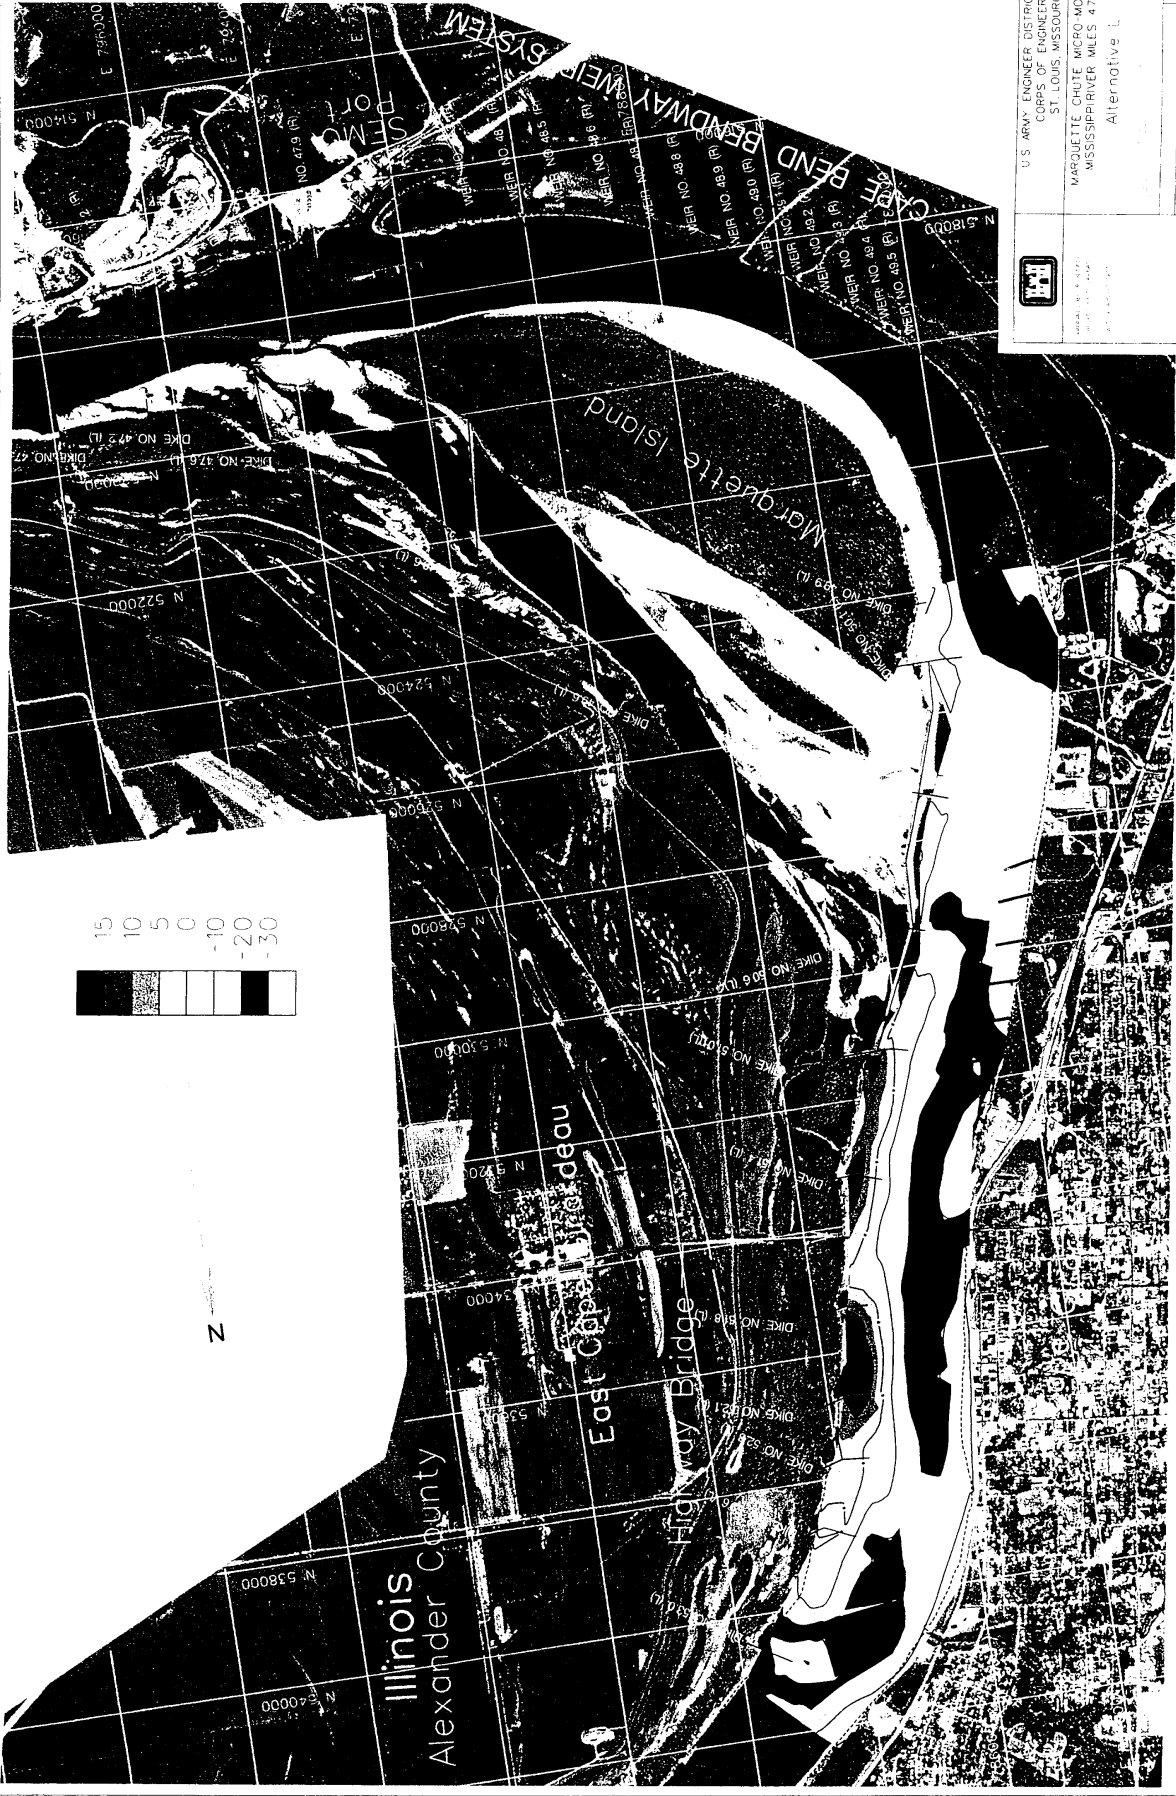
MARQUETTE CHUTE MICRO-MODEL STUDY  
MISSISSIPPI RIVER WILES 470 - 530  
Alternative 1

Plate 27 is a plan view contour map of the resultant bed configuration of Alternative L. Scour was noted about one mile upstream from the installation of new bendway weirs. The weir construction increased scour around Dike 53.0L at the beginning of the study reach. Noticeable deposition occurred on the inside or left of the channel around the existing dikes. The side channel was not surveyed.

- Raising dike 47.6 (L) in alternative I caused increased sedimentation upstream of the dike.
- The Bendway Weirs in alternatives L and M did not ensure a navigation channel in order to lower the upper closure structure. This was because of the lack of cross section needed to allow the weirs to work effectively.
