Technical Report M3

**SIDE CHANNEL SEDIMENTATION STUDY OF THE  
MISSISSIPPI RIVER  
MARQUETTE CHUTE/CAPE BEND  
RIVER MILES 51 TO 47**

**HYDRAULIC MICRO MODEL INVESTIGATION**

December 1997

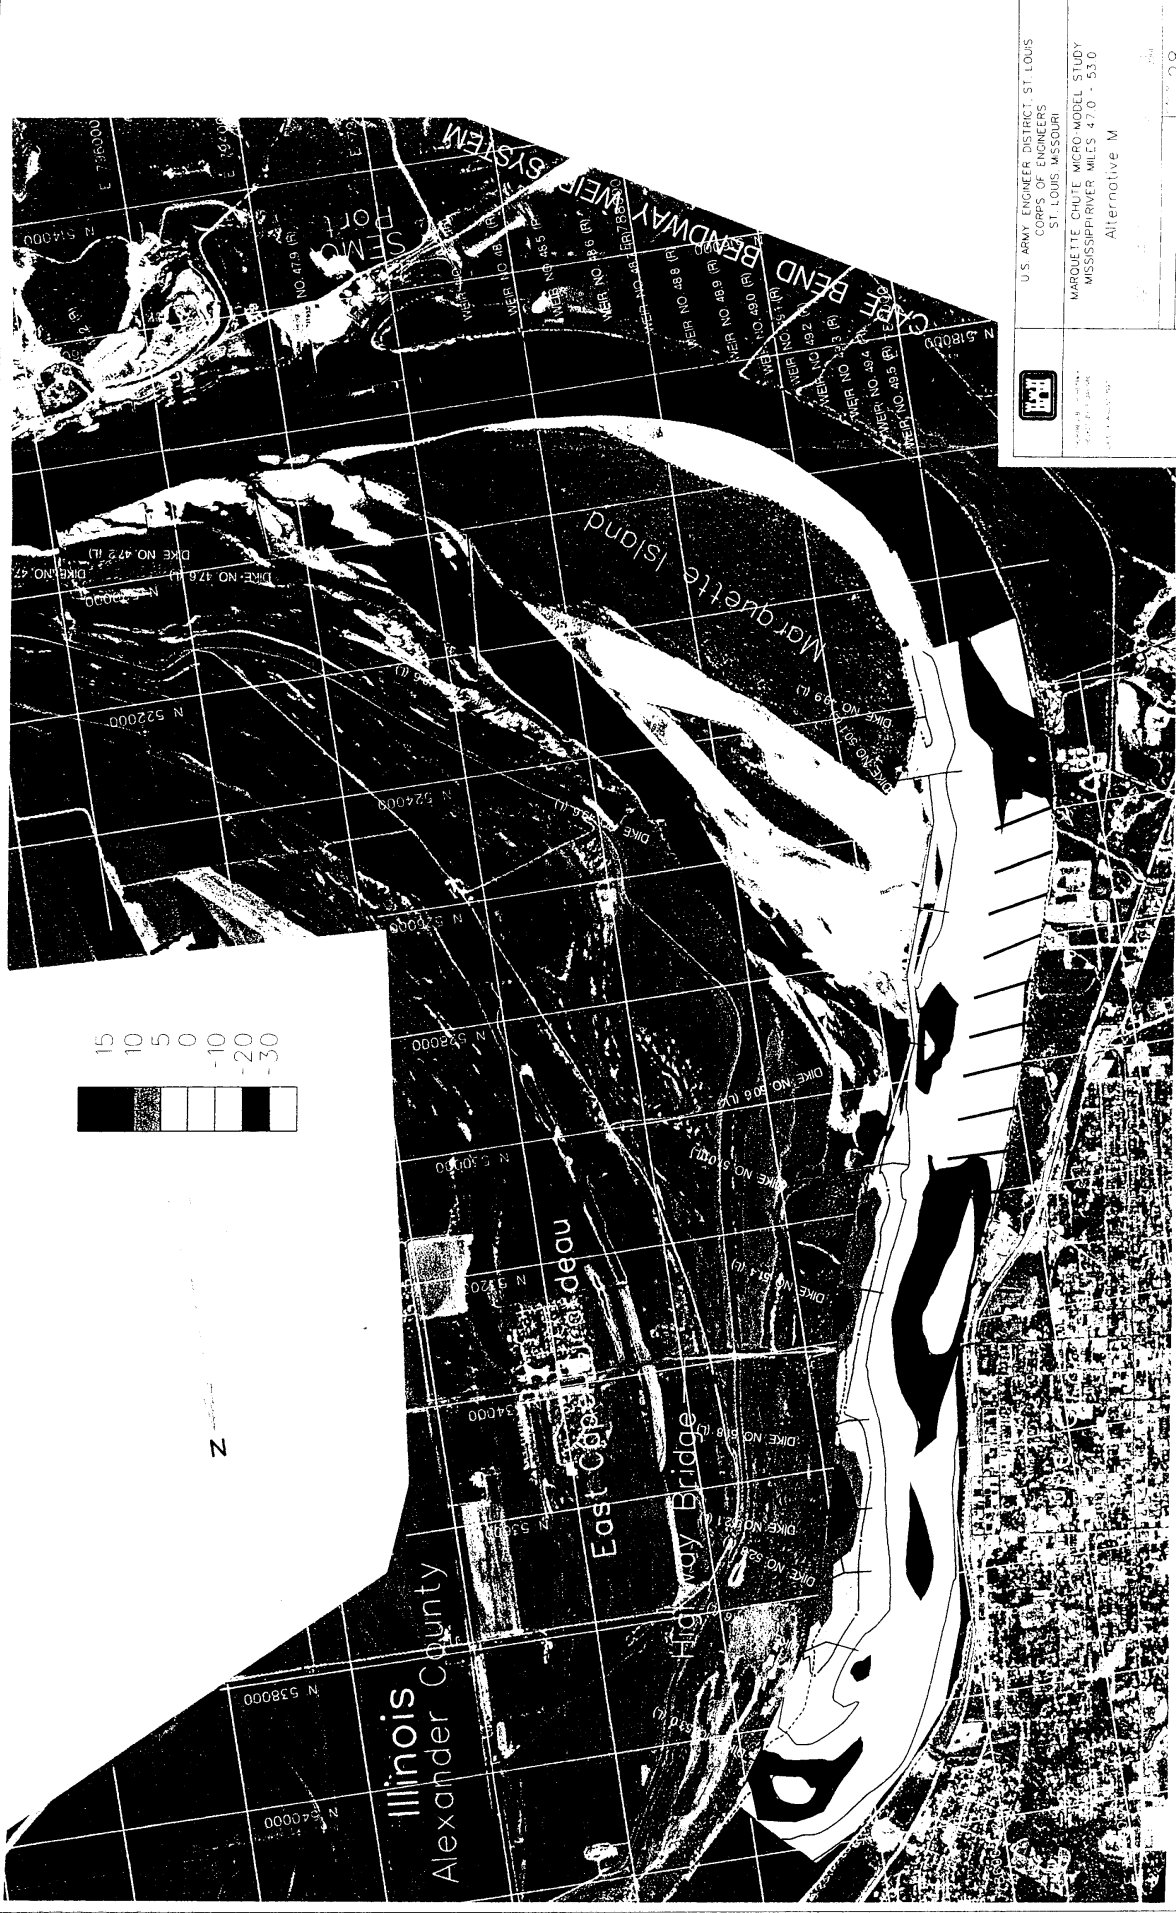
MARQUETTE CHUTE MICRO MODEL STUDY  
 MISSISSIPPI RIVER MILCS 470 - 530  
 Alternative M

Plate 28 is a plan view contour map of the resultant bed configuration of Alternative M. The results from Alternative M are very similar to those observed in Alternative L, although the scour pattern created upstream of the weirs was shorter and wider. Similar deposition on the left side of the channel occurred, as well. Most importantly, a large scour hole developed at the entrance to the side channel.

- Raising dike 47.6 (L) in alternative I caused increased sedimentation upstream of the dike.
- The Bendway Weirs in alternatives L and M did not ensure a navigation channel in order to lower the upper closure structure. This was because of the lack of cross section needed to allow the weirs to work effectively.

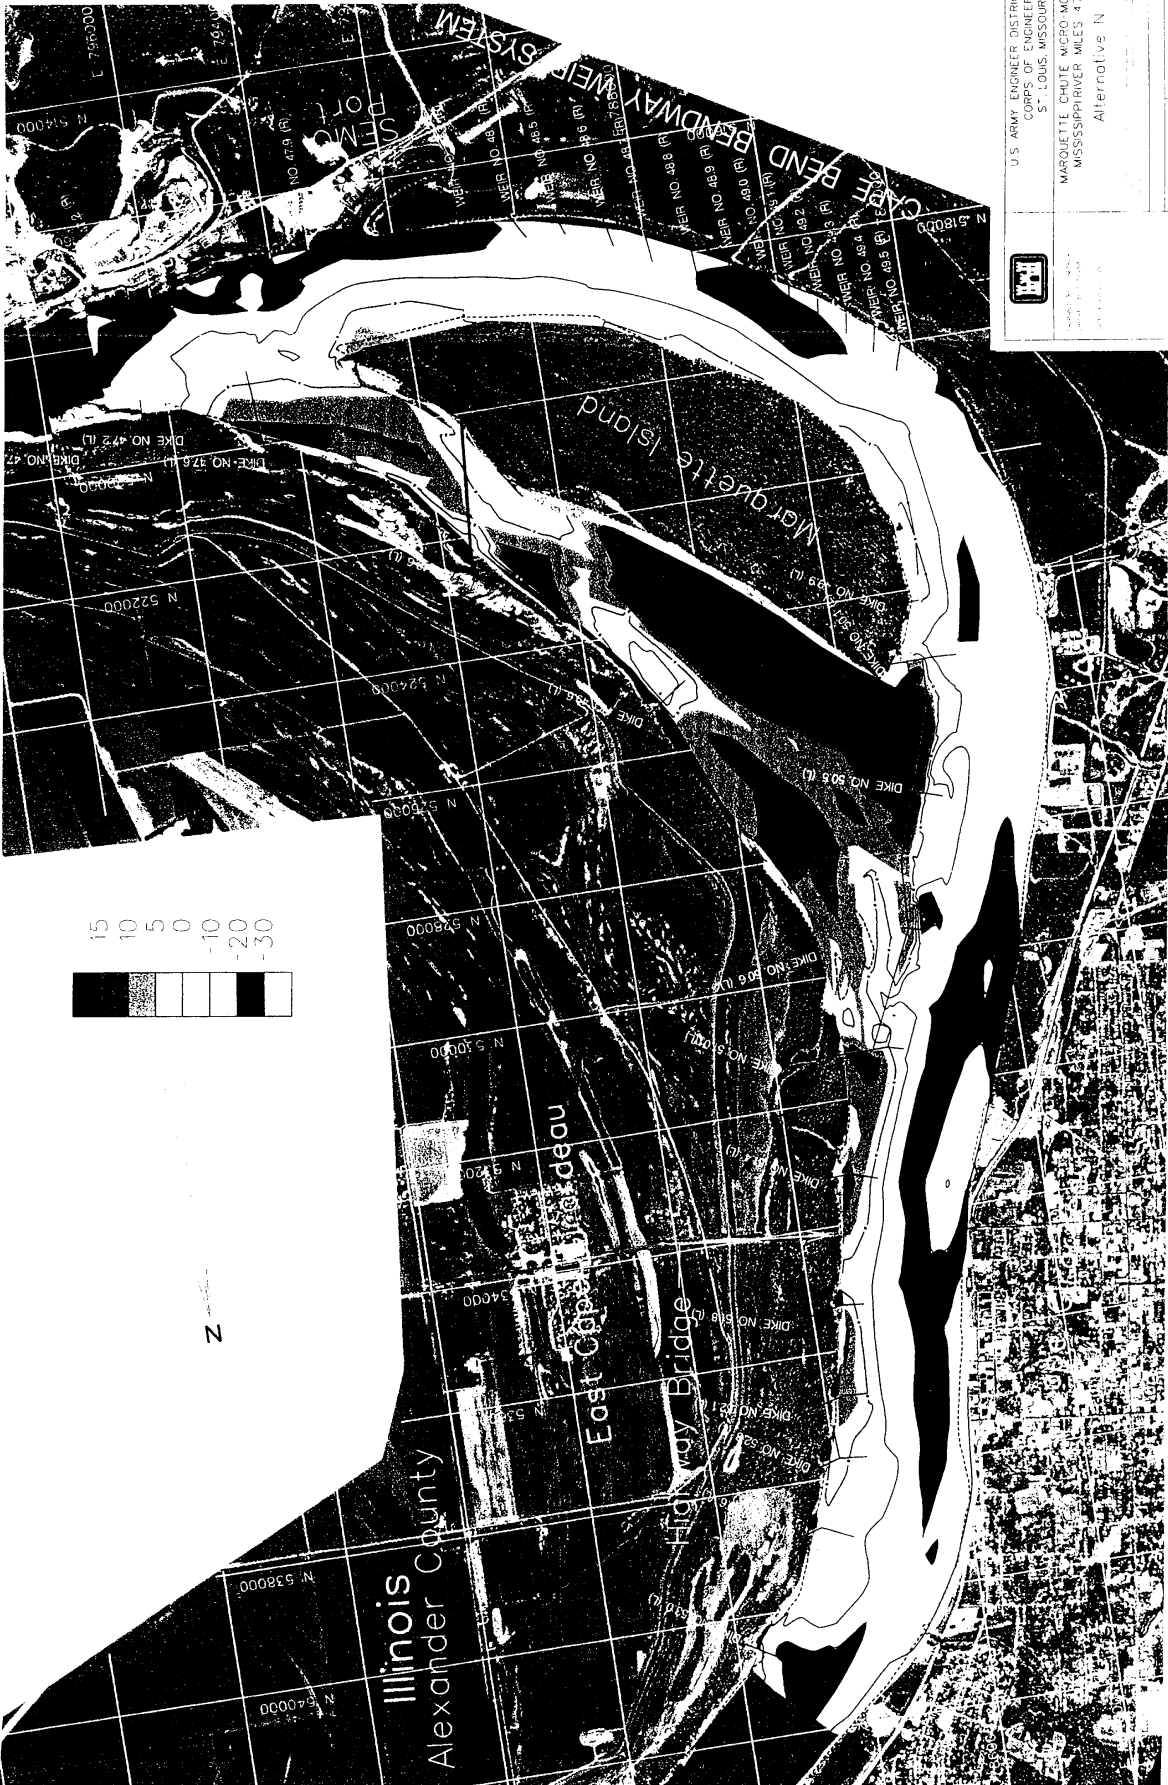
MARQUETTE CHANNEL MICRO MODEL STUDY  
 MISSISSIPPI RIVER, MILES 47.6 - 53.0  
 Alternative N

Plate 29 is a plan view contour map of the resultant bed configuration of Alternative N. Removal of the lower closure structure caused scour in the main channel near the entrance to the side channel. Some erosion occurred downstream of the newly removed closure structure. Deposition was noted in the main channel at the end of the side chute.

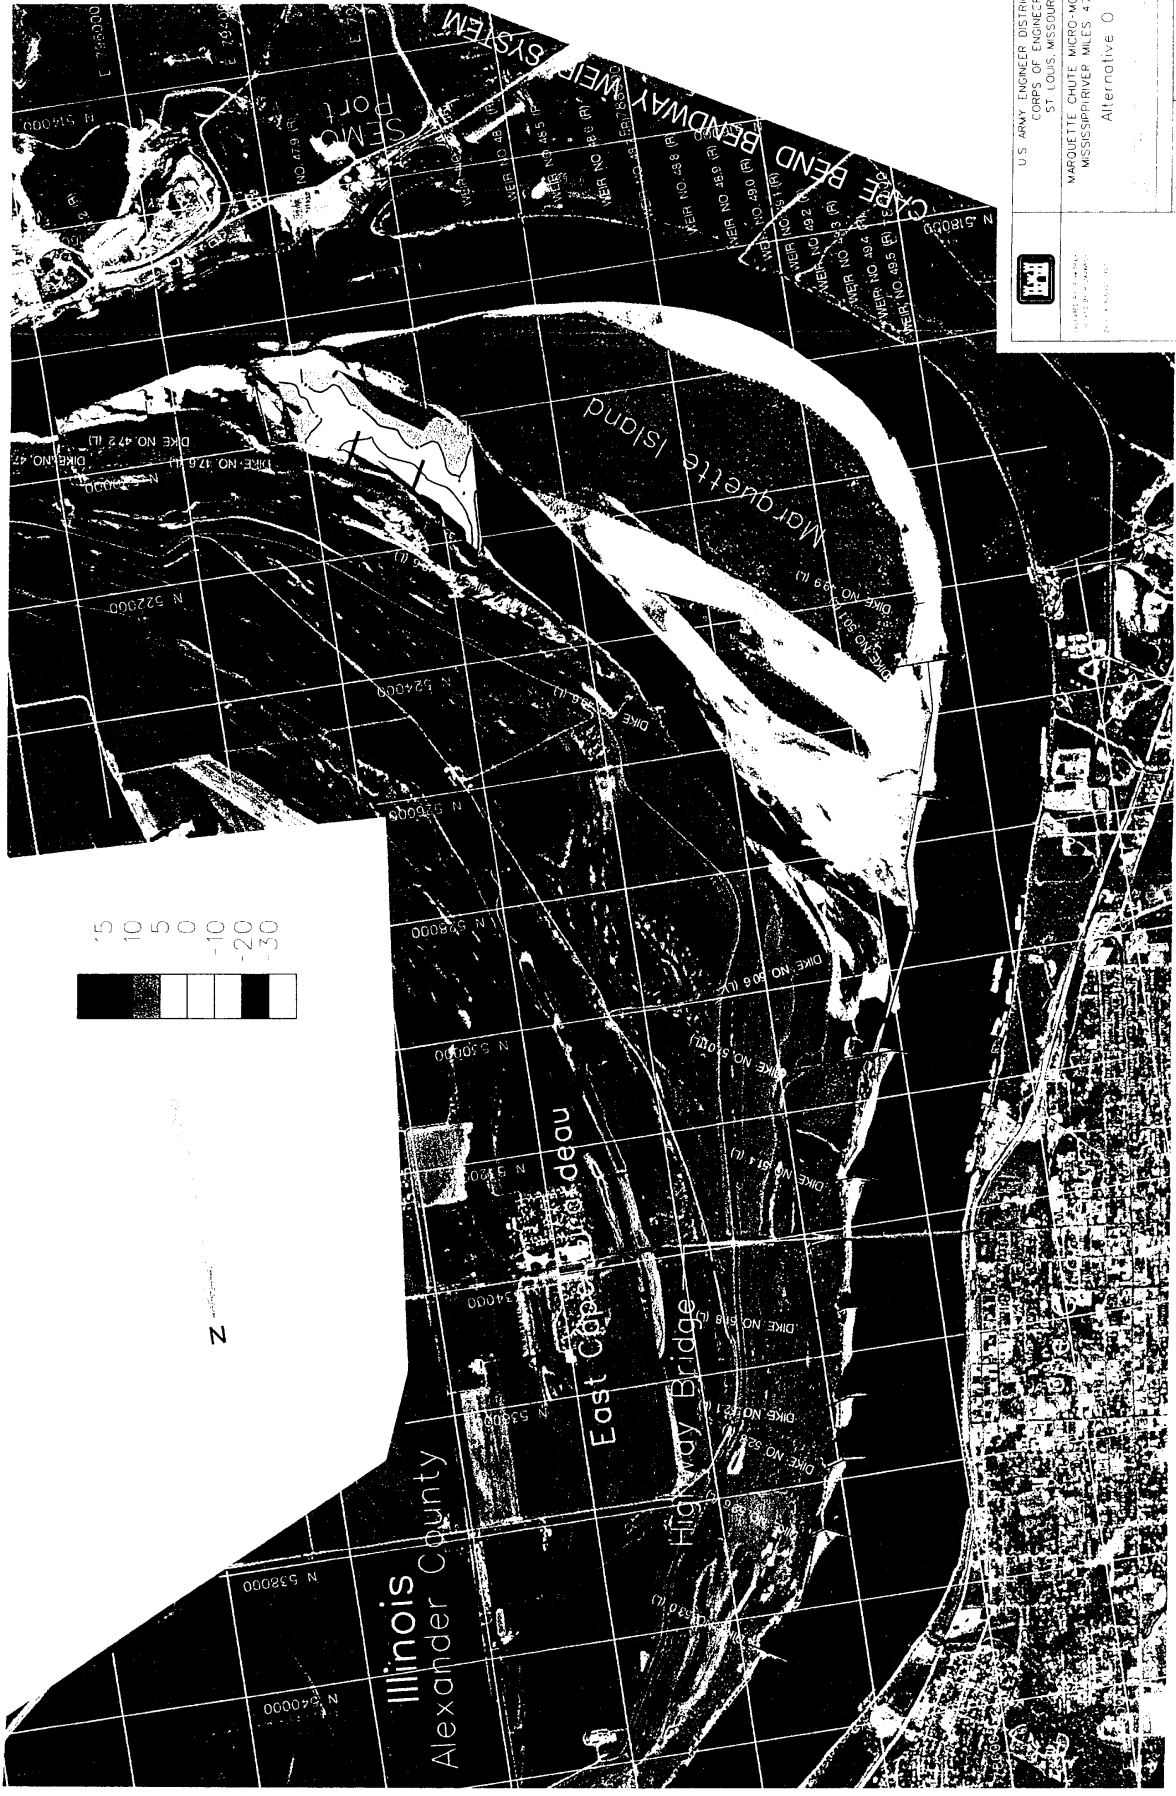
Plate 30 is a plan view contour map of the resultant bed configuration of Alternative O. The installation of two dikes in the side channel caused some deposition directly adjacent to the structures.

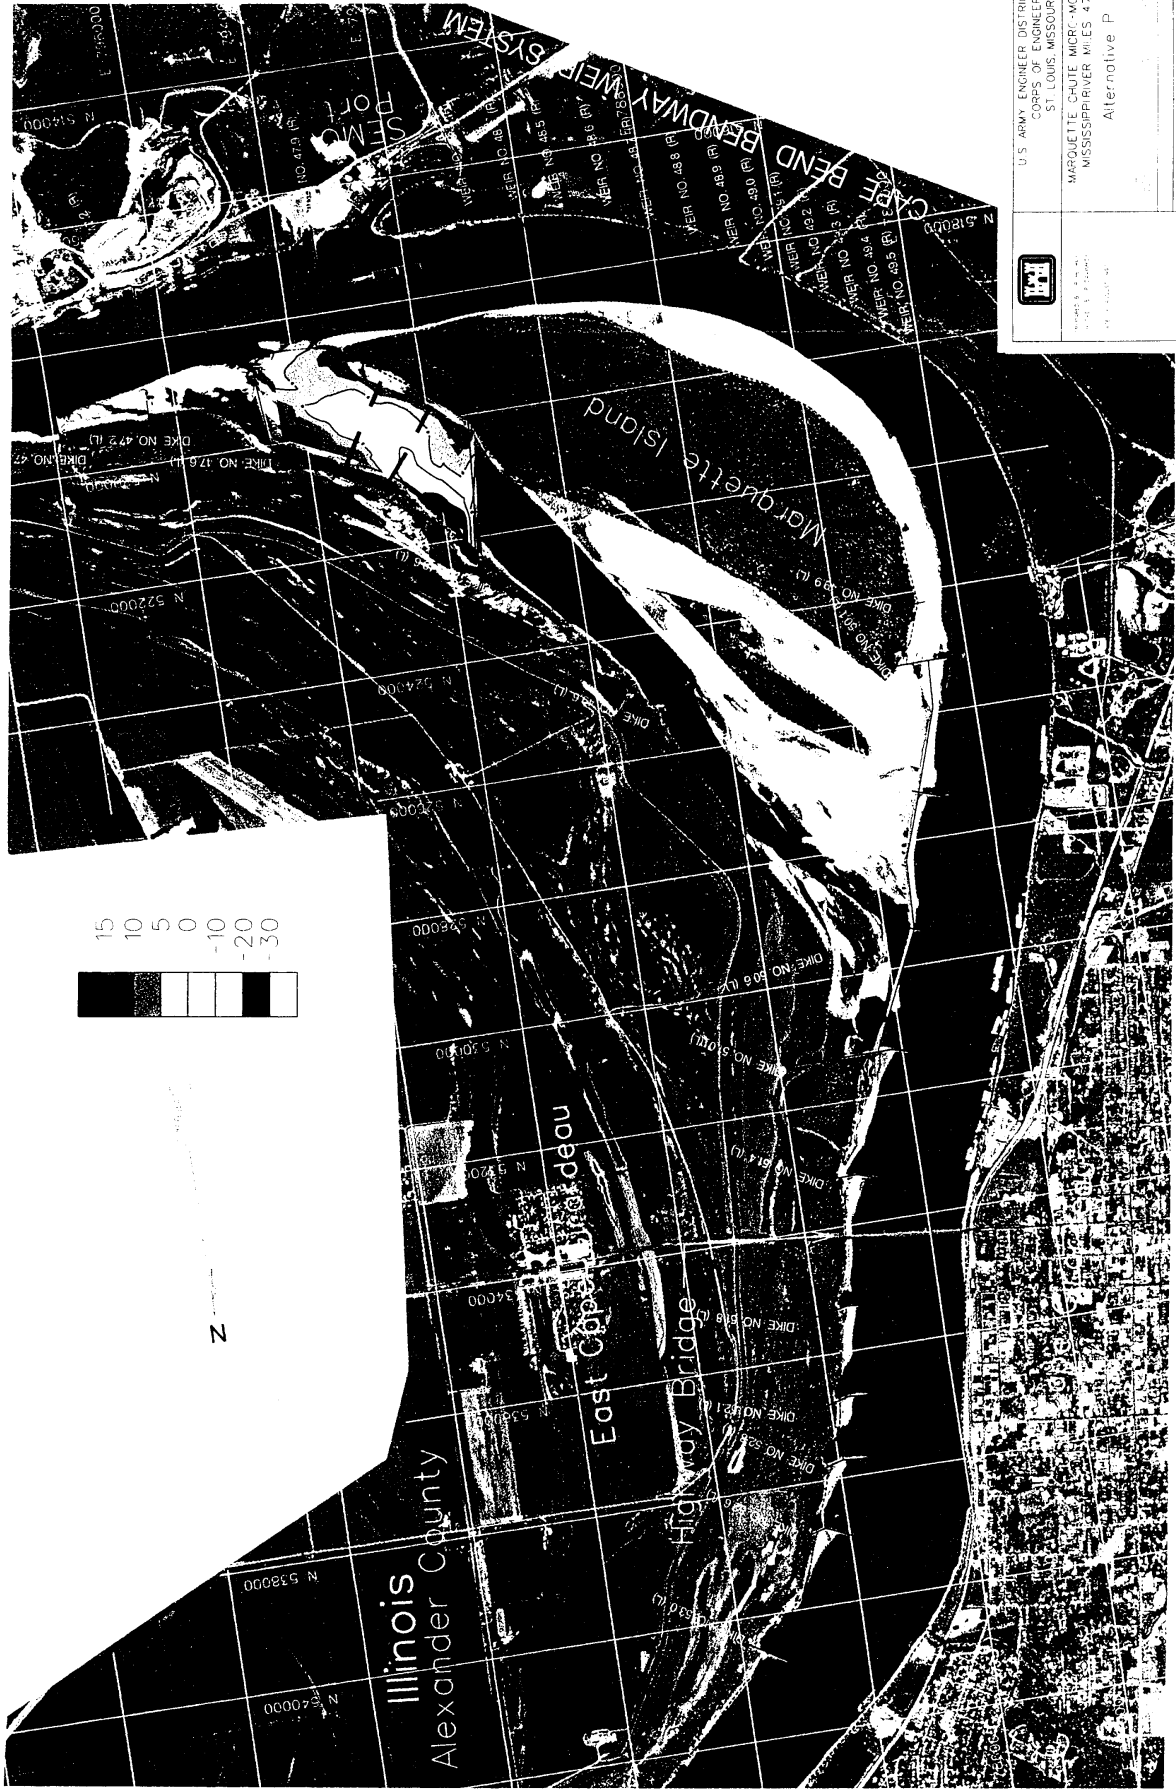
Plate 31 is a plan view contour map of the resultant bed configuration of Alternative P. The installation of four dikes in the side channel caused some scour around the new structures and approximately ten feet of deposition just downstream of the dikes.
