Non- Chromium Conversion Coatings on Aluminum

**Dr. O.Berkh, Dr. S. Tamir,
Prof. A. Bodnevas, M. Rotel
Israel Institute of Metals
Technion - Israel Institute of Technology
Haifa, 32000, Israel**

**Annual Report
Special Project No. SPC-98-4005
USAF contract No. F61775-98-WE 054**

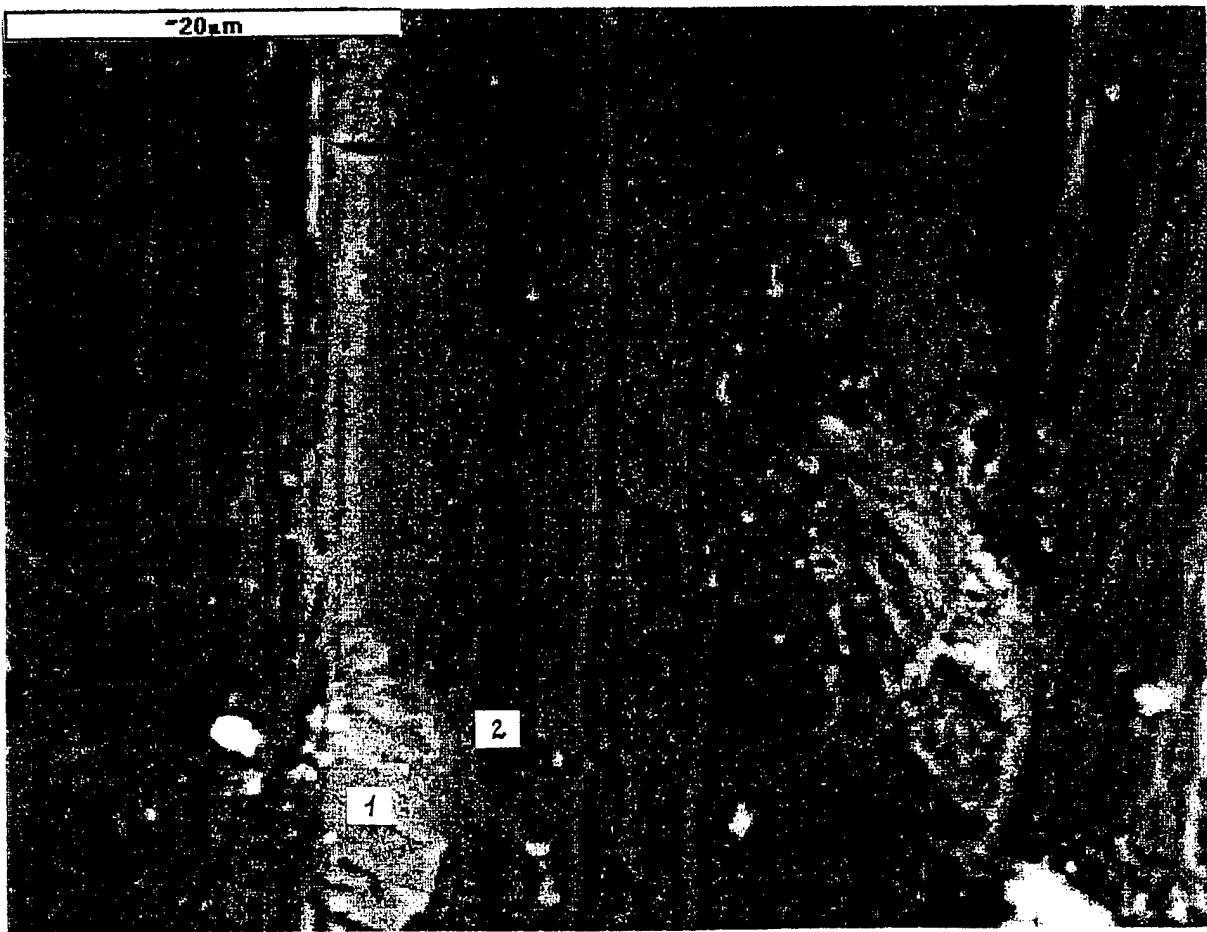
Fig. 9. Surface morphology at area of adhesion failure. a - Sample 282. b - Sample 284.

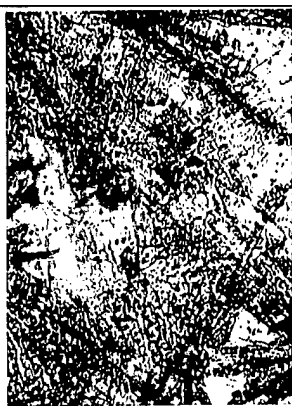
Fig. 14. Initial stage of zinc / phosphate coating growth. Deposition time 2 min.
Optical microphotographs. Magnification 200.

Several samples of Al 2024 T3 were treated in 30 % H_3PO_4 at 25 °C for 3 min, rinsed in water and immersed in a 3 % colloidal solution of SiO_2 at 25°C for 3 min. After that the samples were immersed in the phosphating solution and treated as usual. As can be seen in Fig. 14 the treatment in the colloidal SiO_2 solution contributed to the formation of faceted crystals.

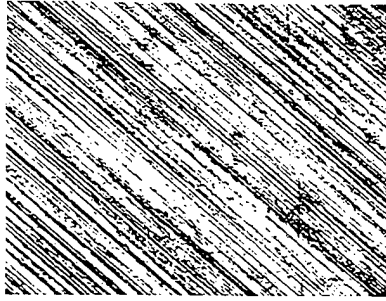
Fig.16. Structure of Al 2024 T3 surface before (a) and (b) after sand blasting. Optical microphotographs. Magnification 200.

Several Al 2024 samples were subjected to sand blasting and then treated as shown in Table 6. Sand blasting essentially increased roughness of the surface . The surface structure before and after sand blasting is shown in Fig. 16. The immersion of sand blasted samples in H_3PO_4 solutions resulted in very intensive etching process with an extremely

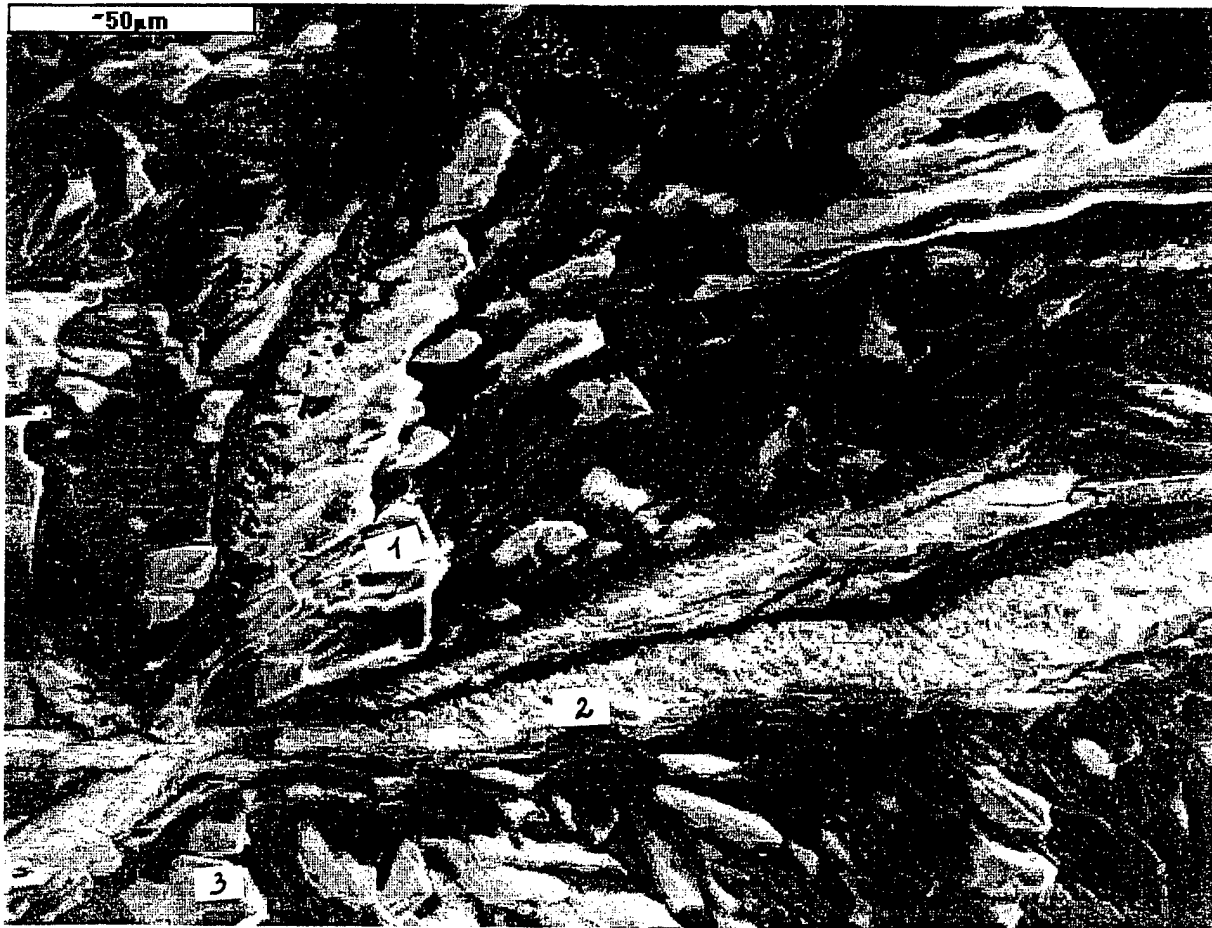
Spot	Zn / P / O
1	1.42 / 1 / 3.94
2	1.57 / 1 / 4.92
3	1.71 / 1 / 4.73

Fig.17. Surface morphology and composition of zinc/phosphate coating. Sample 234..
Magnification 500.

The composition the coatings was determined by EDS and XR analyses. The results of EDS analysis for two different samples are shown in Figs. 18,17. The crystals of different forms, namely, faceted and dendritic (star rays) had the same composition . The crystals consisted of Zn, P and O. The concentrations of these elements were about 22, 16 and 62 % (a.c.), respectively.

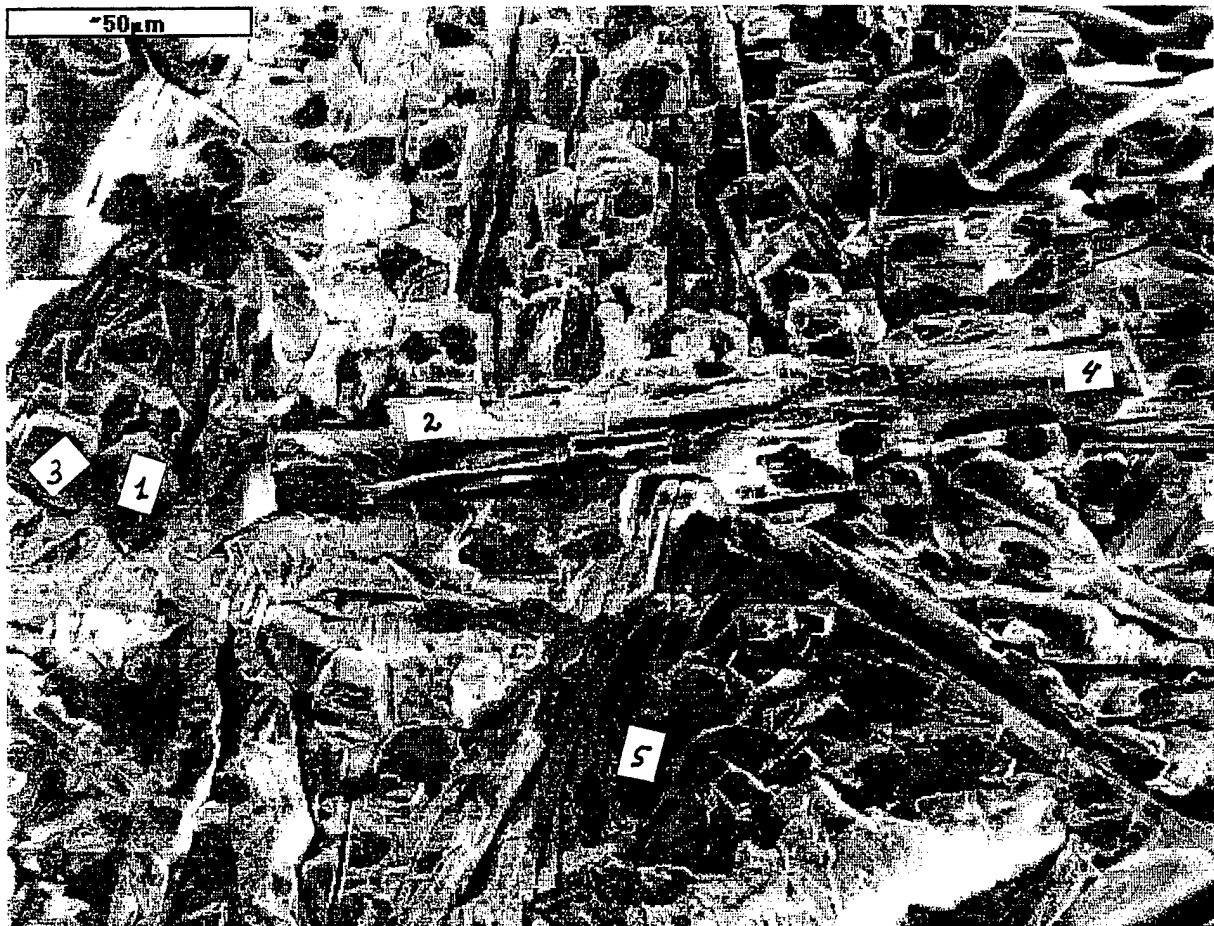
Spot	Zn / P / O
1	1.73 / 1 / 5.49
2	1.72 / 1 / 5.27
3	1.50 / 1 / 4.28
4	1.61 / 1 / 4.88
5	1.56 / 1 / 4.41

Fig 18. Surface morphology and composition of zinc/phosphate coating. Sample 240. Magnification 500.
