NATIONAL ADVISORY COMMITTEE FOR AERONAUTICS

TECHNICAL NOTE

No. 1679

FLIGHT MEASUREMENTS OF THE LONGITUDINAL STABILITY, STALLING,
AND LIFT CHARACTERISTICS OF AN AIRPLANE HAVING A
35° SWEPTBACK WING WITHOUT SLOTS AND WITH
40-PERCENT-SPAN SLOTS AND A COMPARISON
WITH WIND-TUNNEL DATA

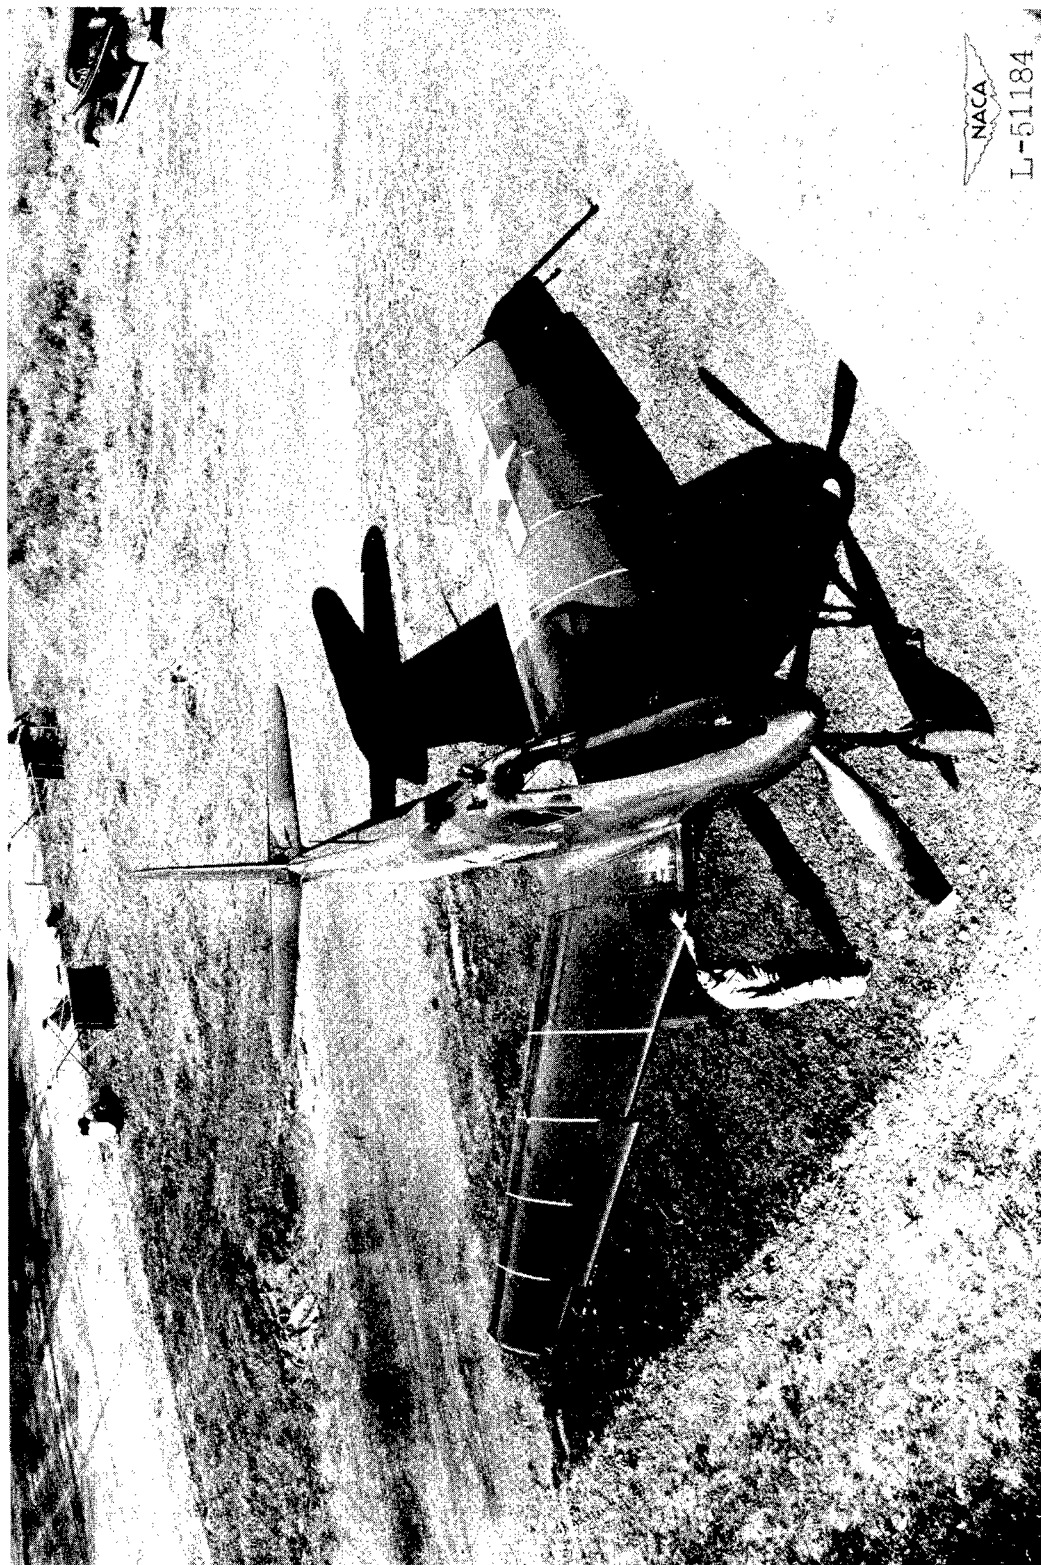
Figure 2.- Front view of test airplane.

A three-view drawing of the test airplane is shown in figure 1 and general dimensions and characteristics are listed in table I. Figures 2 and 3 are photographs of the airplane.

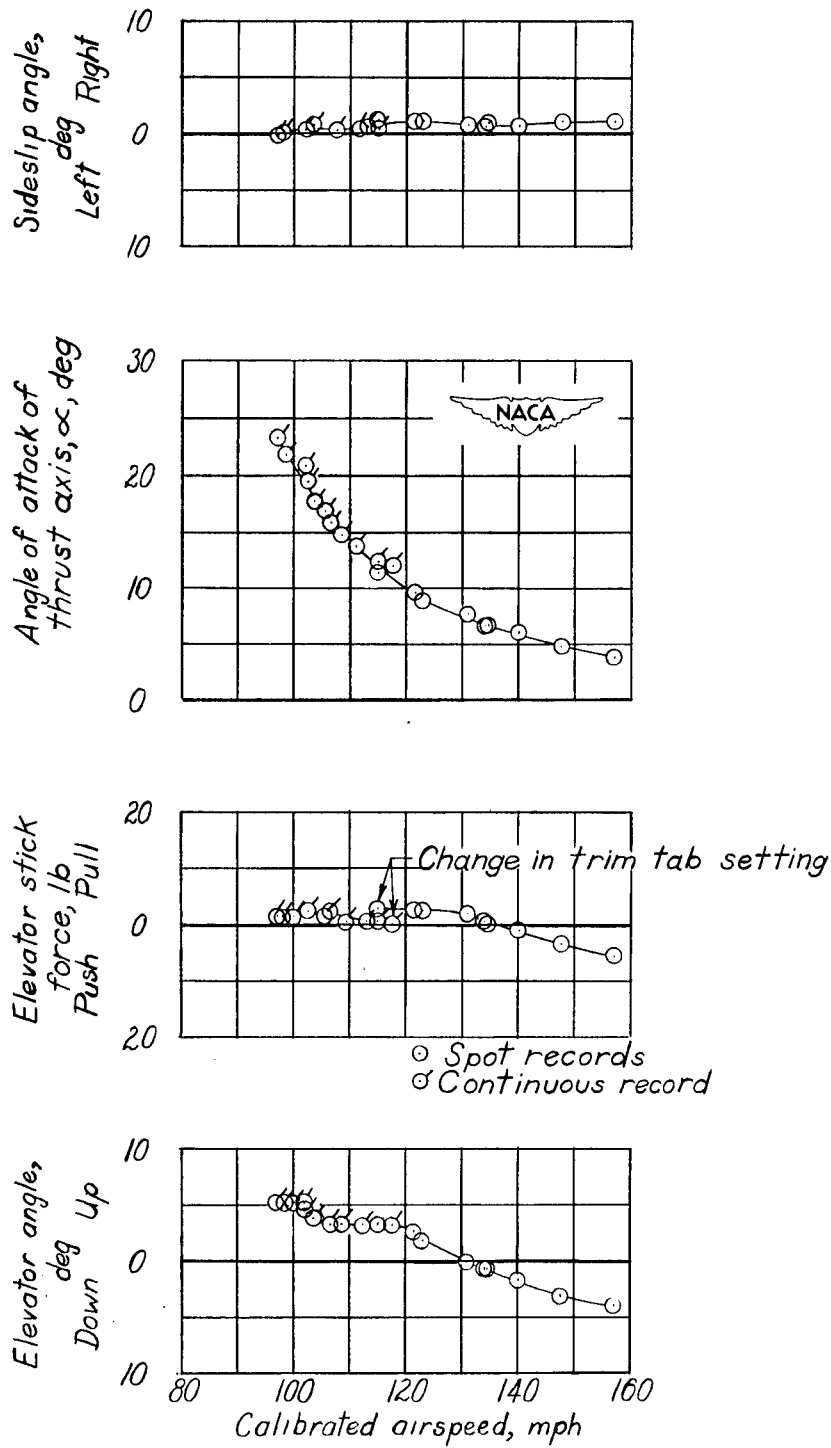
Figure 7.- Static longitudinal stability characteristics of test airplane without slots on wing. Flaps down; nose wheel down; engine idling; center of gravity at 26.4 percent mean aerodynamic chord.

The static longitudinal stability characteristics of the test airplane without slots were determined with the flaps up and down and with a center-of-gravity location of approximately 26 percent mean aerodynamic chord. Figures 6 and 7 show the variation of elevator angle, elevator-stick force, angle of attack of thrust axis, and side-slip angle with calibrated airspeed for the airplane with flaps up and flaps down, respectively. The variation of elevator angle required for trim with normal-force coefficient is presented in figure 8 for both the flaps-up and flaps-down conditions.

With the flaps up (figs. 6 and 8) both the stick-fixed and stick-free stability are high throughout the speed range tested. With the flaps down figure 8 shows the stick-fixed stability is high up to a normal-force coefficient of approximately 1.0. A large decrease in stability occurred at a normal-force coefficient of 1.0 and the stability was neutral or slightly negative near the maximum normal-force coefficient. Figure 7 shows the stick-free stability was also neutral or slightly negative near the stall.

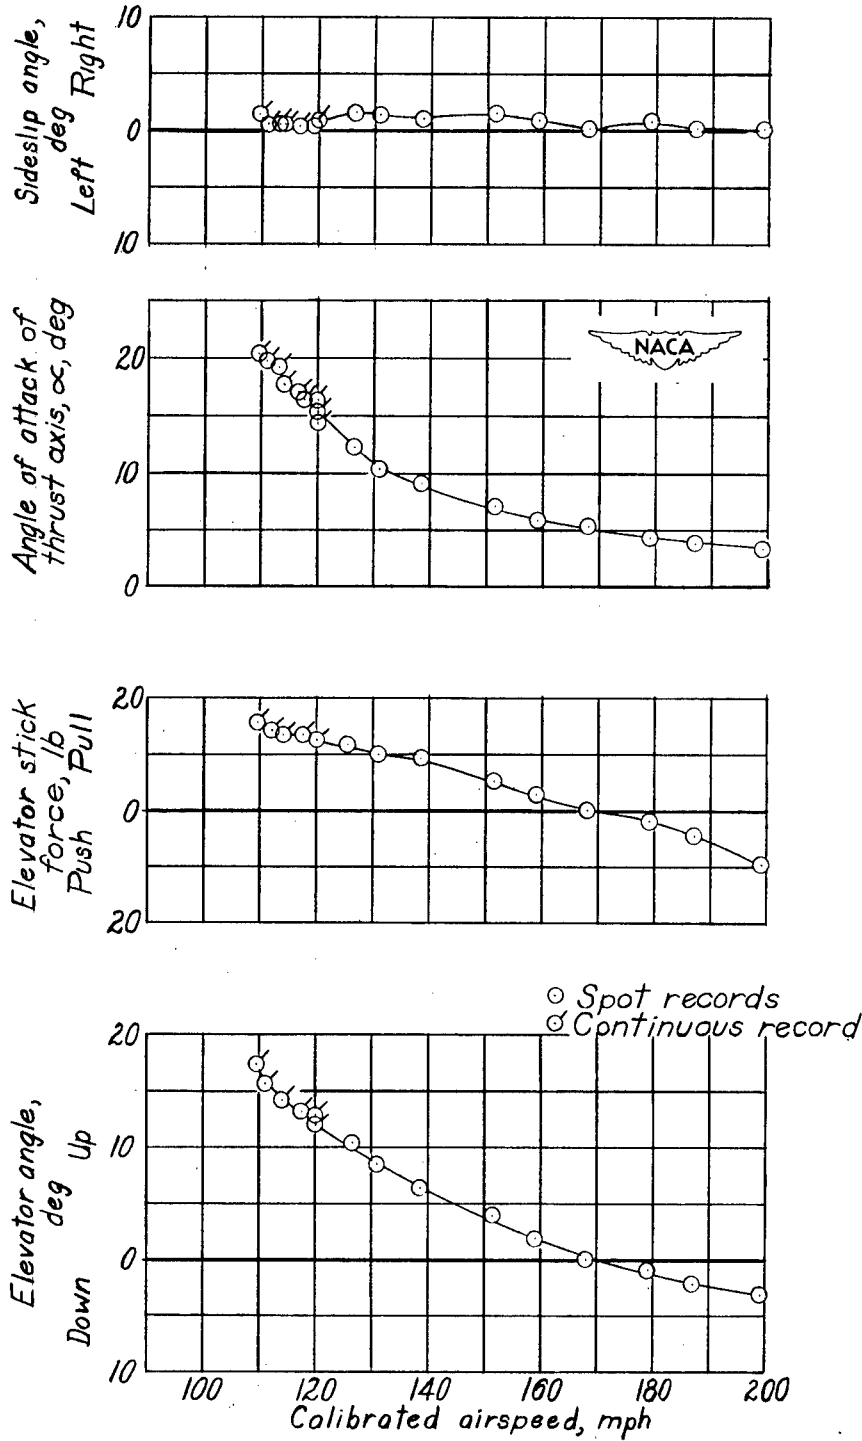
(a) Center of gravity at 20.6 percent mean aerodynamic chord.

Figure 9.- Static longitudinal stability characteristics of test airplane with 40-percent-span slots on wing. Flaps up; nose wheel up; engine idling.

(b) Center of gravity at 26.2 percent mean aerodynamic chord.

figure 9 for the flaps-up condition and in figure 10 for the flaps-down condition. Figures 11 and 12 show the variation of elevator angle required for trim with normal-force coefficient and figures 13 and 14 show the variation of elevator stick force divided by impact pressure with normal-force coefficient.

With the flaps up the addition of slots had a negligible effect on the longitudinal stability at normal-force coefficients less than 1.0. At normal-force coefficients greater than 1.0 a decrease in stability occurred with the slots on the wing and an increase in stability occurred without slots. With the flaps down and the center of gravity at approximately 26 percent mean aerodynamic chord (figs. 12 and 14) a large decrease in stability occurred at a normal-force coefficient of approximately 1.2. The neutral or slightly negative stability extended over a smaller normal-force coefficient or speed range with slots on the wing than without slots, partly because the maximum normal-force coefficient was lower with the 40-percent-span slots than without slots. The data in figures 9 to 14 are shown only for unstalled conditions of flight. Although the stability was neutral at speeds slightly greater than the stalling speed, after the stall had occurred the stability was again positive inasmuch as up elevator was required to keep the airplane from pitching down. The wind-tunnel measurements of longitudinal stability showed the same trends as the flight data since with the flaps up there was no decrease in stability near the stall, but with the flaps down instability was present over a small range of angles of attack near the stall. After the stall stable pitching tendencies were again present. With the flaps down and the center of gravity at approximately 20 percent mean aerodynamic chord, the reduction in stick-fixed stability near the stall was apparently not so great as that for the more rearward center-of-gravity position. (See fig. 12.) Any changes in stability which occur with change in normal-force coefficient should be independent of the center-of-gravity location. With the center of gravity forward, considerably greater up elevator deflections were required for trim near the stall. It is believed that a loss in elevator effectiveness occurred at the higher deflections, and this loss is probably the reason the loss in stability near the stall was not apparent from the curves of elevator angle against normal-force coefficient and speed for the forward center-of-gravity location.

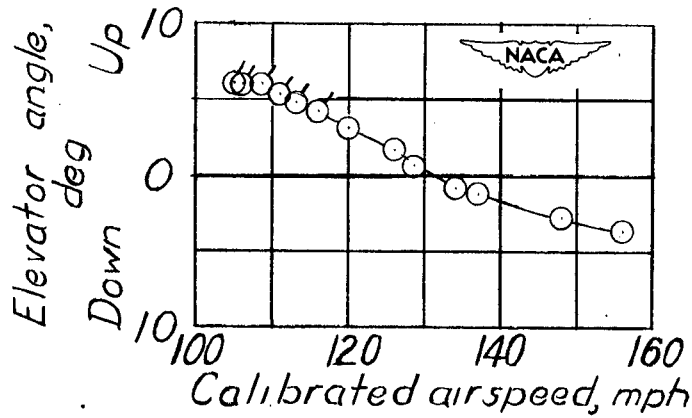
(a) Center of gravity at 20.3 percent mean aerodynamic chord.

Figure 10.- Static longitudinal stability characteristics of test airplane with 40-percent-span slots on wing. Flaps down; nose wheel down; engine idling.

(b) Center of gravity at 26.5 percent mean aerodynamic chord.

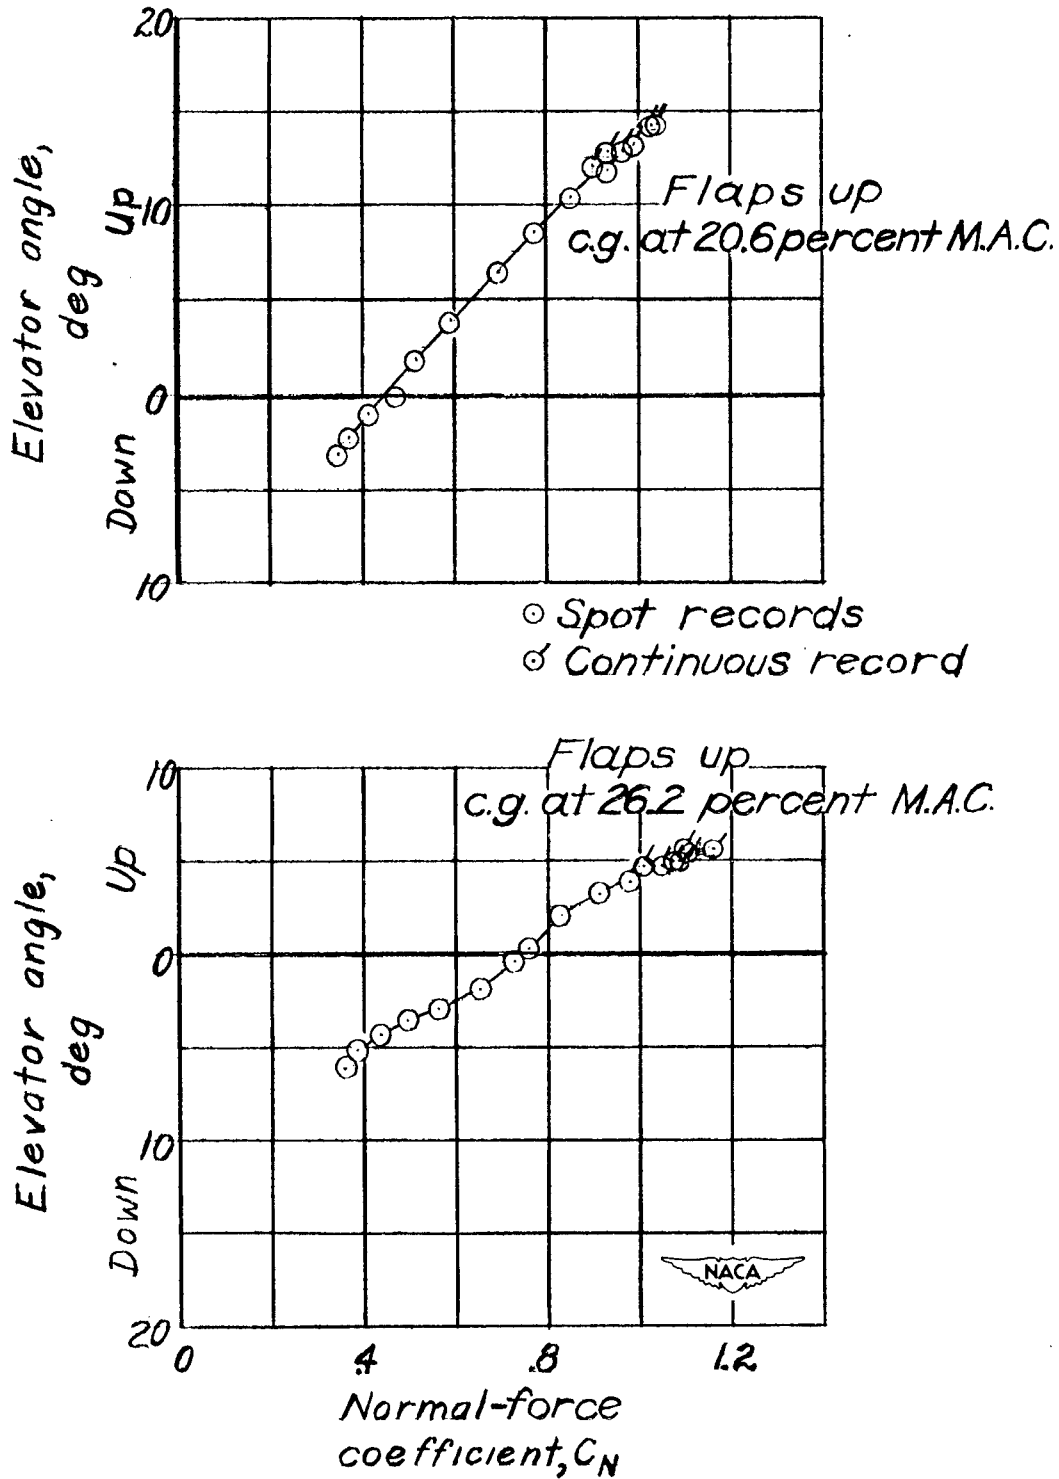
Figure 11.- Variation of elevator angle required for trim with normal-force coefficient for test airplane with 40-percent-span slots on wing. Flaps up; nose wheel up; engine idling.

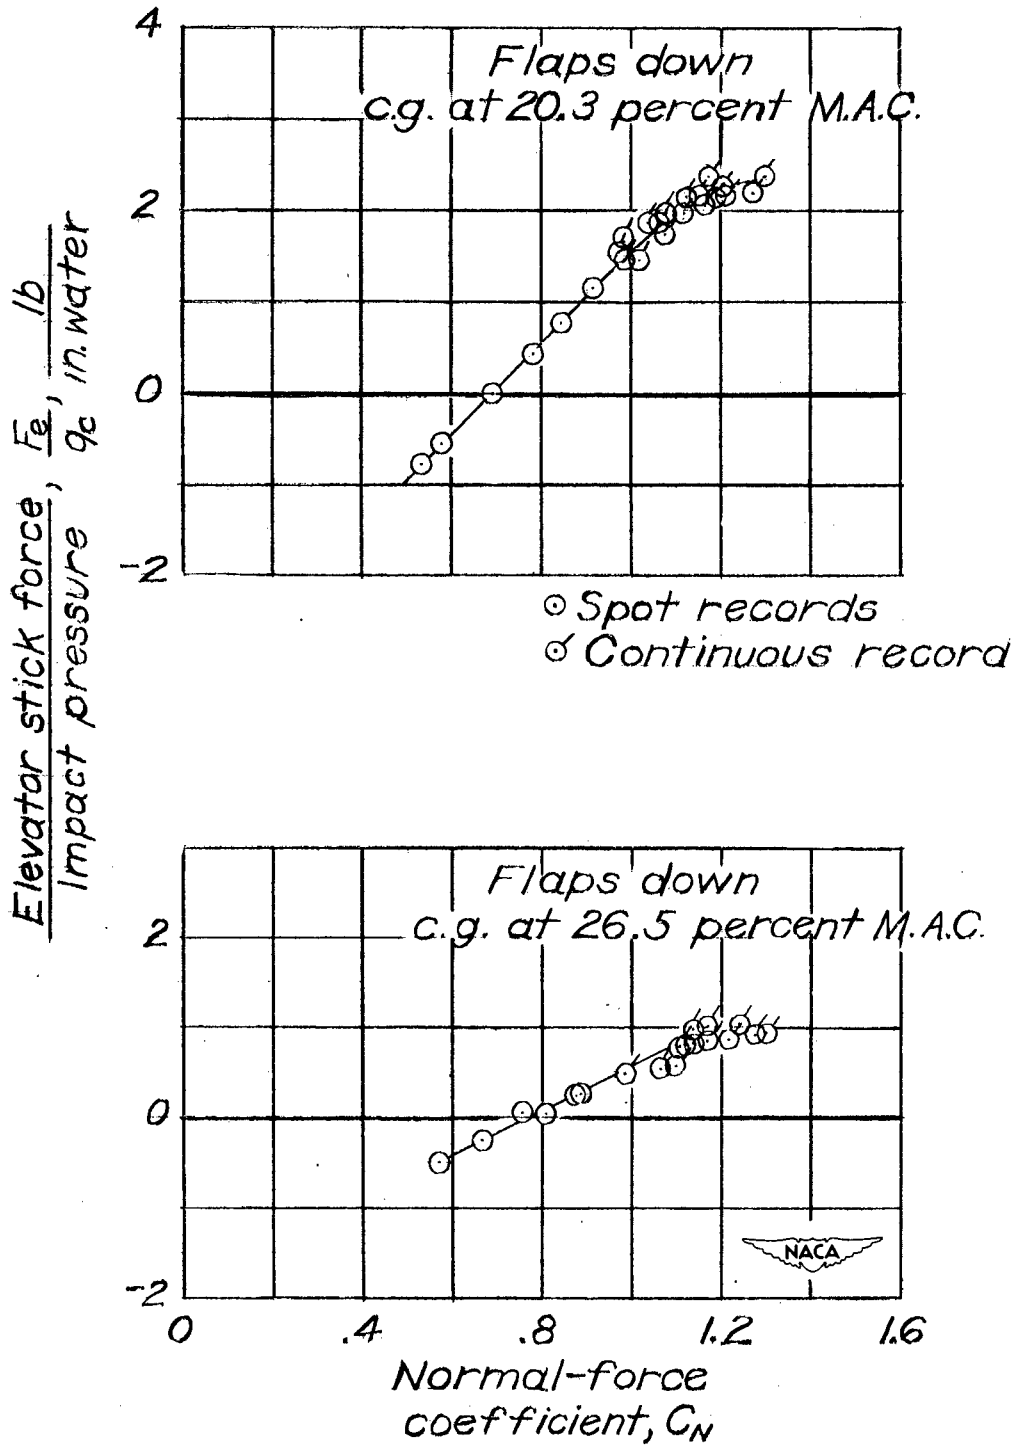
Figure 14.- Variation of elevator stick force divided by impact pressure with normal-force coefficient for test airplane with 40-percent-span slots on wing. Flaps down; nose wheel down; engine idling.

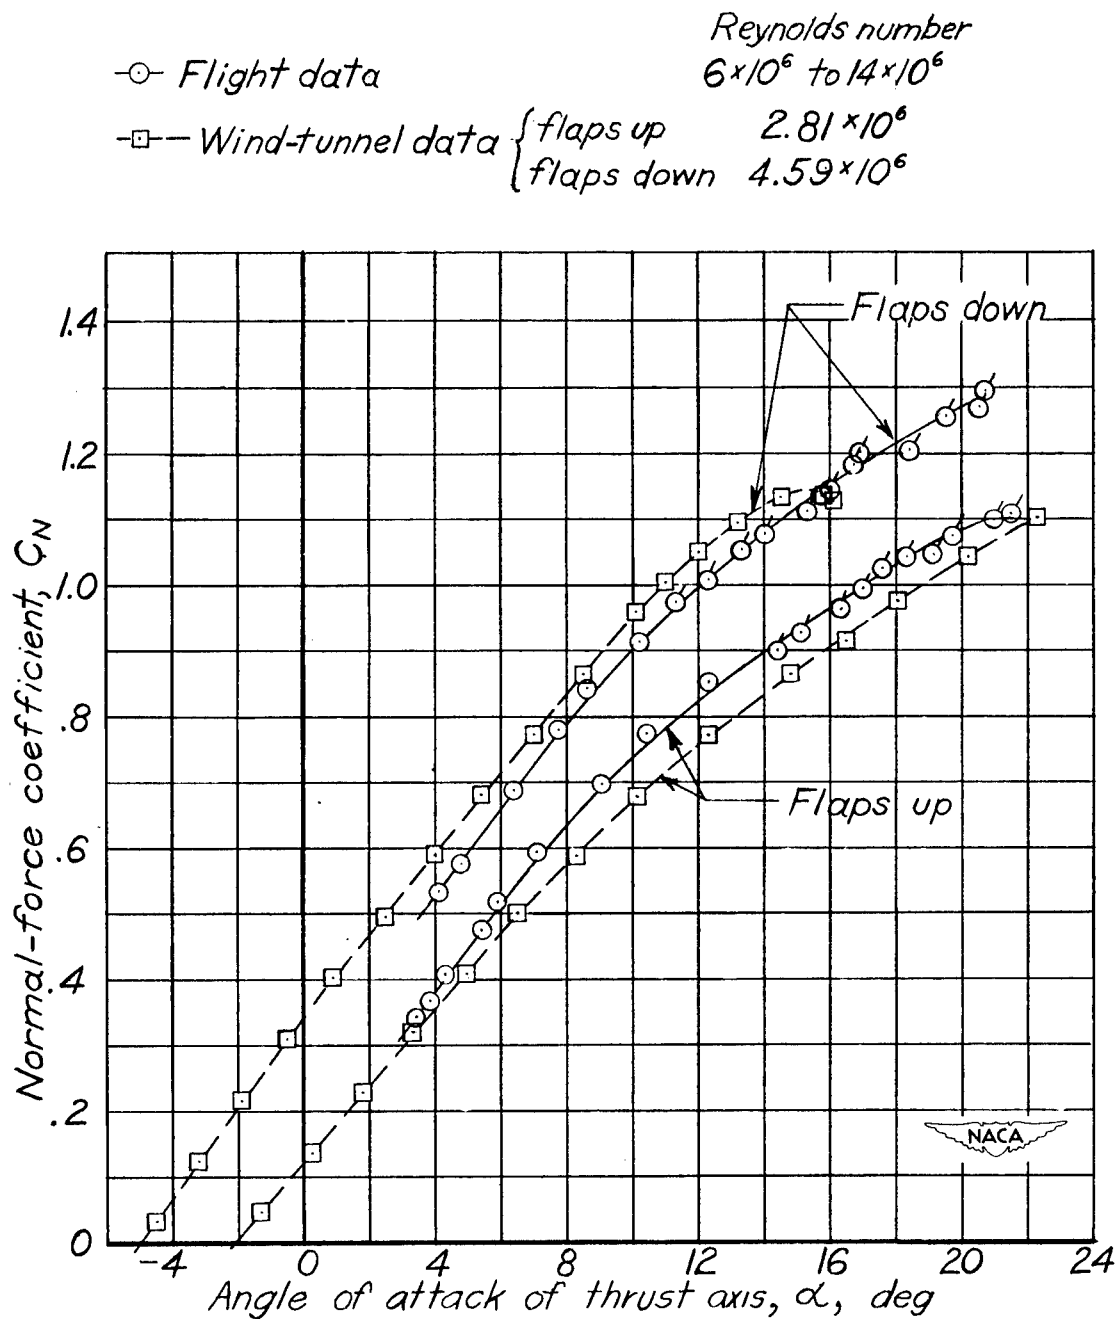
Figure 24.- Flight and wind-tunnel variation of normal-force coefficient with angle of attack of thrust axis for test airplane with 40-percent-span slots on wing. Engine idling.

The flight measurements of the variation of normal-force coefficient with angle of attack of thrust axis are shown in figure 23 for the airplane without slots and in figure 24 for the airplane with 40-percent-span slots. The maximum normal-force coefficients presented are those reached before any appreciable uncontrolled-for motions of the airplane

With the 40-percent-span slots and with the flaps up (fig. 24) the slopes of the flight and wind-tunnel curves are in good agreement throughout most of the angle-of-attack range, but the curves are displaced approximately 1.5° . The flight and wind-tunnel values of maximum normal-force coefficient are approximately the same, but as previously mentioned higher values of maximum normal-force coefficient were obtained in flight after uncontrolled-for motions of the airplane due to stalling had occurred. In the flaps-down condition, the agreement of the flight and wind-tunnel results is fair. Again a part of the displacement of the curves is due to the greater flap deflection used in the wind-tunnel tests. The flight data were obtained at considerably higher Reynolds numbers than the wind-tunnel data, which probably accounts for the higher maximum normal-force coefficients which occurred in flight. Deflecting the flaps resulted in a considerably greater increase in maximum normal-force coefficient in flight than in the wind tunnel. For the wing without slots, deflecting the flaps increased the maximum normal-force coefficient approximately 0.3 in flight and only 0.07 in the wind tunnel; whereas, for the wing with 40-percent-span slots, the increase was 0.2 in flight and 0.04 in the tunnel.
