**Confirmation Sampling and Analysis Report  
for the BX Service Station, Facility 736, Site ST-29**

**FINAL**  
**CONFIRMATION SAMPLING AND ANALYSIS REPORT**  
**FOR THE**  
**BX SERVICE STATION, FACILITY 736, SITE ST-29**  
**PATRICK AIR FORCE BASE, FLORIDA**

**Contract F41624-92-8036, Delivery Order 17**

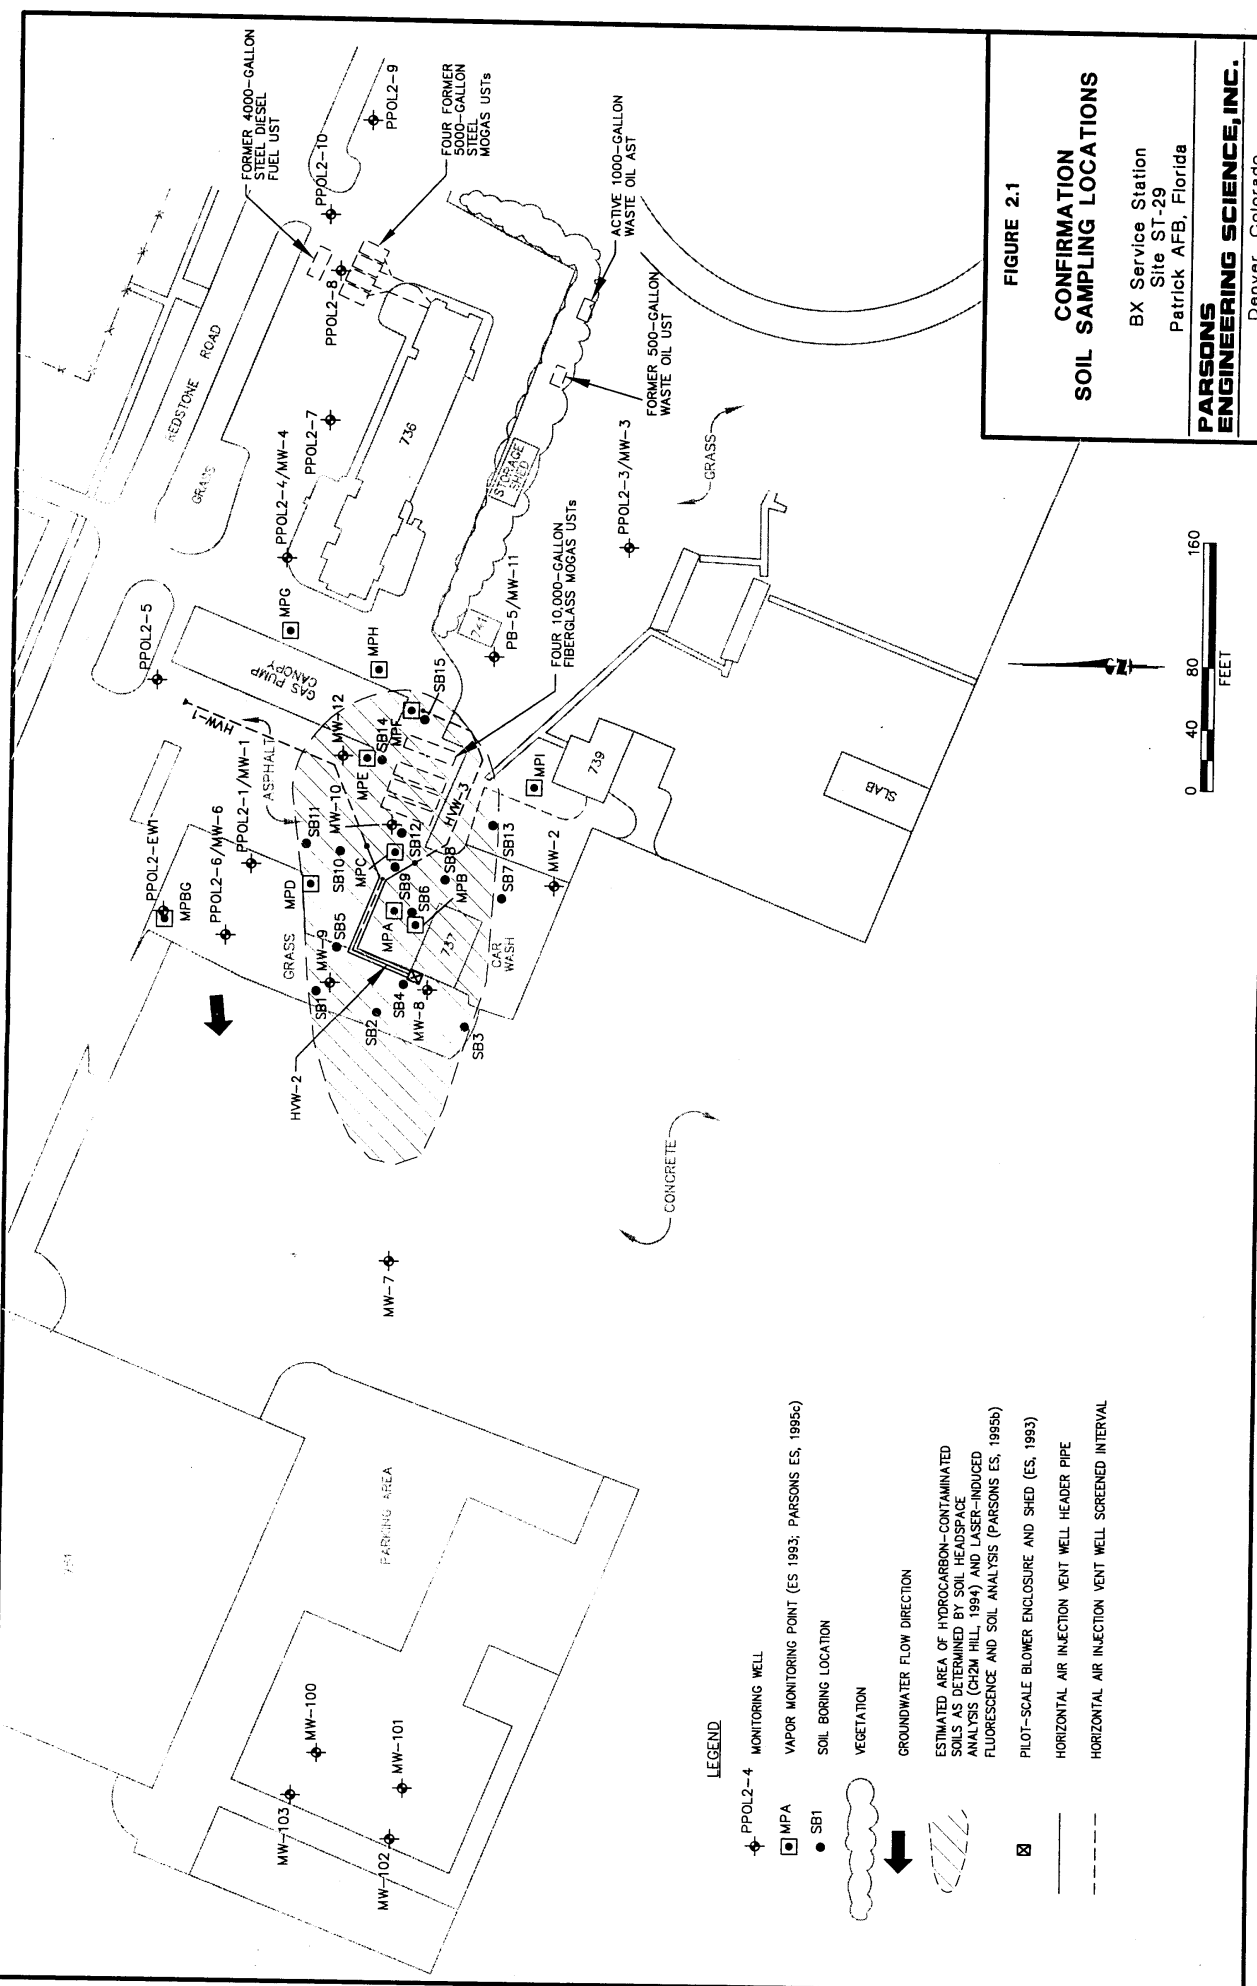
**FIGURE 2.1**  
**CONFIRMATION**  
**SOIL SAMPLING LOCATIONS**  
 BX Service Station  
 Site ST-29  
 Patrick AFB, Florida  
**PARSONS ENGINEERING SCIENCE, INC.**  
 Denver, Colorado

Based on field screening results, one sample from each boring (SB1 through SB15) was selected and submitted for laboratory analysis using laboratory-prepared containers. Replicate samples also were collected from boreholes SB1 and SB15.

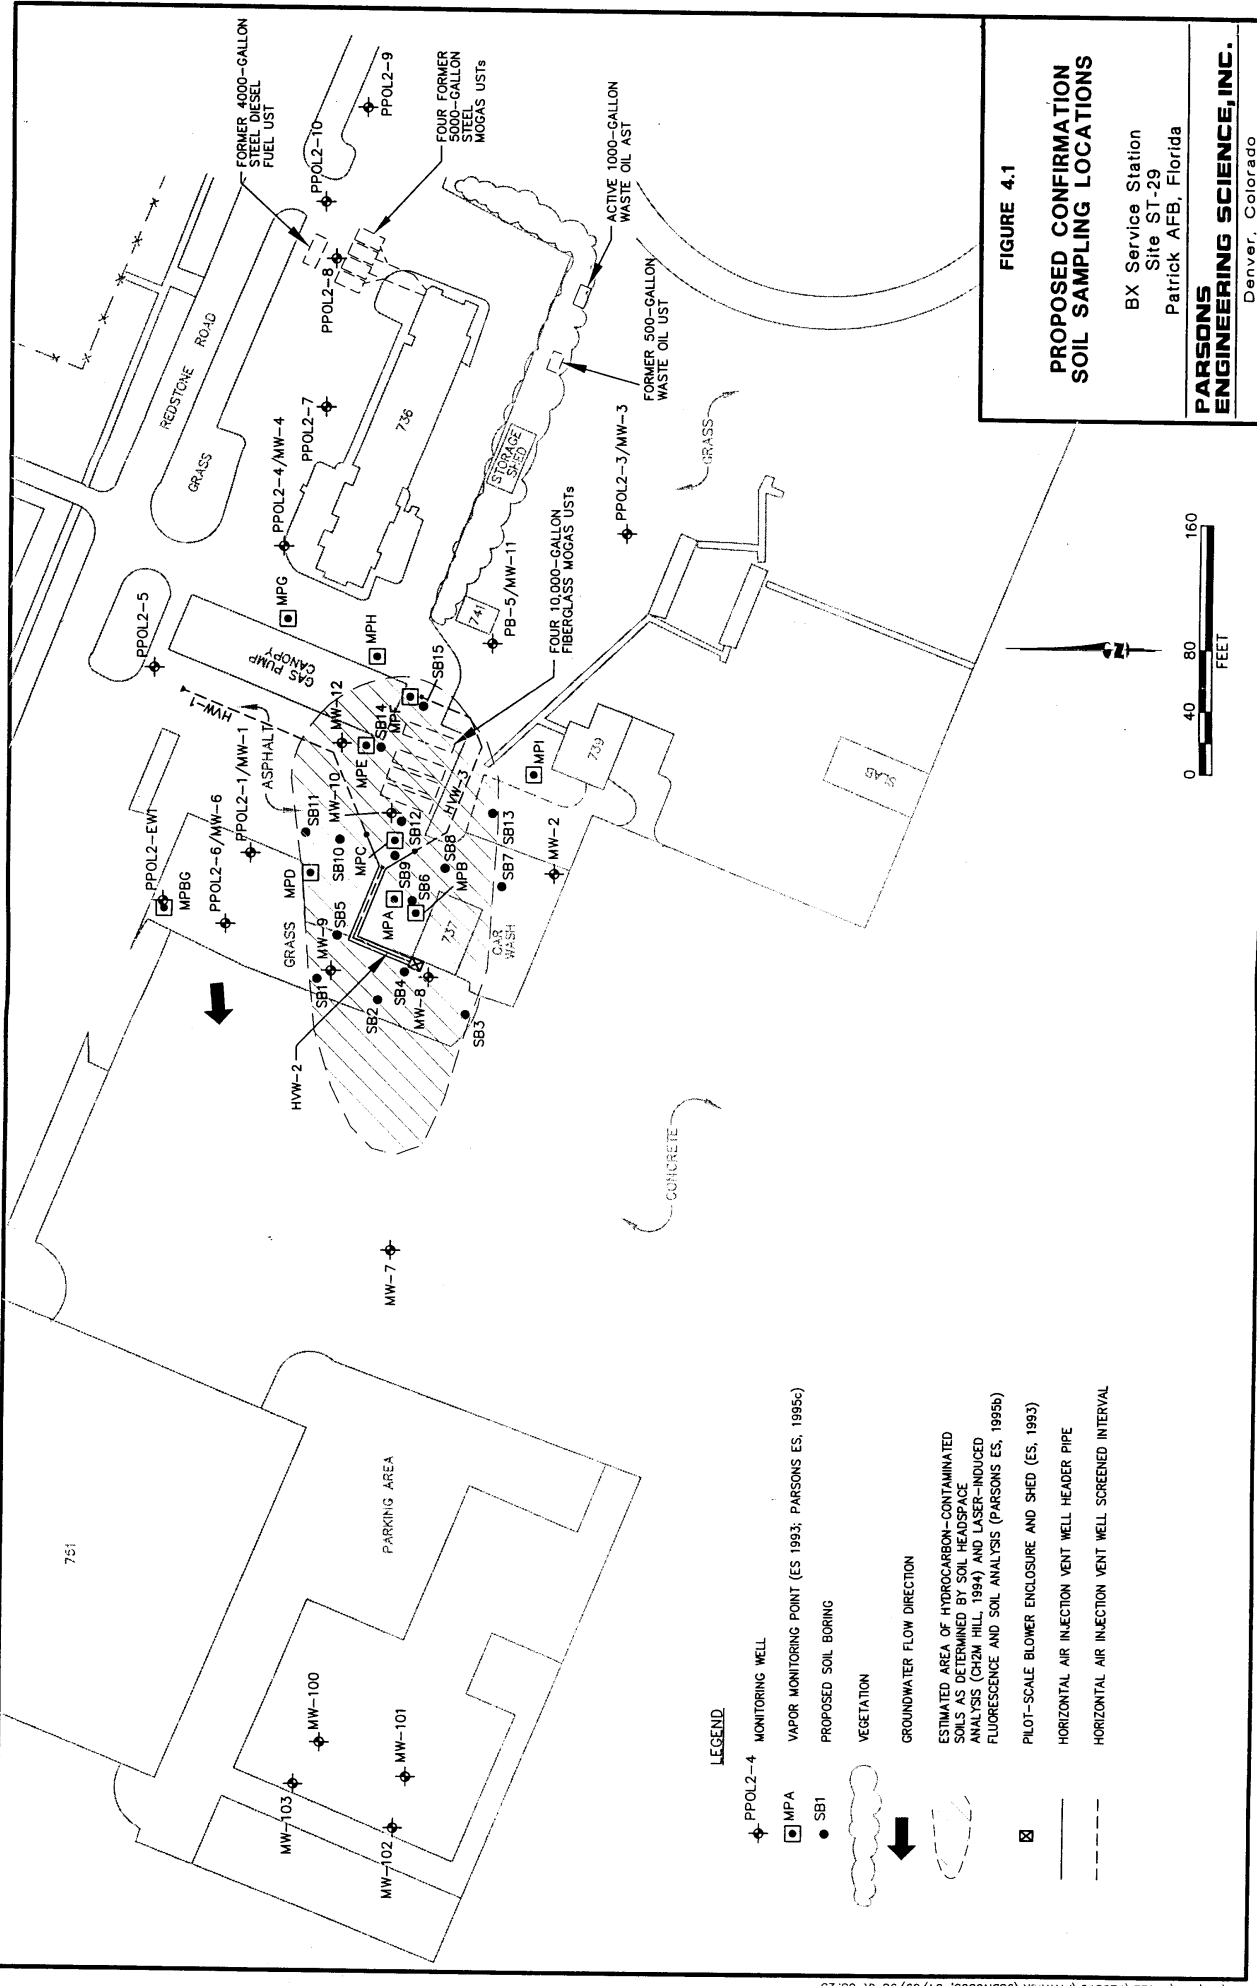
- ◆ PPOL2-4 MONITORING WELL
- MPA VAPOR MONITORING POINT (ES 1993; PARSONS ES, 1995c)
- SBT PROPOSED SOIL BORING
- VEGETATION
- GROUNDWATER FLOW DIRECTION
- ESTIMATED AREA OF HYDROCARBON-CONTAMINATED SOILS AS DETERMINED BY SOIL HEADSPACE ANALYSIS (CR2M HILL, 1994) AND LASER-INDUCED FLUORESCENCE AND SOIL ANALYSIS (PARSONS ES, 1995b)
- PILOT-SCALE BLOWER ENCLOSURE AND SHED (ES, 1993)
- HORIZONTAL AIR INJECTION VENT WELL HEADER PIPE
- HORIZONTAL AIR INJECTION VENT WELL SCREENED INTERVAL

Soil boreholes will be advanced to the groundwater table surface (approximately 4 to 6 feet bgs) with a hand auger. Undisturbed soil samples, suitable for chemical analysis, will be obtained from each borehole by collecting the required volume of soil directly from the hand-auger bucket. Soil types will be classified according to the Unified Soil Classification System (USCS) and described in accordance with the standard Parsons ES soil description format. All soil samples will be visually examined, and sample headspace will be field screened for VOCs using a photoionization detector (PID) or a TVH analyzer (TVHA). The data obtained from the logging and screening will be recorded on borehole logs.

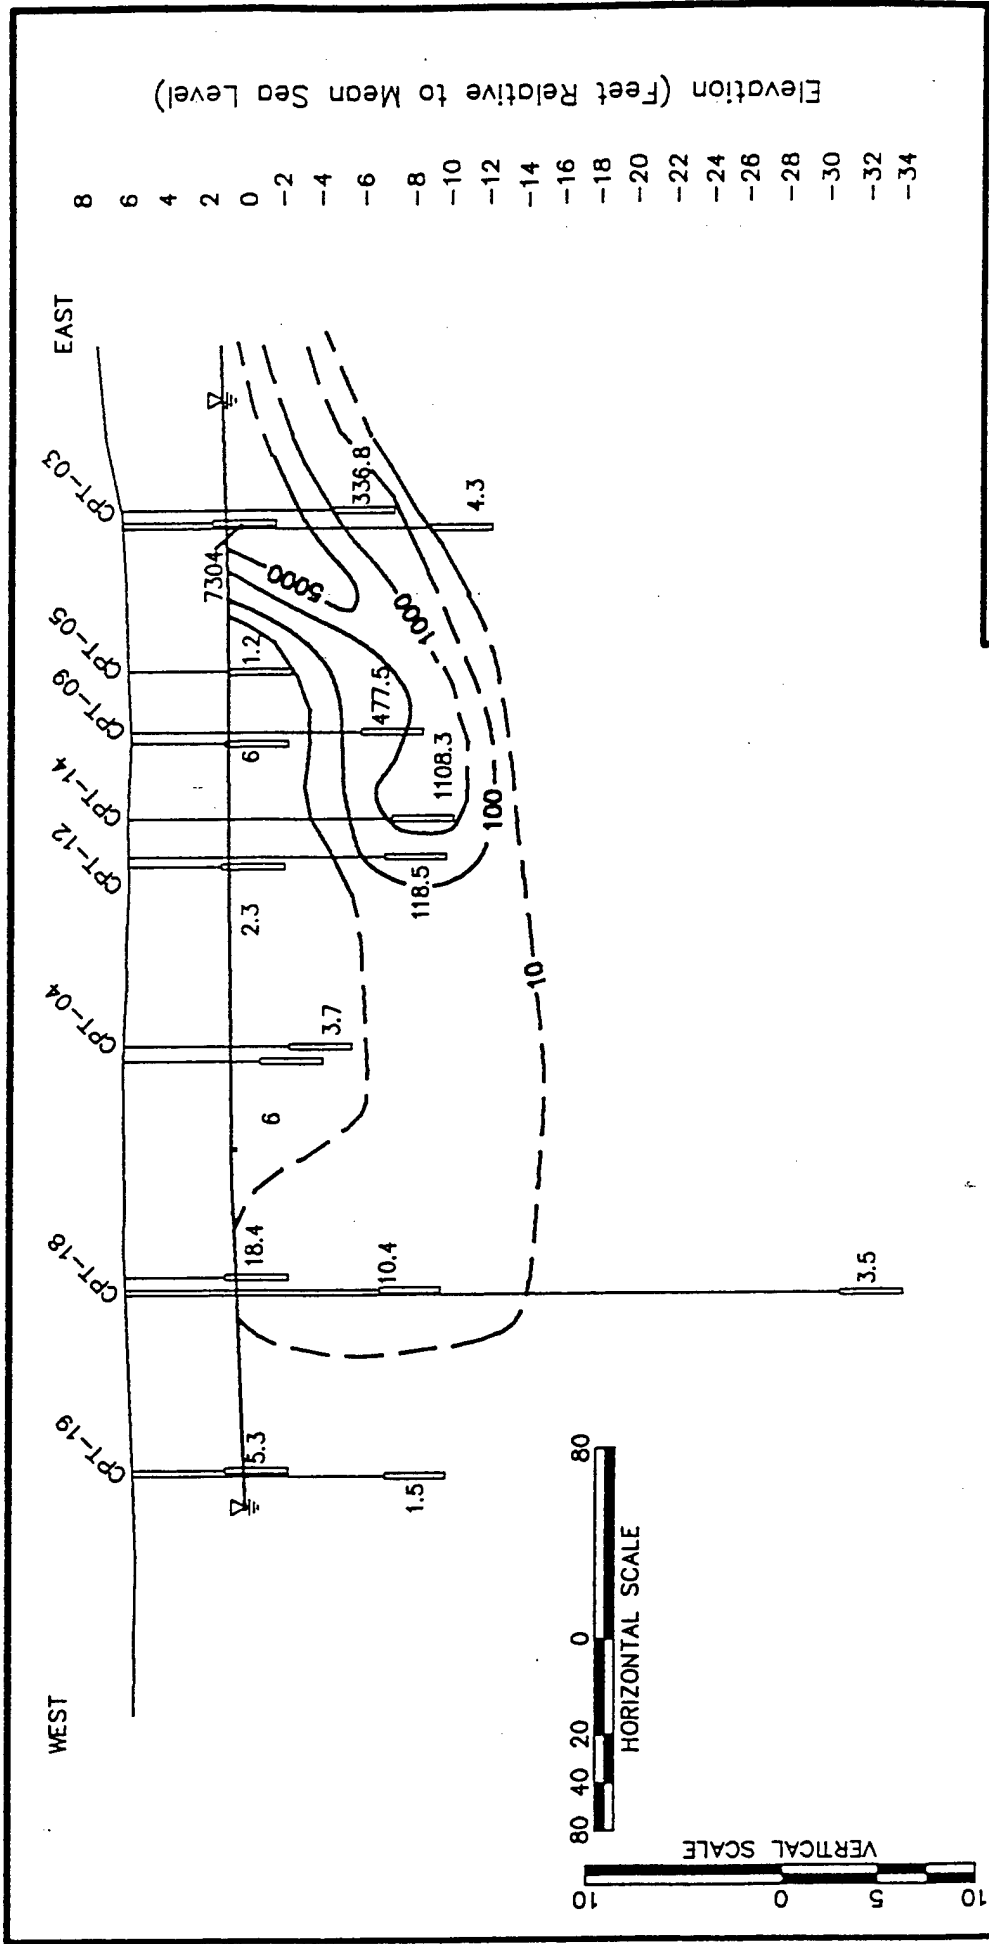
FIGURE 4.3

**VERTICAL PROFILE OF  
TOTAL BTEX ISOPLETHS  
FOR GROUNDWATER  
MARCH 1994**

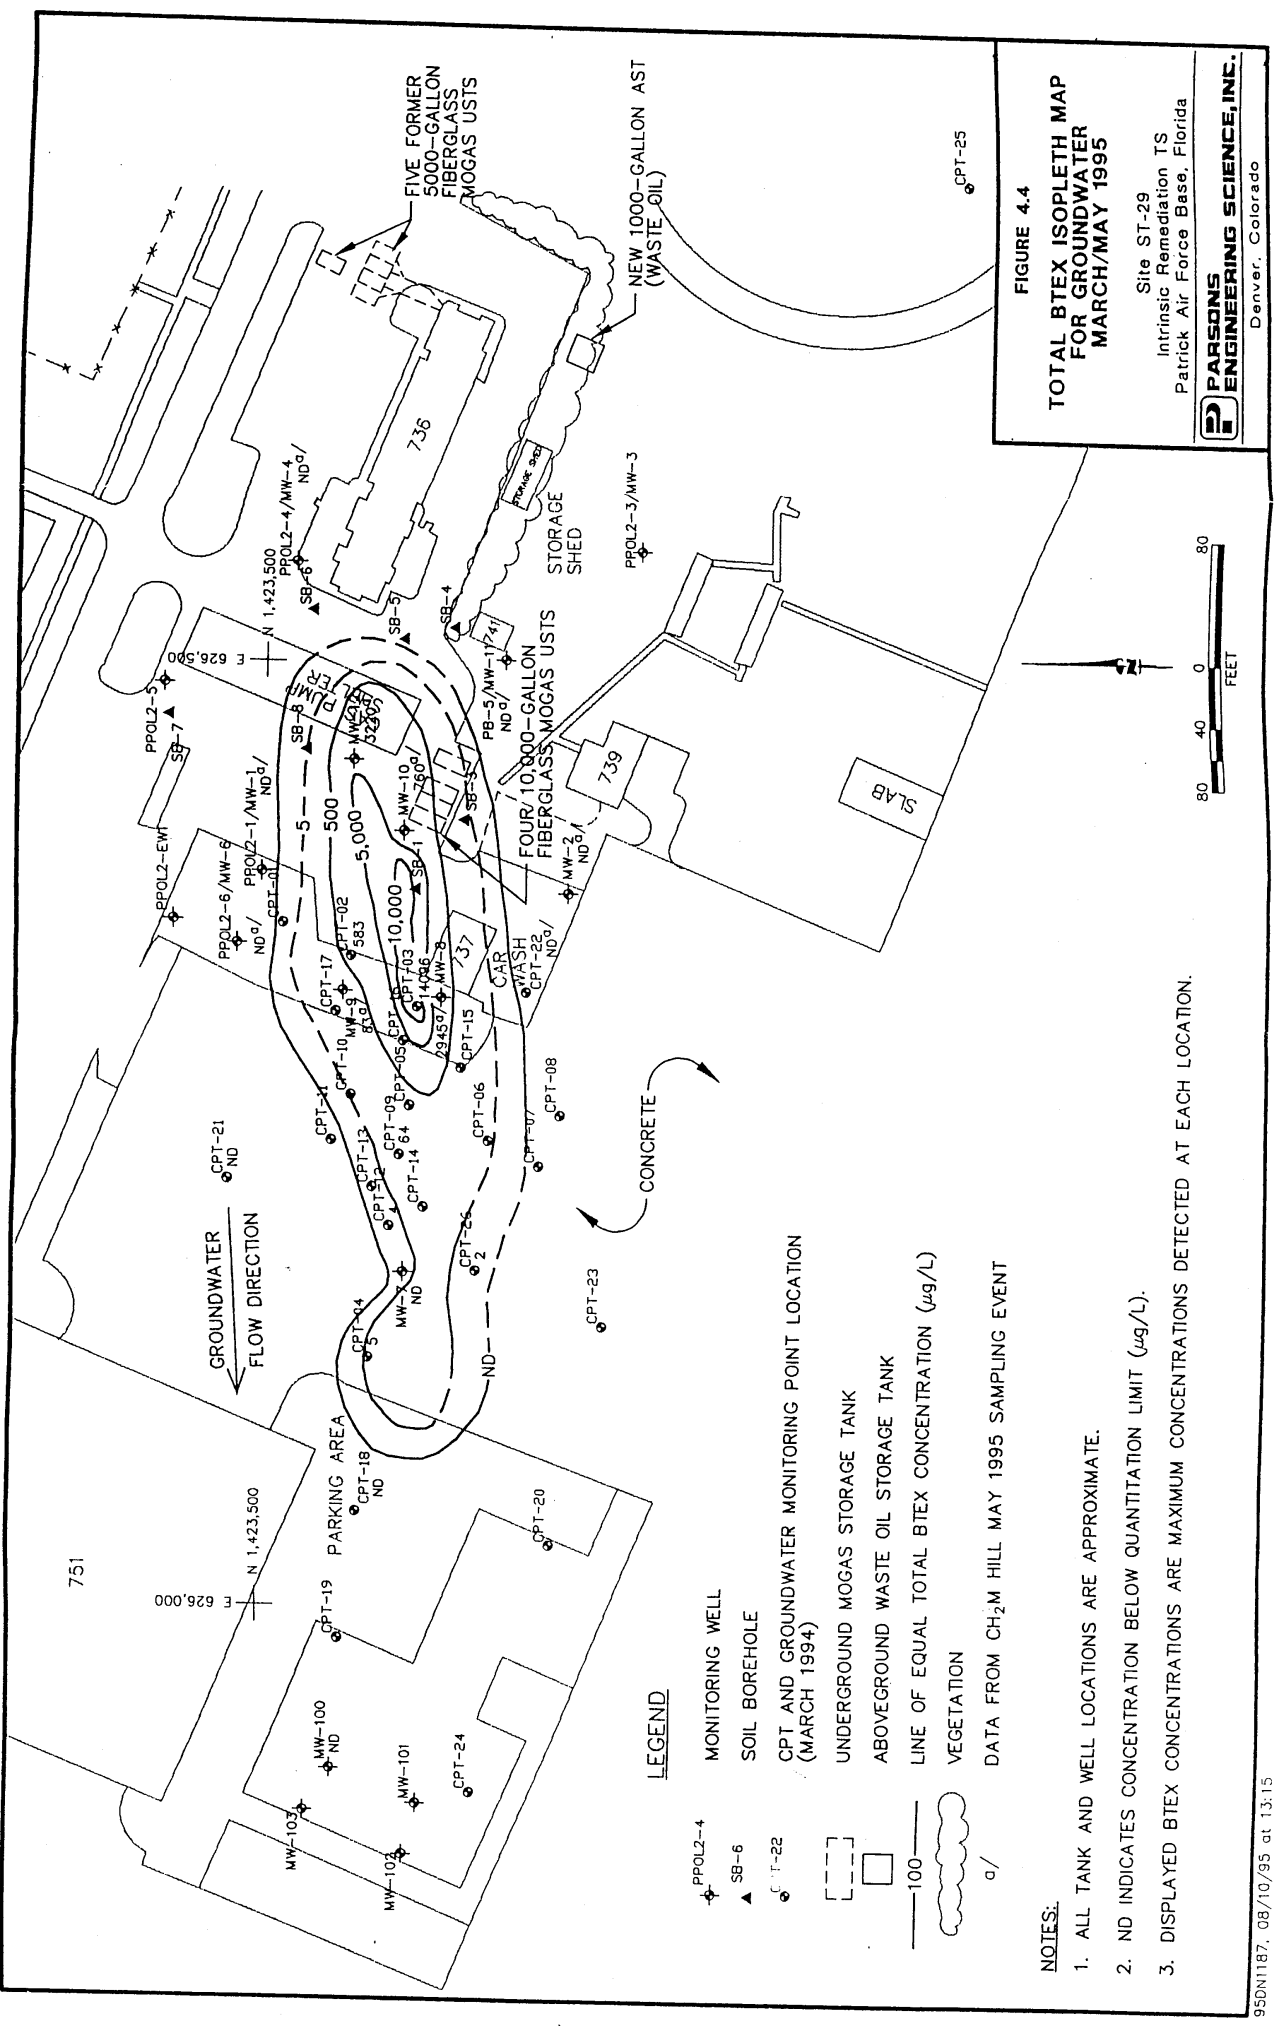
**FIGURE 4.4**  
**TOTAL BTEX ISOPLETH MAP**  
**FOR GROUNDWATER**  
**MARCH/MAY 1995**

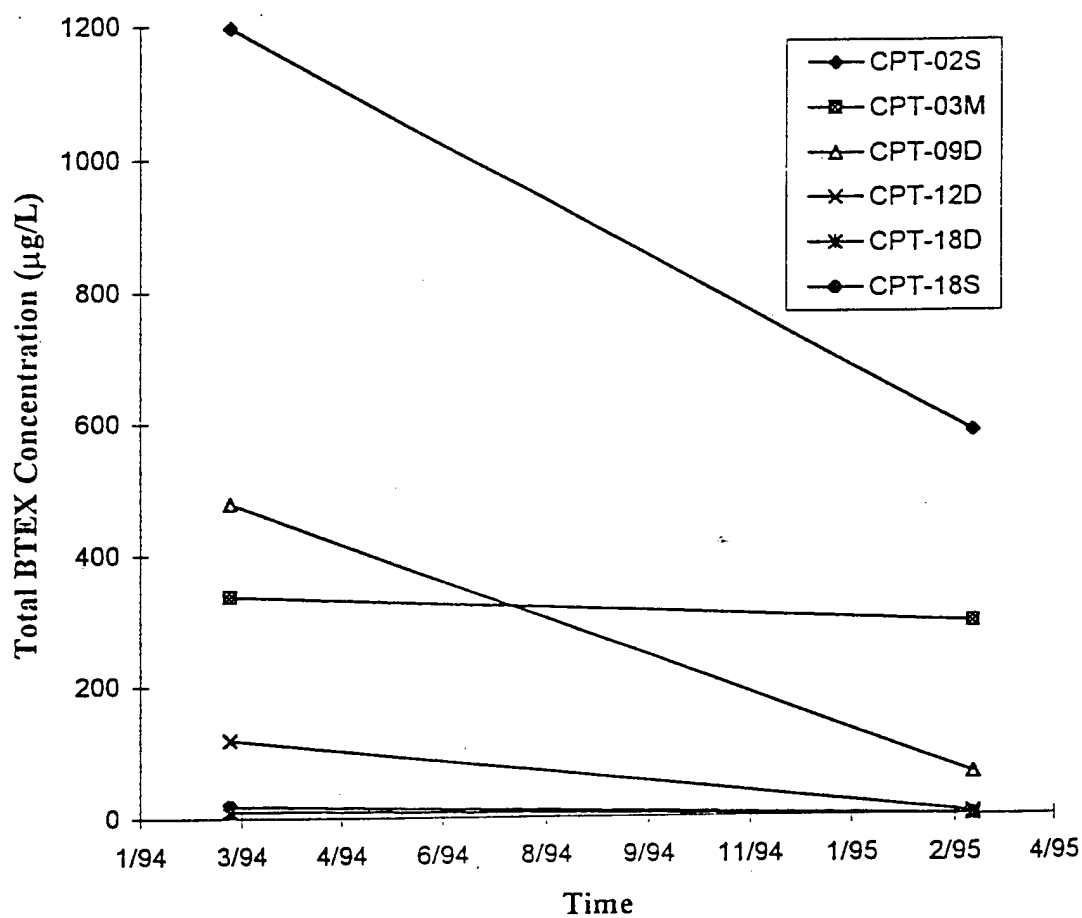
FIGURE 4.5A

PLOT OF TOTAL BTEX VERSUS TIME FOR SAMPLING LOCATIONS  
WITH DECREASING BTEX CONCENTRATIONS  
SITE ST-29 INTRINSIC REMEDIATION TS  
PATRICK AFB, FLORIDA

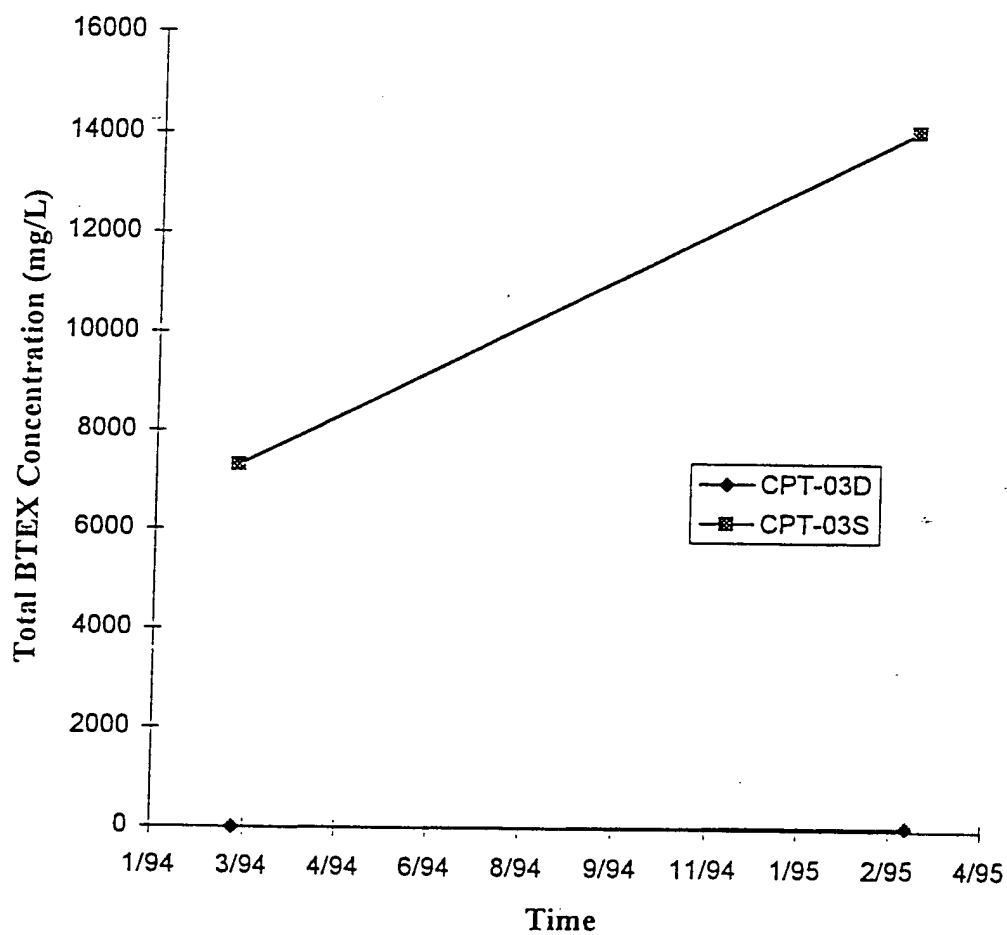
FIGURE 4.5B

PLOT OF TOTAL BTEX VERSUS TIME FOR SAMPLING LOCATIONS  
WITH INCREASING BTEX CONCENTRATIONS  
SITE ST-29 INTRINSIC REMEDIATION TS  
PATRICK AFB, FLORIDA

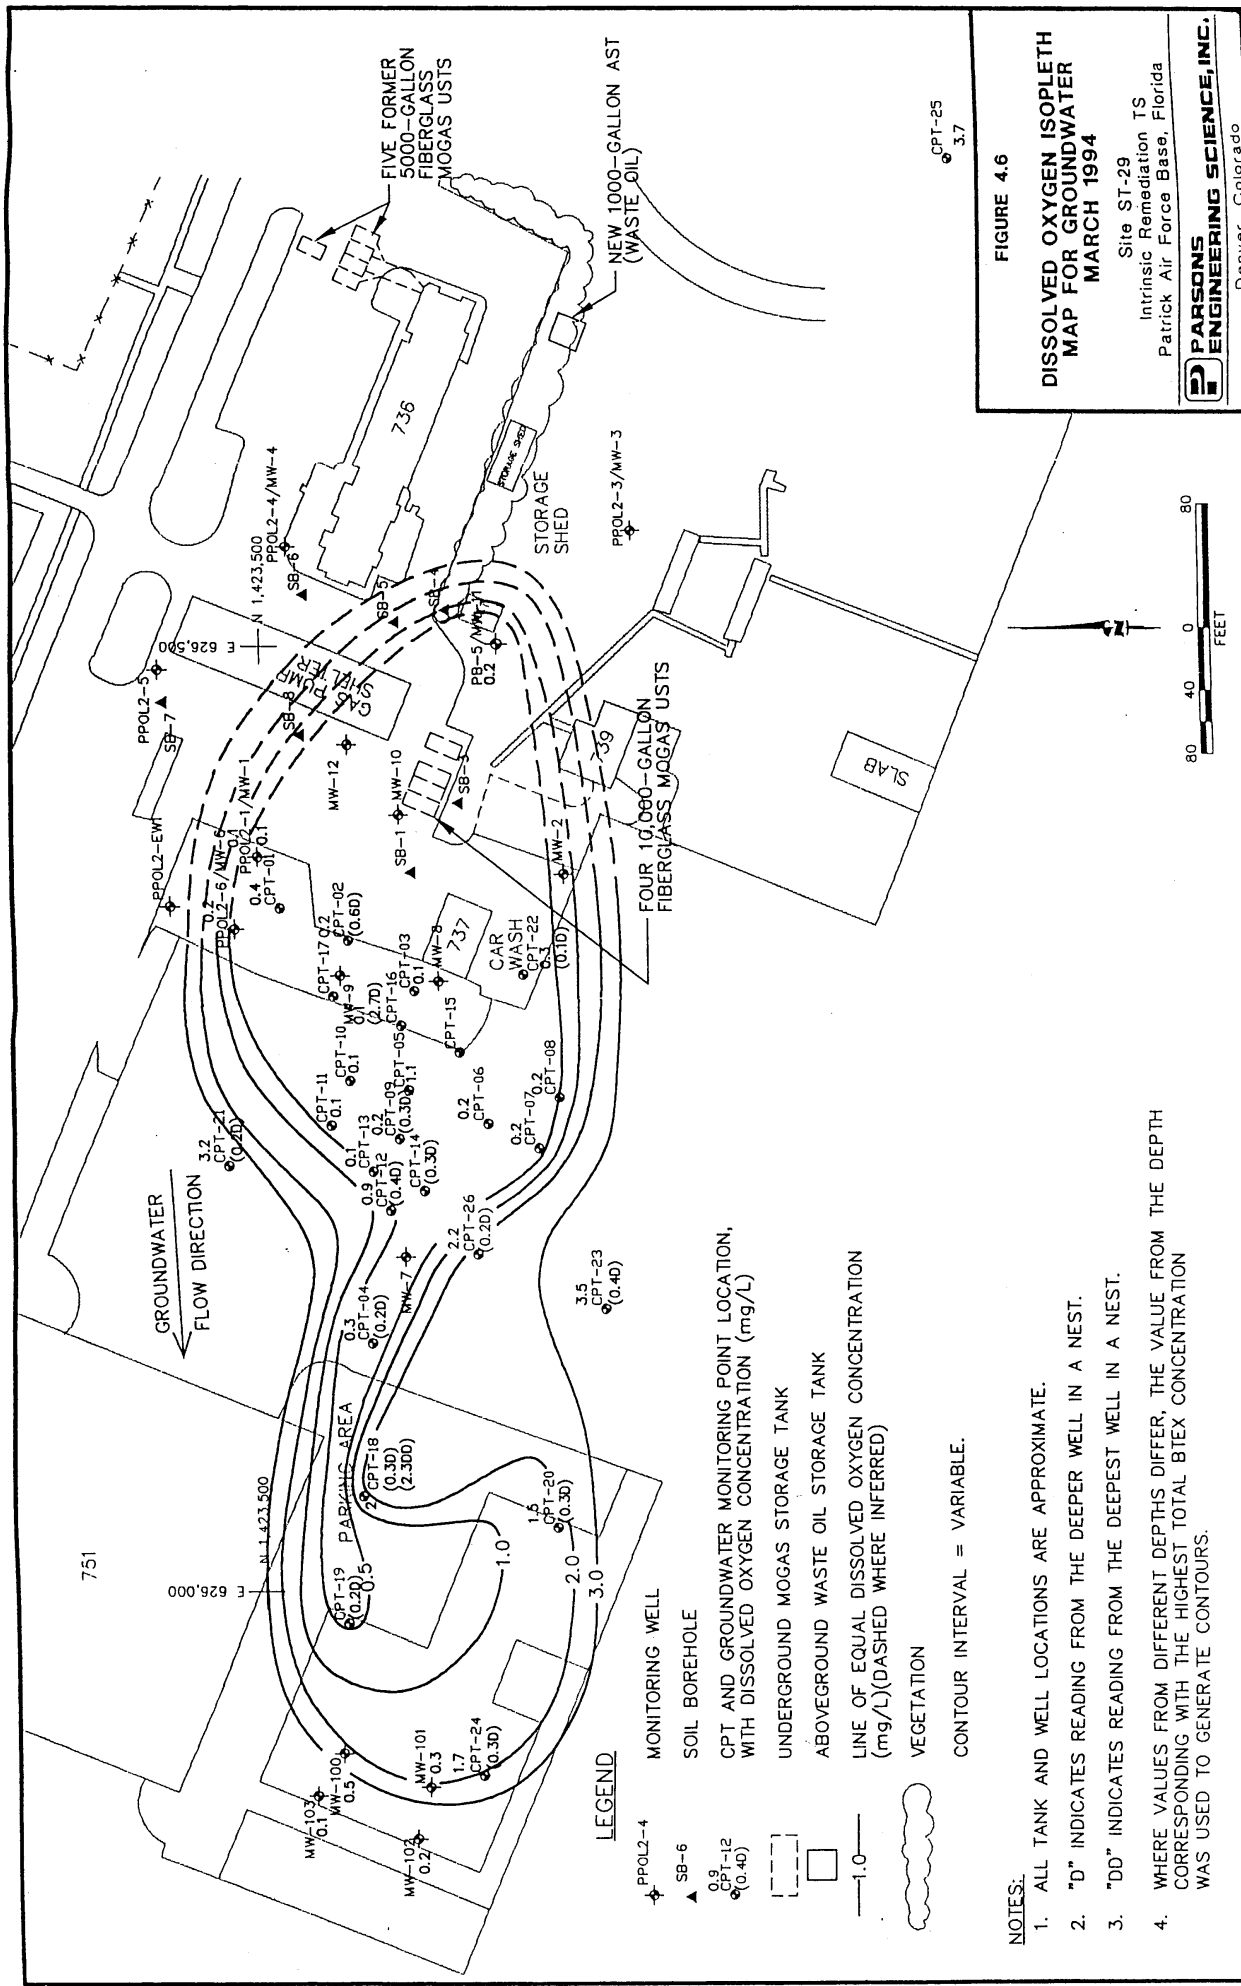
**FIGURE 4.6**

**DISSOLVED OXYGEN ISOPLETH MAP FOR GROUNDWATER**

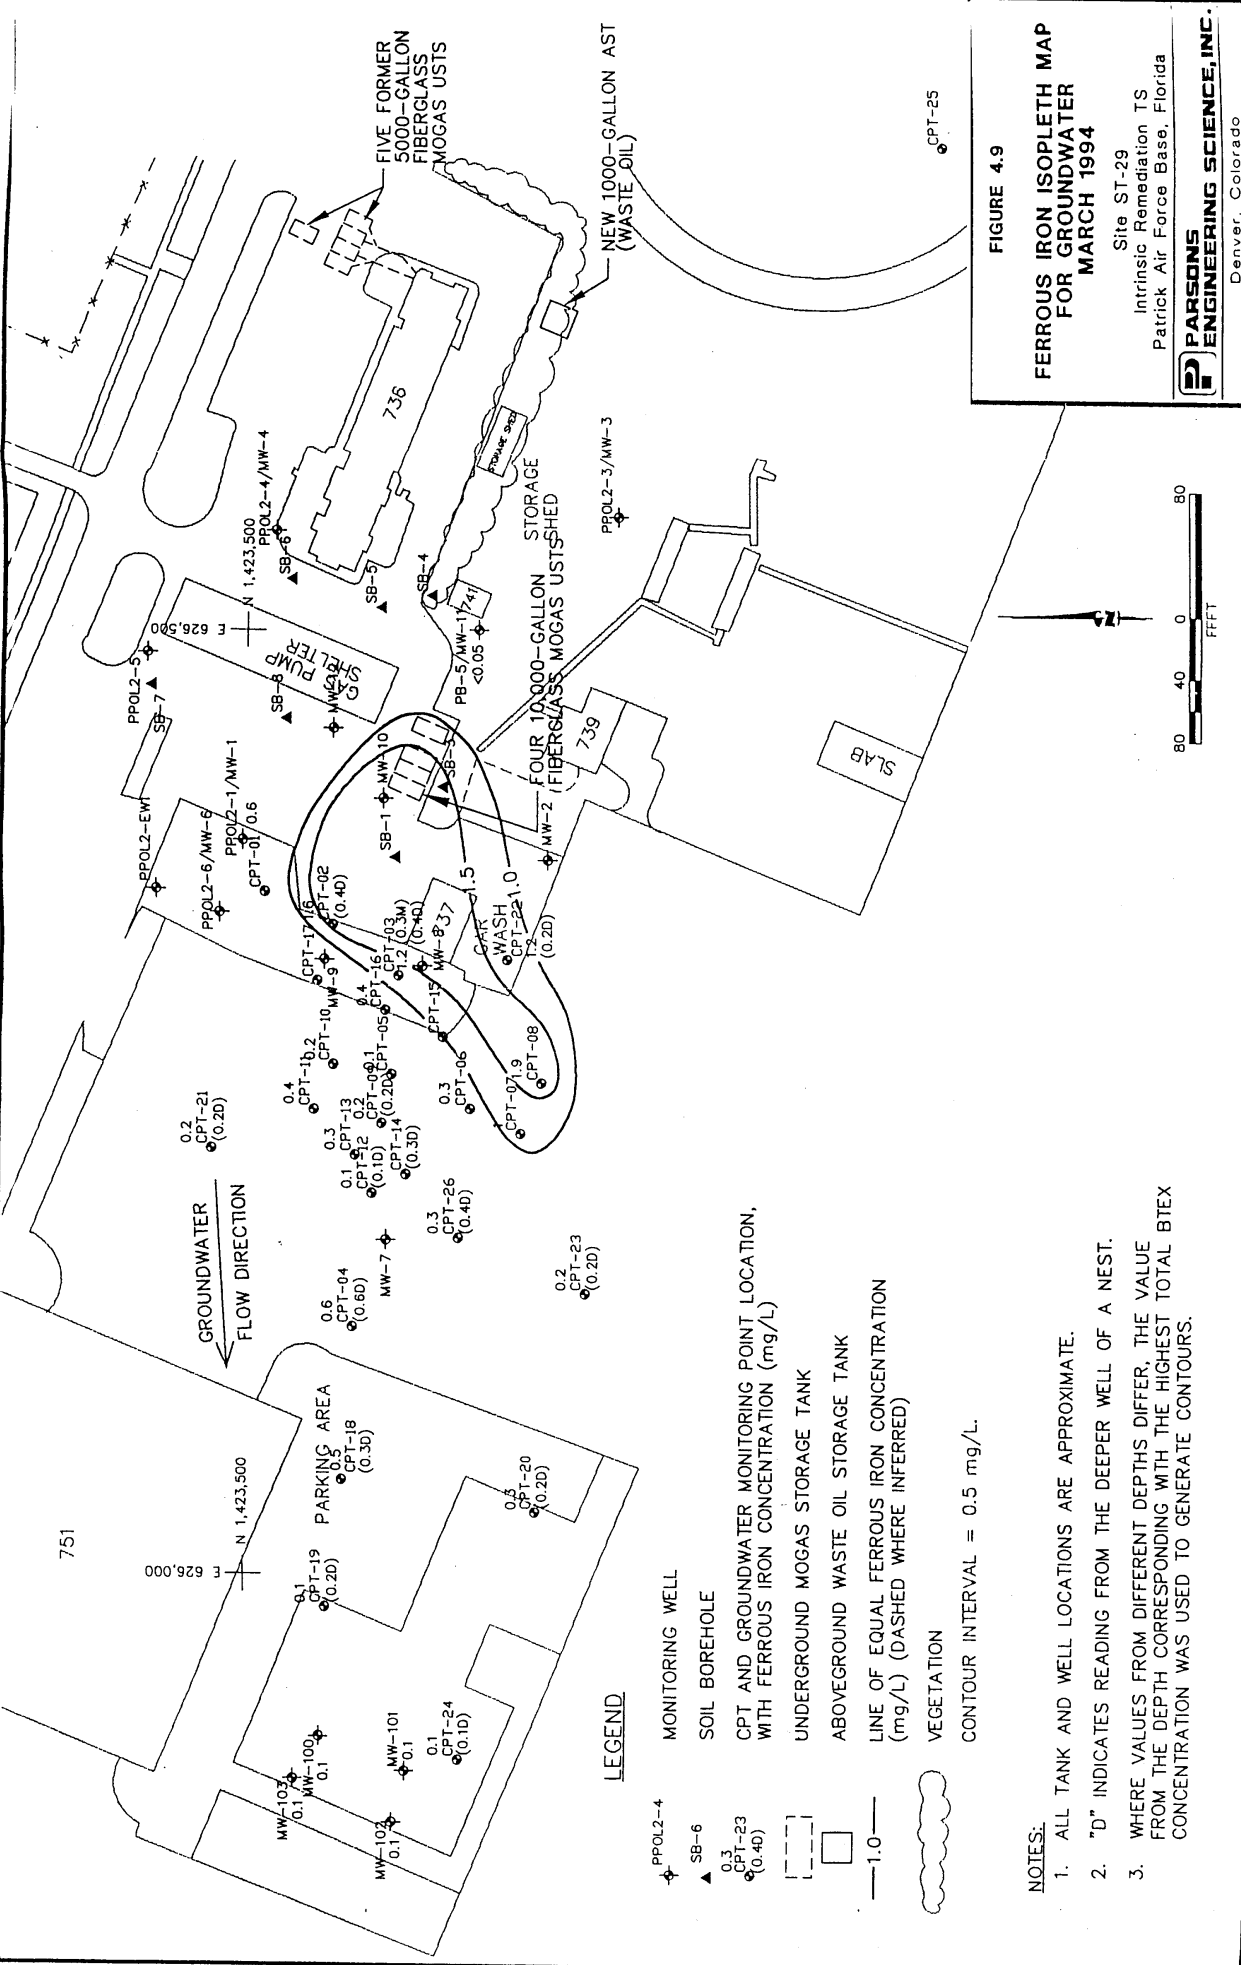
**FIGURE 4.9**  
**FERROUS IRON ISOPLETH MAP FOR GROUNDWATER**  
**MARCH 1994**  
 Site ST-29  
 Intrinsic Remediation TS  
 Patrick Air Force Base, Florida  
**PARSONS ENGINEERING SCIENCE, INC.**  
 Denver, Colorado

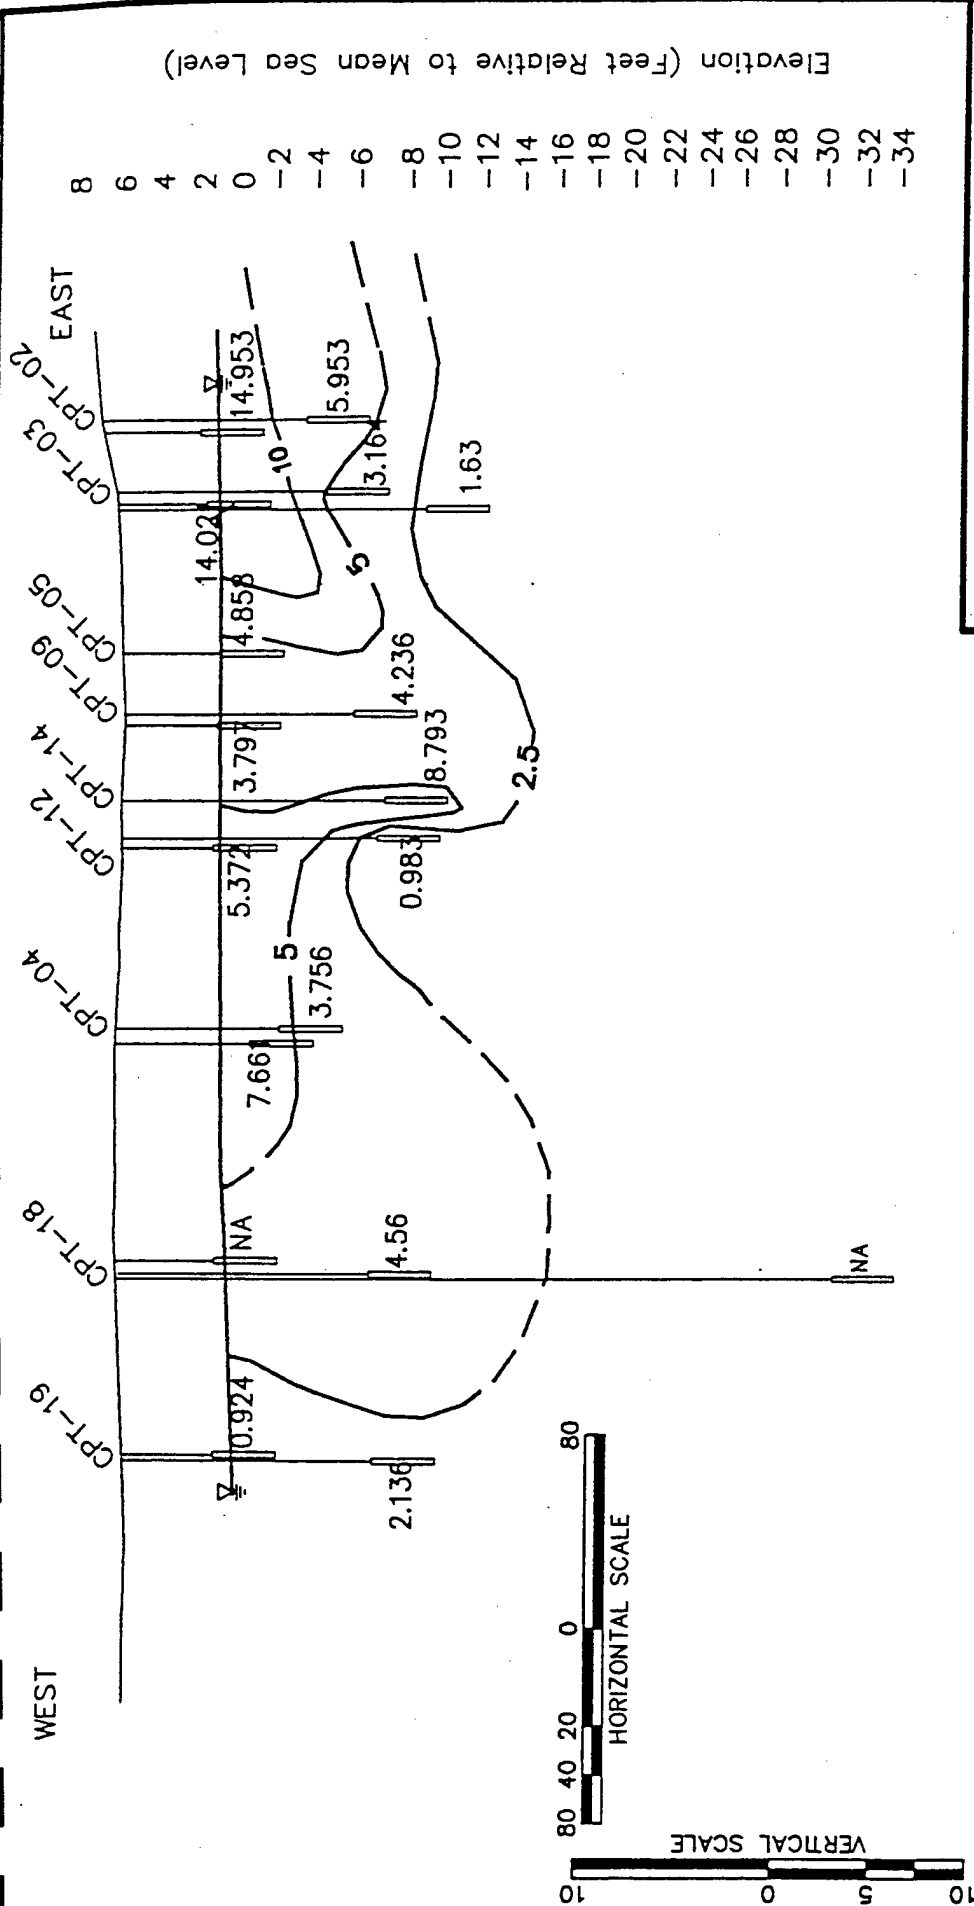
**FIGURE 4.11**

**VERTICAL PROFILE OF METHANE ISOPLETHS FOR GROUNDWATER MARCH 1994**

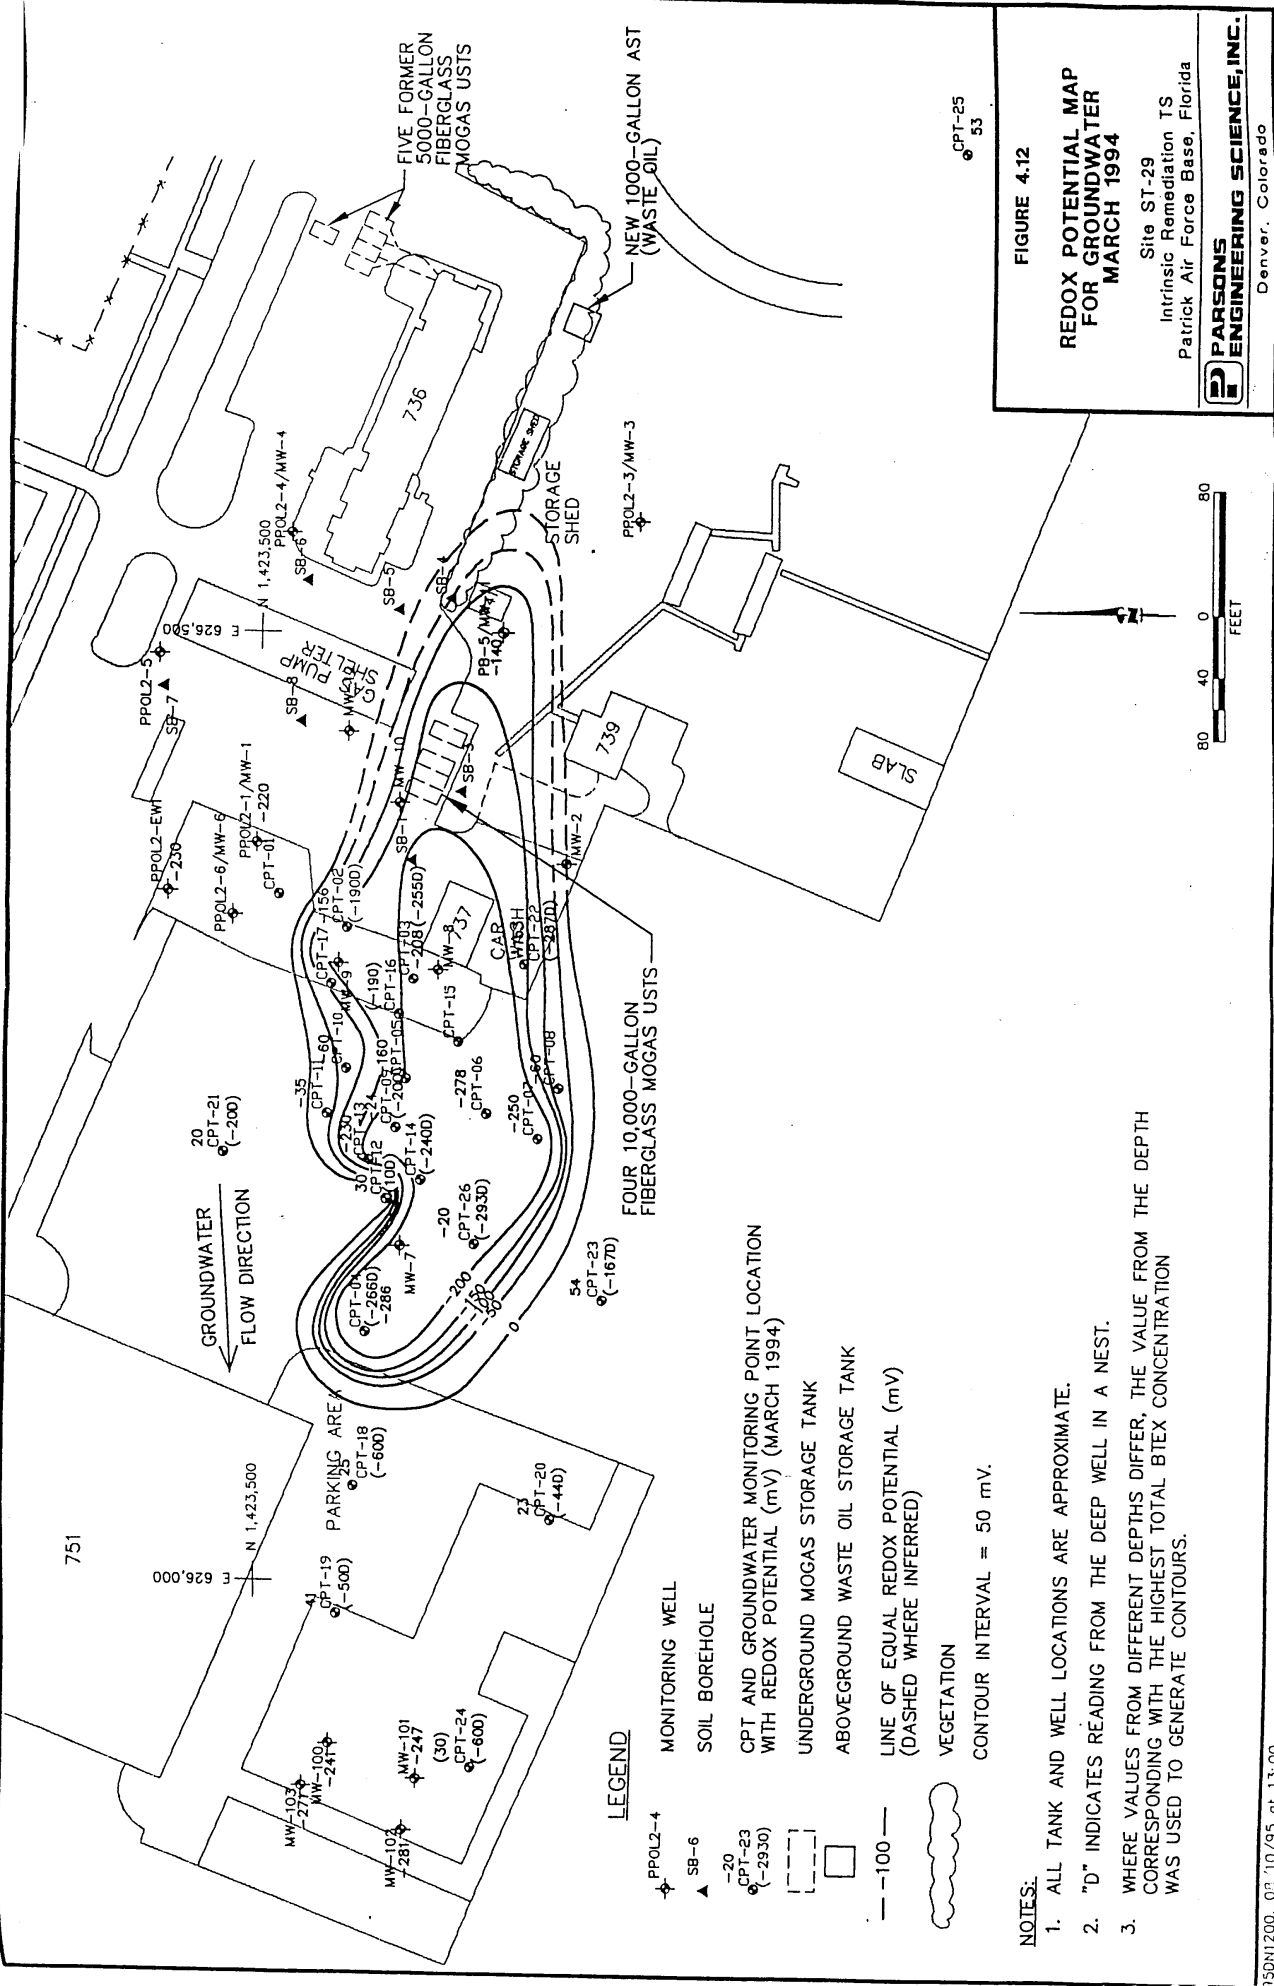
**FIGURE 4.12**

**REDOX POTENTIAL MAP FOR GROUNDWATER**
