Final Report

Contract No. 14-01-0001-1440

A STUDY OF THE STRESS CORROSION SUSCEPTIBILITY OF  
CUPRO-NICKEL AND TITANIUM UNDER DESALINATION CONDITIONS

Office of Saline Water  
U. S. Department of the Interior  
Washington, D. C.

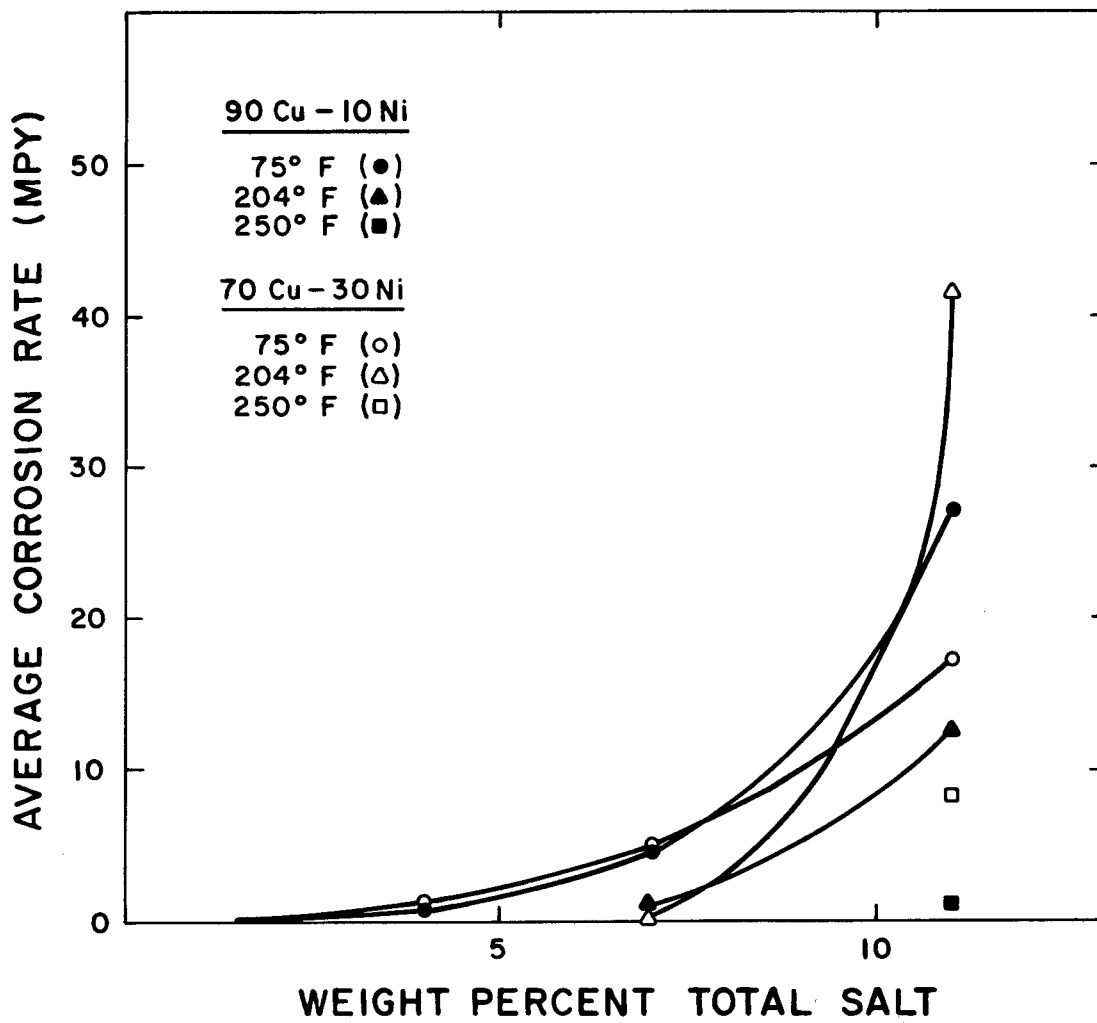
Figure 7. Effect of Total Salt Content of Corrodent on the Average Corrosion Rate of Cu-Ni Sheet Tested at 8.5 fps

At 75 and 204°F, it was found that an increase in the total salt content increased the corrosion rate, as illustrated in Figures 7 and 8. For example, as contrasted to less than 1 mpy in San Diego Bay water (4% salt), a maximum average rate of ~40 mpy (70Cu-30Ni, 204°F) and a maximum pitting rate of nearly 200 mpy (90Cu-10Ni, 204°F) were obtained in 11% brine.

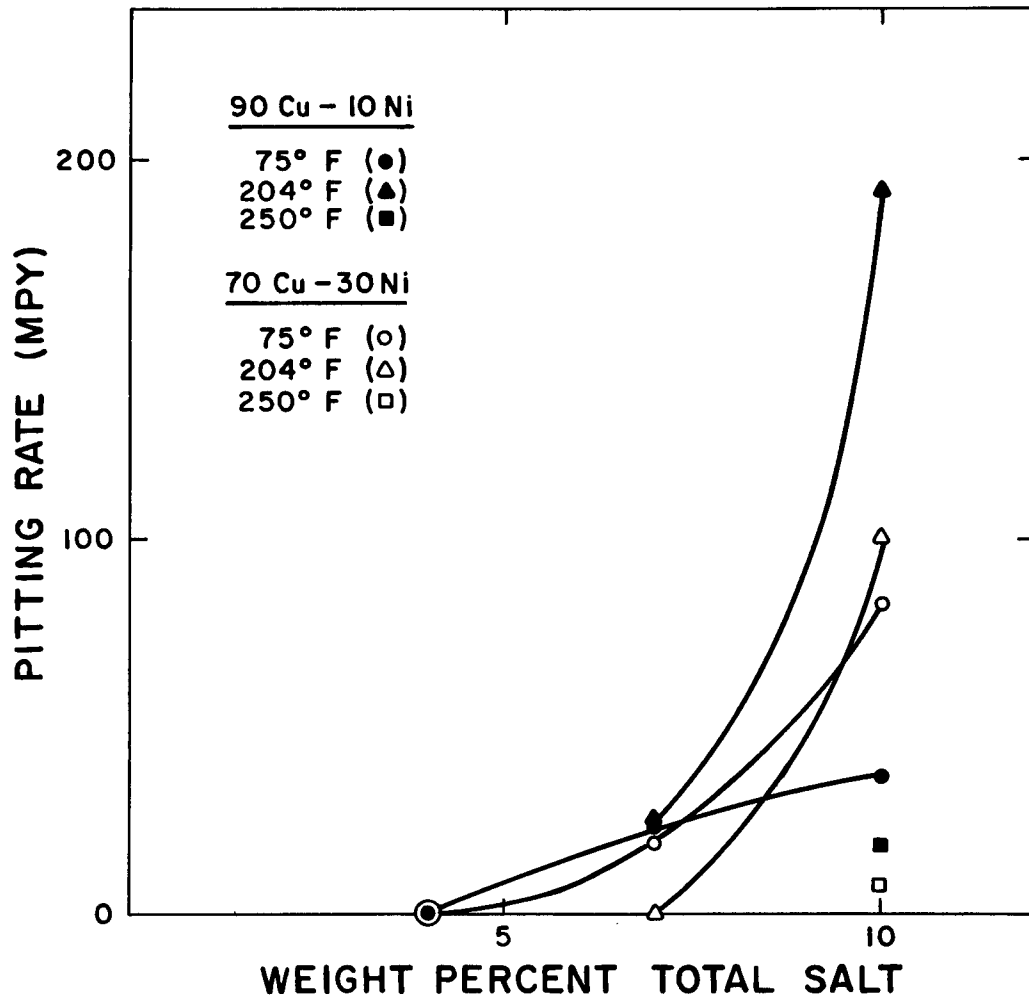
Figure 8. Effect of Total Salt Content of Corrodent on the Pitting Rate of Cu-Ni Sheet Tested at 8.5 fps
