GASBUGGY
POSTSHOT INVESTIGATIONS IN GB-ER

TID-4500, UC-35
Nuclear Explosions—
Peaceful Applications

Lawrence Radiation Laboratory
UNIVERSITY OF CALIFORNIA
LIVERMORE

Abstract

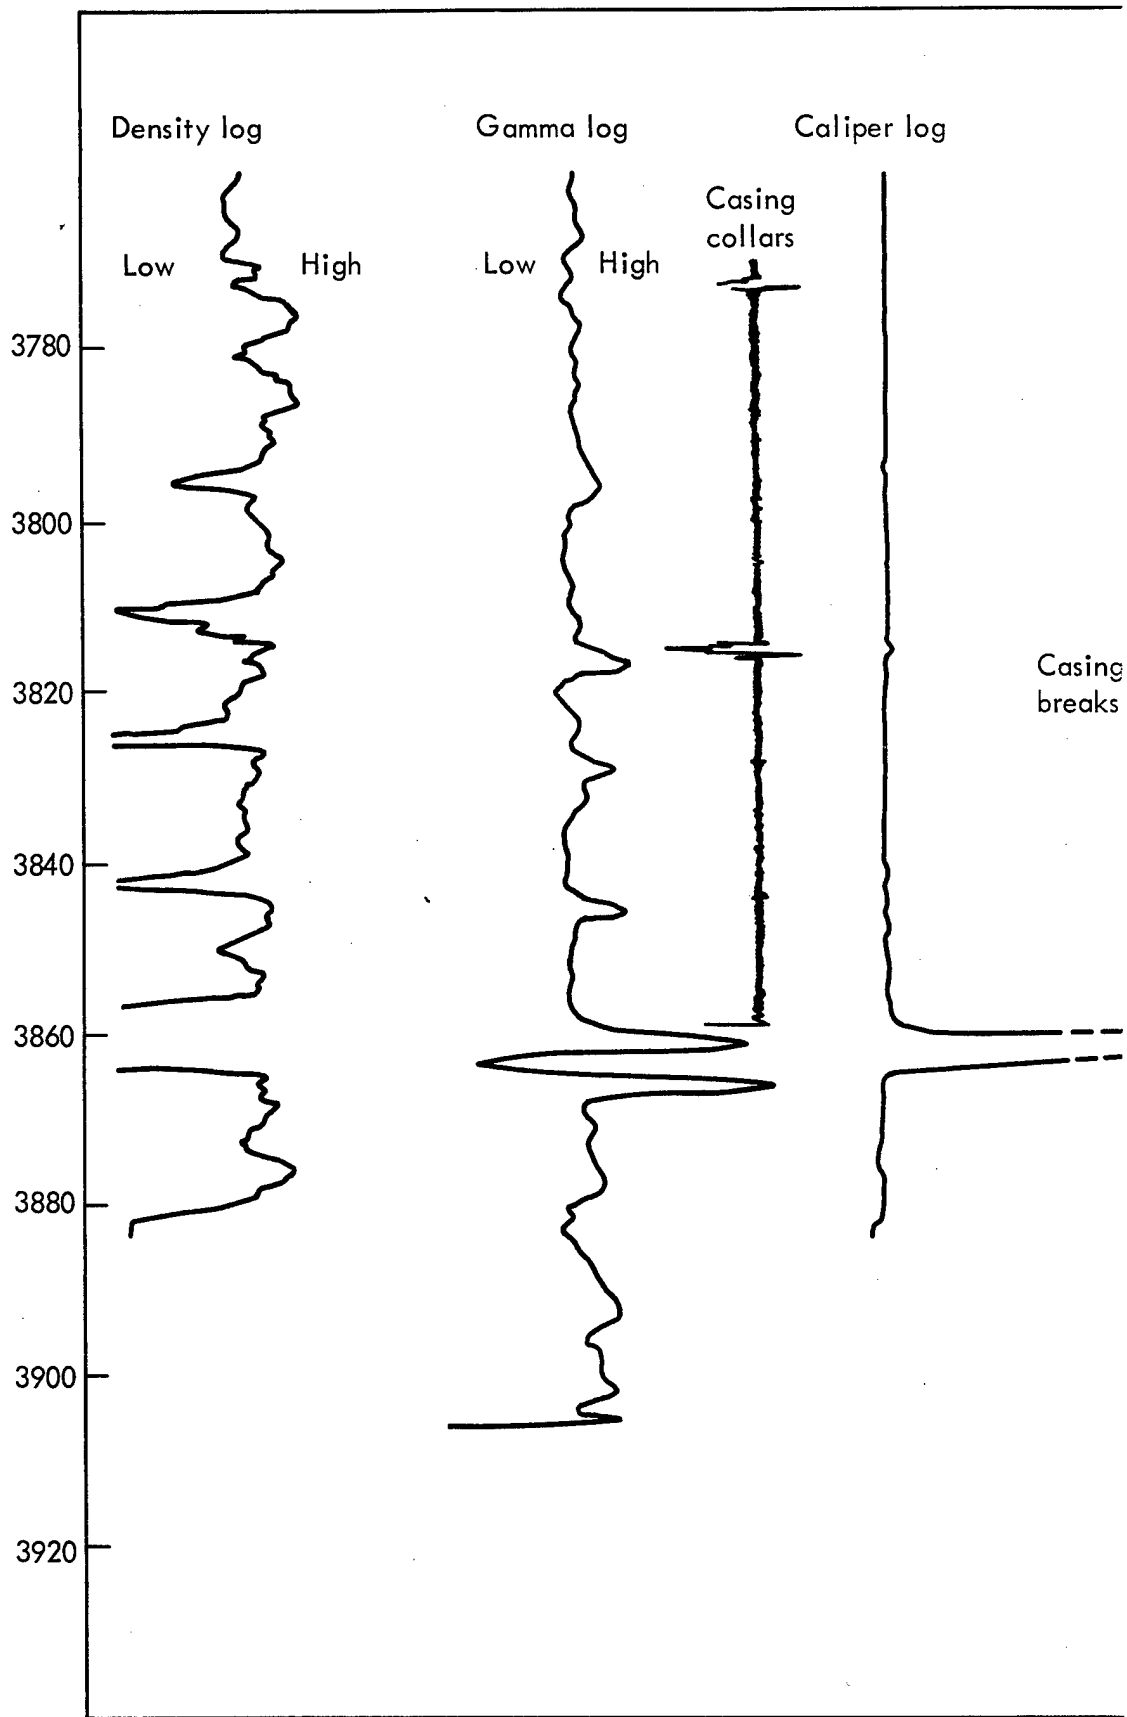
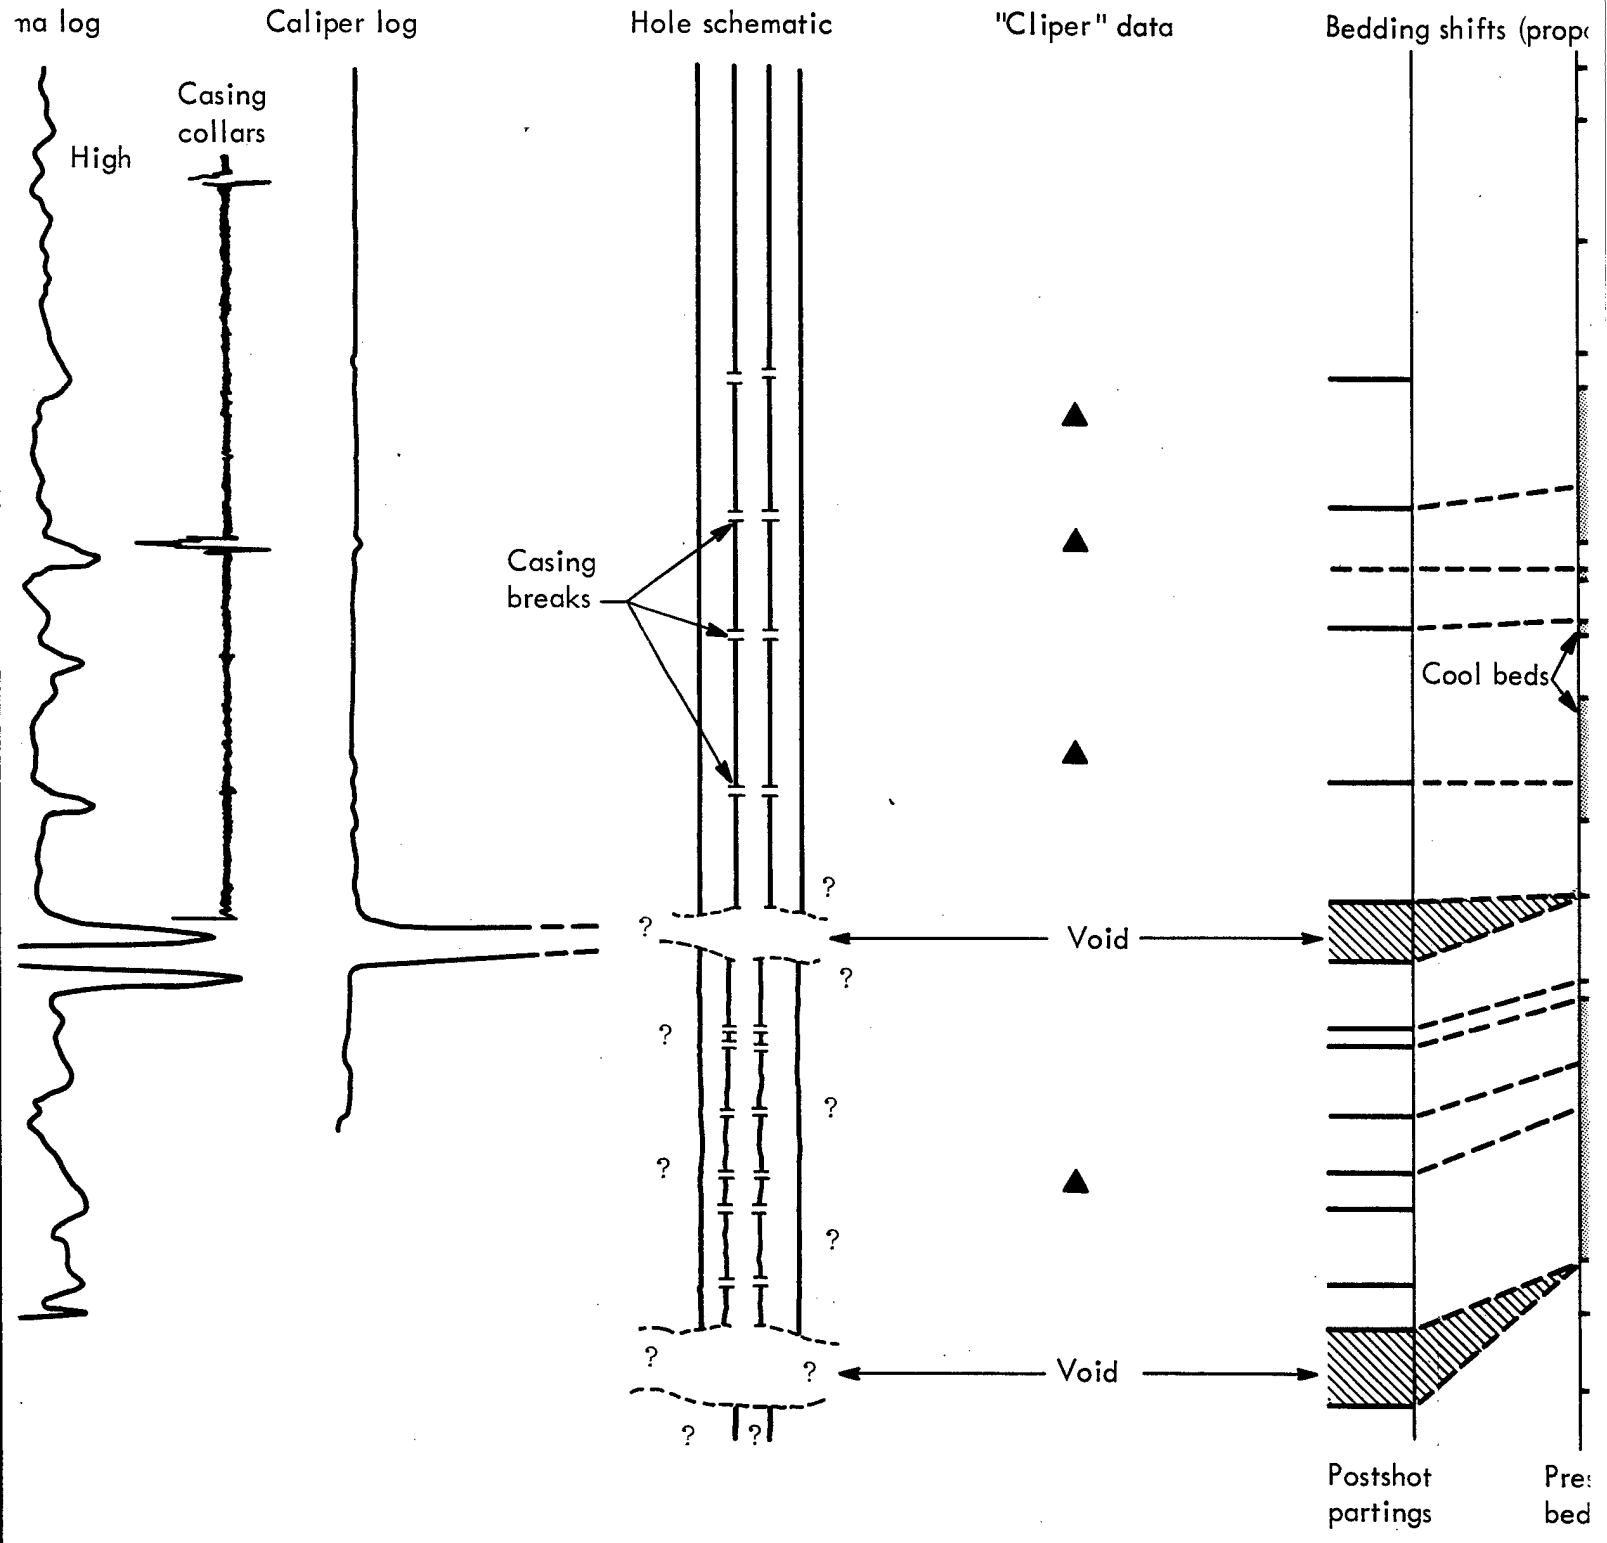
Fig. 4. Postshot characteristics.

"Cliper" data

Bedding shifts (proposed)

Void

Cool beds

Postshot partings

Preshot bedding

Alamo at 3,550 ft and the radiation spikes, where the casing parted, in the interval 3,790 to 3,870 ft (Fig. 4). In cementing off the slotted sections where there was sand stemming (Fig. 1), the cement did not bond to the casing such that it was gas and water tight. It is likely that a finite permeability existed, preshot, in the stemming as well. Water apparently was able to migrate from the leak at 3,550 ft up to at least 3,260 ft and possibly up as far as

Figure 4 illustrates the casing breaks found in GB-ER and a proposed correlation

of these breaks with preshot bedding plane "weaknesses" interpreted from the density log of the emplacement hole. The correlation is not conclusive, but is suggestive of breaks due to slight shifts or tensional openings along the boundaries of rock with different densities. Also shown are the breaks of the "cliper" cables in Hole GB-1. The extent, location, and frequency of the breaks also suggests failure along rock boundaries. Figure 7 is a plot of the "cliper" data with density log in GB-E. This further illustrates the correlation between breaks and the locations of major density changes or bedding plane boundaries. The relative depth uncertainty of the cable breaks is about ± 1 ft, the absolute depth is uncertain to ± 10 ft.

A density log, run later in this interval (3,500 to 3,862 ft), showed low density spikes at the following, approximate depths: 3,817, 3,826, 3,843, and 3,851 ft. These spikes can be interpreted as breaks in the 7-in., and possibly in the 20-in. casings. A caliper log run simultaneously with the density log showed small offsets in the 7-in. casing at approximately 3,815, 3,826, and at 3,843 ft. At 3,857 ft the caliper measured a hole at least 14 in. in radius. Also, since a magnetic collar locator, which was run in the area of the water leak showed the casing slots so well, the locator was run again here to see if it would show casing breaks. The log performed well in showing the casing irregularities (see Fig. 4).

A formation density log was run, but as with the gamma log, the bad hole conditions below 3,862 ft prevented the tool from going lower than 3,886 ft. As can be seen in Fig. 4, the low density areas on this log correlate well with the high radiation areas on the gamma log.
