## **Expedient MESL Construction in Cold Weather**

Jeffrey A. Stark, Rosa T. Affleck, and Sherri A. Orchino

Technical Report  
ERDC/CRREL TR-00-8

Prepared for  
OFFICE OF THE CHIEF OF ENGINEERS

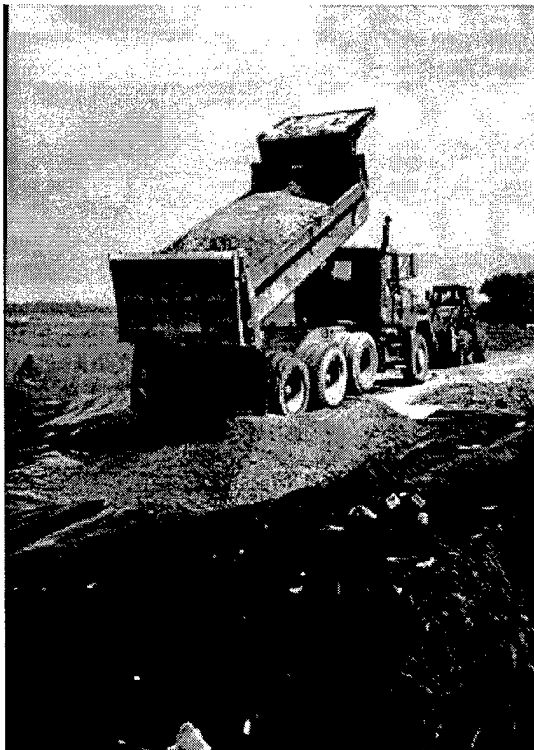
*Figure 5. Using a D-7 to spread soil in the MESL.*

The fill material was transported to the site in 20-ton dump trucks. Because vehicle traffic would damage the membranes, the trucks had to back to the edge of the excavation to dump the fill soil (Fig. 4) and a dozer pushed the material over the membrane (Fig. 5). A loaded 20-ton dump

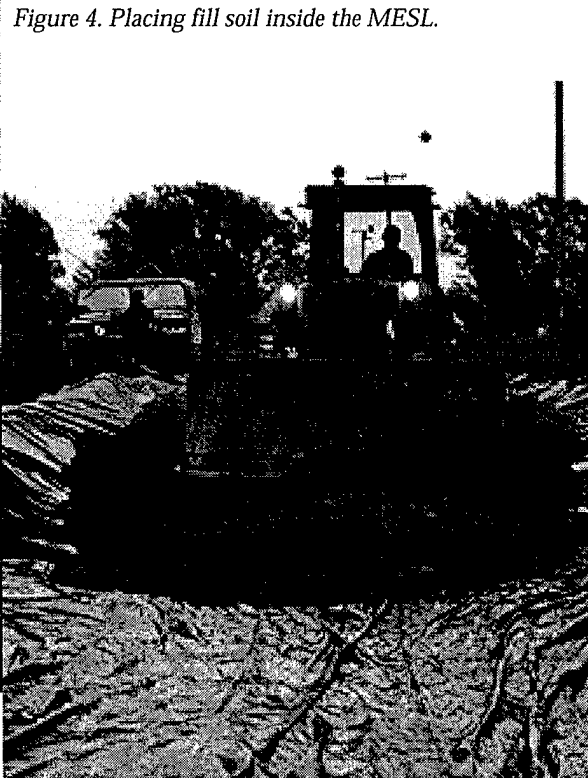
*Figure 4. Placing fill soil inside the MESL.*

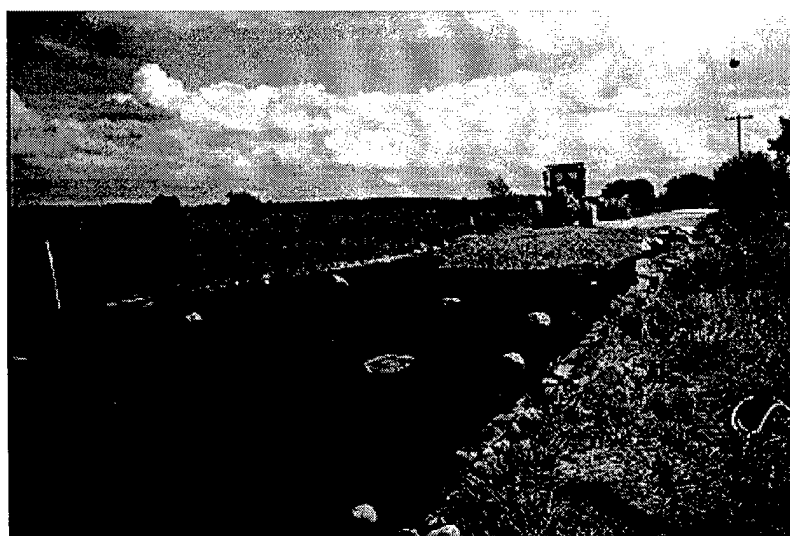
*Figure 7. Spreading the gravel wearing course on the MESL.*

The gravel for the wearing surface was brought to the site in 20-ton dump trucks. Once again the trucks had to back to the edge of the MESL to dump the gravel to avoid damaging the membrane. The D-7 dozer and a bucket loader were used to spread the gravel over the MESL. On the final day of construction a grader was brought from another construction site to spread the gravel to a 152-mm (6-in.) lift (Fig. 7). The gravel was compacted by vehicle traffic.

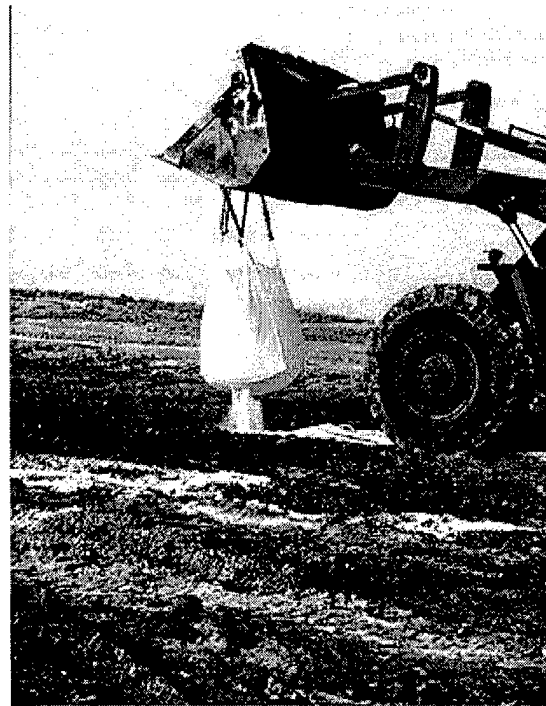
*Figure 8. Bucket loader spreading lime.*

small gullies formed by erosion. The one-ton supersacks of lime were loaded on a lowboy trailer using a forklift and were then delivered to the site where a bucket loader was used for unloading. The supersacks were picked up with the loader using four chains placed through loops on the bag. The bucket loader carried the bags to the mixing area where three holes were cut in the bottom of the bags. The loader then drove back and forth to spread the lime (Fig. 8) in lines with piles of lime where the bags were opened and where the loader changed directions. Water was then spread on the lime to hydrate it and wet the clay. The clay was dry because the soil was sloped and exposed to the sun.

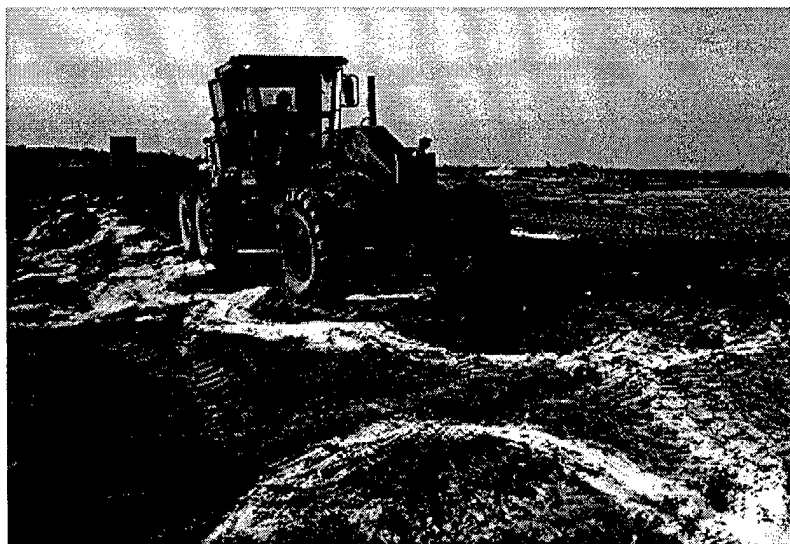
*Figure 9. Grader mixing soil and lime.*

The scarifying teeth of a grader were used to mix lime into the soil to a depth of approximately 102 mm (4 in.) (Fig. 9); the soil also was bladed. Water was added several times until there was enough moisture for compaction.

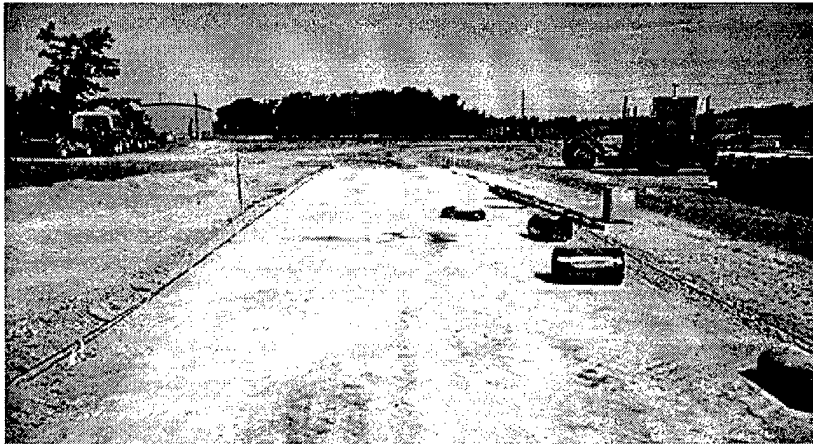
Figure 10. Compacted clay layer used to simulate the top of a MESL.

pan. These trenches provided an area to wash the gravel into when the test was completed. Next, six inches of clay was placed on the test section. Water was added to the clay, scarified, and compacted to simulate the top of a finished MESL, prior to placement of the upper membrane (Fig. 10).

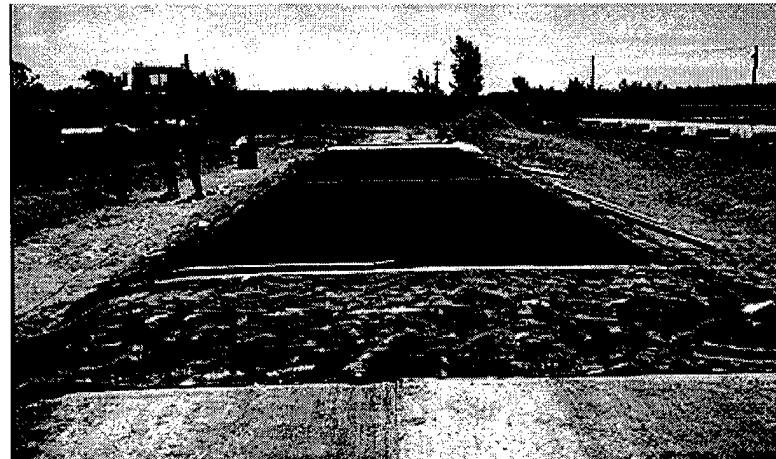
Figure 11. Completed puncture test section before placing a wearing surface.

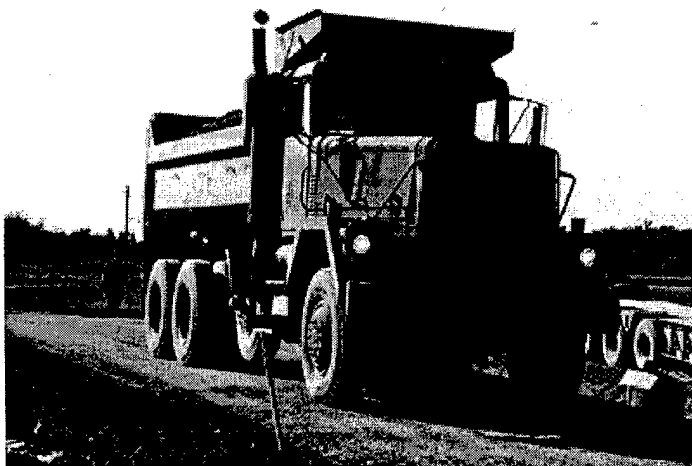
*Figure 14. Trafficking the puncture test.*

The test section was trafficked with a loaded 20-ton dump truck for 170 passes (Fig. 14). The truck made a loop to traffic and traveled at approximately 10 mph on the test section. The truck also followed approximately the same path each time, simulating a worst-case scenario.

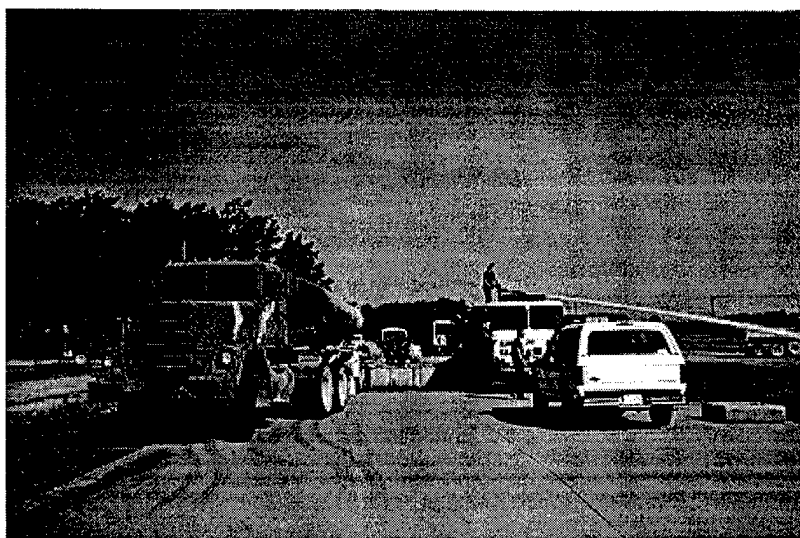
*Figure 15. Equipment used to wash gravel off the test section.*

After trafficking, the gravel was removed to observe any membrane damage. A grader removed the top few inches of gravel from the test section. The Fort Drum Fire Department then used one of its fire trucks to remove the rest (Fig. 15 and 16). This procedure worked well and mini-

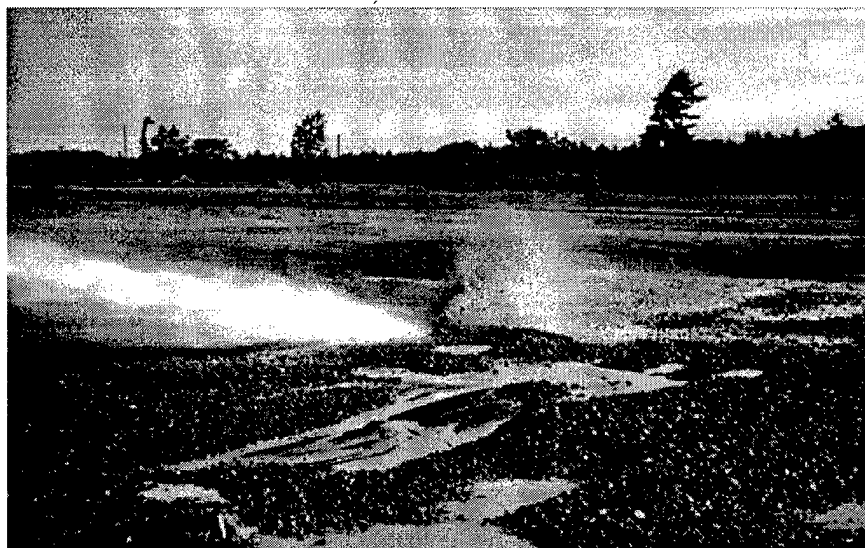
*Figure 16. Washing gravel.*

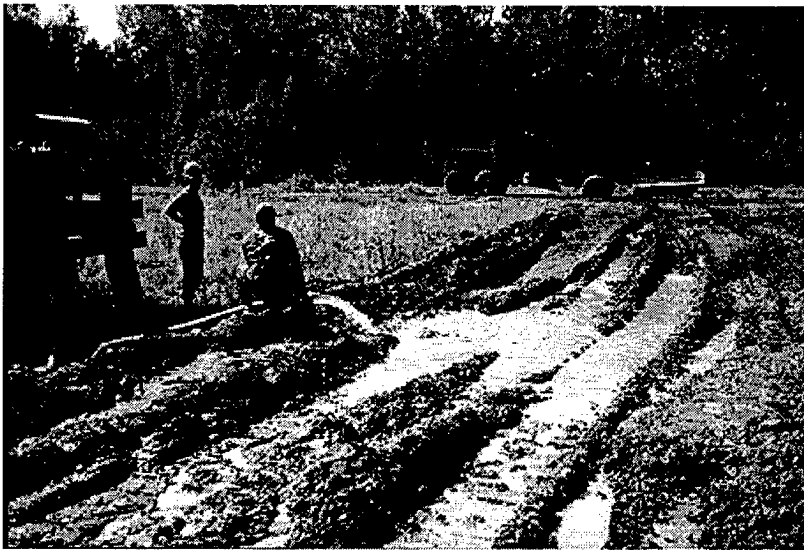
*Figure 17. Adding water to the absorbent test section at Ethan Allen Firing Range, Vermont.*

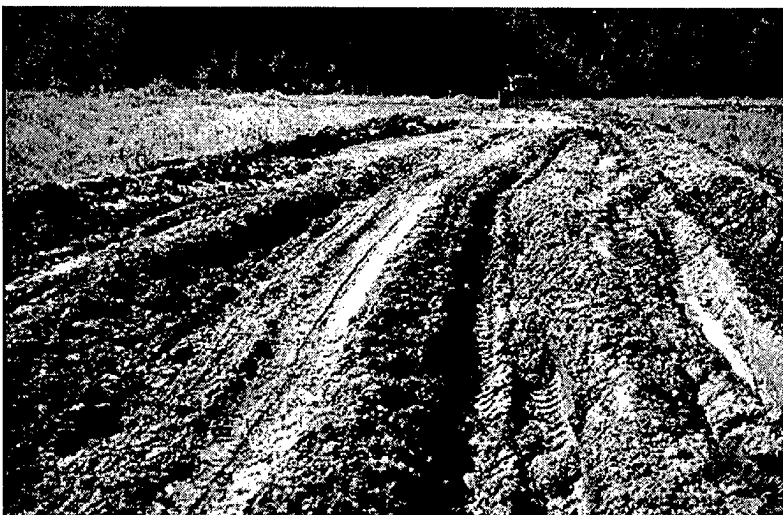
*Figure 19. Wheel ruts after one pass.*

The test site was an old gravel pit. Because of the low quality of the gravel (due to a high fines content), it was typically used as a fill material at least 0.61 m (2 ft) below the road surface. A thin organic layer had formed on the gravel and supported grass growth. A test section approximately 4.57 m (15 ft) wide by 130 m (100 ft) long was prepared for the test. The existing material was mixed together using a dozer, and additional silty sand was added. Water was added to make the soil muddy (Fig. 17). The wet layer was approximately 305 mm (1 ft) deep with a solid layer underneath. When trafficked, a 5-ton truck (Fig. 18) would sink to the hard layer, and in some places the soil was too weak to maintain the wheel ruts (Fig. 19).

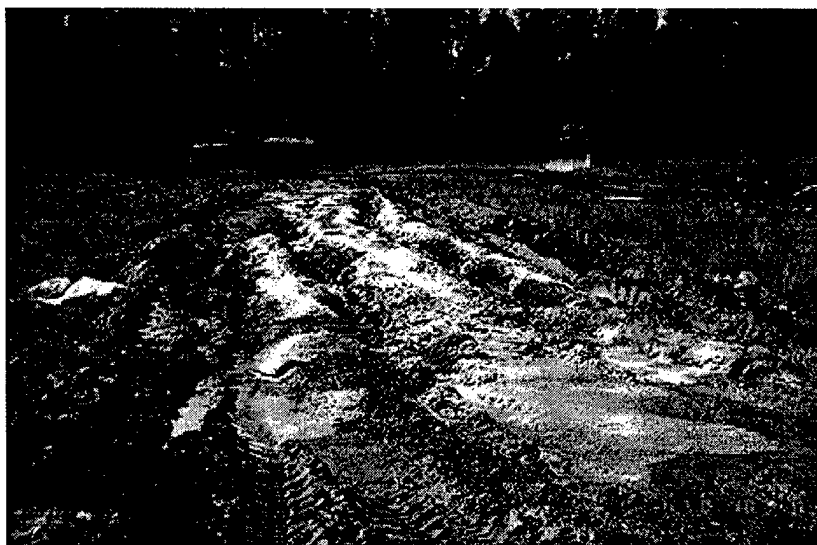
*Figure 20. Absorbent spread on test section.*

Next, 136 kg (300 lb) of the absorbent was added (Fig. 20) and mixed with a grader (Fig. 21). The grader trafficked only the test section and did not use its blade or scarifying teeth to mix the soil and absorbent. After mixing, a dozer was used to back-blade the test section and provide a smooth surface. The center of the section was dryer than the ends. This was due to standing water before the absorbent was added at the far end of the test section and not enough absorbent being added to the near end of the test section.

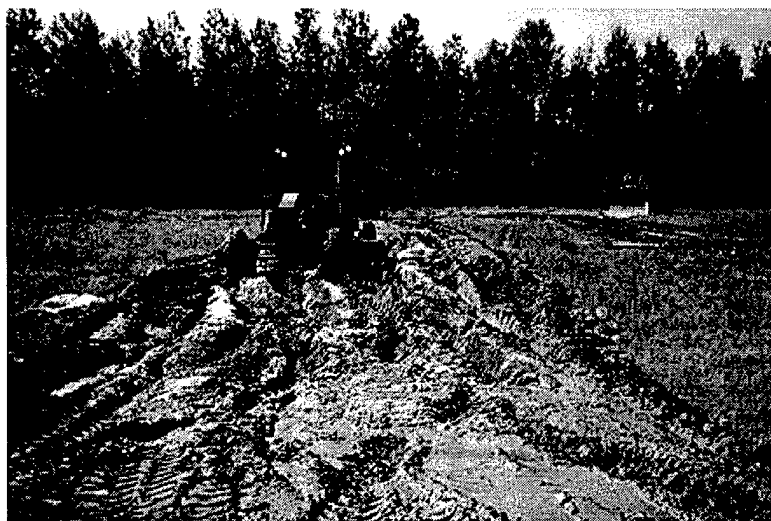
*Figure 21. Mixing absorbent and soil together.*

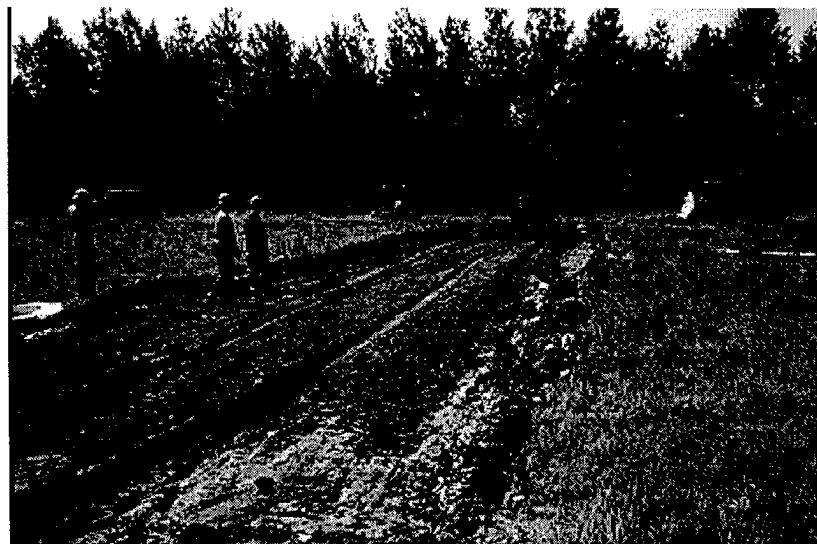
*Figure 22. Test section after one pass with a CUCV.*

A Commercial Utility and Cargo Vehicle (CUCV) was driven across the test section leaving approximately 51-mm- (2-in.-) deep ruts in the center of the section and 152-mm (6-in.) ruts on either end (Fig. 22). The CUCV was able to drive through the test section in 2-wheel drive when

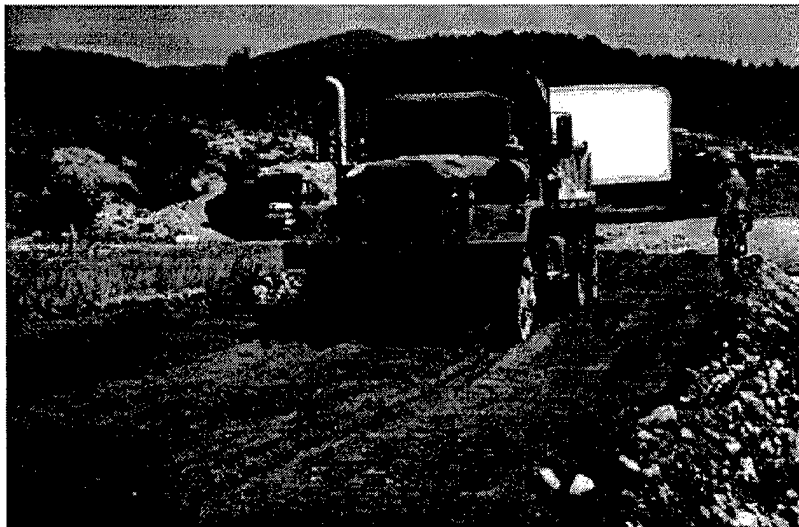
*Figure 23. Trafficking the section with a 5-ton dump truck.*

the test section would have been impassable in 4-wheel drive before treatment. A loaded 5-ton dump truck was then driven through the test section (Fig. 23 and 24). It left approximately 102-mm- (4-in.-) deep ruts in the center and 203-mm- (8-in.-) deep ruts on either end. The 5-ton dump truck then trafficked the section 30 times and left 178- to 279-mm- (7- to 11-in.-) deep ruts in the center and far end and 356-mm- (14-in.-) deep ruts at the near end (Fig. 25). The rutting was not caused by the soil being too "wet" but the result of a lack of cohesion. At the end of the test the soil looked dry and friable. The average water content of the top 76 mm (3 in.) of soil was 17.8%. Its grain size distribution was not determined. The cone penetrometer test results were not valid because the cone hit the larger gravel pieces.

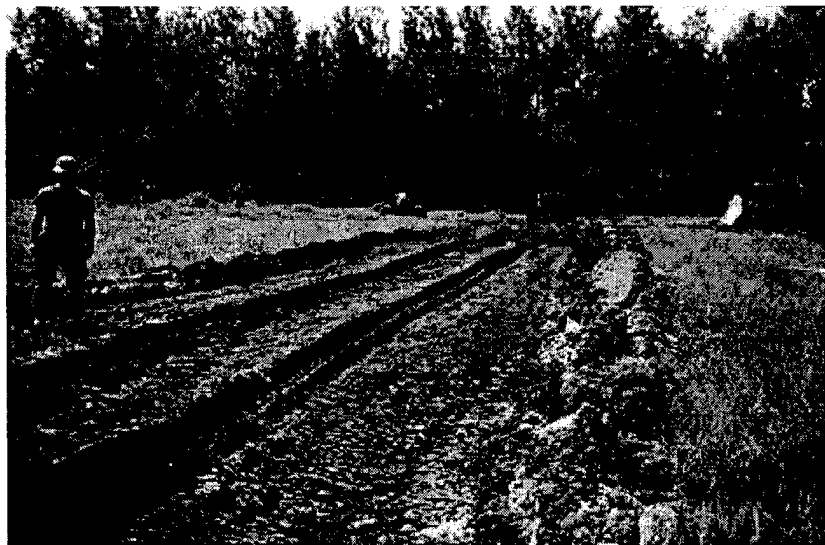
*Figure 24. Test section after one pass with a 5-ton dump truck.*

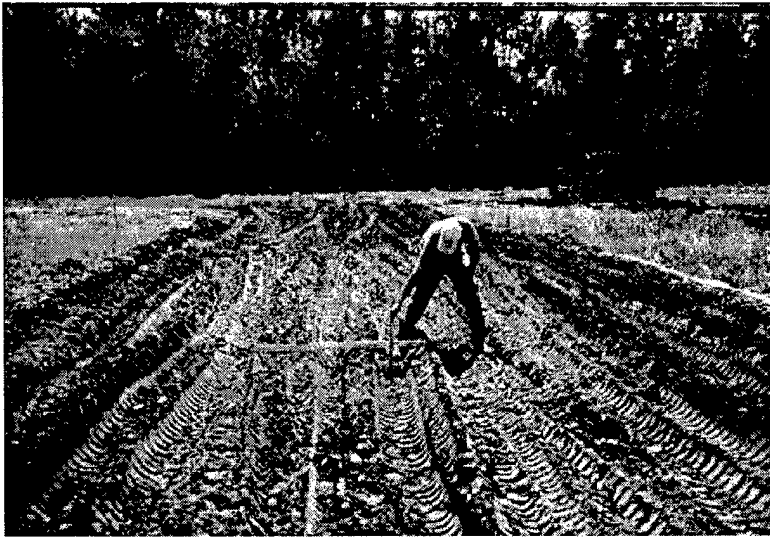
*Figure 25. Test section after 30 passes with a 5-ton dump truck.*

The section still rutted too much during truck traffic for use in a MESL. A 152-mm (6-in.) wearing course would reduce rutting but would not eliminate it. Rutting would stress the upper membrane and could lead to punctures and tearing.

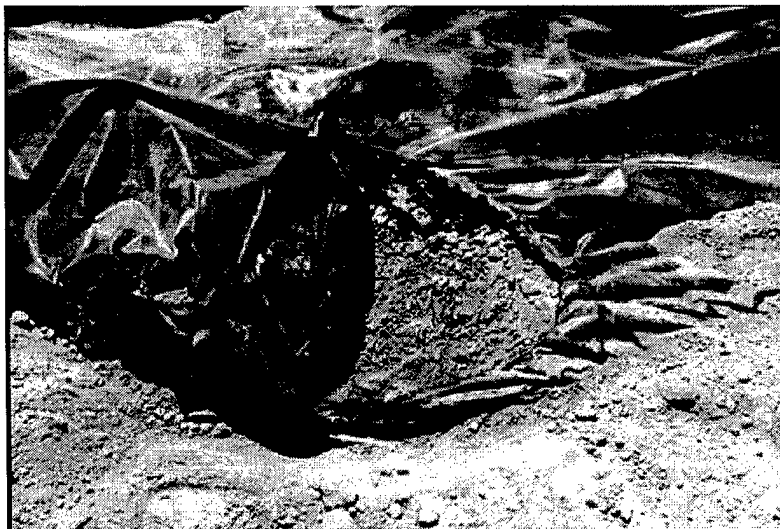
*Figure 27. Membrane tear.*
