ERDC/SL TR-00-6

## **Ultimate Deflection Response of Lightly Reinforced Concrete Intake Towers**

Richard C. Dove

August 2000

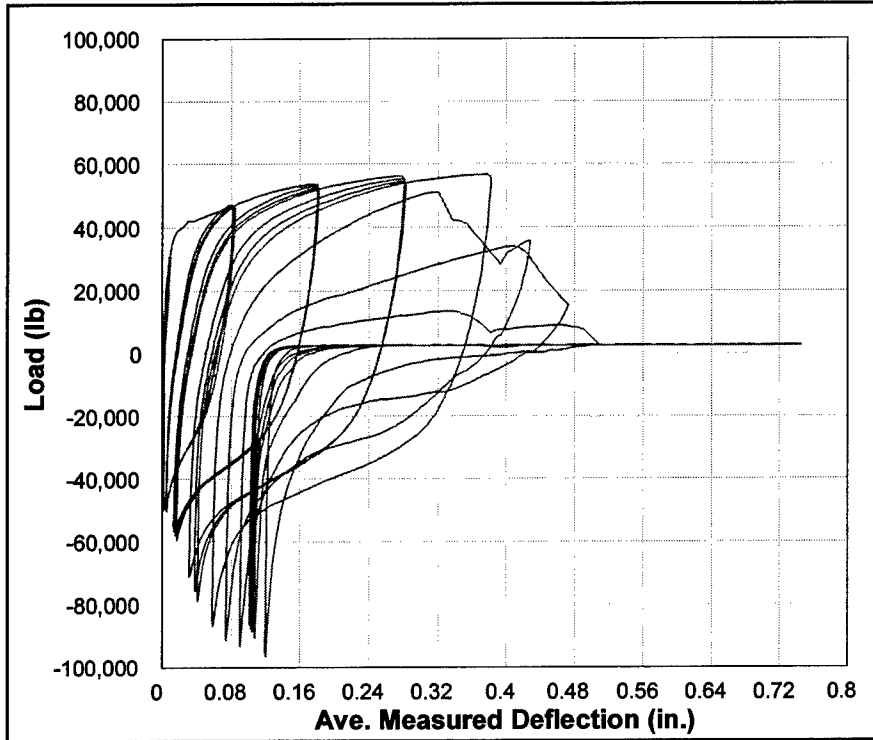
Figure 18. Load-deflection curve for experiment 3SLCH

deflection at failure was 0.382 in., as measured by the average of four 40-in. and four 8-in. LVDT gages. The load-deflection curve is shown in Figure 18. Loading was continued until complete failure was reached. The apparent failure mode was a localized response of the rebar with no concrete degradation. There was only a small degree of very localized crushing of the concrete immediately around the rebar failure zone. This conical zone of crushed concrete extended about one bar diameter into the model above and below the cold joint. The reinforcing bar appeared to fail in tension. Some bending of the rebar was evident, caused by the compression of the rebar during the reverse loading cycles.

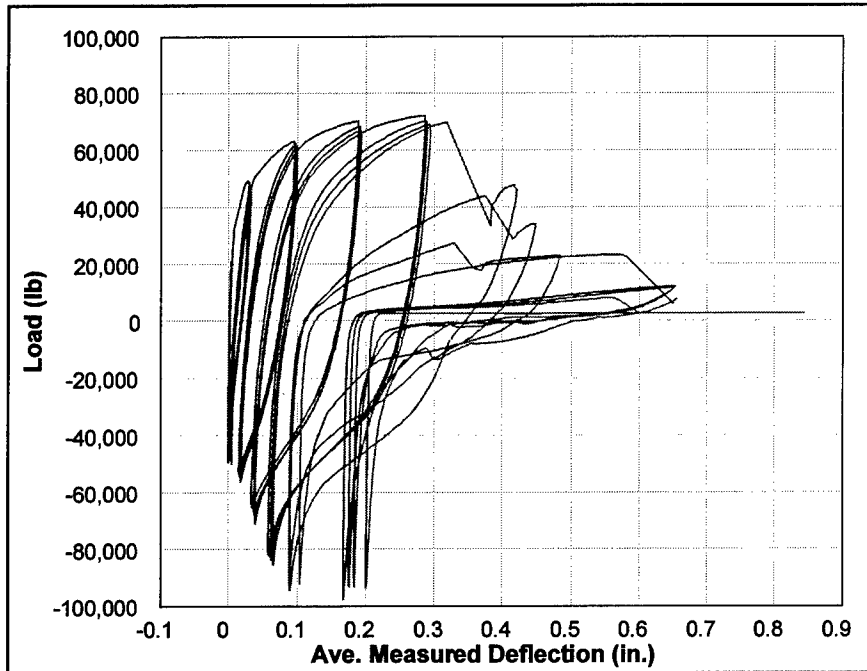
Figure 24. Load-deflection curve for experiment 3SHCH

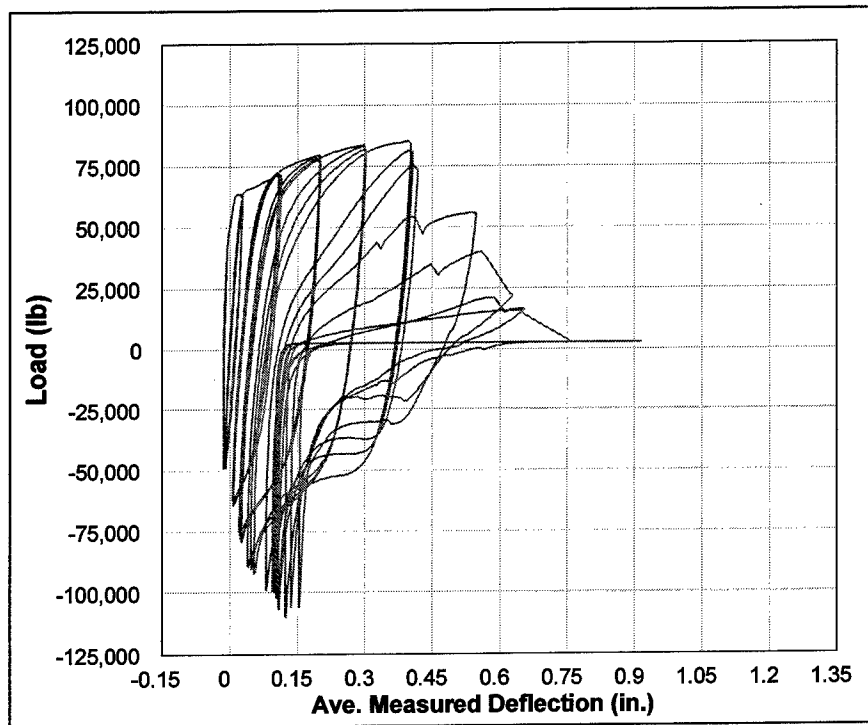
Figure 30. Load-deflection curve for experiment 4SHCM

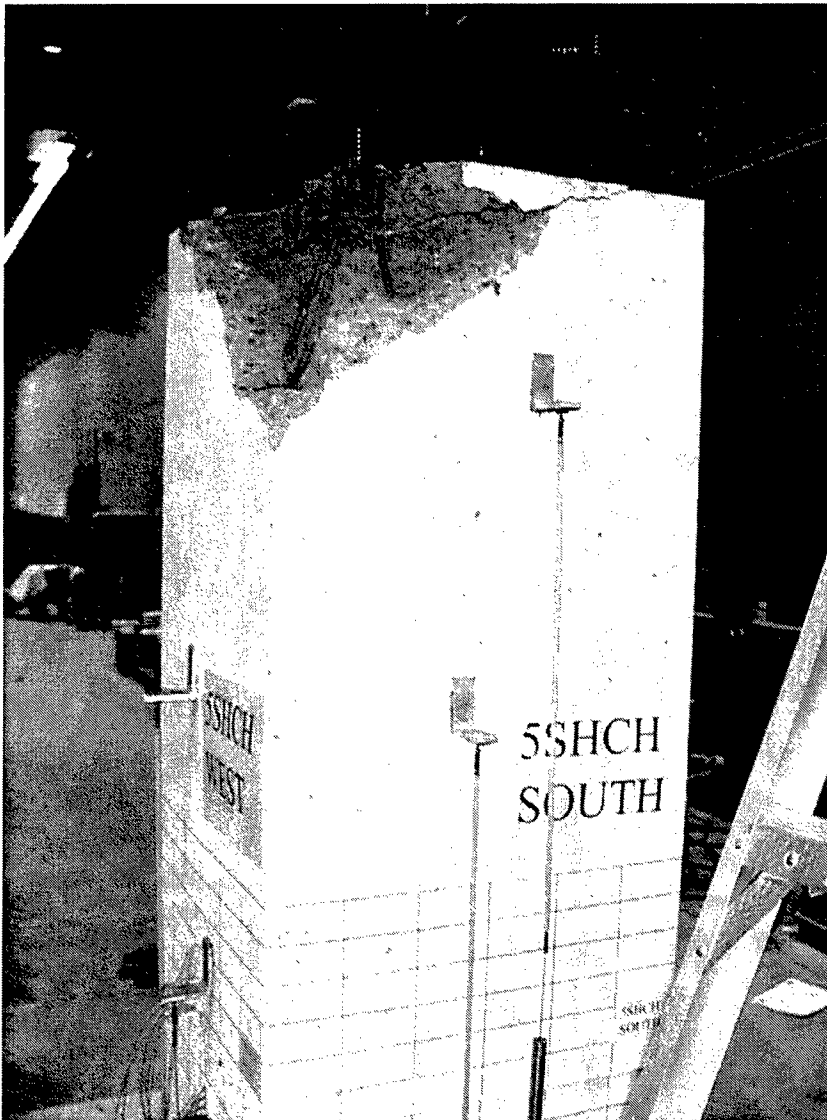
Figure 42. Damage to 5SHCH model due to accidental loading

upon application of the dead load to the model. As a result of this oscillation, one of the load plate bolt nuts vibrated down to contact the load plate. When the hydraulic system was shut down and then restarted, the ram violently rebounded upward about 2 in. pulling upward on the single bolt and failing one corner of the model (Figure 42). Fortunately no one was injured. An attempt was made to salvage the model by removing the damaged portion, replacing the lifting bolts, providing additional anchoring and replacing the concrete with very high strength grout (Figures 43 and 45). When an attempt was made to load the repaired model, failure occurred at the interface of the new and old concrete (Figure 46). This failure mode was obviously an artifact of the repairs made and the experiment was abandoned.

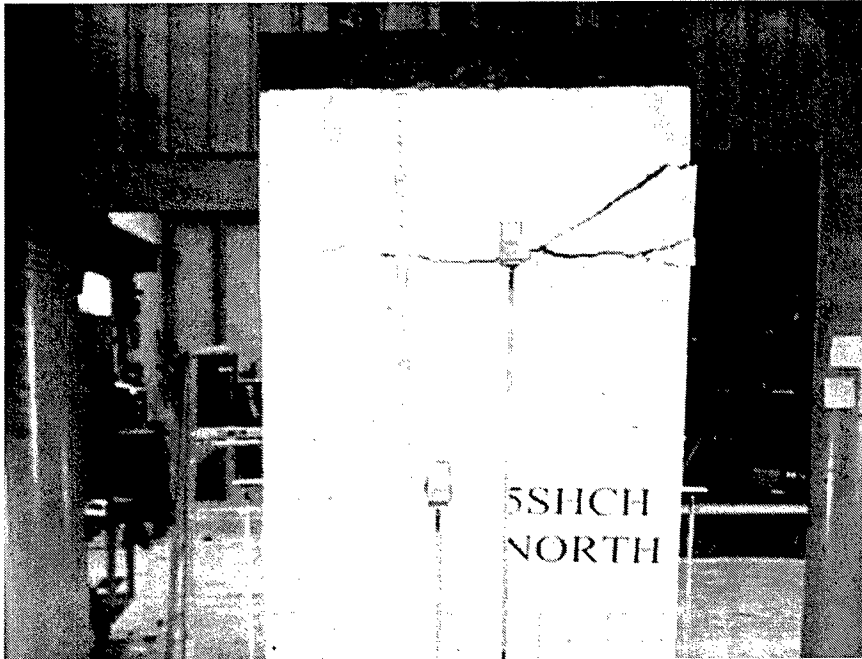
Figure 45. Failure of 5SHCH model at repair

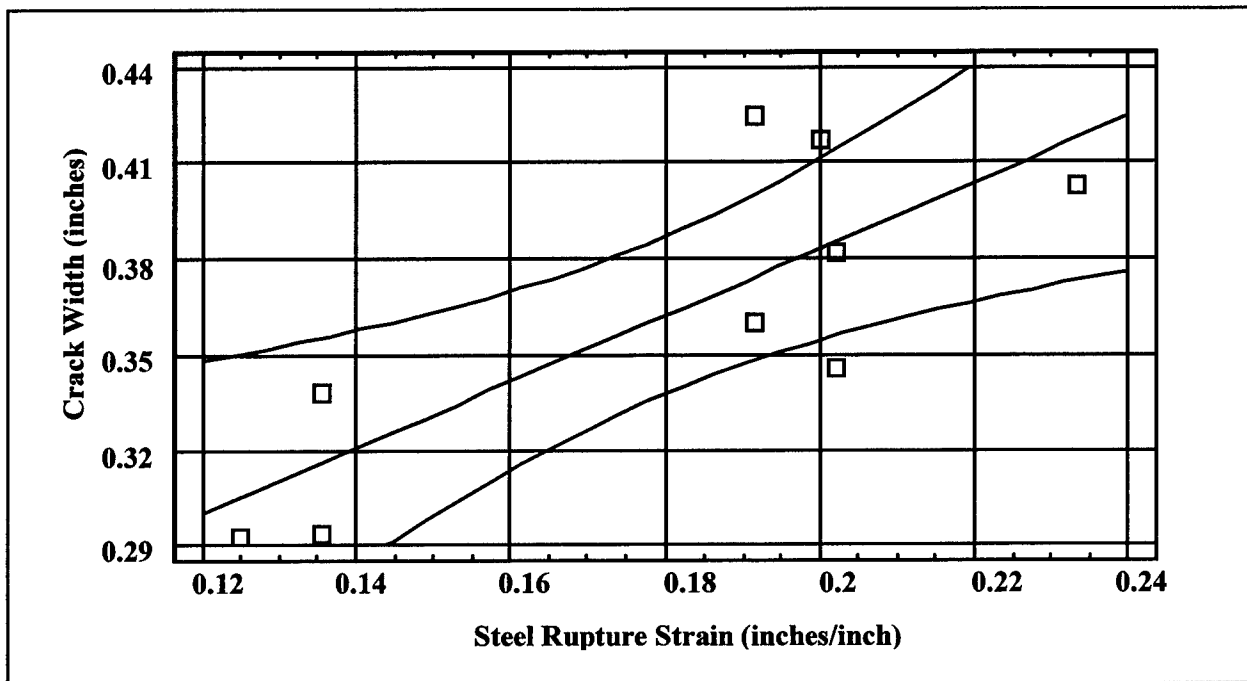
Figure 49. Plot of model predicting ultimate crack width from reinforcing steel rupture strain, including 95-percent confidence intervals

$$\text{Ultimate crack width } (C_u) = 0.175913 + 1.03506 * \text{Ultimate rupture strain } (\epsilon_u) \quad (2)$$

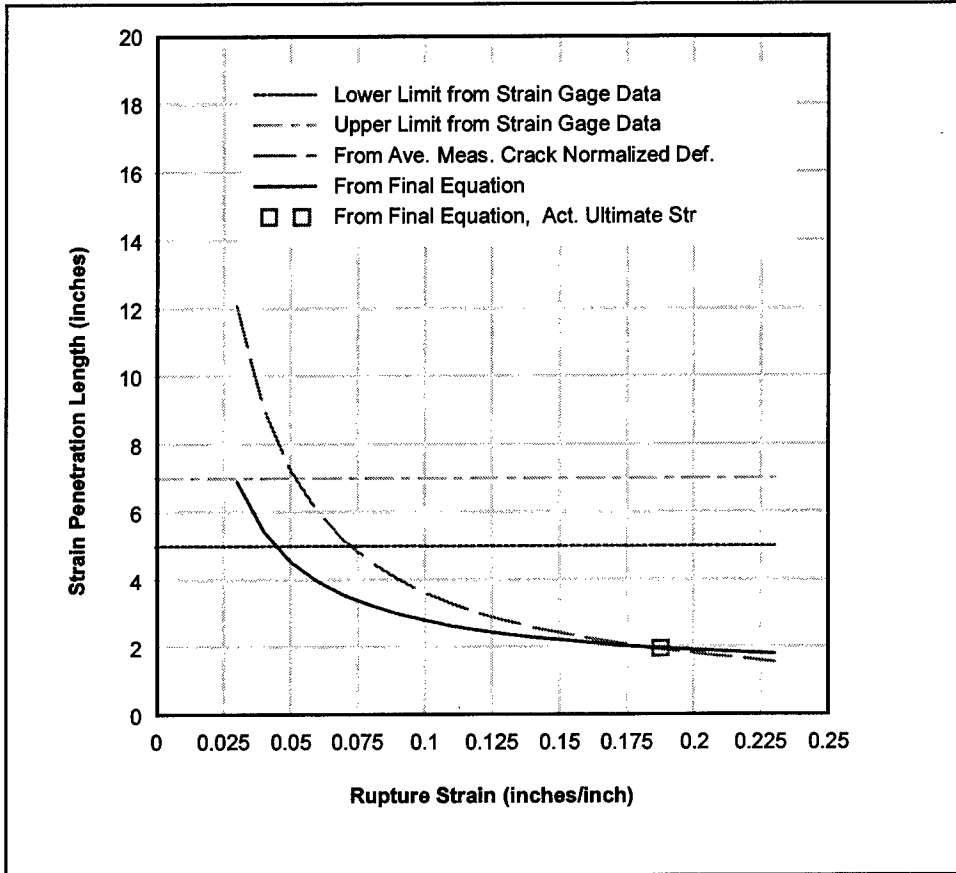
Figure 51. Example of calculated and experimental strain penetration lengths, experiment 5CLSH

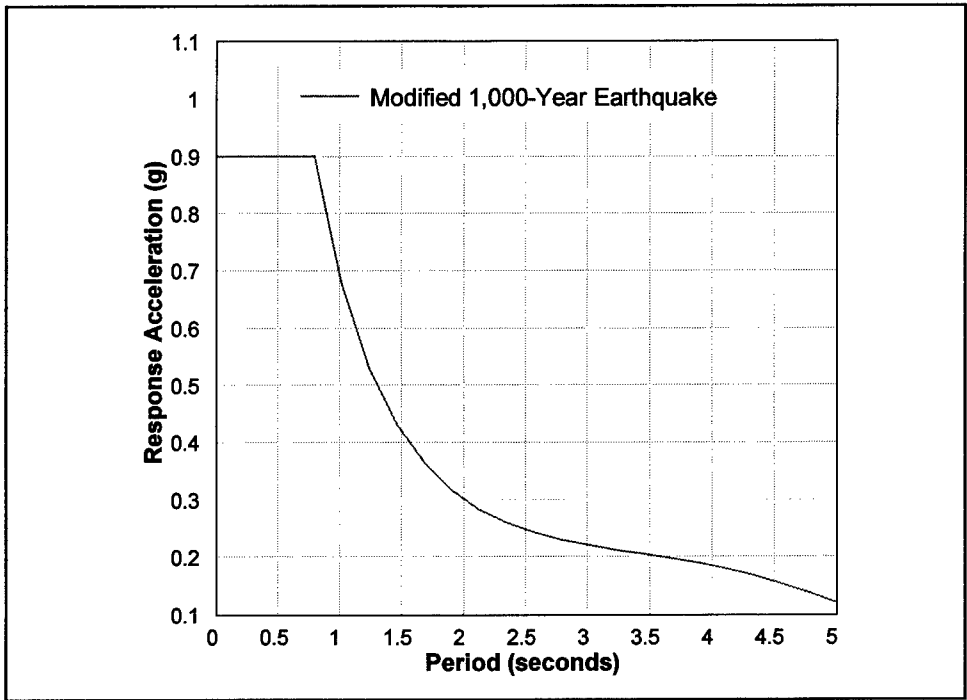
Figure 57. Modified response spectra, 1,000-year-return earthquake

The next step was to conduct an ABAQUS response spectrum analysis. Only the modified response spectrum for a 1,000-year-return earthquake was modeled, as this is the most severe case (Figure 57). The element properties were consistent with those calculated by Dr. Truman for elements above the 395-ft elevation. Note that there is no added mass due to water as the maximum water level is below the critical section. The analysis shows that a maximum top deflection of 0.014 in. was calculated. This is the deflection demand placed on the system by the given earthquake.

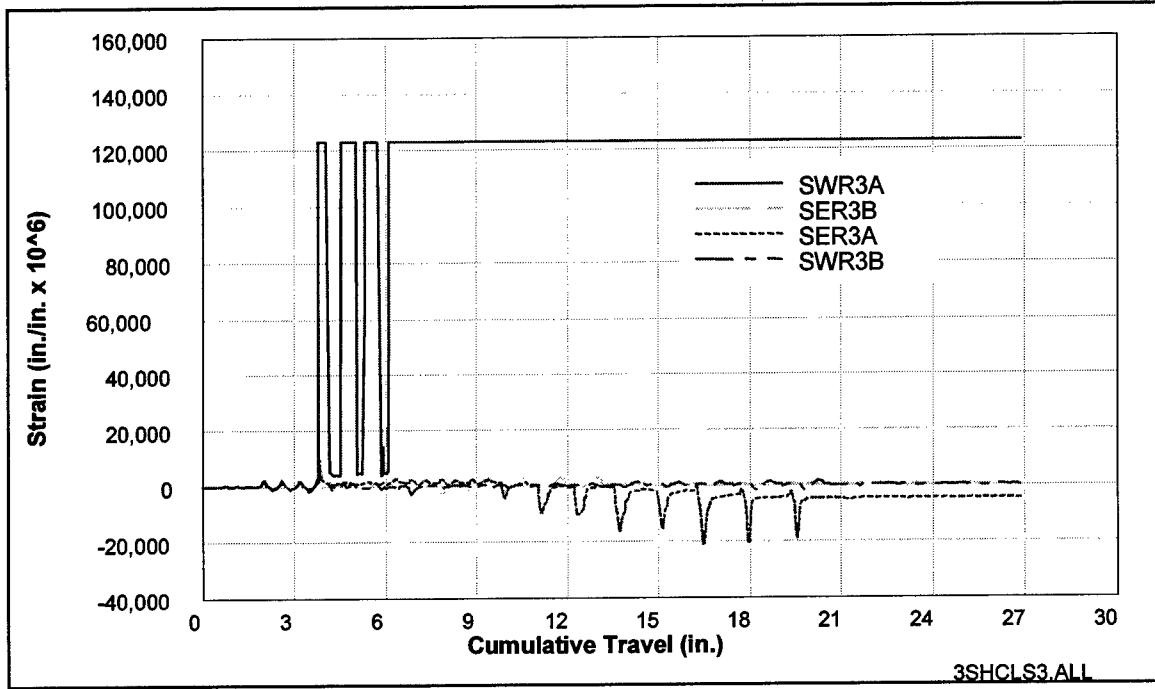
Figure C11. Strains measured 2.0 in. above and below cold joint, 3SHCL

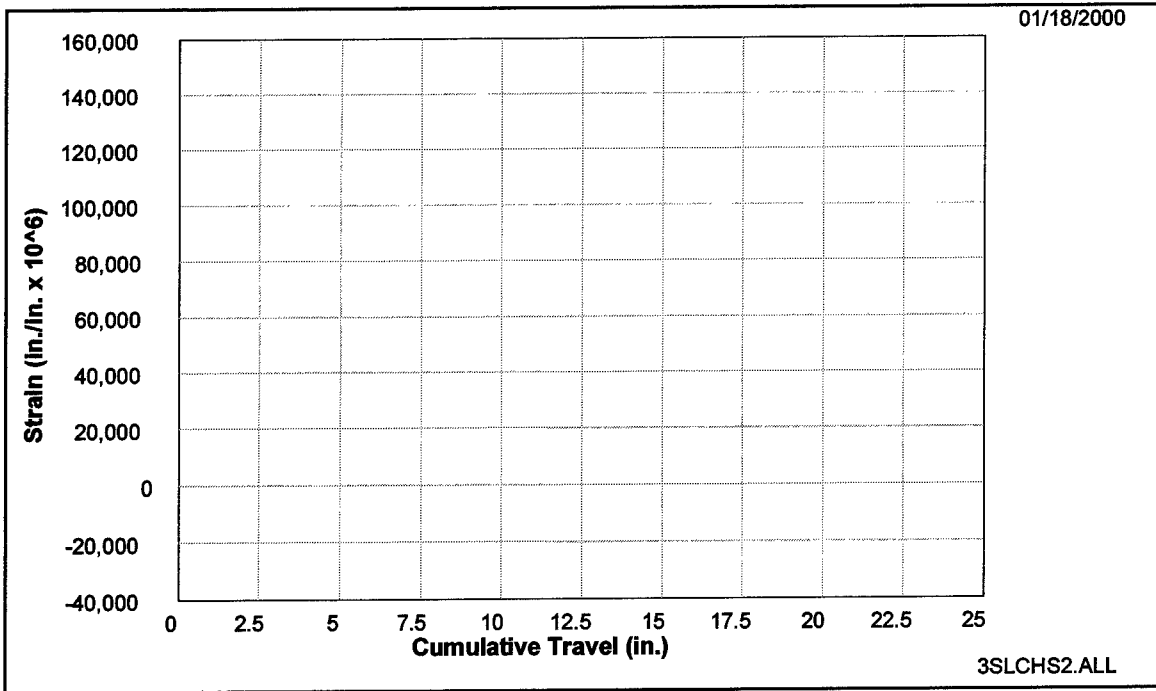
Figure C17. Strains measured 1.0 in. above and below cold joint, 3SLCH
