## Implementation Guidance for the Control of Undesirable Vegetation on Dredged Material

**PURPOSE:** The purpose of this technical note is to provide guidance for implementing selected management practices to control undesirable vegetation on dredged material.

Lee, C. R. (2000) "Implementation guidance for the control of undesirable vegetation on dredged material," *DOER Technical Notes Collection* (ERDC TN-DOER-C20), U.S. Army Engineer Research and Development Center, Vicksburg, MS.  
[www.wes.army.mil/DOTS/DOER/](http://www.wes.army.mil/DOTS/DOER/)

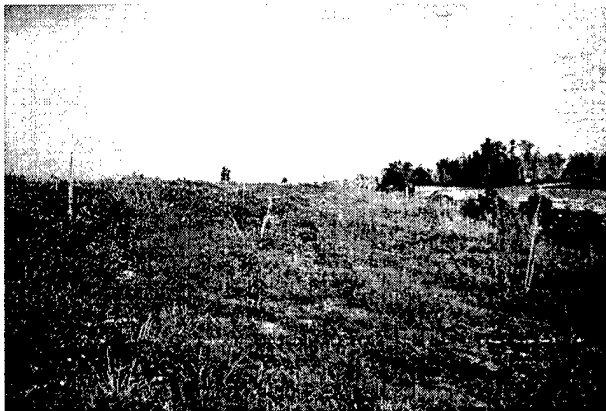
Figure 11. Vegetative cover on yardwaste and N-Viro biosolids demonstration plots (Sep 98)

all demonstration plots. The bagasse and N-Viro biosolids plots showed the least amount of undesirable vegetation and the best growth of planted desirable vegetation (Figure 10). After 2 years of herbicide wiping, Spanish needle continued to reestablish from the massive seed bank collected over the years (Figures 11 and 12). However, perennial peanut became established on the bagasse and N-Viro plots despite the continuous regrowth of Spanish needle (Figure 13).

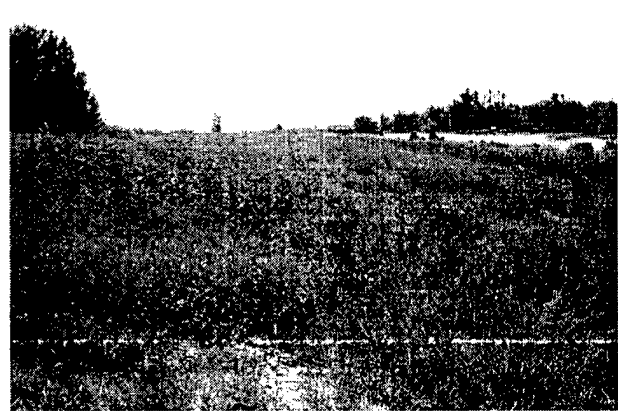
Figure 12. Vegetative cover on bagasse and N-Viro biosolids demonstration plots (Sep 98)

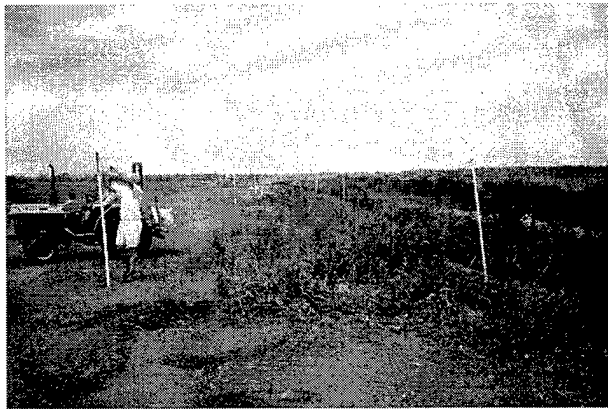
Figure 27. Wiper applying Round-Up® herbicide at a rate of  $2.3 \times 10^2$  ml/ha (32 oz/acre) adjacent to Plot 2 at Eagle Island CDF, NC (23 May 00)

was sought to manage the plant tops. After 6 months, the compost was used as cellulose in a manufactured topsoil according to RSMT. On May 23, 2000, the new regrowth of the *Phragmites* was wiped with a wiper panel on two separate demonstration plots (each 6 by 30 m (20 by 100 ft)) with the glyphosate herbicide Round-Up® at a rate of  $2.3 \times 10^2$  ml/ha (32 oz/acre) once (Figures 24-27) and then a second time after 4 days. Two similar size control (untreated) plots were established for comparison. The plant height was approximately 0.6 m (2 ft) high each time wiping was performed. Effects of the wiping were observed on 24 Jun 2000 (32 days) (Figures 28 and 29). On 5 Jul 2000 (44 days), some new regrowth was observed (Figures 30 and 31). A gallon of ready-to-use Round-Up® was applied by hand spray to spot-spray the green leaves present on each demonstration plot. The concentration of glyphosate was 0.96 percent as the isopropylamine salt. Observations (Figures 32 and 33) were made on 22 Jul 2000 (60 days after the initial wiping and 14 days after hand spot-spray application). Control plots that were not wiped with herbicide were covered with *Phragmites* and other undesirable weeds (Figures 34 and 35). It is expected that the roots/rhizomes of *Phragmites* in these plots will be dead allowing material from that area to be used for RSMT manufactured topsoil or other uses without the interferences caused by *Phragmites*.

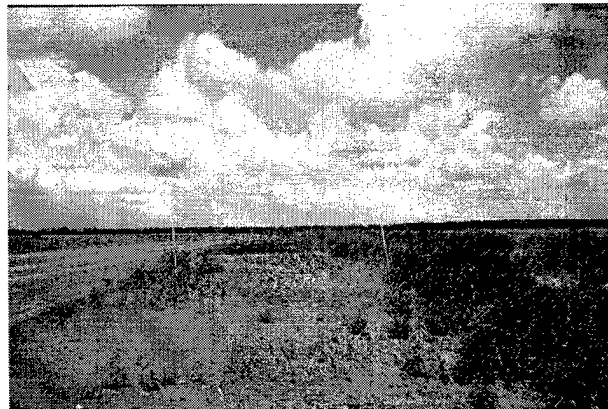
Figure 29. Observation at 32 days of the herbicide-wiped Plot 2 in the foreground with the unwiped control in the background (24 Jun 00)
