Systems Engineering Investigation of Navy Electrical Bomb Fuzing

Gary A. Evans (Naval Air Warfare Center, Patuxent River, Maryland)

Abstract

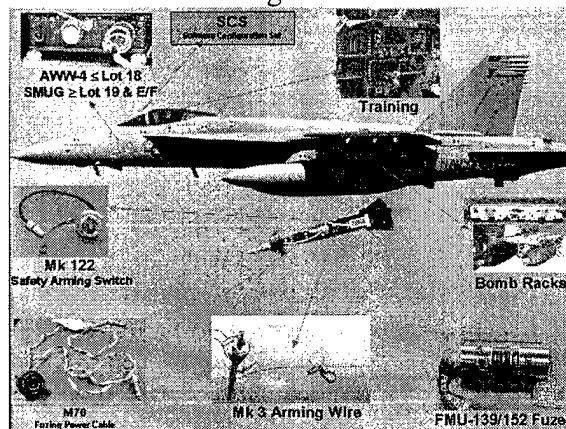
Figure 1

The current electrical fuzing system is comprised of several components. Some of these components are approaching 30 years in age with their specifications preceding them by 10 years. The major components of the electrical fuzing system are illustrated in figure 1.

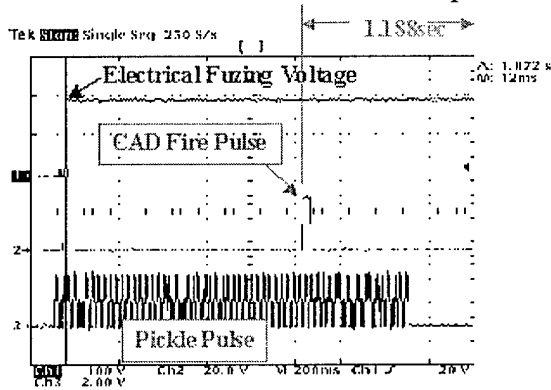
specified limits and of a sufficient duration and magnitude to fully arm the fuze. Figures 3 and 4 show software test data for the JDAM electrical fuzing signal. Both figures 3 and 4 indicate that the proper electrical fuzing signal was present prior to the bomb rack CAD firing. Sufficient signal remained until after the Mk 122 co-axial connector was extracted from the bomb rack connector.

Figure 3
Aircraft Software Data Sample

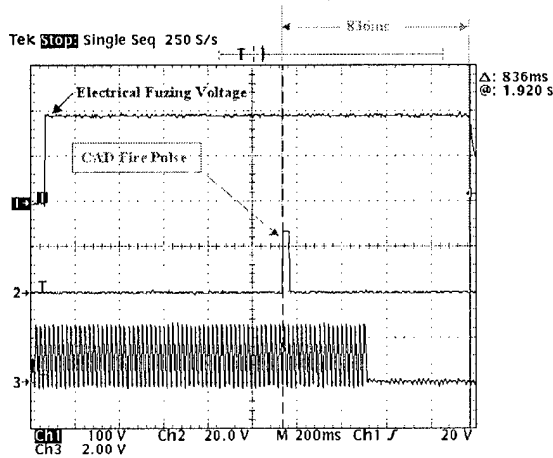
Figure 4
AYK-22 Electrical Fuze Timing Data
JDAM on BRU-32, TOO release

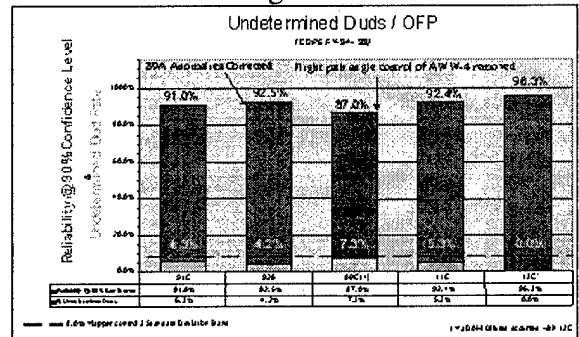
Figure 5

electrically fuzed bomb releases over a period of six years subsequent to the OFF fix. These data shown in figure 5, relate the undetermined dud bomb releases with the aircraft software present in the releasing aircraft. These data were then correlated with the software updates. This analysis identified that no correlation existed between unknown dud bomb rates and aircraft software changes. These operational data agree with the lab test results.

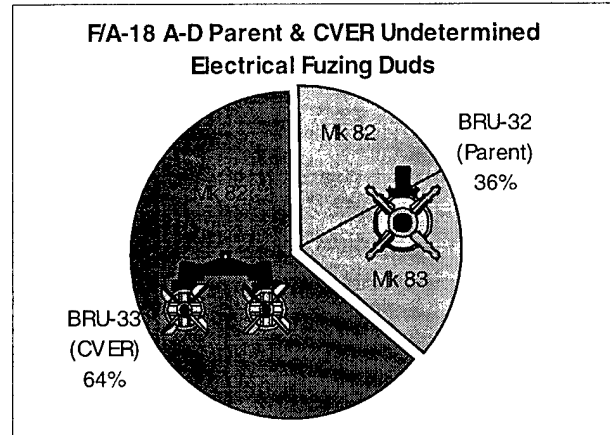
Figure 13

The BRU-32 and BRU-33 have some of the highest ejection velocities of current operational Navy bomb racks. From the analysis of Navy COPE data, figure 13, it was determined that 64% of the F/A-18 undetermined duds occurred when bombs were released from the CVER. Parent station undetermined duds were evenly split between Mk 82 and Mk 83 bombs. The COPE data sample for CVER was made up mainly of 500lb Mk 82 Bombs.

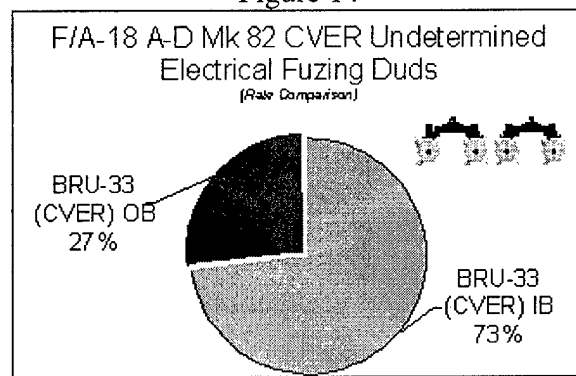
Figure 14

The largest percentage of undetermined duds from the CVER occurred from the inboard CVER station, figure 14 that is the second bomb to be released from the CVER.

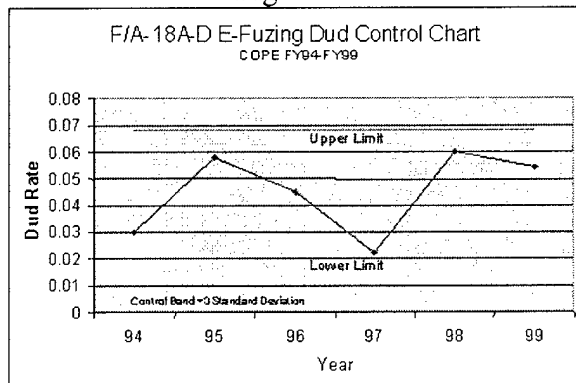
Figure 24

The F/A-18 COPE data set were first verified to ensure they fit within the 3-sigma control limit constraints, figure 24. From analysis of the F/A-18 COPE data, the duds were split into three categories as depicted in figure 25. The first of the categories, known delivery errors, had a 3.5% delivery error rate. The second category, known hardware malfunctions, had a 4.3% hardware failure rate. The third category, undetermined dud sources, had a 4.4% undetermined dud rate.
