AFRL-ML-WP-TR-2000-4035

**RETIREMENT FOR CAUSE (RFC) EDDY
CURRENT INSPECTION SYSTEM
CALIBRATION IMPROVEMENT**

**THE UNIVERSITY OF DAYTON RESEARCH INSTITUTE
300 COLLEGE PARK
DAYTON OH 45469-0104**

FEBRUARY 2000

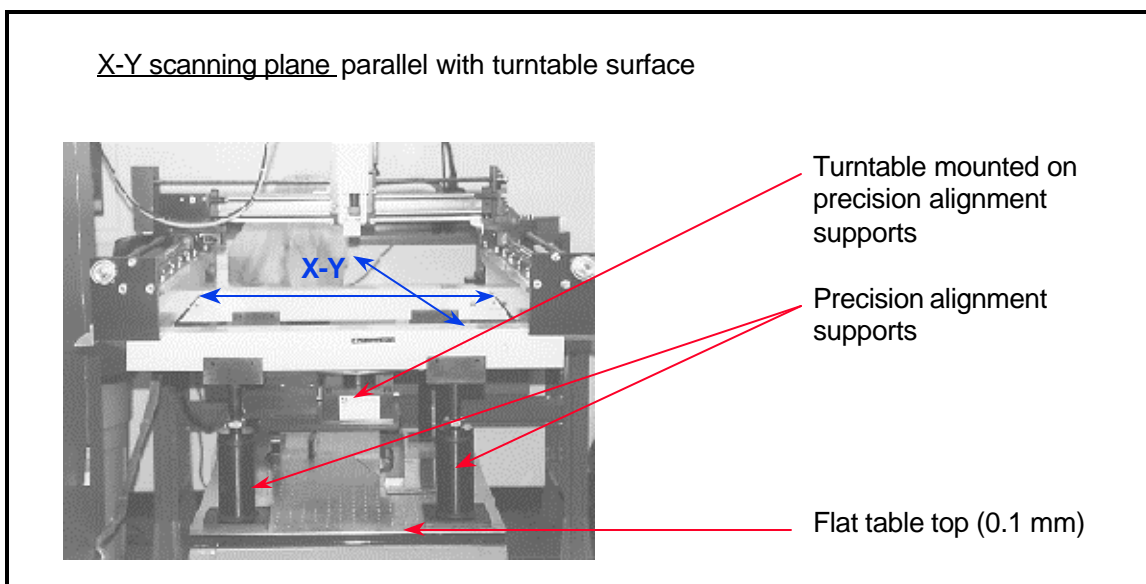
Figure 1 - Mechanical frame, motorized axes, and alignment fixtures of the eddy current data acquisition system used to develop the new calibration blocks.

The eddy current system procured from Structural Diagnostics Incorporated had motorized X,Y, and Z axes and a motorized turntable (see Figure 1). It also integrated a Robin bolt hole scanner that was modified to accept RFC style probes, including both surface and RECHII probes. The frame containing the motorized axes was modified so that it could be "leveled" to make the X-Y plane parallel to the base plane supporting the frame and turntable. The base plane was created from a 900 x 600 mm (~ 36 x 24 inches) optics table that was flat to within 0.100 mm (0.004 inches) over its entire area. The alignment of the two planes help reduce probe lift-off when acquiring data.

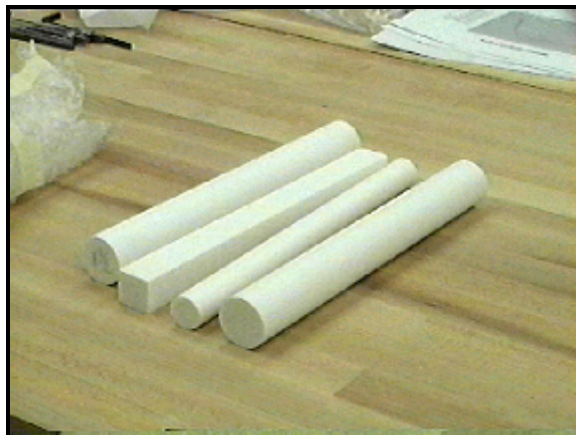
Figure 3 - MACOR[®] stock used for substrate material for surface calibration blocks and RECHII inserts.

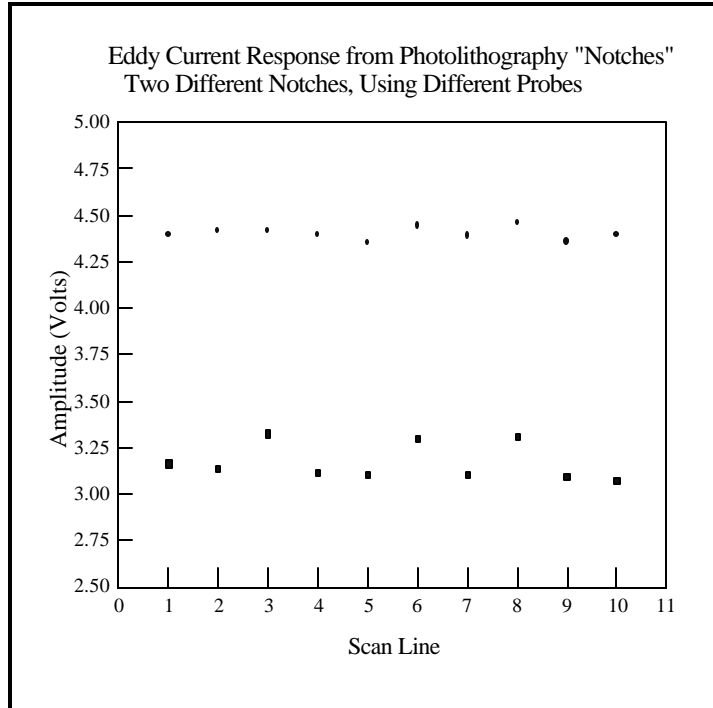
Figure 6 - The eddy current response along a photolithographic “notch” was very uniform.

Continued evaluation of the eddy current response from the photolithography notches in gold showed that the responses taken along a given notch were very uniform. Figure 6 shows typical eddy current responses at different positions along two different notches. In this figure it should be noted that a different eddy current probe was used for each notch. The variation seen from location to location along a given notch is very small, less than 5% scatter from an average value. However, comparison of signals from different notches produced much greater variations, as can be seen in Figure 6.

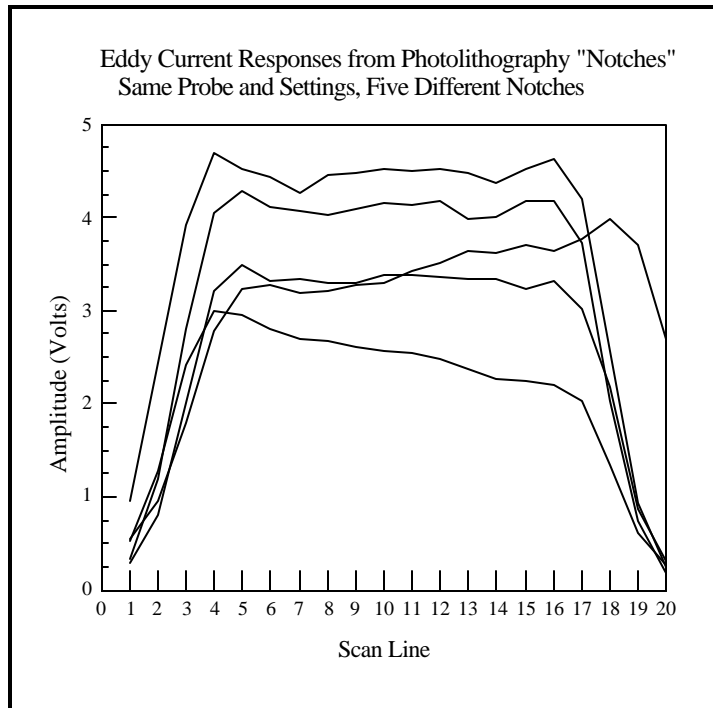
Figure 7 - Eddy current responses from five different photolithography notches on a MACOR® substrate.

Figure 7 contains results from scanning an eddy current probe across multiple locations on five photolithography notches on one MACOR® block. One notch from each face of the five-sided MACOR® block was scanned. The sharp rise and fall of the eddy current response at each side of the graph shows where the probe was just starting or ending being over the notches. The variation between responses is primarily due to differences in the thickness of the films on each face. This block was coated with Nichrome/gold films with the goal of producing a uniformly thick coating. However, very slight differences in the film thickness produced much different eddy current responses. Also, on at least

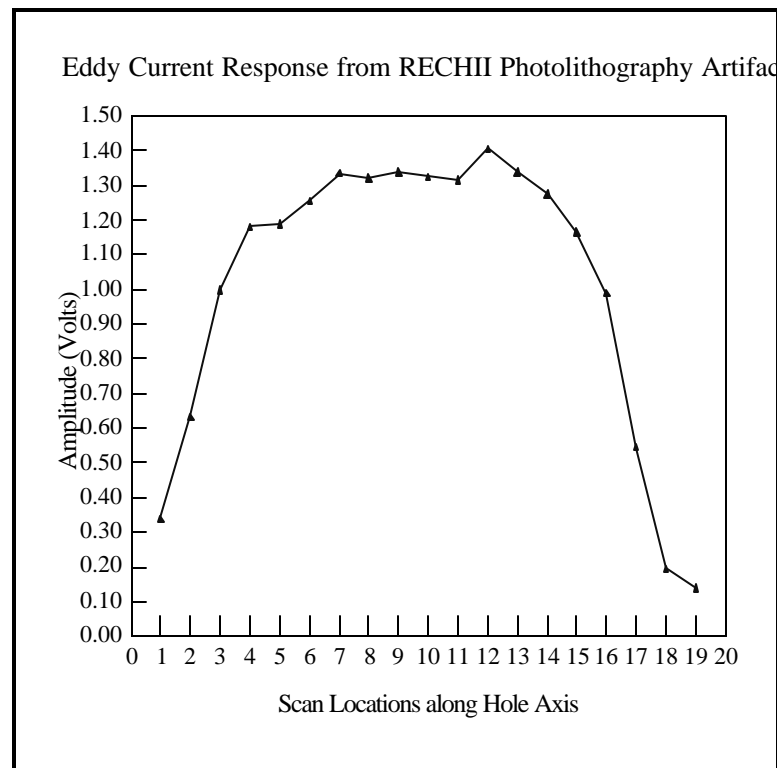
Figure 9 - The eddy current response along the axis of a photolithography artifact, RECHII calibration insert.

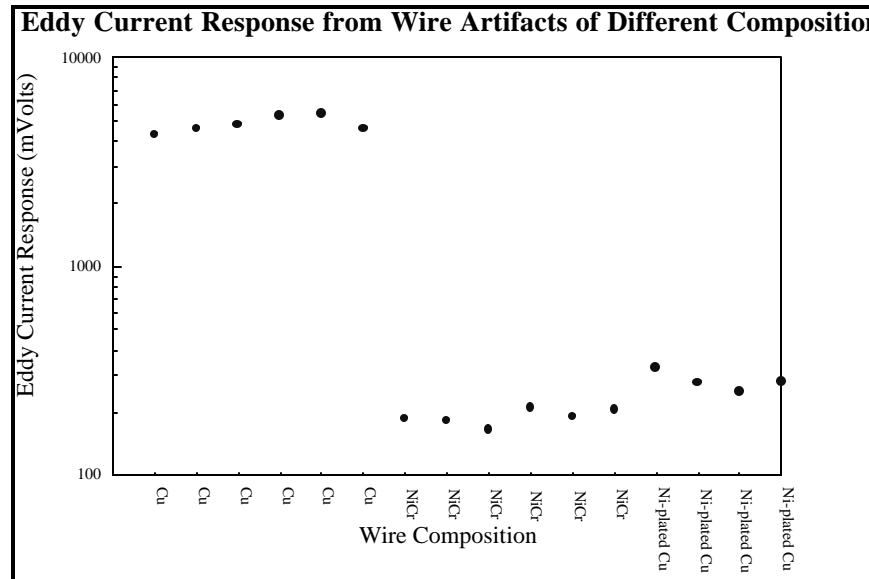
Figure 11 - Different compositions of wire greatly affect the eddy current response.

Figure 11 shows the eddy current responses from several wires of the same diameter but different compositions. The figure clearly shows that the copper wires produced much stronger signals than either

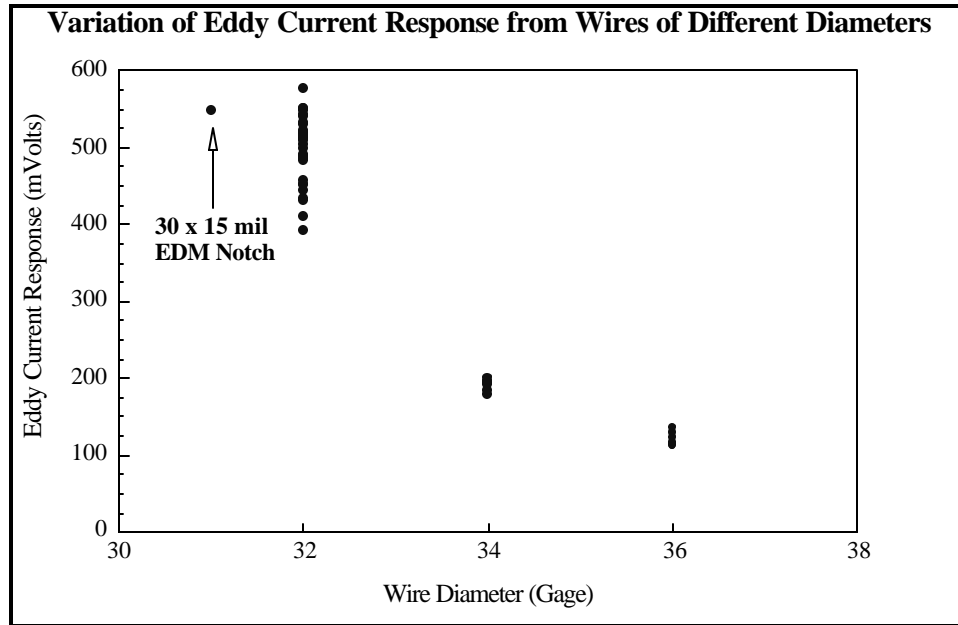
Figure 12 - The difference in gage of the wires clearly affects the eddy current response.

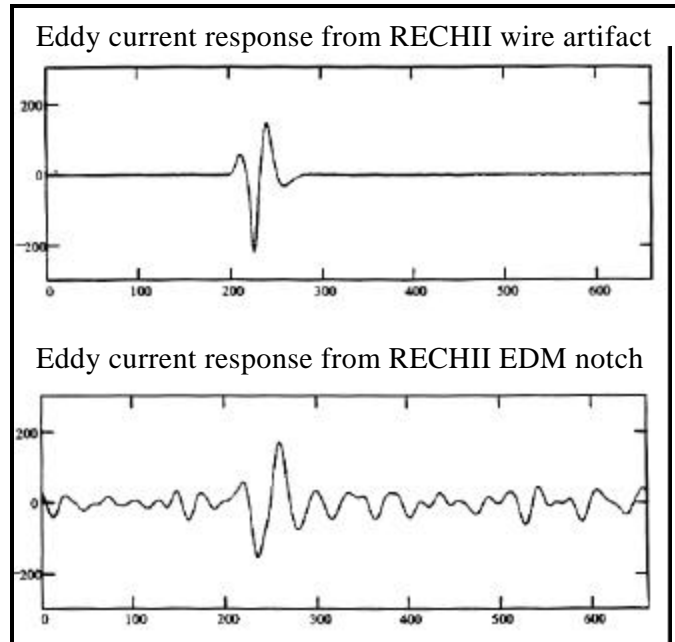
Figure 20 - The greatly superior signal-to-noise ratio of the wire-artifact calibration block compared to an EDM notch in titanium is illustrated.

The absolute amplitude of the eddy current response to the wire artifact was selected to be close to that produced by EDM notches by choosing 32 gage (0.2 mm diameter) Nichrome wire. However, unless the signal-to-noise ratio of the artifact response compared to other noise acquired during calibration process was equal to or less than that of EDM notches, the artifact concept might not produce better overall results. Fortunately, the approach of using an electrical conductor (the wire) bound in a nonconducting medium (binder and substrate) produced very good signal-to-noise ratios. In essence, the epoxy binder and MACOR® substrate produced no eddy current response; this is unlike EDM notch blocks where considerable “material noise” is produced. An excellent example of the superior signal-to-noise ratio of the wire artifacts is shown in Figure 20. Also, in the case of surface calibration blocks, because the surface of the epoxy binder was produced through contact with a granite surface block, almost no probe vibration occurred while the probe was scanned across the block.

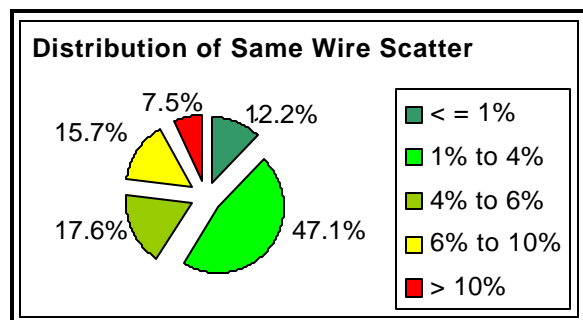
Figure 21 - The uniformity of eddy current response along any given wire is shown by a pie chart of the variations from an average response.

The first goal in producing the artifacts was to have uniform eddy current response along the artifact itself. This was required to eliminate the searching for a maximum response necessary with EDM notches. Uniformity along an artifact was the primary “quality” factor used to judge artifacts in Phases I and II of the project. Early on in the project, success was established in obtaining eddy current response uniformity along a given artifact. The pie chart shown in Figure 21 breaks down the percent variation in the eddy current signal obtained from different locations across a given wire. More than 90 different wire artifacts were included in this summary. The percentage variation was defined as the difference between the largest and smallest signal obtained from a wire divided by the smallest signal. For example the scans across a given wire produced signals with the largest amplitude being 550 mV and the smallest

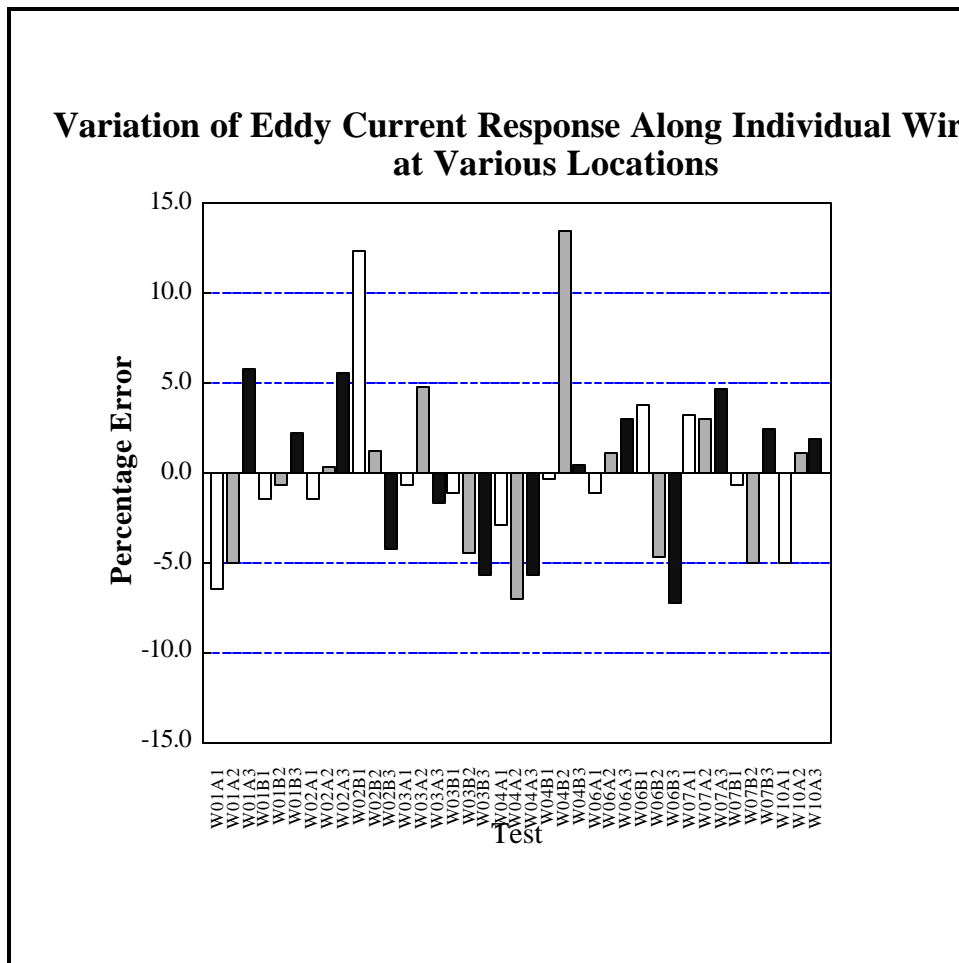
Figure 22 - The variation in eddy current response from wire-to-wire is shown for 33 different NiCr wires on acrylic substrates.

The next objective was to compare the eddy current response from different wire artifacts. Thirty-nine NiCr wire artifacts on acrylic substrates were scanned with a 2 MHz RFC differential eddy current probe. The peak-to-peak amplitude of the eddy current response from the wire was recorded as the probe was scanned over the same location three times. The three peak-to-peak responses were averaged to produce an average response for that location. Then the probe was moved 5 mm to a different location on the wire and three more peak-to-peak responses were averaged. The probe was again moved 5 mm to a third location and the averaged response obtained. A “population” average was obtained by averaging all of the location averages (1.695 Volts with a standard deviation of 0.098 volts). The percentage difference of the location average, compared with the population average, is shown in Figure 22 for each location. So, the Percentage Error of -6% for “W01A1” means that the average of the three peak-to-peak

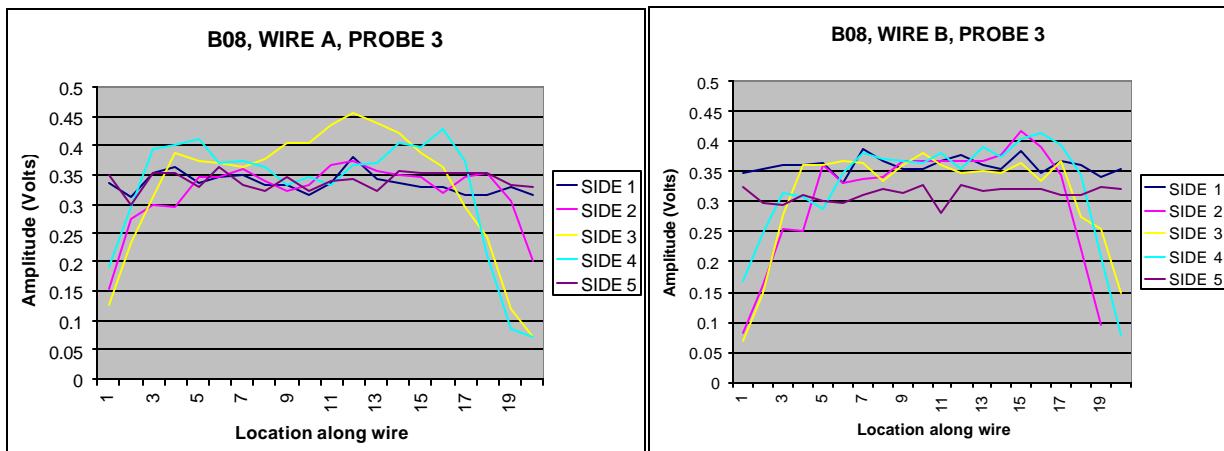
Figure 23 - The uniformity of the eddy current response along any given wire and from wire-to-wire is shown for a five-sided, MACOR® substrate, RFC-style calibration block.

After establishing the uniformity of eddy current response along a given wire and from wire-to-wire on acrylic substrates, similar tests were conducted on five sided, MACOR® substrate blocks. The MACOR® substrate blocks contained two wires on each of the sides. Tests measuring the variation in the eddy current response from wire-to-wire were conducted using the UDRI eddy current system. Figure 23 shows the variation in eddy current response along each of the ten wires in Block 08, a MACOR® substrate, five-sided, RFC-style block. If an “average response” of 0.35 volts is assumed, a 1 dB variation results in bounds of 0.31 to 0.39 volts. Figure 23 shows that Block 08 was very close to being useful as

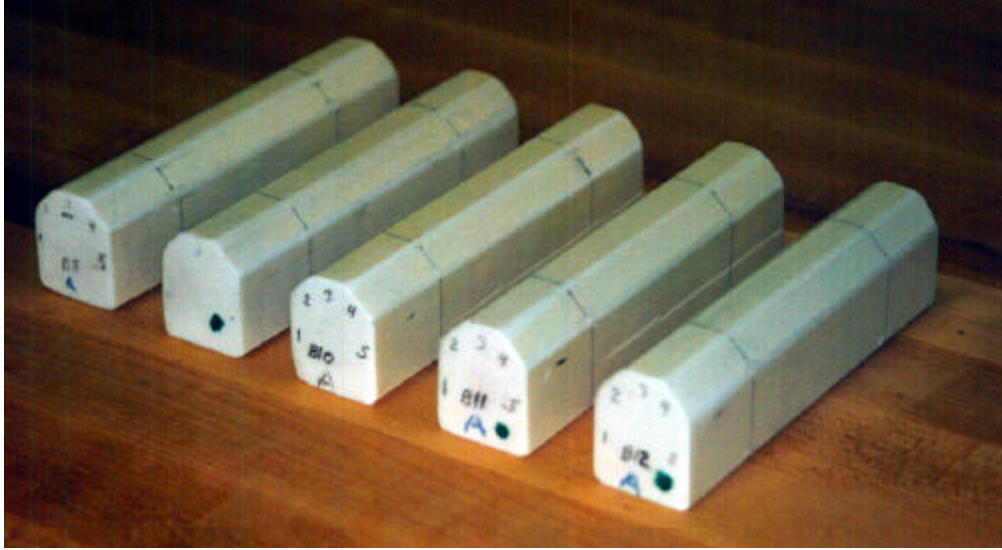
Figure 24 - Five wire-artifact, five-sided, RFC-style, MACOR® substrate calibrations blocks are shown.

In March 1998 UDRI began evaluation of wire artifacts on five-sided, MACOR® substrates at Systems Research Laboratories using RFC inspection systems. UDRI had produced five MACOR® blocks by this time and selected three blocks that appeared to produce the most uniform eddy current responses across all wires. Figure 24 shows a photograph of the five blocks. Blocks 09, 11, and 12 were chosen for testing on the RFC system. Data were gathered using a 2 MHz surface probe and the standard RFC gain calibration algorithm. The standard gain calibration algorithm raster scans the probe along the calibration block indexing typically 0.1 - 0.2 mm (0.004 - 0.008 inches) between scans. The algorithm retains the maximum eddy current response acquired during the raster scanning process. Approximately

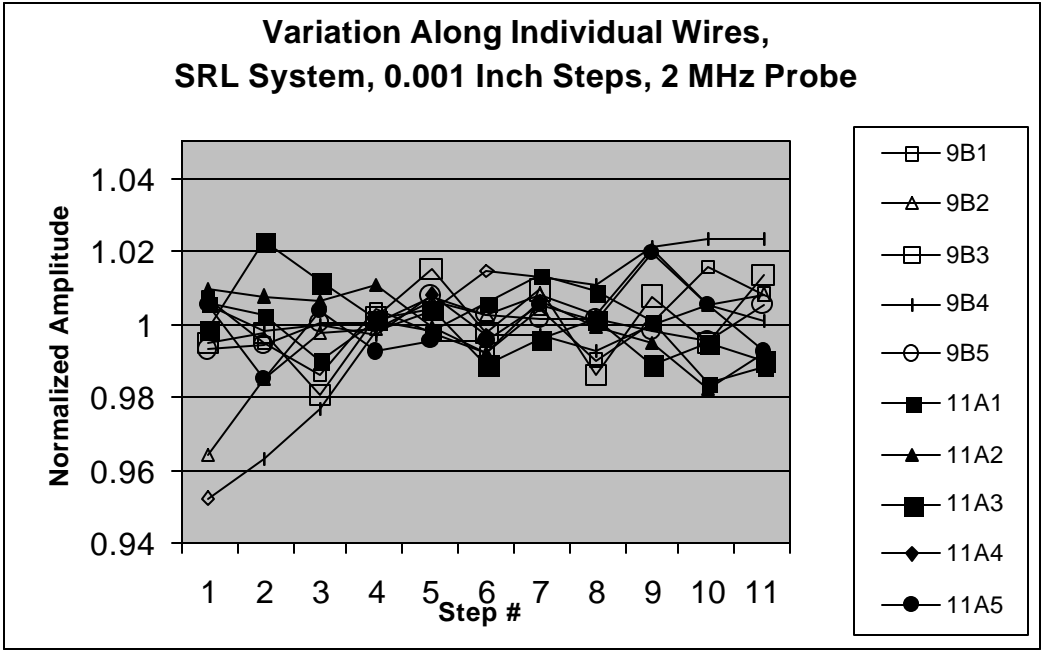
Figure 25 - The uniformity of eddy current response along any given wire on the five-sided, RFC-style, MACOR® substrate blocks is clearly validated.

20 indexes are performed resulting in the probe gathering eddy current responses across 2 - 4 mm (0.08 - 0.16 inches) of the block. When this algorithm was used with the wire-artifact MACOR® blocks, it sometimes resulted in the maximum eddy current response occurring away from the middle of the wire, towards the corner of the side of the block. This happened because on some of the sides the wires protruded from the epoxy binder near the corner. (Note: This problem was resolved on later blocks by slicing a channel through corners of the blocks so that the wires could conform more closely to the surface of the blocks - see Appendix E).

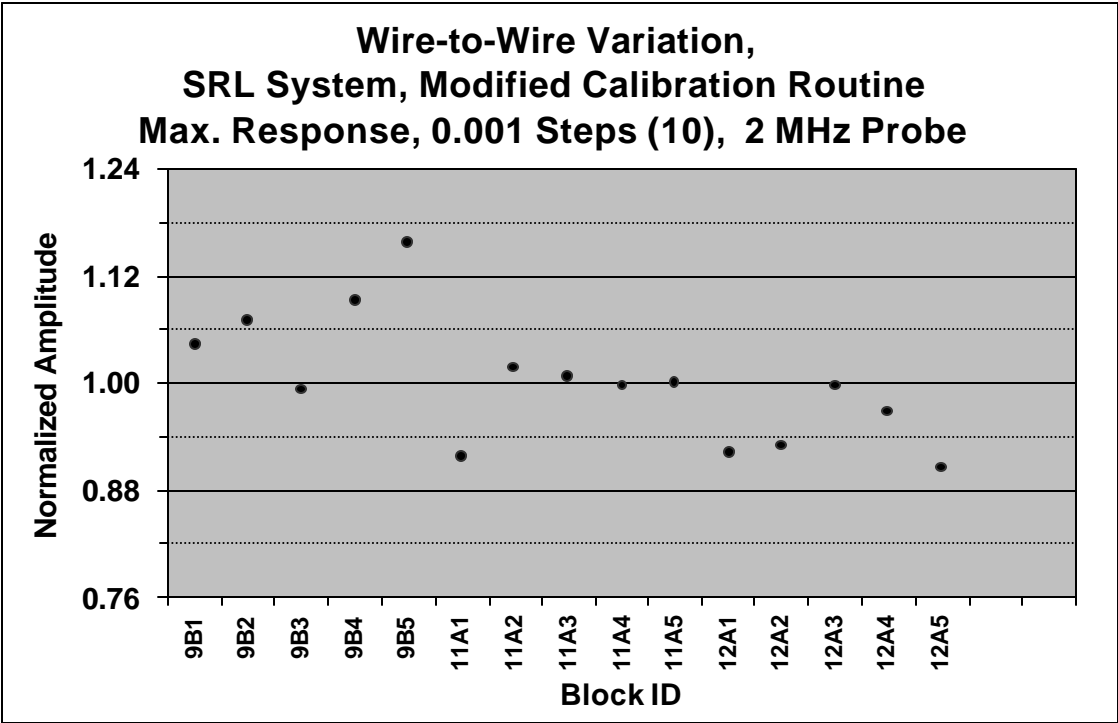
Figure 26 - The wire-to-wire variability for three RFC-style calibration blocks (15 wires) is shown to be less than 1 dB for all but one of the wires (2 MHz probe).

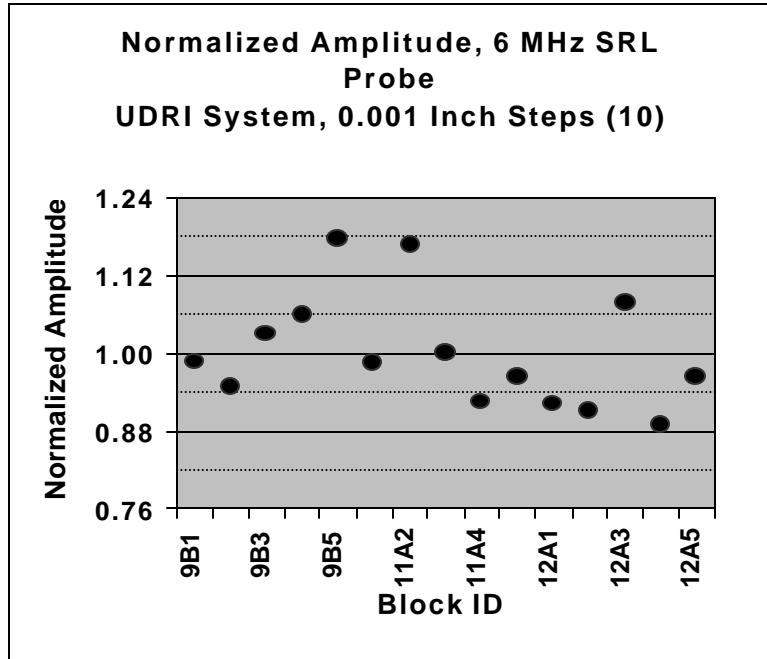
Figure 27 - The wire-to-wire variability for three RFC-style calibration blocks (15 wires) is shown to be less than 1 dB for all but two of the wires (6 MHz probe).

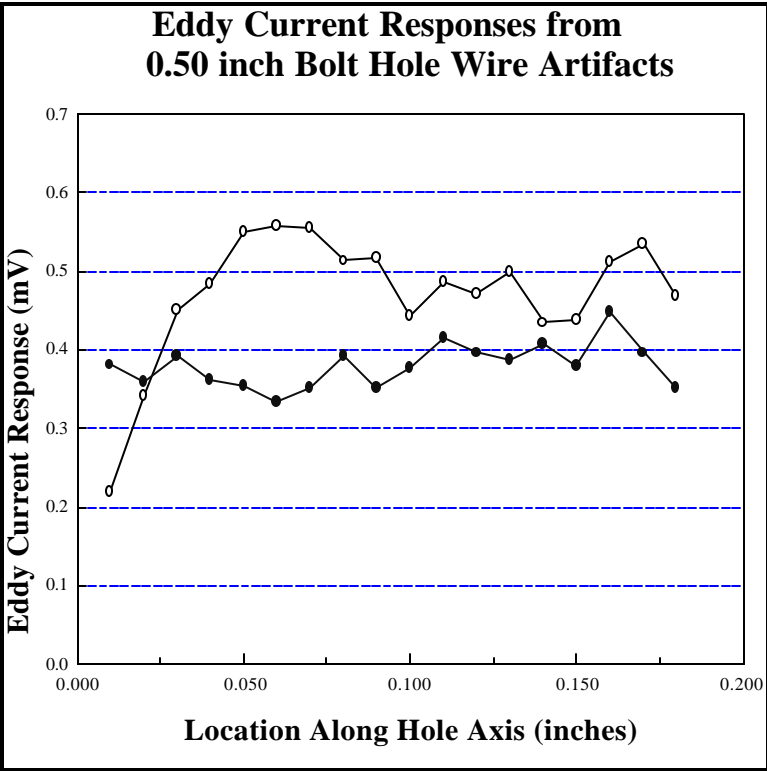
Figure 28 - The variation in the eddy current response along the wire artifact in two RECHII inserts is shown.

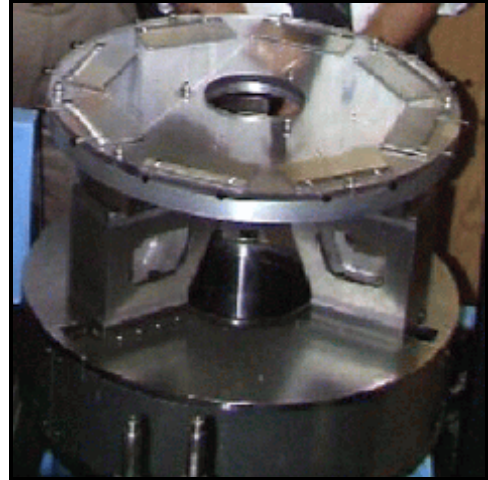
Figure 29 - Flat plate Waspaloy reliability specimens were used to compare inspections using the new calibration blocks with Waspaloy master EDM calibration blocks.

The uniformity and repeatability of eddy current responses from the calibration blocks on both UDRI and Veridian inspection systems cleared the way for the final testing phase of the program. Tests using flat plate reliability specimens (see Figure 29) containing fatigue cracks, were designed to detect differences in the detection results when using the new calibration blocks versus a master EDM notch block. The tests were conducted at Systems Research Laboratories using an RFC eddy current inspection system and RFC probes. Four D20 differential eddy current probes were used, two operating at 2 MHz (Probe 872, S/N 15077 and 15078) and two at 6 MHz (Probe 4005, S/N 13653 and 13652). Sixteen Waspaloy flat plate specimens (PWA-1016) were selected for testing. Veridian's flat plate reliability test scan plan "IN100-FP-20T" was used to acquire data. UDRI selected for testing four of the five-sided, MACOR® substrate, RFC-style, wire artifact calibration blocks. The block and wire identification numbers were B09, B11, B12, and B16. Block B16 was made using a pneumatic mold that is described in a later section in this report. A Waspaloy calibration block containing an EDM notch was used for comparison purposes. Veridian chose the master Waspaloy surface block, S/N QMM022 for these tests.

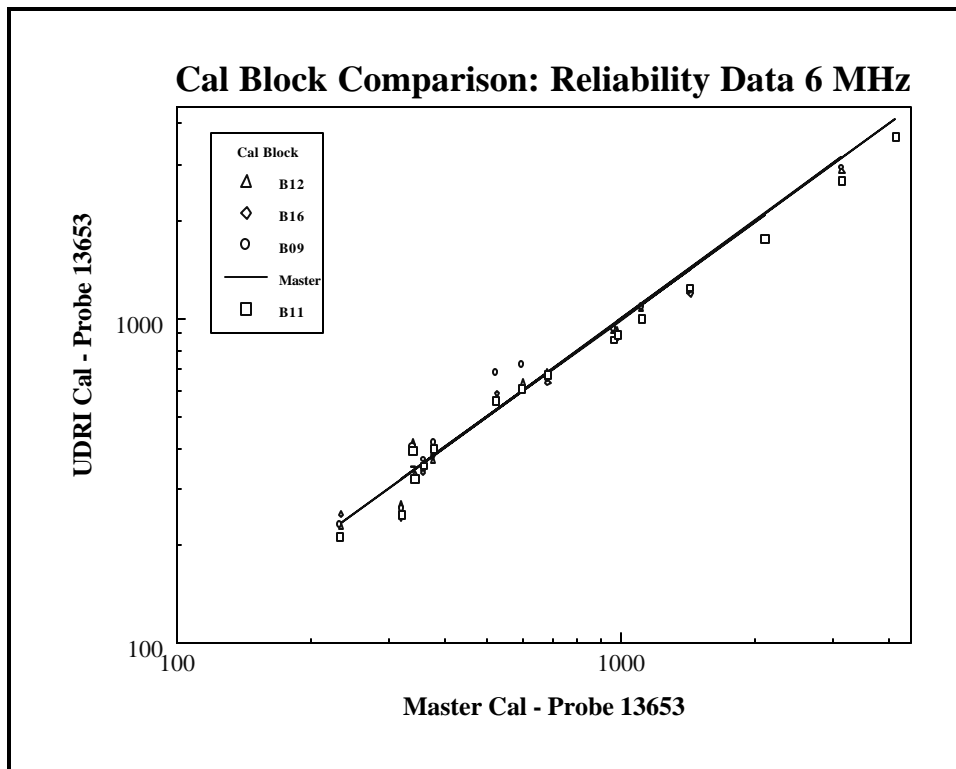
Figure 32 - Comparison of 6 MHz reliability results using probe 13653.

A summary of the eddy current responses from the Waspaloy flat plate specimens is shown in Table II. The amplitude of the response from each crack for each inspection is contained in Appendix F. Figures 31 - 36 graphically compare the eddy current signal amplitudes from the cracks for inspections calibrated with the UDRI calibration blocks and those calibrated using the master Waspaloy EDM notch. It is easily seen in the figures that there are no statistically significant differences between using the new UDRI calibration blocks and the master Waspaloy EDM calibration block to calibrate the reliability inspections. In fact, Figures 35 and 36 show the variation that can occur when two probes (of the same frequency) are calibrated using just the master Waspaloy calibration block. The only differences between the two inspections that produced the data shown in each figure was the switching from one probe to the other. No changes were made to the scan plan and the calibration and inspection algorithms were allowed to proceed without interruption.

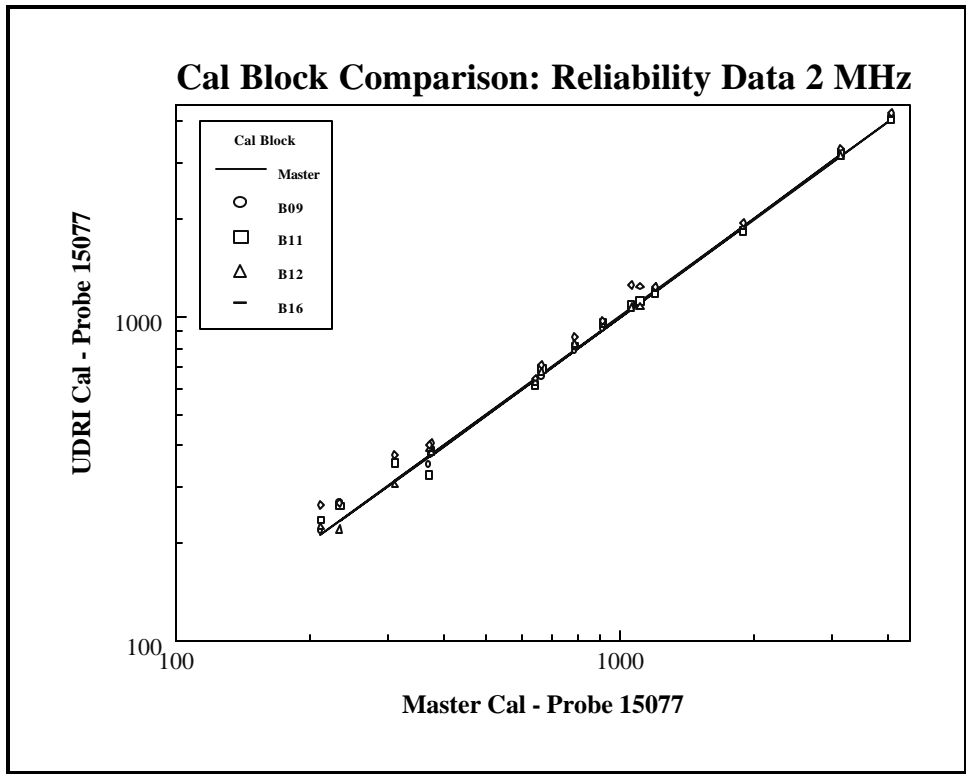
Figure 33 - Comparison of 2 MHz reliability results using probe 15077.

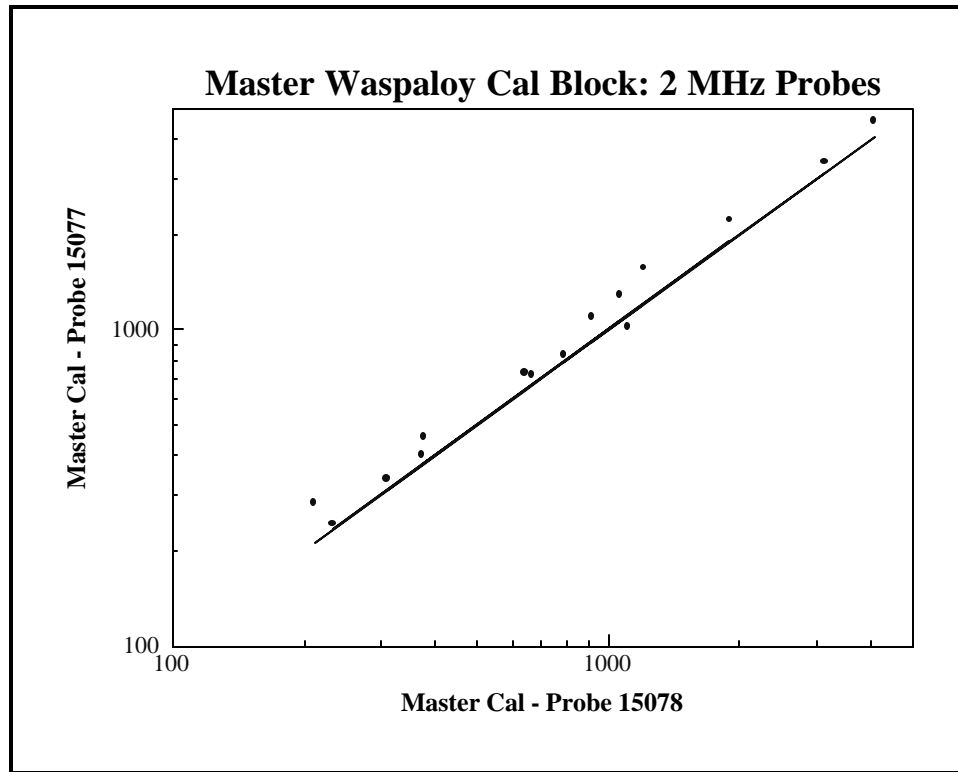
Figure 35 - Comparison of 2 MHz reliability results: probe-to-probe variation.

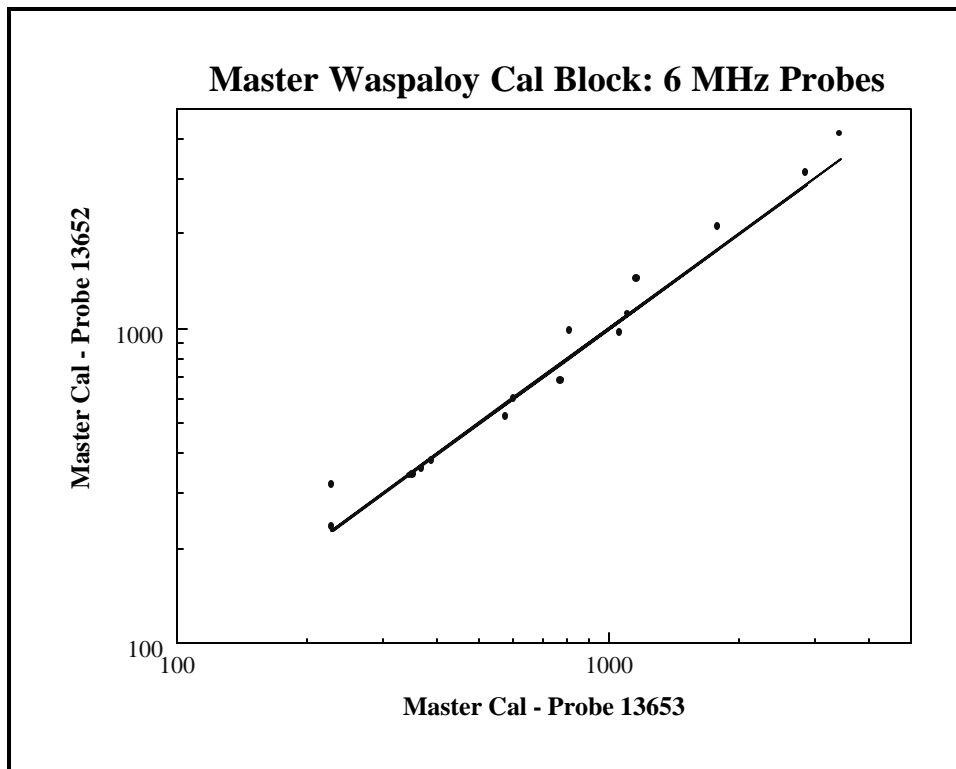
Figure 36 - Comparison of 6 MHz reliability results: probe-to-probe variation.

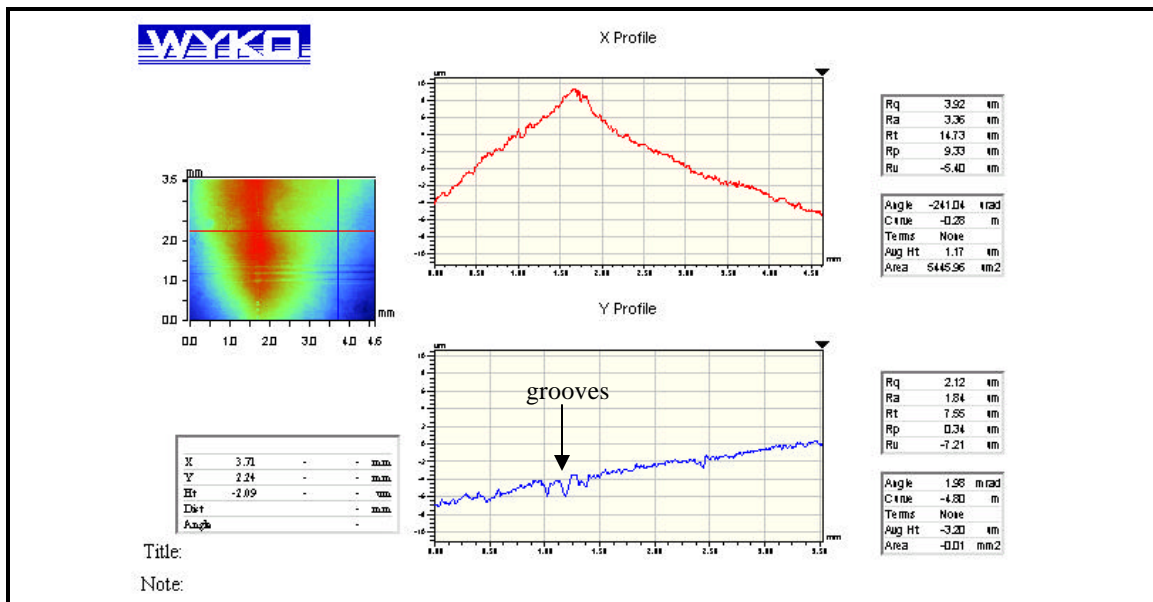
Notes: The red profile was taken along the long axis of the block. The peak represents the wire artifact protruding approximately 0.014 mm (~ 0.0005 inches) above the surface of the block. The blue profile was taken perpendicular to the probe shoe scanning path. Three grooves are evident. The two deepest grooves are approximately 0.002 mm (~ 0.00008 inches) deep.
