# An Archaeological Curation-Needs Assessment for the U.S. Navy, Engineering Field Activity, Chesapeake Division

**Technical Report No. 19**

**Mandatory Center of Expertise for the  
Curation and Management of Archaeological Collections**

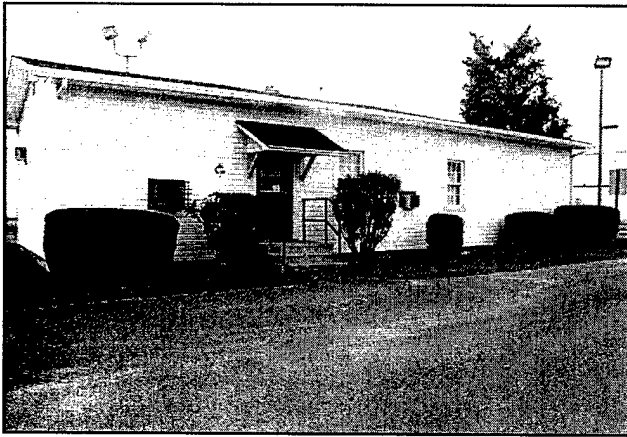
Building 337 is a steel-frame structure with a concrete foundation. Exterior walls are concrete

**Figure 1. Exterior view of NSWC Dahlgren curation facility.**

block, and the original roof is shingled. No cracks in the foundation or leaks in the roof have been noticed by staff members; however, the roof has been repaired in the past. Interior walls are made of plasterboard, and the ceiling is suspended acoustical tile. The floor is concrete with carpeting, and windows in the repository have blinds and aluminum window frames. According to staff, none of these windows have shown any evidence of water leakage.

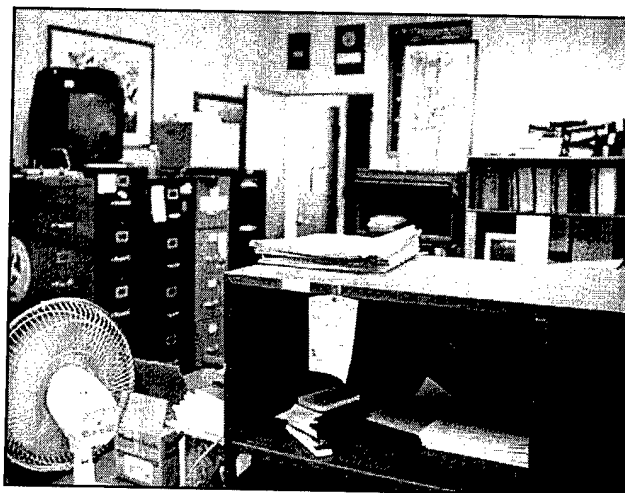
Figure 2. Interior view of NSWC Indian Head documentation collections area.

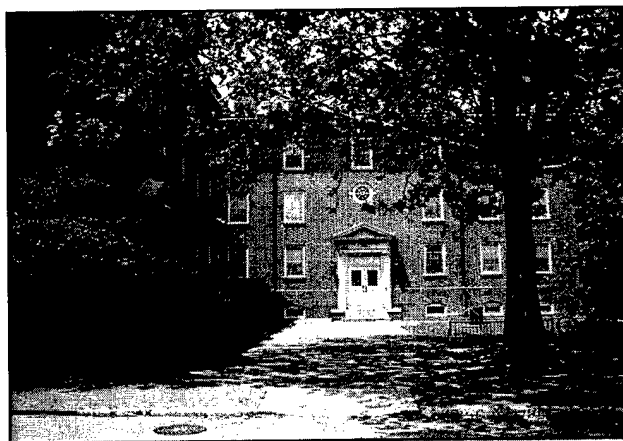
Figure 3. Exterior view of the William and Mary curation facility.

This repository was constructed in the late 1930s as a dormitory with the three floors above grade still being used for this purpose. The building has a concrete foundation (covered with tile in the storage areas), concrete block walls below grade, and concrete block walls with a brick facade above grade. The roof consists of slate tiles and is original to the building. Interior walls in the basement are also concrete block, and the ceiling is of poured concrete. Plumbing and electrical systems have been previously updated, and the heating system has been renovated within the last year. Overhead pipes are in close proximity to fluorescent lights in all rooms, but there have never been any problems with leaking.

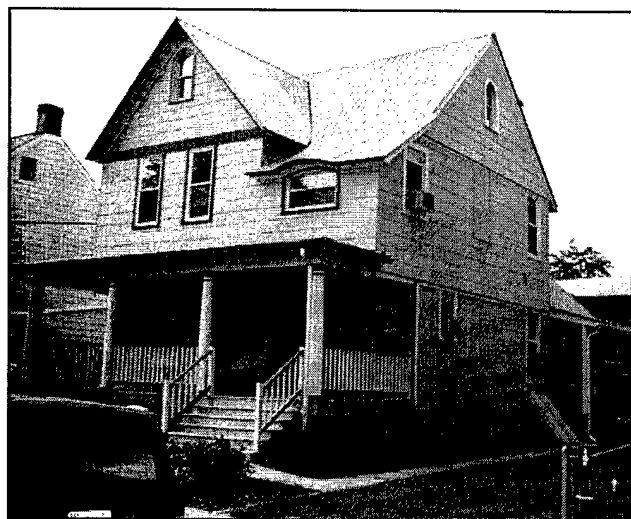
Originally built in 1920 as a residence, the house was renovated about five years ago. The newest portion, an addition to the rear of the house, was

**Figure 4. Exterior view of the Goodwin and Associates Frederick, Maryland, office.**

completed at about the same time as the renovation. The foundation of the facility is composed of concrete block, and the roof is tin. Exterior walls for the older portion are asbestos shingle and corrugated metal for the newer addition. The roof of the older portion of the house has been replaced in the past 10 years, whereas the roof of the newer addition was replaced in 1993. Both the foundation and the roof appear to be structurally sound and free of cracks and leaks.

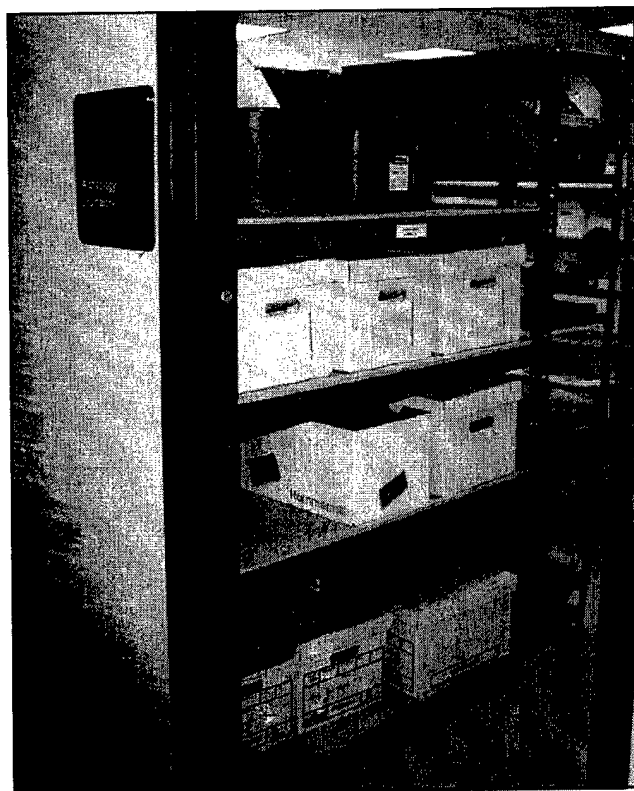
Figure 6. Shelving units in Greenhorne and O'Mara collections area.

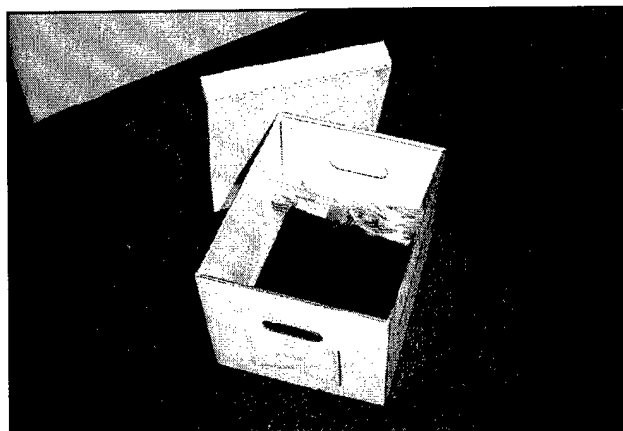
The primary container consists of one acid-free cardboard box with a telescoping lid. The exterior tag is an acidic yellow paper sheet inserted in a plastic zip-lock bag and attached to the cardboard box (Figure 7). The paper tag is labeled with the facility name.

Figure 7. Primary container for artifacts and records.

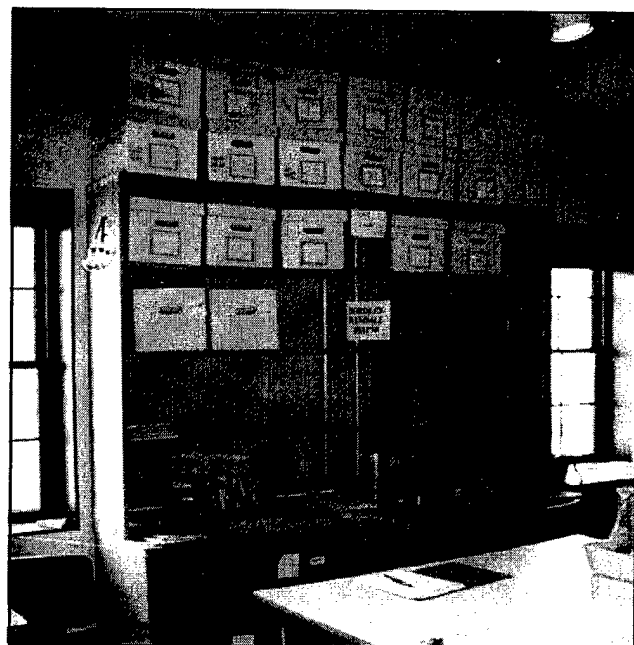
Artifact primary containers are stored on plywood shelves measuring 1.3 x 8 x 7.4 feet (l x w x h). Boxes are stacked two high on the top shelf (Figure 9).

Figure 9. Storage units at the Historic Annapolis Foundation.

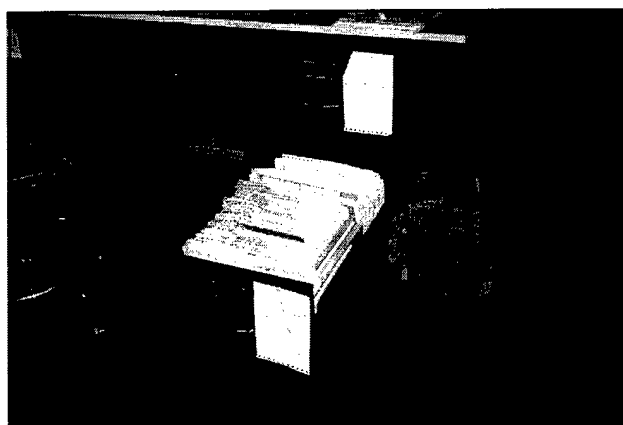
Approximately 0.9 linear feet of paper records associated with archaeological work conducted on the U.S. Naval Academy are stored in the office, which is set off from the collections storage area (Figure 10). Records are stored in a standard two-drawer, legal-sized file cabinet. The file cabinet is labeled with site number and contents written directly in marker on a paper tag taped to the cabinet drawer. Secondary containers for the records consist of manila folders; some records are stored loose. Manila folders are not labeled. Organization is by project and by provenience within project. Paper records consist of field notes, excavation records, and analysis records.

**Figure 10.** Extent of documentation from U.S. Naval Academy projects.

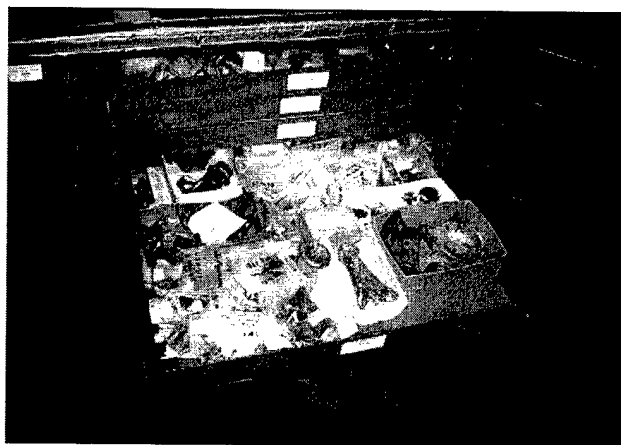
Archaeological type collections are stored in a standard size, locking enameled metal lane case (Figure 13) that measures 3.5 x 3 x 3.5 feet (l x w x h). Each lane case contains a typed acidic paper label in a metal tag holder that includes project name, site number, and accession number information.

**Figure 13.** Metal lane case holding archaeological type collections.

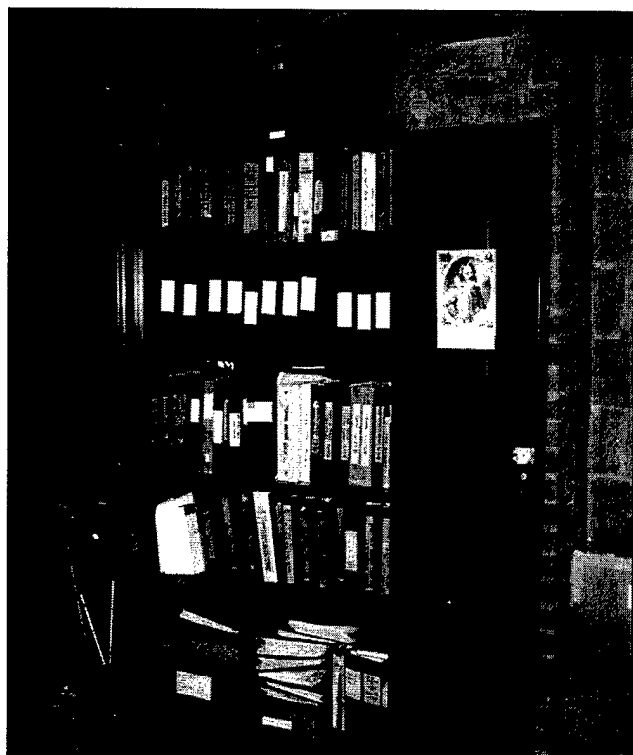
Paper records are stored in 2.5-inch plastic three-ring binders on unsealed wooden shelving units measuring 6 x 2.5 x 1 feet (l x w x d) and in an

enclosed enameled metal cabinet (Figure 14) measuring 6.5 x 3 x 1.4 feet (l x w x d).

**Figure 14. Storage unit for records.**

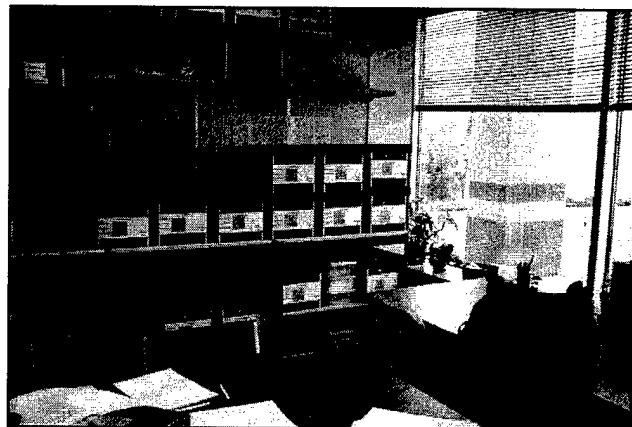
Artifact collections are stored on multiple sets of adjoining, nonmovable metal frames fitted with fiberboard shelves (Figure 15). Units measure 1.5 x 3 x 3 feet (l x w x h). The U.S. Naval Academy collections total 29.6 ft<sup>3</sup> (Table 12).

Figure 15. Primary containers for U.S. Naval Academy archaeological materials.

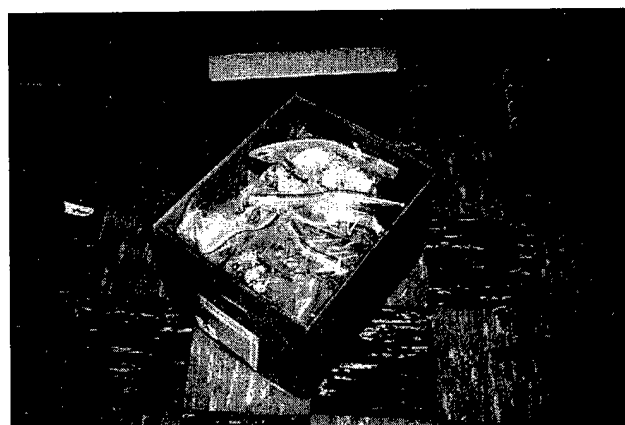
Artifact collections are stored in 46 boxes, encompassing 45.2 ft<sup>3</sup>. There are multiple types of boxes, most (33) of which are acid-free cardboard boxes (measuring 1.3 ft<sup>3</sup> each) with telescoping lids. The remainder of the primary containers are acidic cardboard boxes with telescoping lids (Figure 18), ranging from 0.9 ft<sup>3</sup> to 1.2 ft<sup>3</sup> in volume. Labels for all primary containers consist of a paper label placed

**Figure 18. Primary and secondary containers used to hold artifacts.**

inside an adhesive plastic jacket that is directly attached to the container. The paper label is a computer printout that contains contents, box numbers, and site numbers.

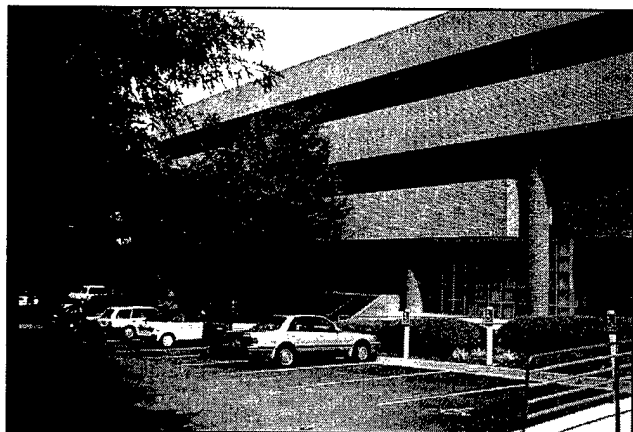
The repository has a concrete foundation, and exterior walls are composed of concrete block and steel framing with a brick exterior. The roof, which

**Figure 19. Exterior view of Parsons Engineering Science.**

is original to the building, is covered with built-up asphalt and has occasionally required repairs. Currently there are no cracks or leaks. There have been no major renovations or upgrades to the building, only minor interior wall remodeling to accommodate changes in office staff. There are multiple exterior windows and doors throughout the building.
