PNE-516  
FINAL REPORT

# PROJECT PRE-SCHOONER II

## POSTSHOT GEOLOGIC AND ENGINEERING PROPERTIES INVESTIGATIONS

ALTON D. FRANDSEN

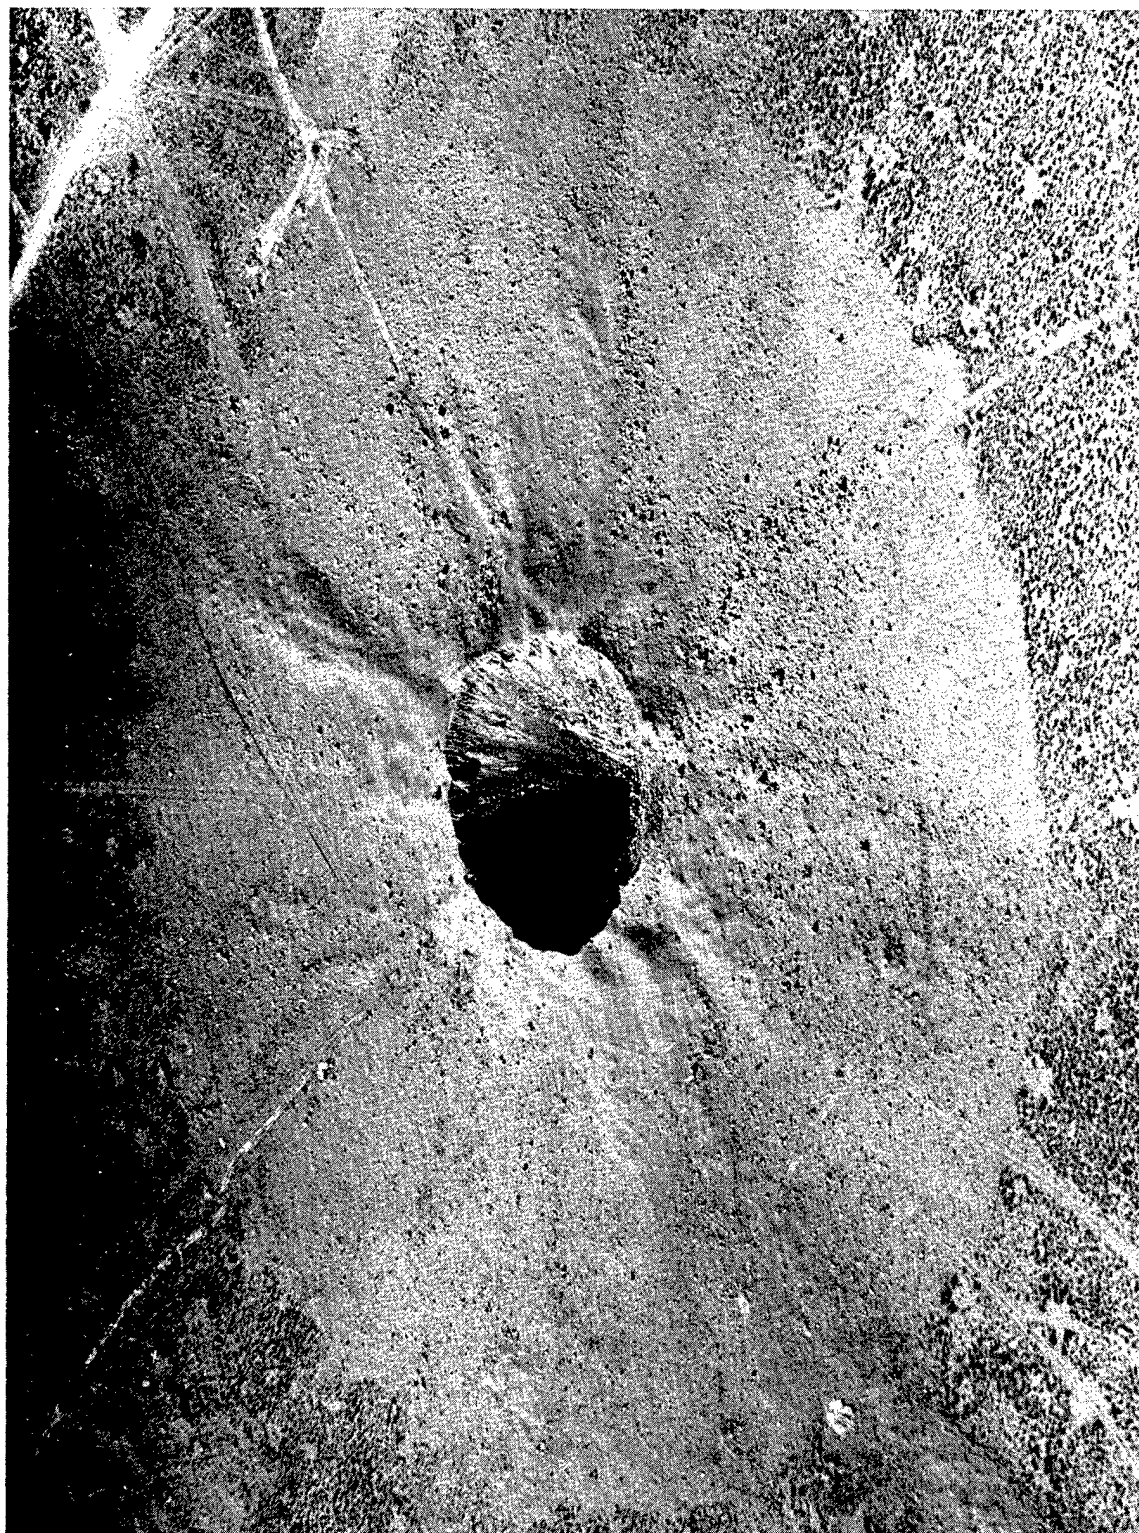
Pre-Schooner II Crater.

The Pre-Schooner II Event was a chemical explosive single-charge cratering experiment in hard, dry rock. The detonation was centered 71 feet below the ground surface and consisted of approximately 85.5 tons of nitromethane. The explosion produced a crater with an apparent radius of 95.2 feet and an apparent crater depth of 60.7 feet.

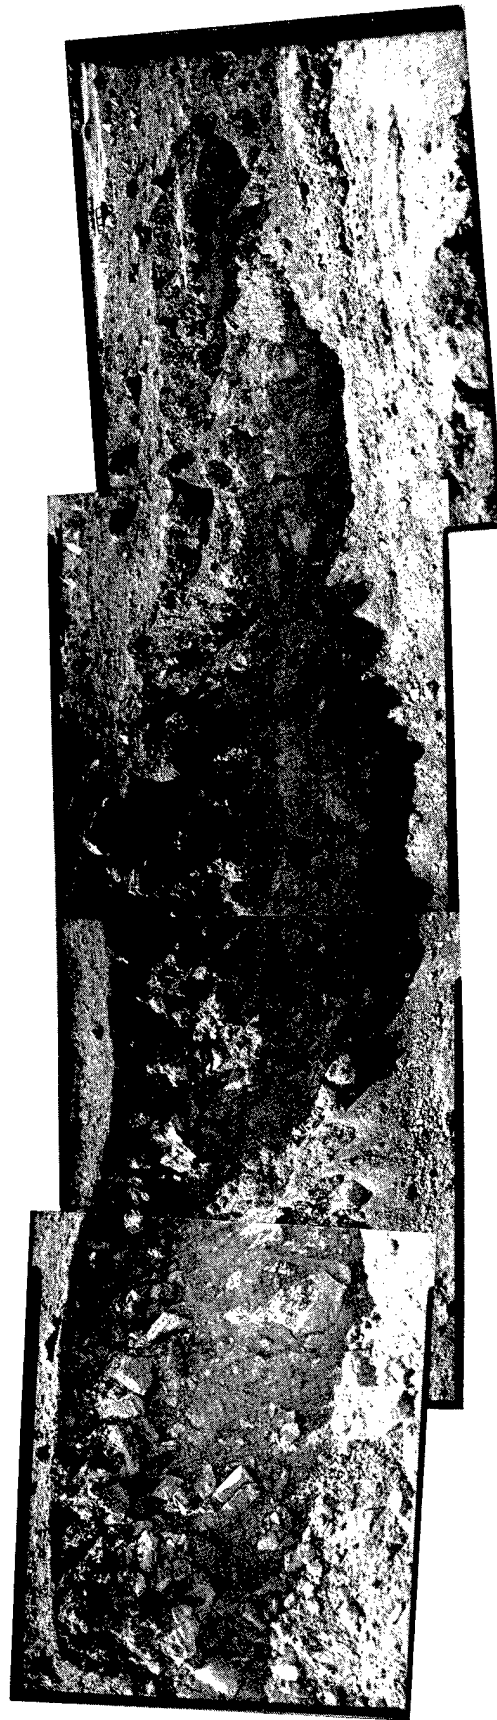
Figure 4.7 Ground profiles from Trench No. 2, west wall.

After the trenches were excavated, one wall of each trench was examined and mapped to delineate the true crater boundary and amount of uplift. The results of this mapping are shown in Figures 4.6 through 4.9 for Trenches No. 1, and No. 3. The true crater radius and amount of uplift are listed in Table 4.4.
