**Evaluation of Korean-Manufactured  
Non-Tactical Vehicle JP-8 Conversion  
Demonstration Conducted by the  
19th Theatre Area Army Command, Korea**

**INTERIM REPORT  
TFLRF No. 352**

**U.S. Army TARDEC Fuels and Lubricants Research Facility (SwRI)**

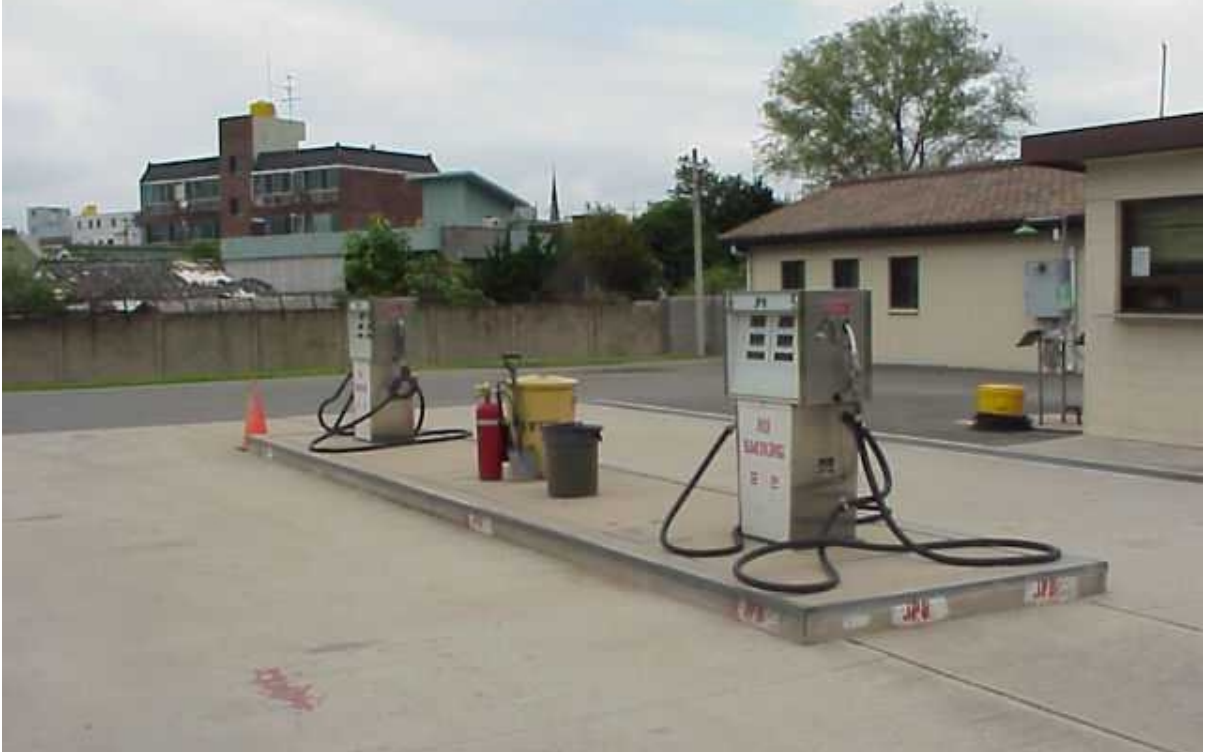
**Figure 9. JP-8 Fueling Facility**

The bulk JP-8 and diesel fuel storage units are located at Camp Walker, a small military post approximately six miles from Camp Henry. The JP-8 is stored in a 20,000-gallon underground tank and is nozzle dispensed as shown in Figure 9. The diesel fuel is stored and dispensed from a 1,200-gallon refueler as shown in Figure 10. All vehicles are fueled at Camp Walker. Nozzle samples were obtained from the JP-8 dispensing pump and the diesel tanker then shipped to TFLRF for analysis.

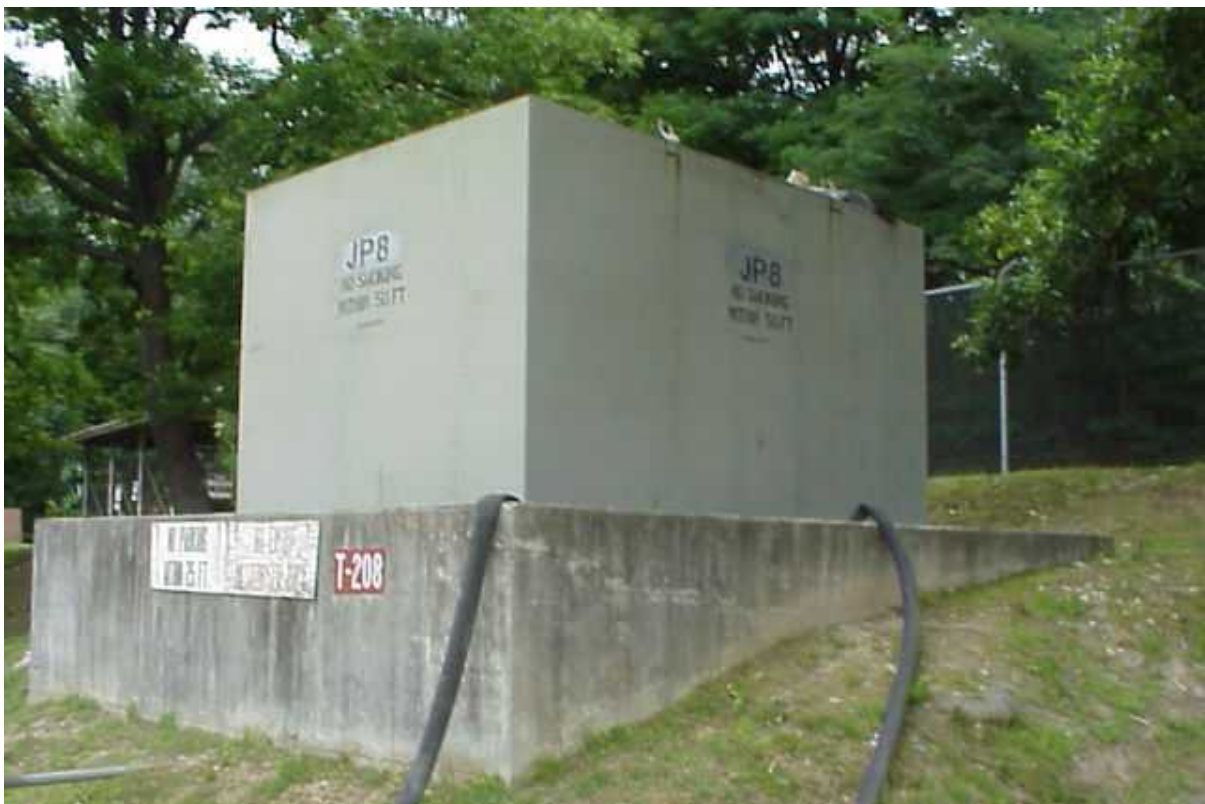
**Figure 25. 10,000-gallon JP-8 Storage Tank**

Samples were obtained from 27 of 50 vehicles, and one-each nozzle from the JP-8 dispensing pump. The fuel samples were shipped via Federal Express from Suwon, Korea on 16 July 1999 to TFLRF for analysis. The bulk JP-8 fuel is stored and dispensed at Camp Long as shown in Figures 25 and 26. The JP-8 is stored in two 10,000-gallon, above-ground tanks, while the diesel fuel is stored in a 20,000-gallon underground tank at Camp Eagle Point, a small military post located approximately 15 miles from Camp Long. The vehicles on the JP-8 fleet test are fueled at Camp Long, and vehicles utilizing diesel fuel are fueled at Camp Eagle Point.

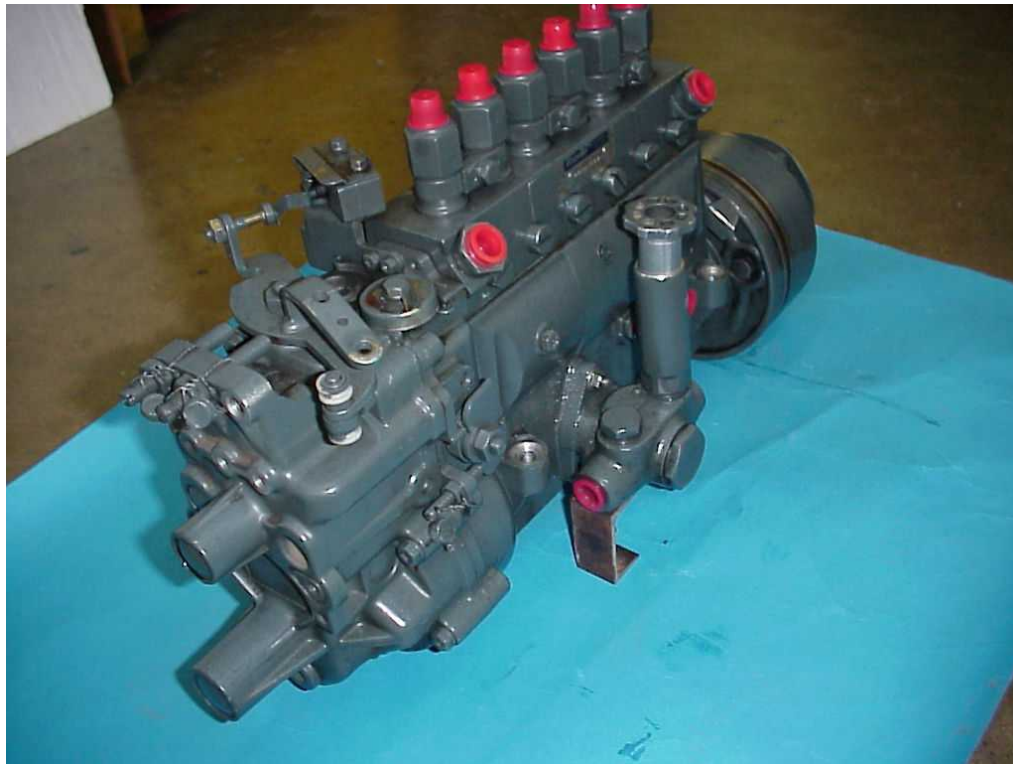
This Doowon 6-cylinder, in-line injection pump was removed from a 1996 Daewoo 45-passenger bus ID No. T-203 exhibiting noticeable power loss. The vehicle had 34,321 kilometers of operation on diesel when converted to JP-8, and it had operated 16,600 kilometers on JP-8 fuel when the pump was removed. The vehicle reportedly was experiencing severe power loss with JP-8. Motor pool maintenance personnel replaced fuel filters and cleaned the fuel lines as remedial actions to alleviate the power loss problem to no avail. When the pump was placed on the calibrating test stand, it would not produce

**Figure 44. Doowon In-Line Fuel Injection Pump**

adequate fuel flow rates. Upon inspection it was found that the primer pump assembly had been cross-threaded into the pump mounting orifice, introducing aluminum shavings into the pump inlet assembly and pump housing. The pump was removed, cleaned, flushed and again placed on the calibrating test stand where it produced proper flow rates at specified rpms. It was concluded that the aluminum shavings were blocking fuel flow orifices in the pump, thereby preventing proper fuel flow. This would account for the severe power loss that the vehicle was exhibiting.

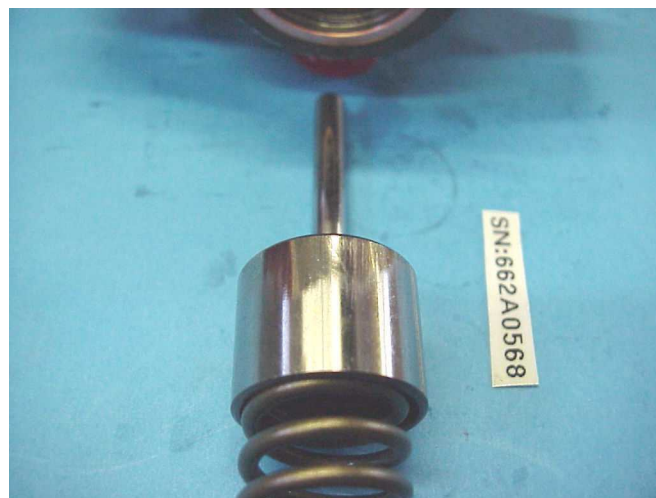
**Figure 49. Piston to Cylinder**
