ERDC TR-01-8

## **Development of a Geomorphology-Based Framework for Cultural Resources Management, Dworshak Reservoir, Idaho**

August 2001

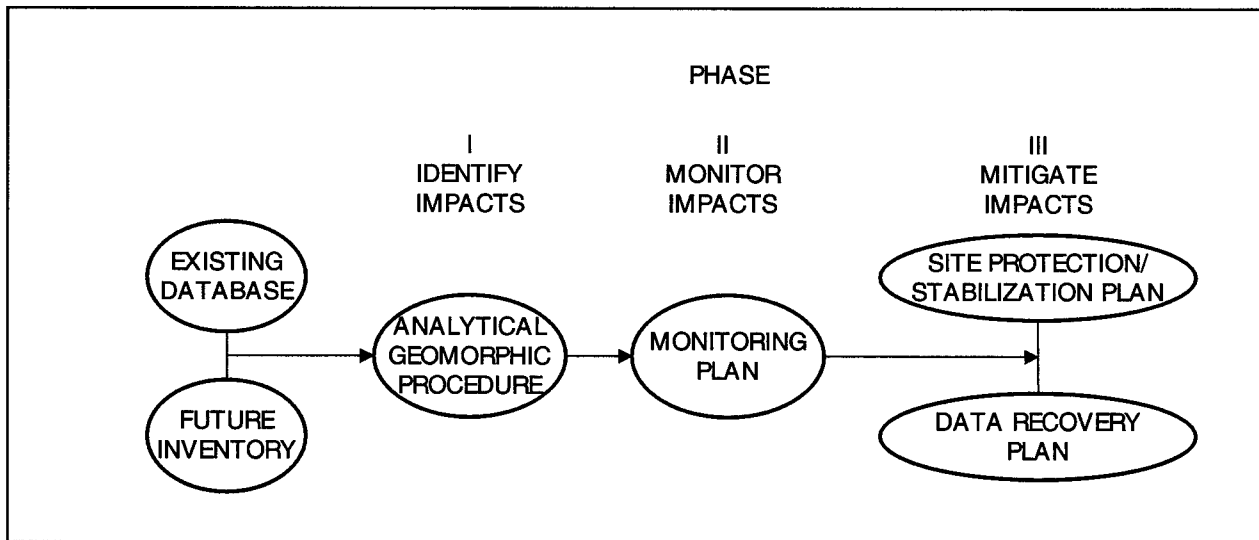
Figure 1. Technical framework of the management process

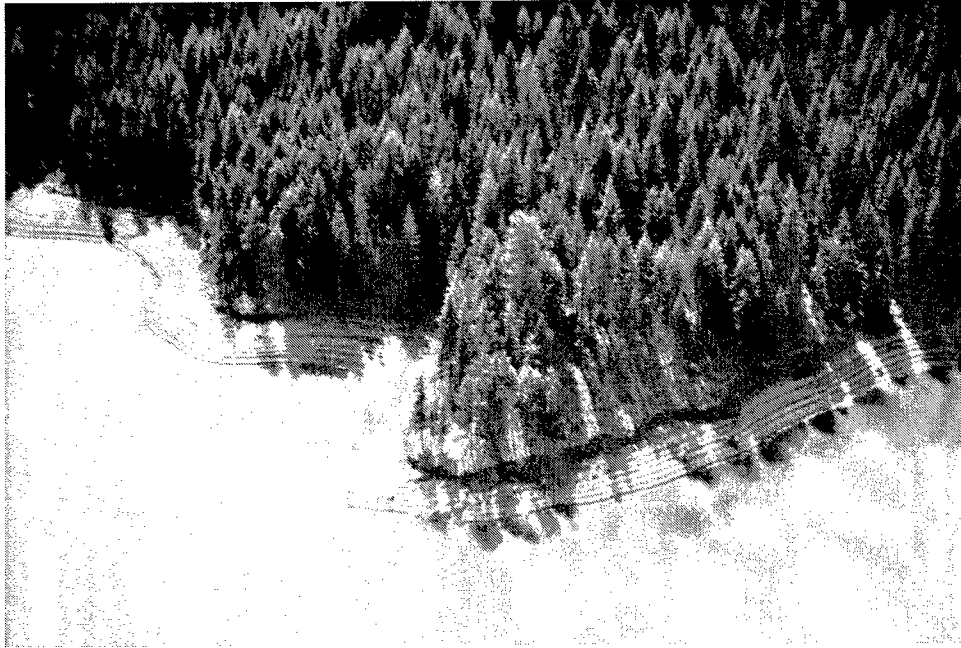
Figure 5. Example of wave impact along the shoreline, Dworshak Reservoir, Idaho

Although numerous factors influence the rate and occurrence of erosion, the primary cause of bank erosion is wave action (modified after Ebert 1989). During this study, wave action was the dominant process not only in occurrence but in extent of destruction as well (Figure 5). Wave action can be generated from wind, tectonism, and pool level fluctuation. Erodibility index of the soil and the slope of the surface also needs to be considered. Erosion exists in both zones of impact although reservoir fluctuations do not directly affect erosional processes or depositional processes of the indirect impact zone. Since most of the indirect impact zone is heavily forested, few geomorphological processes could be identified.

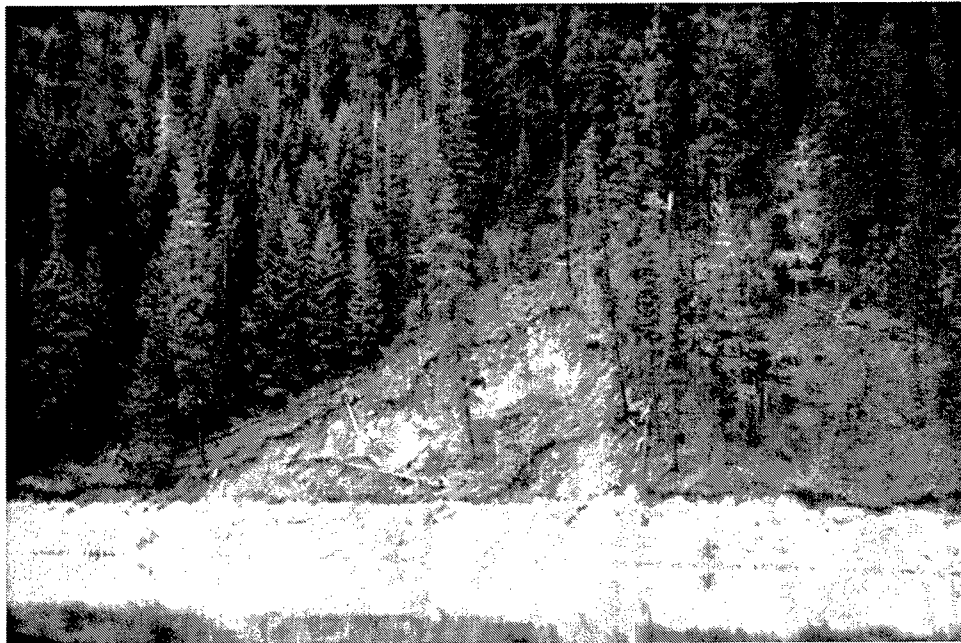
Figure 6. Mass failure in the high impact zone, Dworshak Reservoir, Idaho

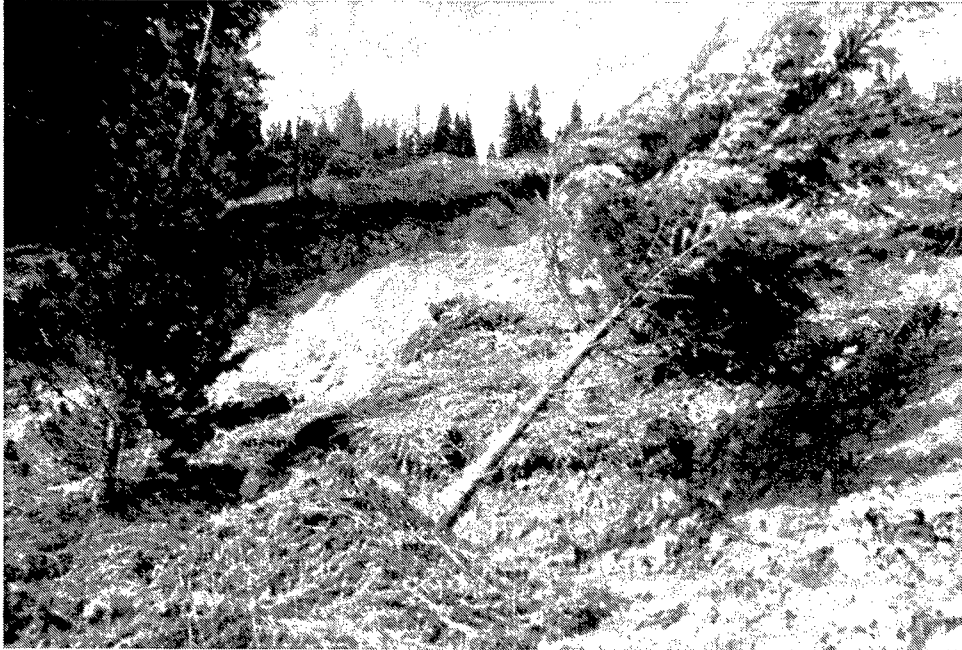
Figure 7. Downward movement of material (soil and vegetation) along the failure plane, Dworshak Reservoir, Idaho

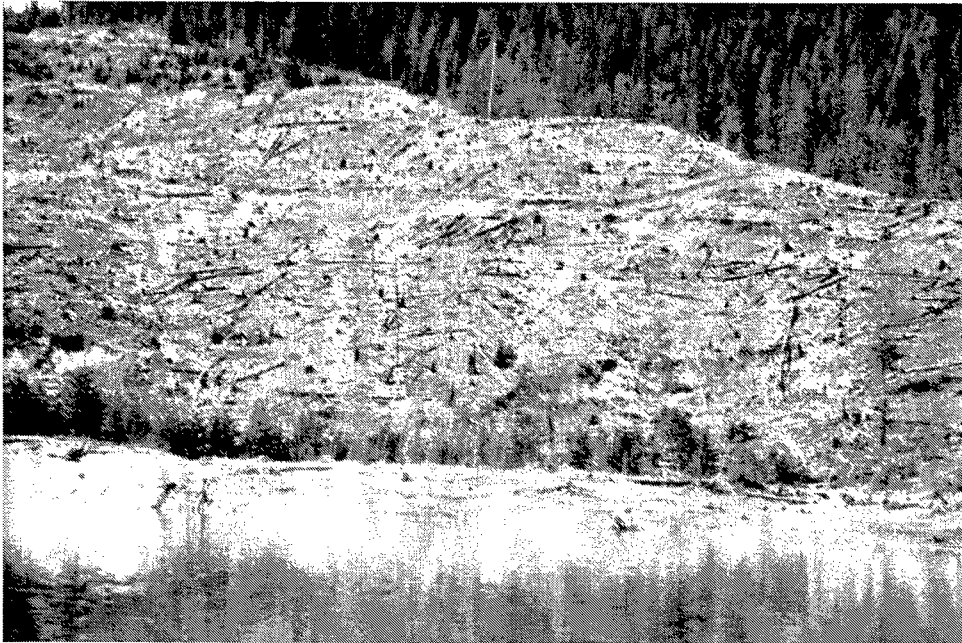
Figure 8. Logging in low impact zone, Dworshak Reservoir, Idaho

Forest practices, especially those associated with timber harvest and road construction, have increased mass wasting on already unstable slopes (Figure 8). Overland flow, identified as sheetwash in the Dworshak GIS, occurs on hillsides during a rainstorm when surface depression storage and either, in the case of prolonged rain, soil moisture storage or, with intense rain, the infiltration capacity of the soil are exceeded (modified after Morgan 1986). Soil loss from sheetwash varies according to velocity and turbulence of the flow and is more prevalent in areas with little or no vegetation. Gully erosion is another major geomorphic process affecting archaeological sites. Gullies are steep-sided stream courses which experience ephemeral flows during rainstorms. The width and depth of gullies vary. Due to their erratic behavior, a relationship between sediment discharge and runoff is difficult to establish. Existence of gullies is mainly attributed to excessive rainfall or extensive clearing of vegetation.

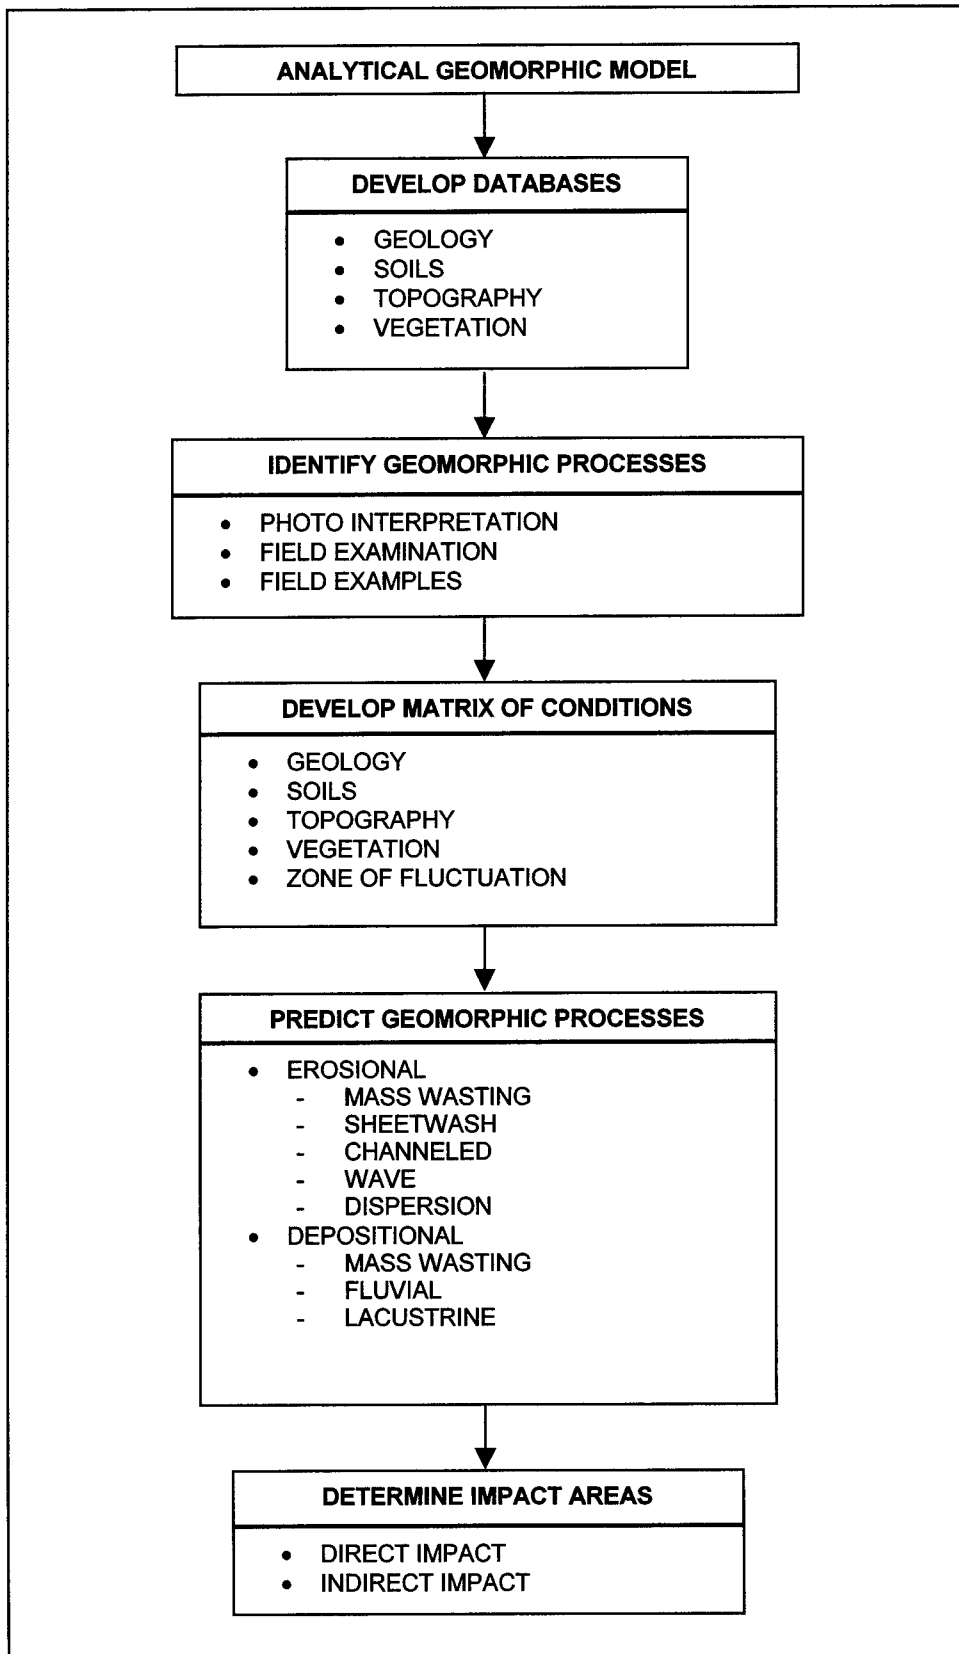
Figure 9. Sequential steps of an analytical geomorphic model

The analytical geomorphic model followed sequential steps in constructing a basic model that can be used in management of a reservoir (Figure 9). A database pertaining to the geomorphology was first developed. Geomorphic processes were then identified from interpretation of existing maps, aerial photography, and video photography of the reservoirs at an altitude of less than 304.8 m (1,000 ft) from a helicopter. The video photography was used during field investigations of the more pronounced mass failures. Aerial photographs were later scanned and interpreted for use in a GIS. Unfortunately, photographs of Dworshak Reservoir were distorted and linkage between photographs was not possible. However, the photographs exist as a separate and important part of the geologic and geomorphic database. After identification and delineation of geomorphic processes active in the reservoir areas, the next step in development of the analytical procedure is development of a matrix of site conditions in the form of a GIS.

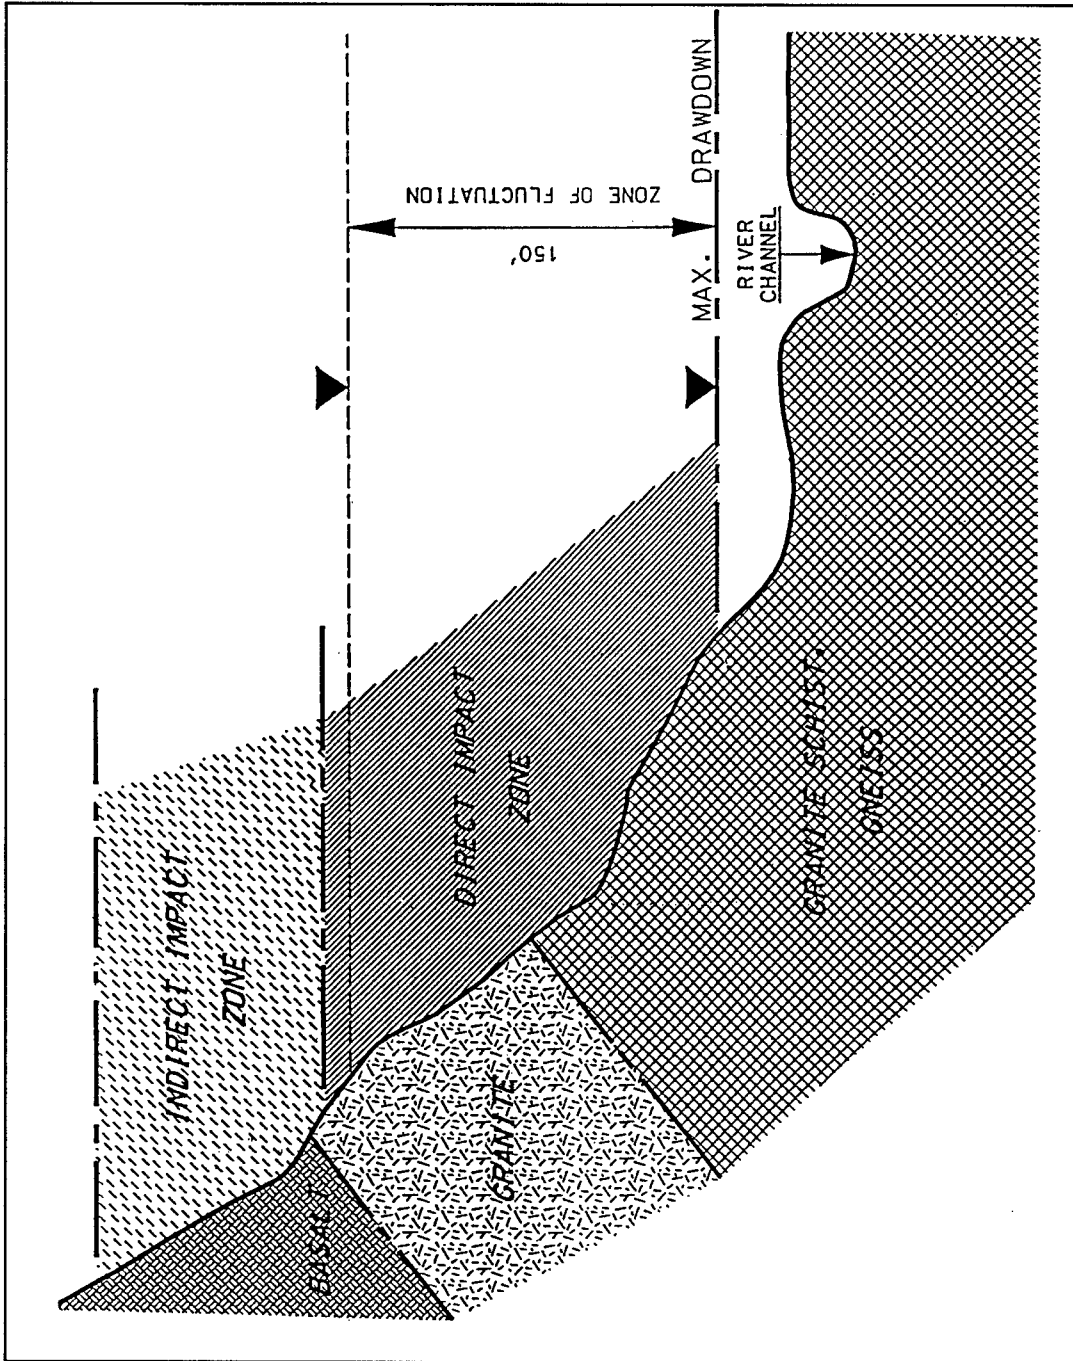
Figure 10. Division of study area into direct and indirect impact zones

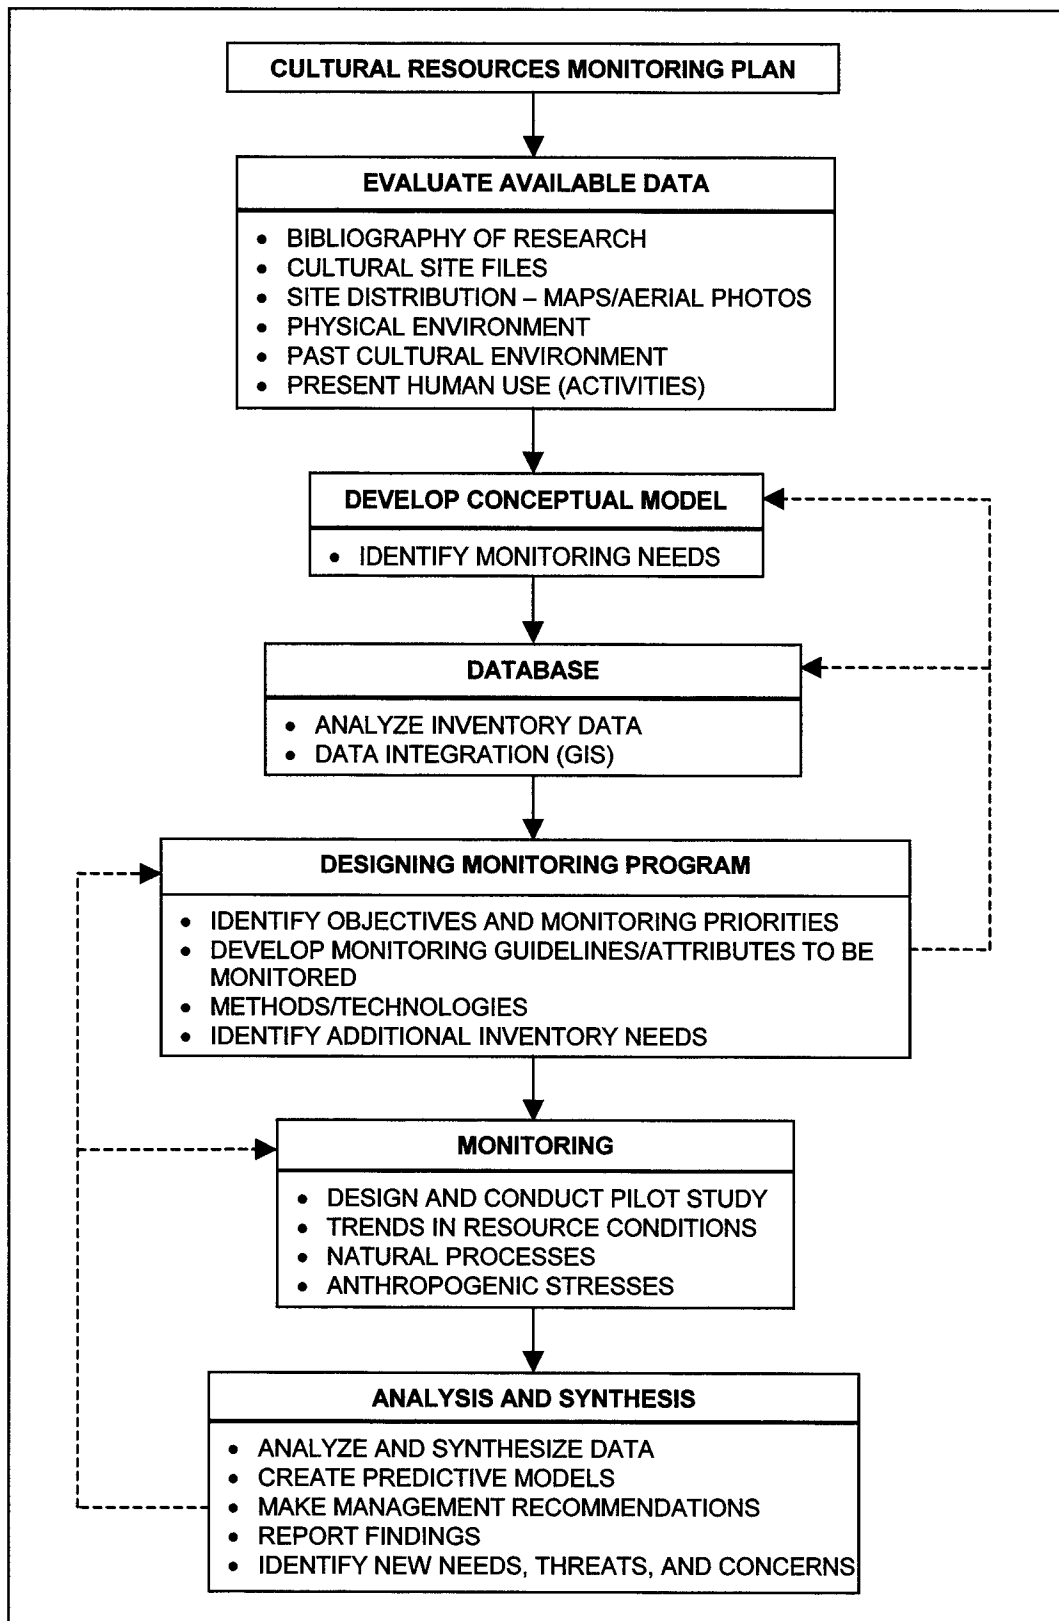
Figure 11. Developmental sequence for cultural resources monitoring plan

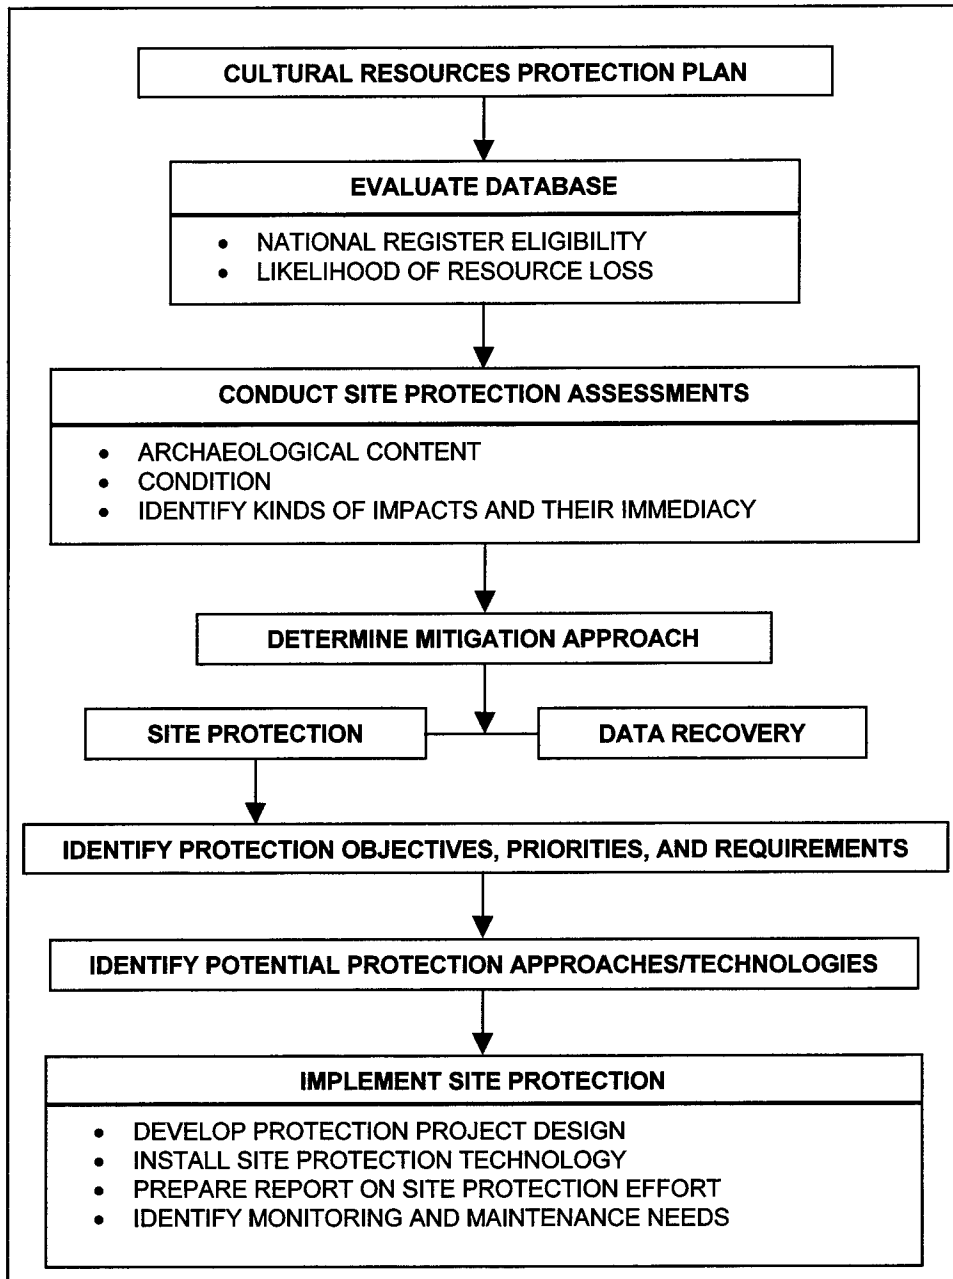
Figure 12. Developmental sequence for a resource protection plan

In the case of site protection, the next action is to determine the protection effort objectives, priorities, and management requirements. Included in this analysis is an evaluation of the potential site protection technologies available for use, based on the site conditions. Information on these topics has been developed by the ERDC and is available to aid resource specialists and managers in identifying the most practical and cost-effective protection strategy.

The final step involves design and implementation of the selected site-protection approach. It is imperative that the installation of the protective technology be intensively documented. It is also critical that the monitoring and
