**NATIONAL REGISTER TESTING OF
A RAILROAD EMBANKMENT FOR THE
HOLLYGROVE DRAINAGE IMPROVEMENTS
FEATURE, SOUTHEAST LOUISIANA URBAN
FLOOD CONTROL PROJECT,
ORLEANS PARISH, LOUISIANA**

Final Report

August 2001

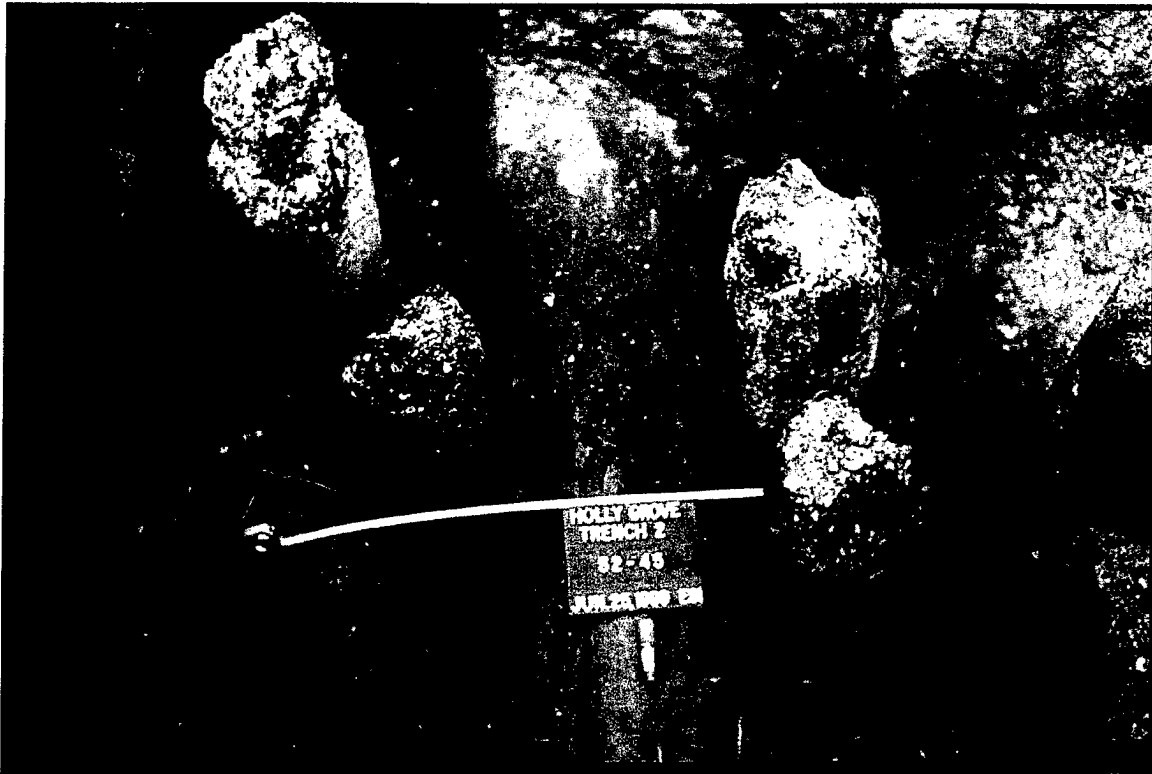
Plate 2. Photograph of Trench 2, Feature S2-45.

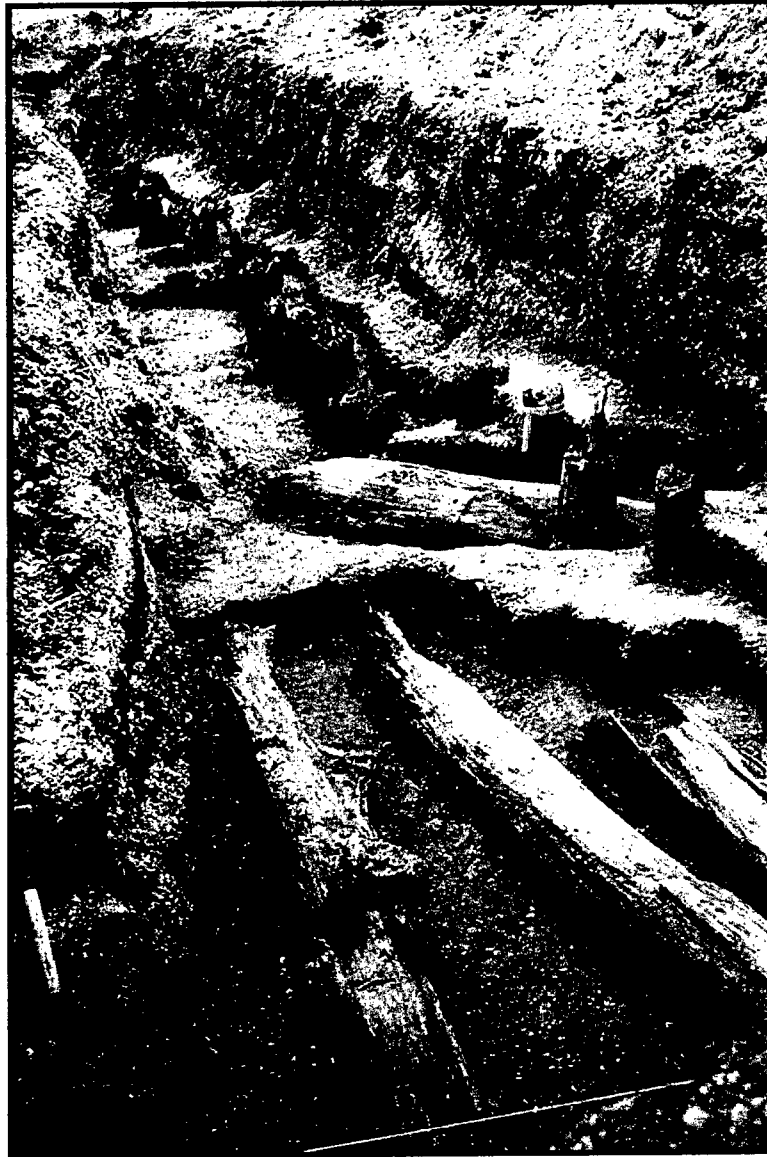
Plate 9. Photograph of cypress and pine structural elements in Trenches 5 and 6.

A number of wooden structural remains were discovered during excavation of Trenches 5 and 6 (Figure 38 and Plate 9). A row of pine pilings was encountered *in situ* along the southern portion of Trench 6. These pilings, as well as those found in Trenches 1 and 2, and the 18 sampling areas (below), are interpreted as the remains of stabilization efforts. They are believed to be later additions to the embankment which intrude on the earlier wooden features buried in the Harahan Clay. These pilings were placed unevenly, approximately 10 to 75 cm (3.9 to 29.5 in) apart, in a row parallel with the embankment. In the lower stratum of Harahan Clay, around each of the pilings, were small rings of sandy, gravelly yellowish red soils, suggesting that the piles had been driven through the gravelly strata into the clay containing the cypress logs of the original building episode. In addition, obvious disruption to the cypress logs was observed on numerous occasions where the pilings had been driven into them.
