PNE-516
FINAL REPORT

P R O J E C T PRE-SCHOONER II

POSTSHOT GEOLOGIC AND ENGINEERING PROPERTIES INVESTIGATIONS

PROJECT PRE-SCHOONER II
POSTSHOT GEOLOGIC AND ENGINEERING
PROPERTIES INVESTIGATIONS

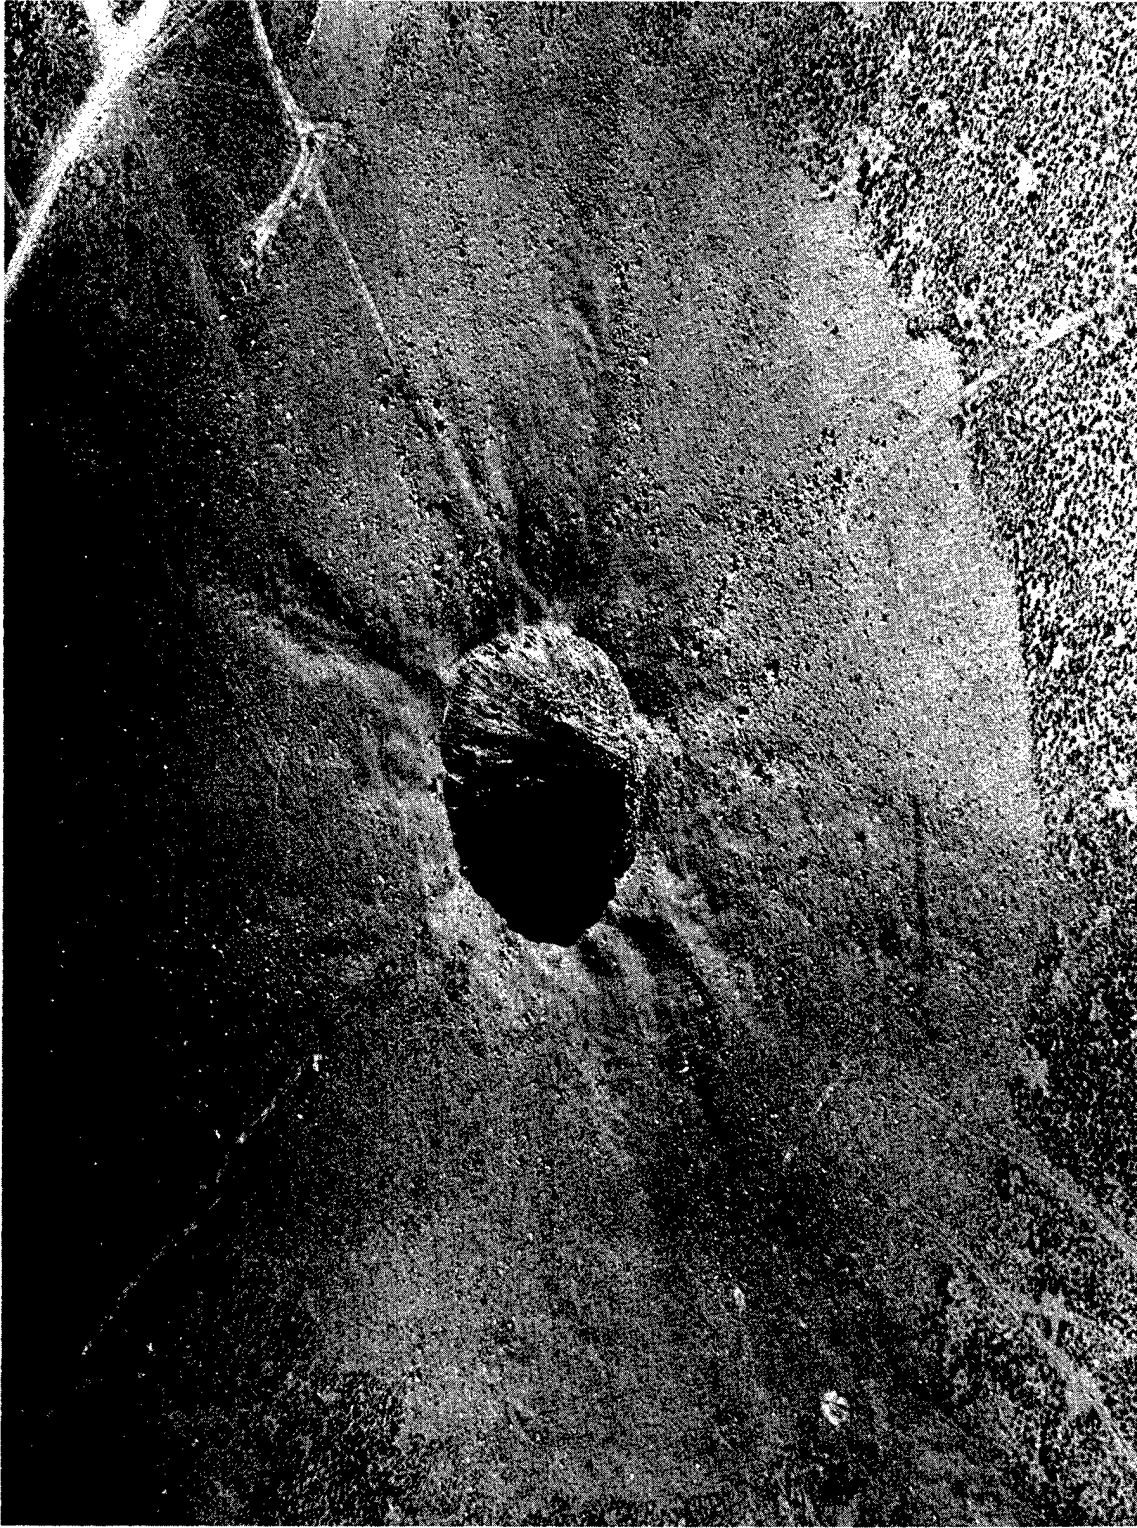
Pre-Schooner II Crater.

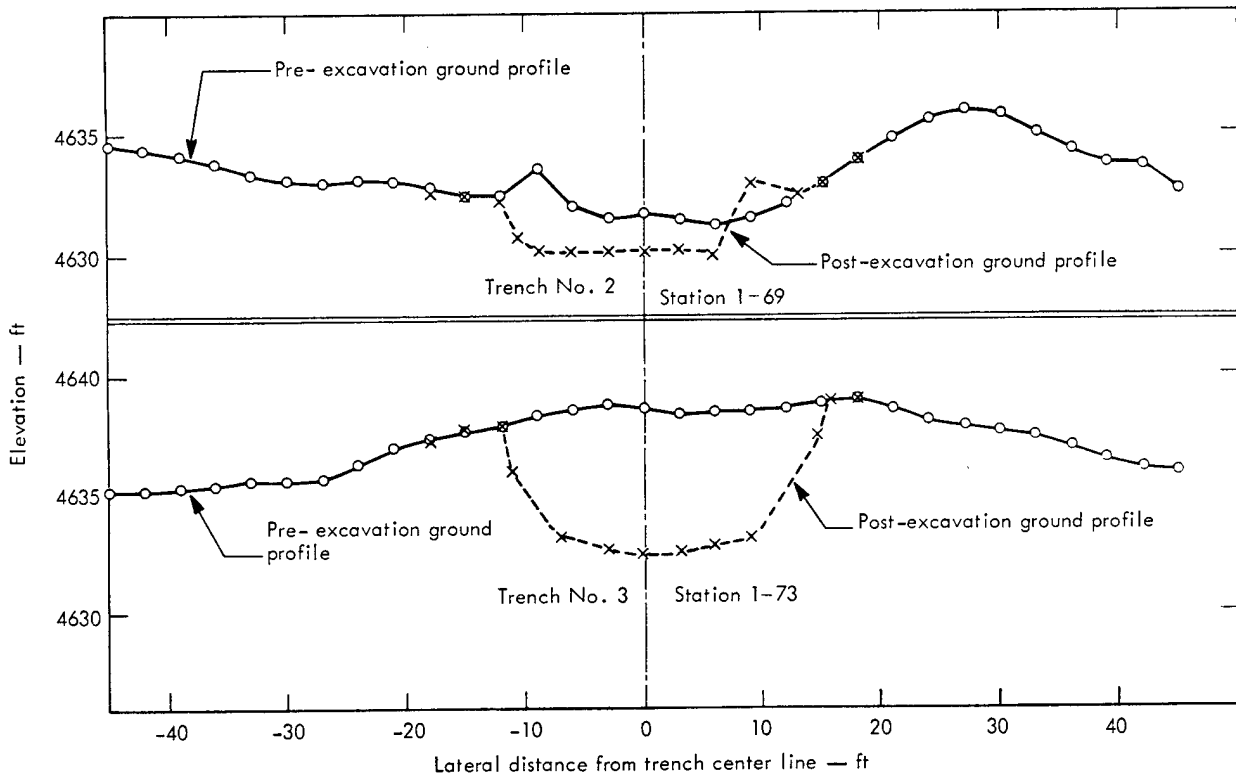
Figure 3.8 Typical cross sections for various stages of trench excavation.

The initial grid for each trench extended from approximately the lip crest in a direction away from SGZ for some distance, depending on the amount of ejecta. Each grid extended 45 feet on either side of the trench centerline. Subsequent grids were extended only a few stations beyond the limits of disturbance caused by excavation. These subsequent grids were also modified to obtain elevations at major slope breaks which did not coincide with the preceding profile, such as at the toe of the slope bounding the trench. Figure 3.8 shows a typical profile for the various stages of trench excavation.

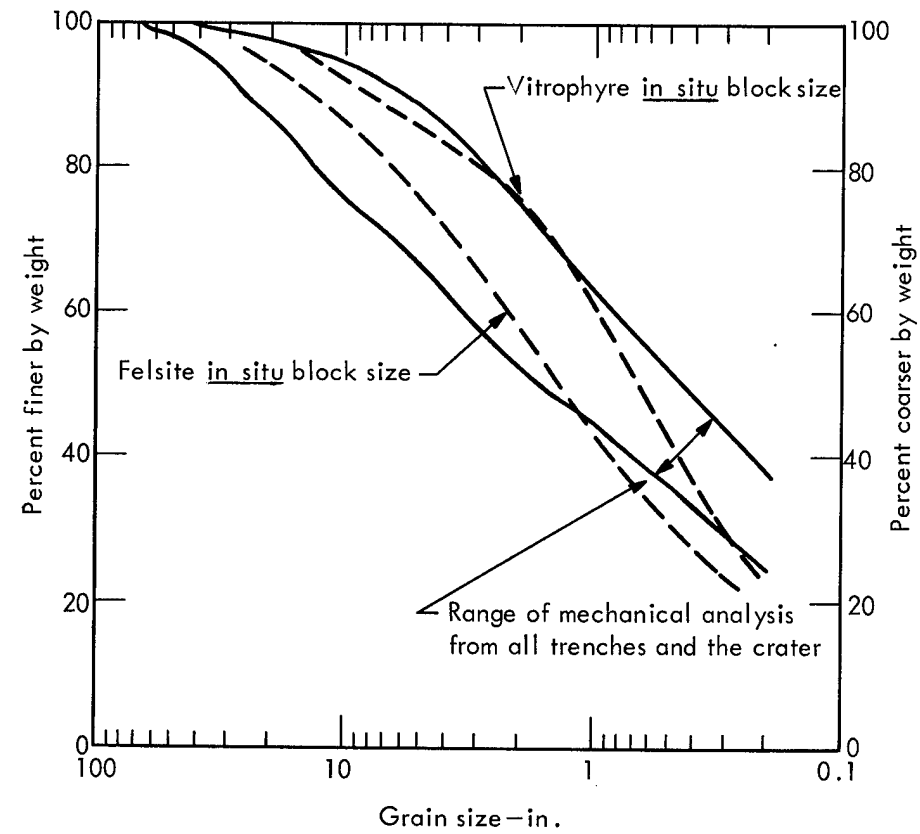
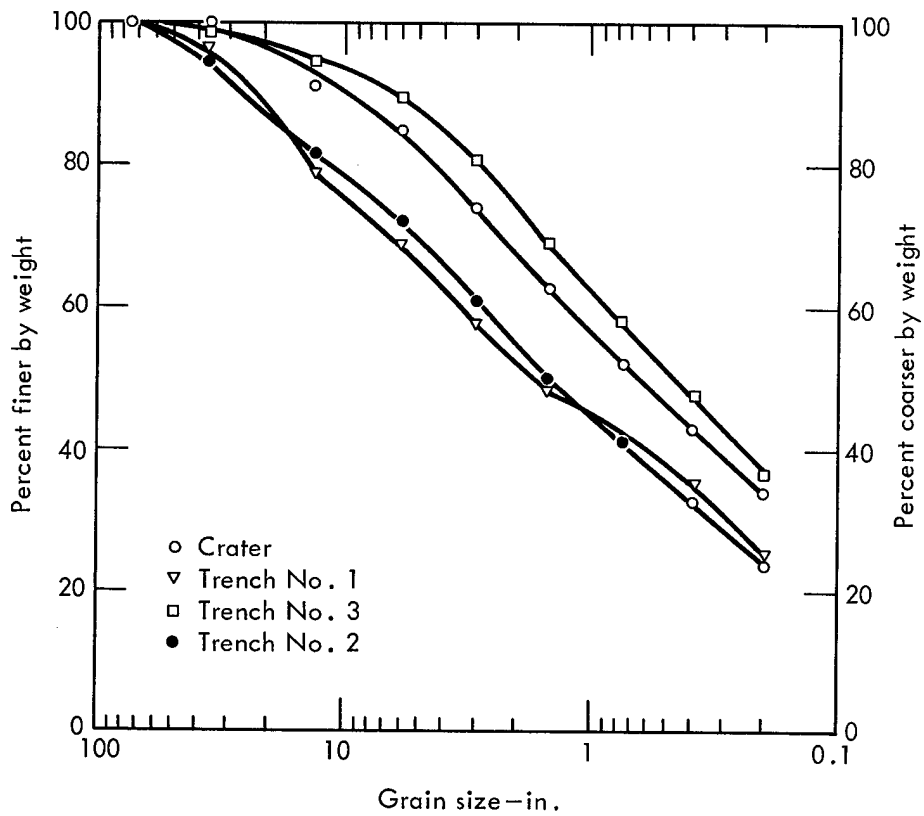
Figure 4.5 Comparison of predicted block size for two major materials, and postshot fallback and ejecta mechanical analyses.

The combined curves from Figures 4.1 through 4.4 for the trenches and crater are shown in Figure 4.5 as a band illustrating the grain size distribution range. Also plotted in this figure are predicted size distribution curves for the vitrophyre and felsite constructed from preshot subsurface information (Reference 13). Because of the distinctly different fracturing characteristics of these two rock types and the predicted differences in grain size distribution, an effort was made to determine what percentage of each rock type was represented in the plus 6-inch size material. The data are shown in Table 4.2 as the percentage of each rock type in the size classifications 6 to 12, 12 to 36, and greater than 36 inches. Data from Trench No. 1 are missing because the material was mistakenly discarded before the percentages were determined. Table 4.3 gives a rough estimation of the relative amounts of the different rock types in the vicinity of each of the trenches prior to the detonation. There is no apparent agreement between the percentages of the different rock types in the ejecta from each trench and the percentages given in Table 4.3.

2. Block size distribution curves of the ejecta and fallback compared to predicted curves based on evaluation of preshot data showed relatively good correlation. This same relatively good correlation was also noted in the Buckboard Mesa basalt cratering experiments. However, the predicted curves for Pre-Schooner II were based solely on a visual examination of the access hole and shot cavity (due to the nature of the rock, core from the exploratory holes and the borehole photography were unusable for joint analysis), whereas previously predicted curves were based on averages of the lineal joint intercept of a number of borings.

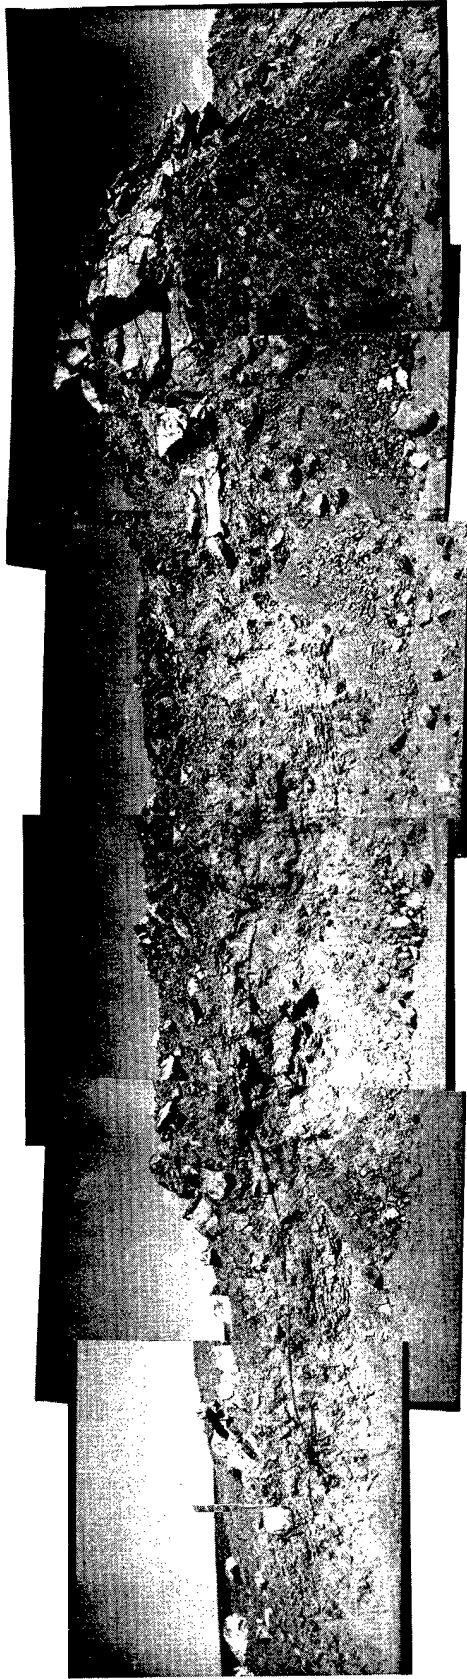
Figure 4.6 Ground profiles from Trench No. 1.

After the trenches were excavated, one wall of each trench was examined and mapped to delineate the true crater boundary and amount of uplift. The results of this mapping are shown in Figures 4.6 through 4.9 for Trenches No. 1, and No. 3. The true crater radius and amount of uplift are listed in Table 4.4.

From an examination of the trench profiles, it can be seen that in all three trenches the soil and caliche have been removed from above the uplifted bedrock for a distance of 8 to 24 feet back from the true crater zone. This condition is probably the result of surface spalling. In Trench No. 1 there has also been overthrusting of wedges of material which, prior to the detonation, constituted the ground surface closer to SGZ.

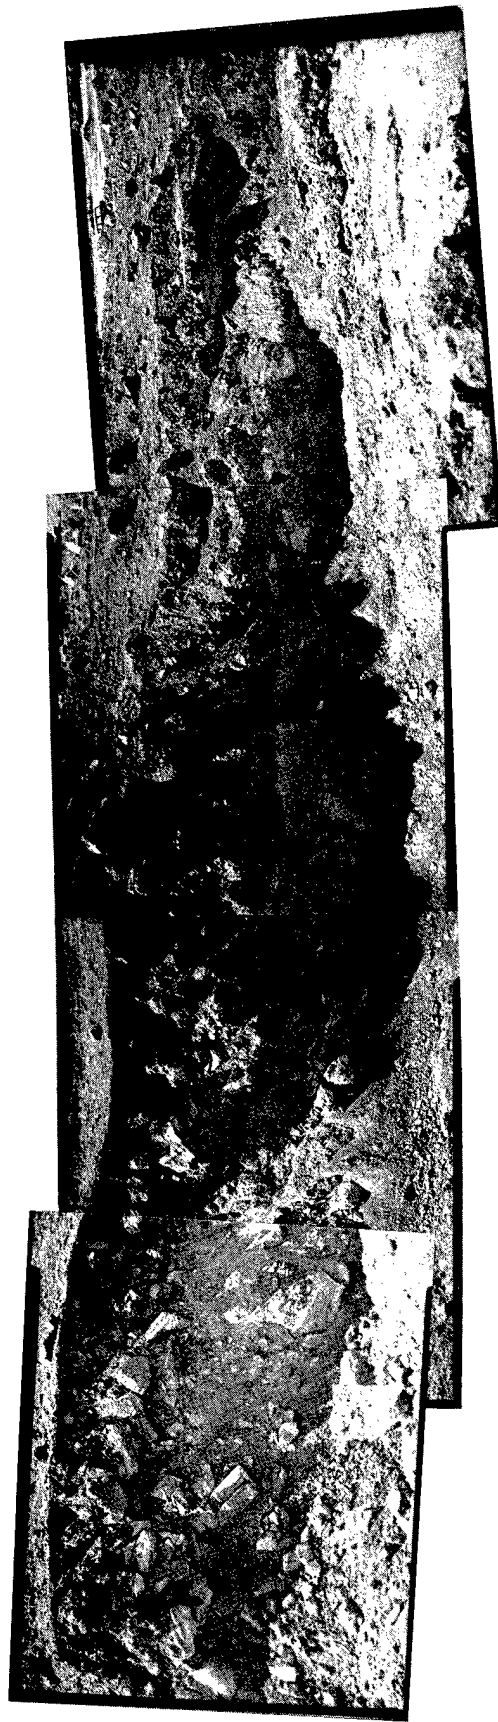
Figure 4.7 Ground profiles from Trench No. 2, west wall.

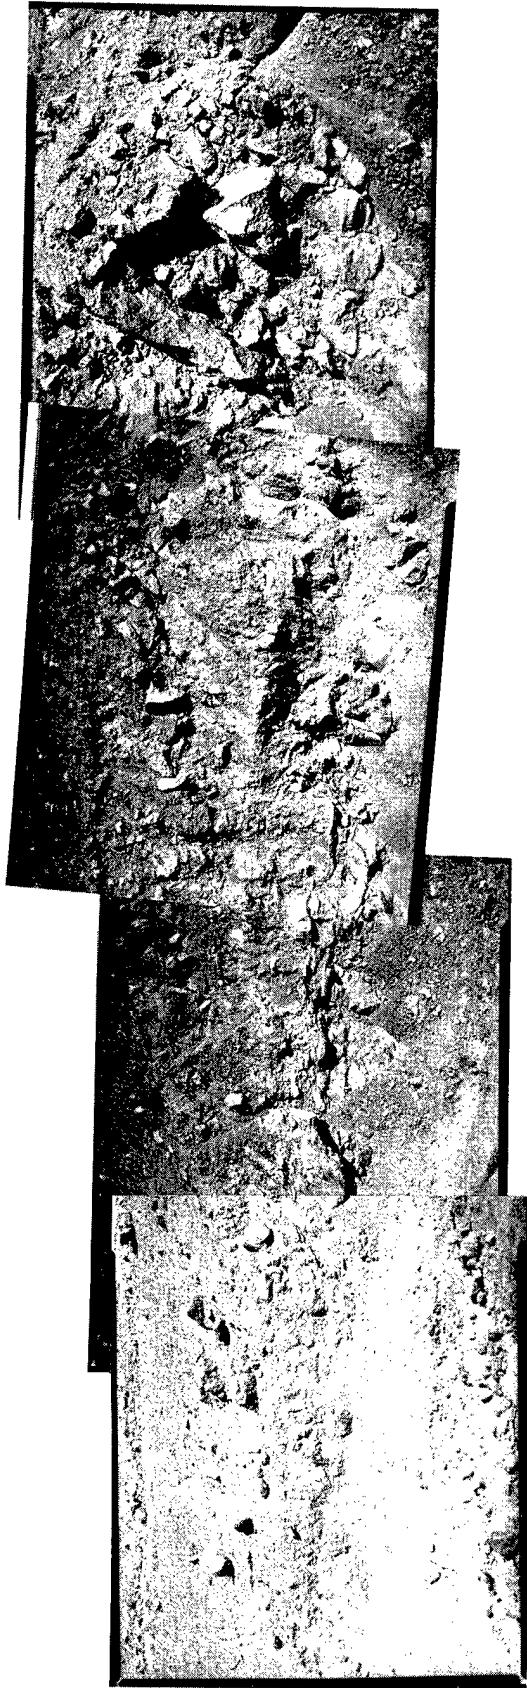
Figure 4.8 Ground profiles from Trench No. 2, east wall.

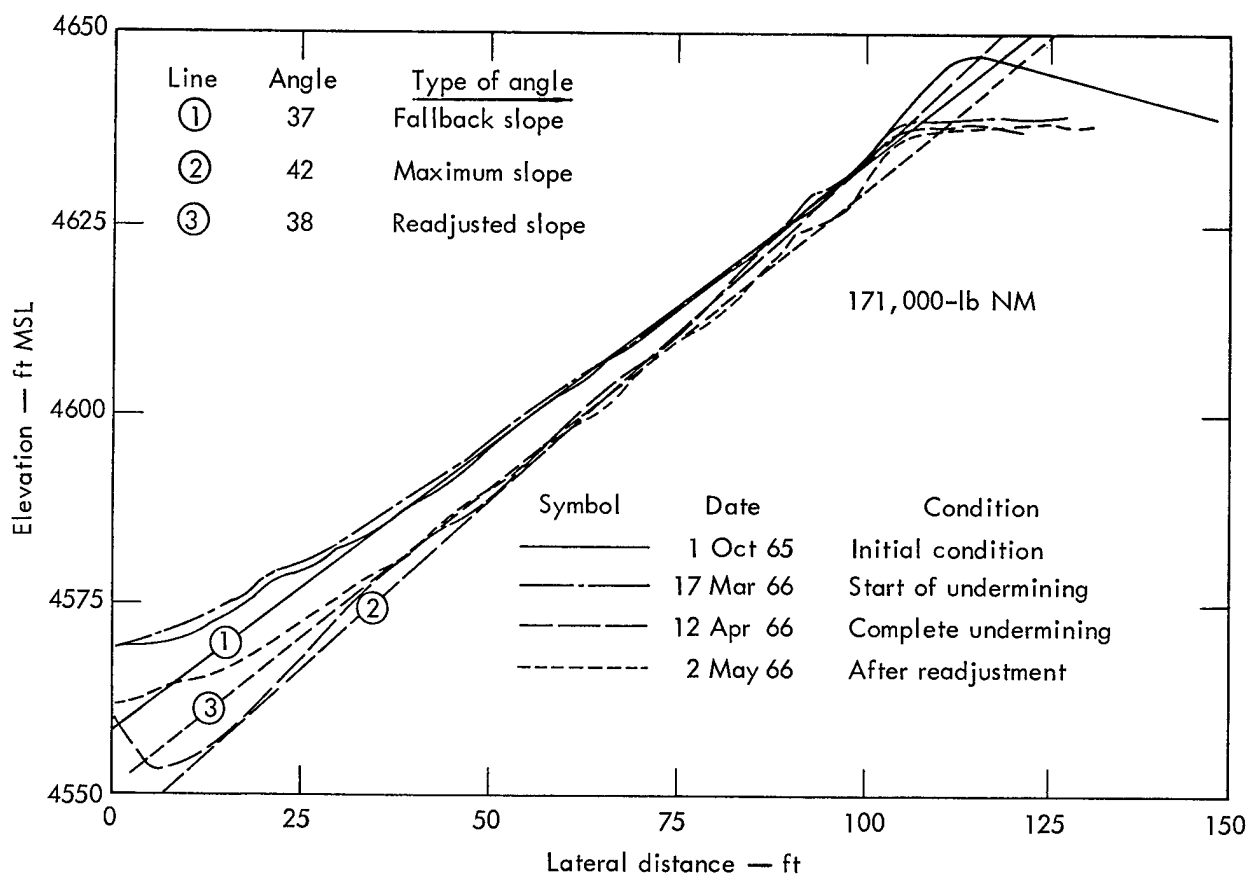
Figure 4.12 Profiles bearing S 40° W of apparent crater illustrating slope adjustment stages (Reference 14).

4.4.3 Slope Angles. The angle of repose for a cohesionless material is the maximum possible inclination of a slope of that material. The angle of deposition has been defined as the inclination of a slope formed by the deposition of cohesionless material

and depends both on the character of the material and the mode of deposition (Reference 14). For all practical purposes, the fallback material at Pre-Schooner II can be considered cohesionless. Therefore, the crater slope angles, prior to any postshot investigations, represented the angle of deposition for this material. This average angle was 37 degrees. The slopes in part of the crater were then steepened by undercutting the toe of the slope to an average inclination (angle of repose) of 42 degrees. After a short period of readjusting (approximately 1 week), the slope stabilized at 38 degrees. Figure 4.12 illustrates the various stages of slope stabilization. A later aerial photograph and topographic map obtained in June 1967 (Figures 4.13 and 4.14) shows that the undercut slopes which readjusted to 38 degrees were remaining at that angle. In other parts of the crater where the slopes were much steeper, readjustment to flatter slopes is occurring. Long term slope adjustments will be examined periodically.
