NRL/MR/6110--01-8584

Response of METS Sensor to Methane Concentrations Found on the Texas-Louisiana Shelf in the Gulf of Mexico

RESPONSE OF METS SENSOR TO METHANE CONCENTRATIONS FOUND ON THE TEXAS-LOUISIANA SHELF IN THE GULF OF MEXICO

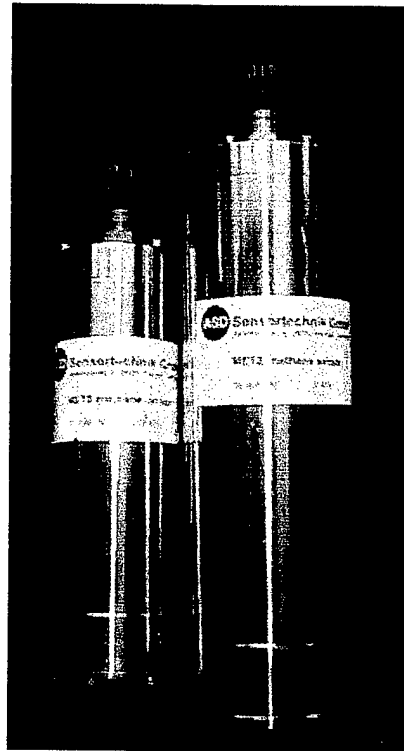
Figure 1. METS sensor D23 located on left, D12 located to the right.

Three sensors were purchased from ASD (D12, D21 and D23). The electronics were the same between D12 and D21/23, but the physical size was very different (Figure 1).

The later two sensors (D21/23) were approximately 50% smaller than D12 and commensurately lighter. The membrane size was the same for all the sensors but the exposed surface area for D21/D23 is approximately 35% greater than for D12. The methane and humidity sensors were also the same size. D12 was received in time to perform preliminary laboratory experiments (fresh and seawater) and to become familiar with the operation of the sensor. D21/23 were received prior to the cruise. They were tested for proper response. Both sensors were responsive to various methane concentrations. None of the sensors were field tested prior to the summer cruise.

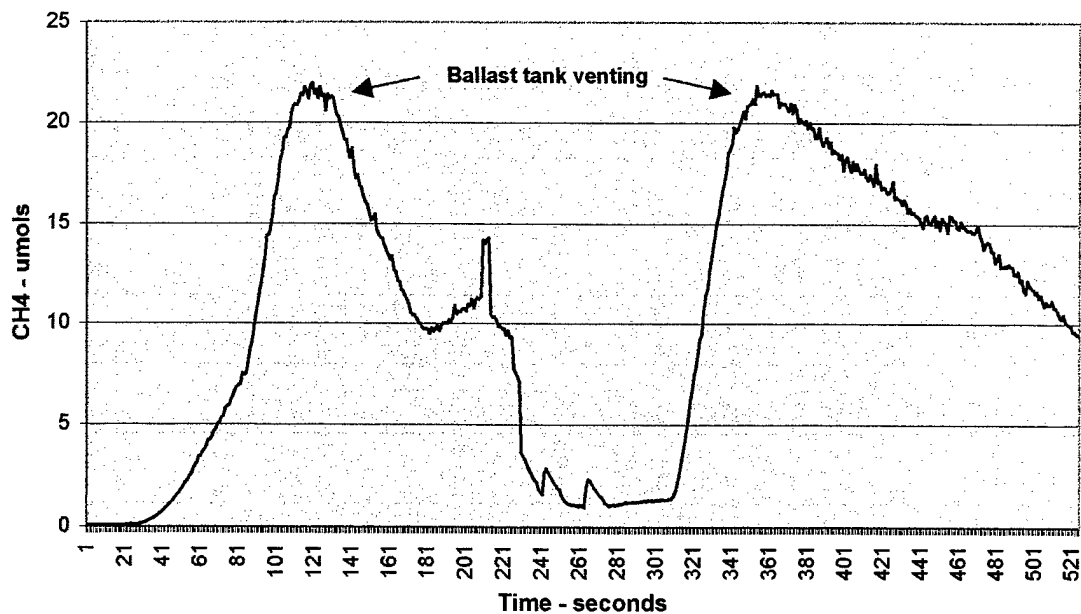
Figure 3. Results of ballast tank (gas and oil) being blown onto the METS sensor.

The two very large peaks decayed reasonably fast after the ballast discharges. The term “reasonable decay of the methane peaks” must be placed in the context that the methane is oxidized only when there is sufficient oxygen present to facilitate the oxidation. The oxygen must also diffusive across the same membrane as the methane. The rapid decay of the methane peak indicates that the bottom water in which the dive took place is well oxygenated.

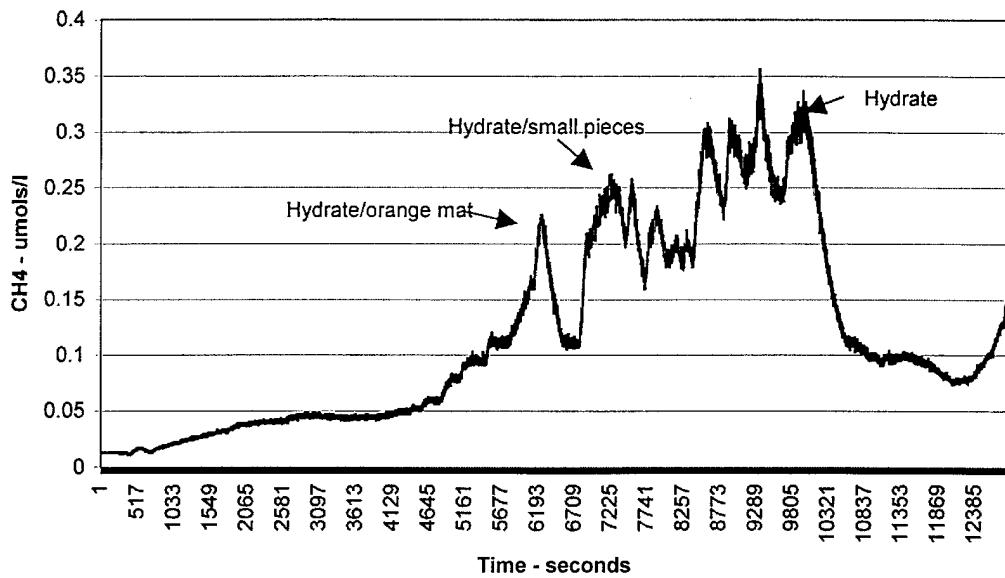
Figure 7. This graph shows methane (plus hydrocarbons) concentrations in the vicinity of hydrates. Methane levels in open ocean conditions should be ~ 0.004 umols/l.

Figure 7 has numerous peaks, however, the maximum peak on this dive is only 0.4 umols/l. The first peak located at approximately 6,274 seconds (~0.22 umols/l) was obtained in the vicinity of small hydrate and an orange mat (bacterial?) associated with it. The second peak at 7,265 seconds is associated with 2/3 small pieces of hydrate. The final peak at 9,884 seconds is associated with a large piece of hydrate. As can be seen from this plot, it is difficult to associate pieces of hydrates with the concentrations obtained by the METS sensor at this particular location.

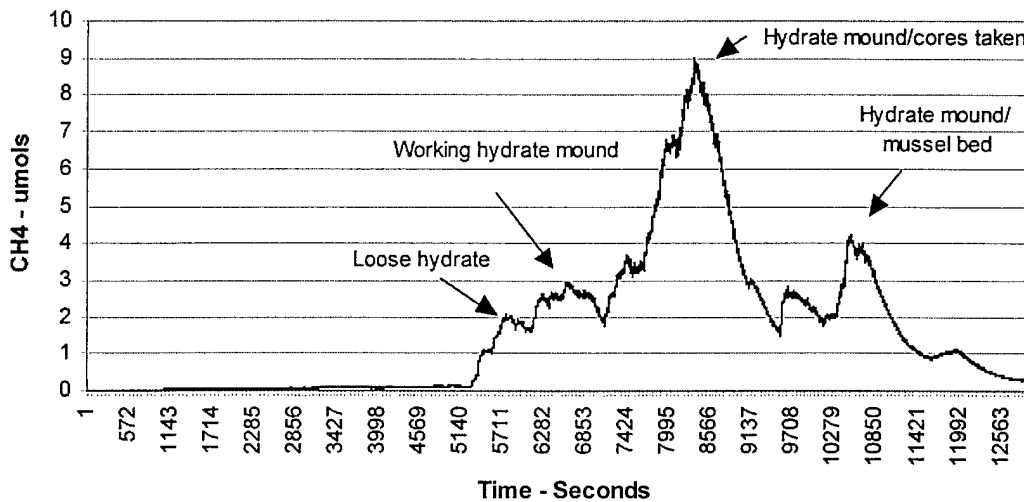
Figure 8. This plot shows that high methane concentrations can be observed in the vicinity of hydrate outcroppings.

Figure 8 shows data collected while working with hydrate mounds or with pieces of hydrate. Methane concentrations rise from a background level of ~0.1 umols/l to a high of ~ 8.8 umols/l. The first peak (~2.1 umols/l) at 5,788 seconds was obtained when working around a loose piece of hydrate. While working a hydrate mound at 6,634 seconds, a concentration of ~2.9 umols/l was obtained. The highest concentration (~9 umols/l) occurred while cores were being taken in a hydrate mound. The peak located at 10,523 seconds occurred while working in a mussel bed located to the left of the hydrate mound.

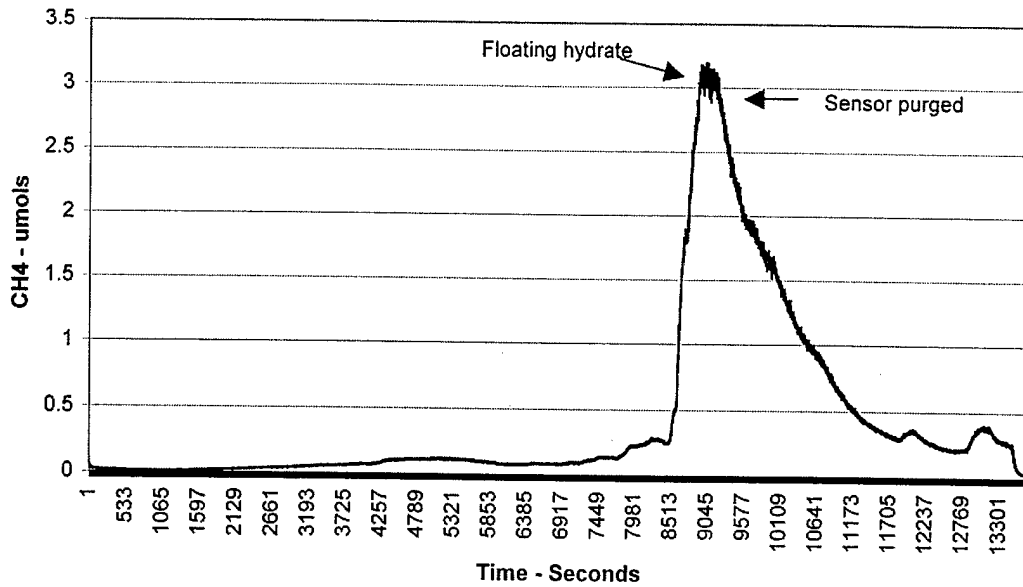
Figure 9. Graph showing results of using ballast air to speed recovery of METS sensor.

Figure 9 has subdued detail except for one peak (~ 3.1 umols/l) at approximately 9,000 seconds. The submersible had stirred up the bottom sediment and was waiting for the sediment to settle down before collecting more hydrate samples. The peak decay was initiated by purging the sensor with ballast air after moving away from the bottom while attempting to retrieving some floating hydrates. The sharp dip in the methane profile at 13,633 seconds indicates that the submersible has been hoisted from the water. It was

found that purging the sensor with ballast air would help it recover more quickly than by the normal procedure of oxygen diffusion from seawater.

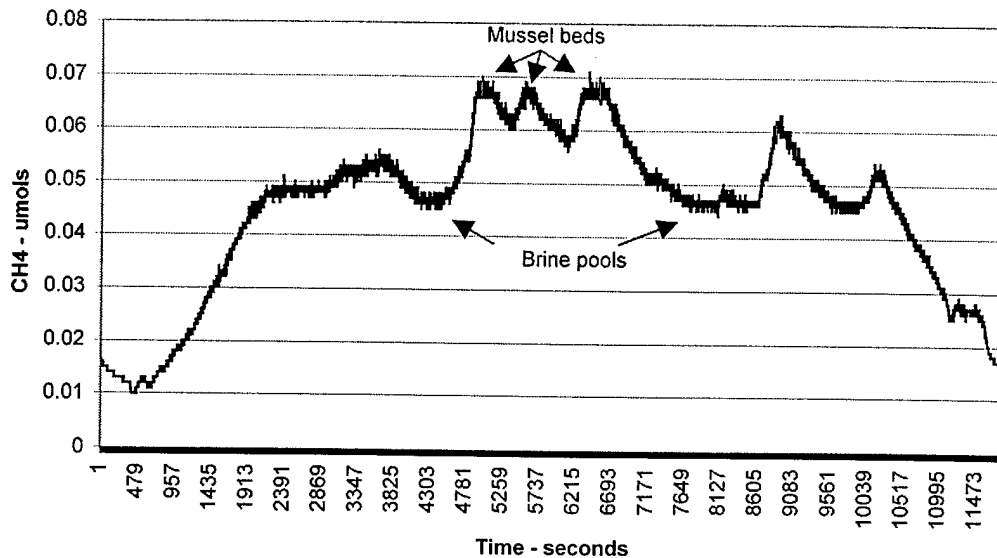
Figure 10. An example of low methane concentrations with strong local variability.

Figure 10 is a departure from the single peak dive in figure 9. In this dive, there are multiple peaks, which are slightly but significantly elevated from bottom background levels. The first plateau occurs at 2,272 seconds when the submersible reaches the bottom. The methane concentration is ~ 0.05 umols/l. The first peak at 3,664 seconds

has a concentration of 0.06 umols/l and is located just prior to a brine pool. There is a decrease in the concentration to ~ 0.045 umols/l as the submersible passes over the brine

pool. The next three peaks, all with an approximate methane concentration of 0.07 umols/l, are located by/over mussel beds. Methane concentrations once again decrease to 0.045 umols/l over the brine pool. The peak at 8,900 seconds was not identified in the logs. The last peak occurred when the submersible was leaving the bottom. There is the possibility that the bottom was stirred and resulted in a slight increase in the methane concentration. The short plateau and then sudden dip in the methane concentration are the result of the submersible reaching the surface and then being hoisted out of the water.

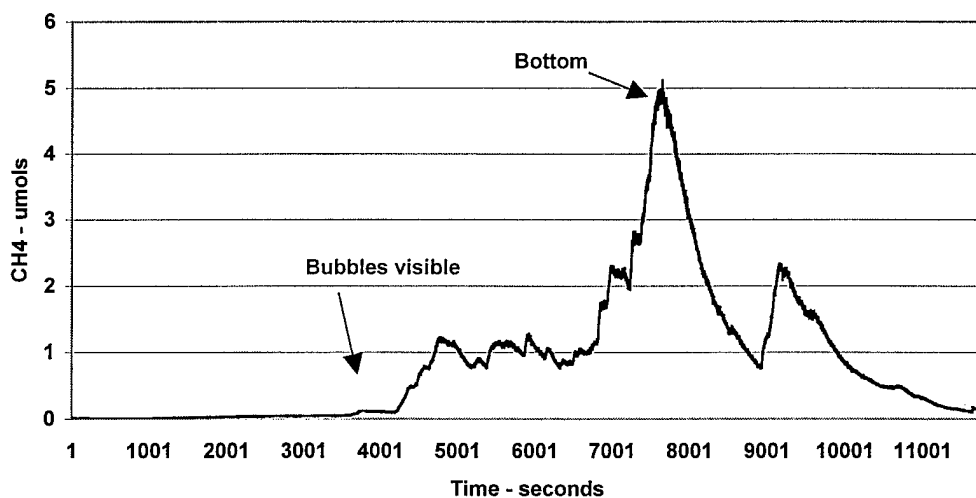
Figure 11. Influence of bubbles on the ambient dissolved methane concentration.

Figure 11 had little log information for association with the methane profile. Compared to the maximum concentration found in figure 10 of 0.07 umols/l, the concentrations in this location are orders of magnitude higher, 5 umols/l. The information that is available indicates that the submersible is entering the lower scattering layer at approximately 3,300 seconds and the visual conformation of bubbles rising from the sea floor at approximately 4,000 seconds. Methane concentrations start to rise shortly after confirmation of rising bubbles. The maximum concentration is obtained at 7,600 seconds when the submersible reaches the ocean floor. Bubbles rising from the sea floor have a marked influence on the ambient dissolved methane concentration. No mention is made of bubbles rising from the sea floor in dive 4222 (figure 10) and the ambient methane concentration is between 0.05 and 0.07 umols/l.
