# **Sampling for Explosives Residues at Fort Greely, Alaska**

**Reconnaissance Visit July 2000**

Technical Report  
ERDC/CRREL TR-01-15

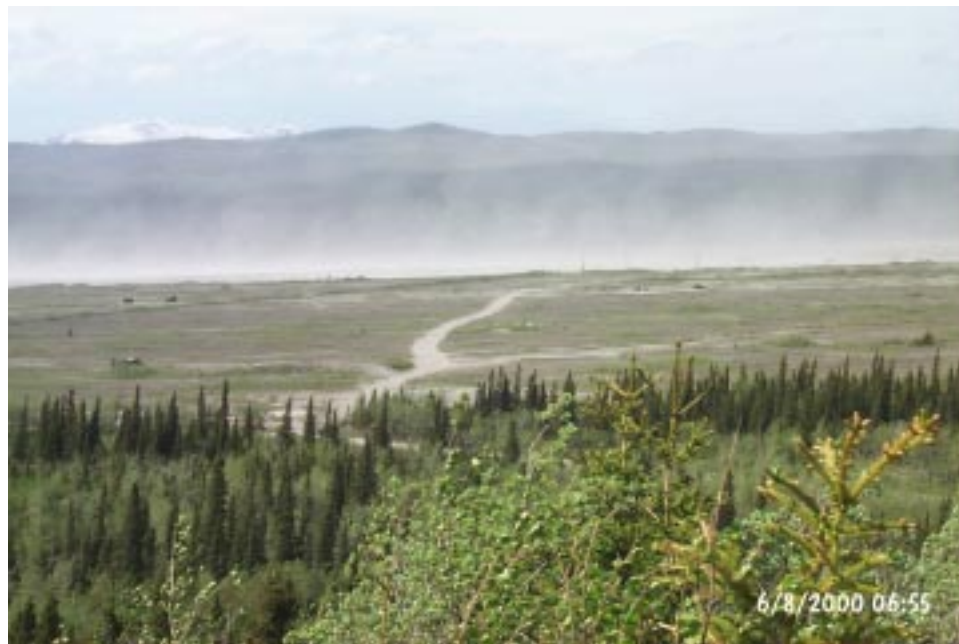
Figure 1. Washington Impact Area.

a. View from Observation Point 10, Fort Greely, Alaska.

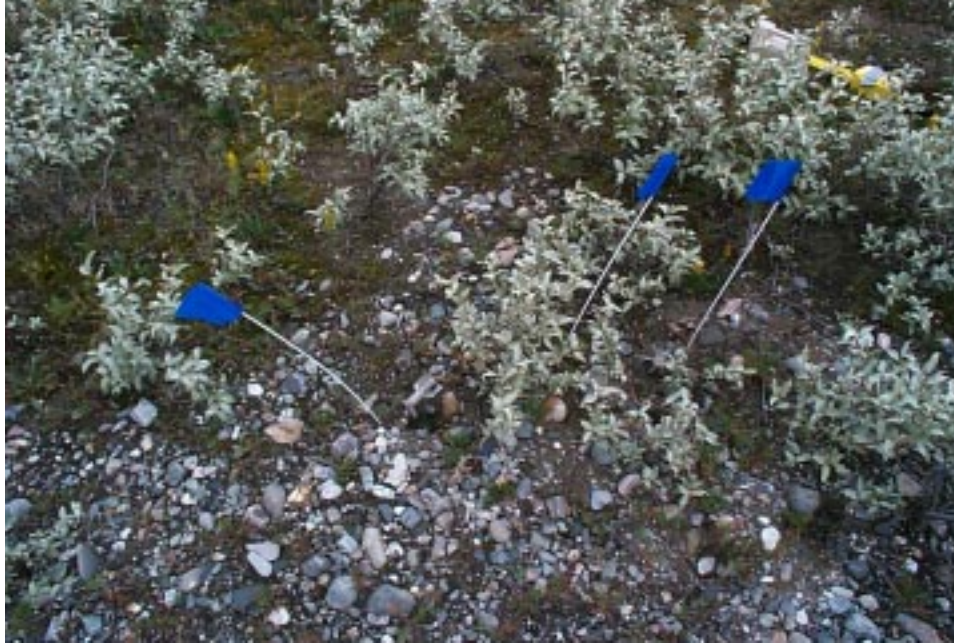
**Figure 2. Typical soil substrate and vegetation (silverberry shrub and yellow goldenrod as well as moss cover) in 81-mm mortar fuse test location. Each blue flag marks a fin from a mortar projectile.**

Much of the terrace of the Washington Range, where we sampled for explosives, is bare gravel with localized areas of sparse shrubs mostly consisting of silverberry (Fig. 2 and 3). Vegetation cover was generally negatively correlated with gravel increasing where there is more sand and silt. Estimates of shrub cover (silverberry) in each of the four 3-m × 3-m sampled plots varied from 15 to 40%. The forb *Potentilla multifida* was also abundant and cover by both mosses (up to 70%) and lichens suggests that the gravels here were well stabilized with little flooding.

We were able to locate the target area from the description of the firing point in the test report and the cluster of mortar projectile fins in a relatively small area (Fig. 2). We found 47 projectile fins, most of which were from 81-mm projectiles, and the remainder were from 60-mm projectiles. We don't know the source of the 60-mm projectile fins, but range records indicate that 60-mm smoke projectiles were frequently fired with

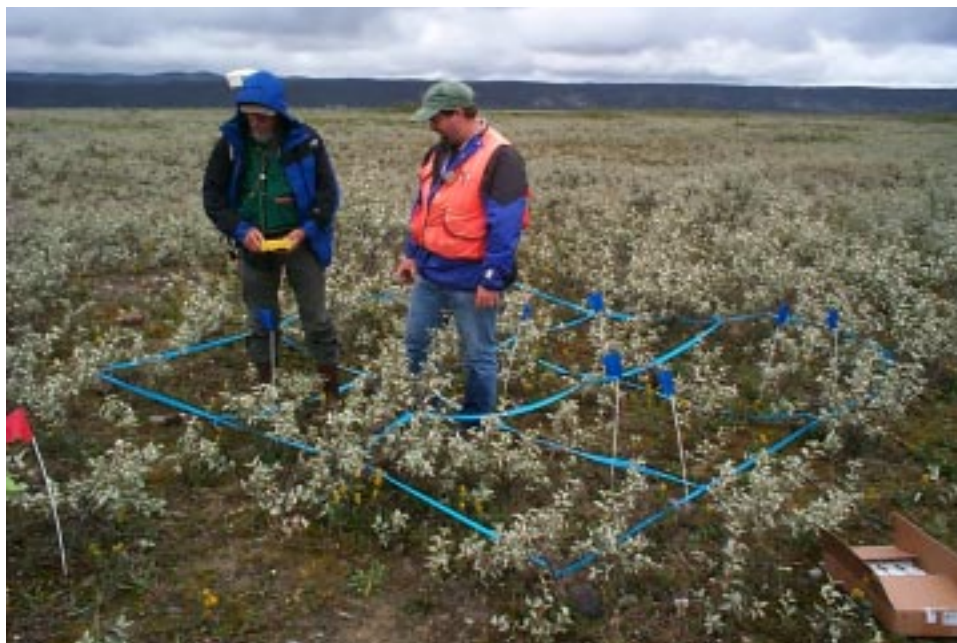
**Figure 3. Sampling grids.**

**a. Sampling grid encompassing the densest concentration of fins (Area Blue). The red flag shows the location of a low-order detonation of an 81-mm projectile.**

**b. Sampling grid with no fins (Area Yellow).**

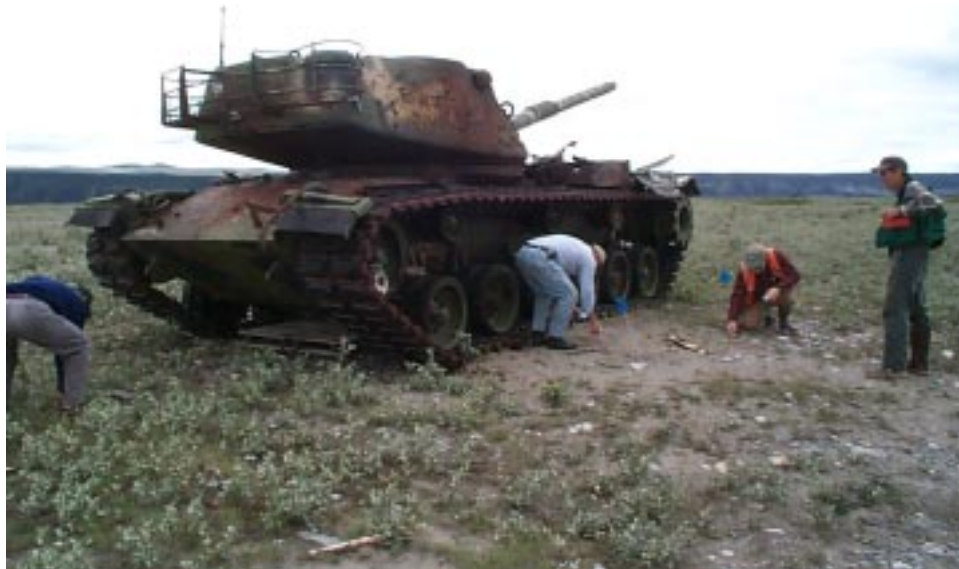
**Figure 6. Tank used as a target during TOW missile tests. Six discrete samples were collected adjacent to the tank, then a series of composite samples were collected radially around the tank out to 50 m at 5-m intervals.**

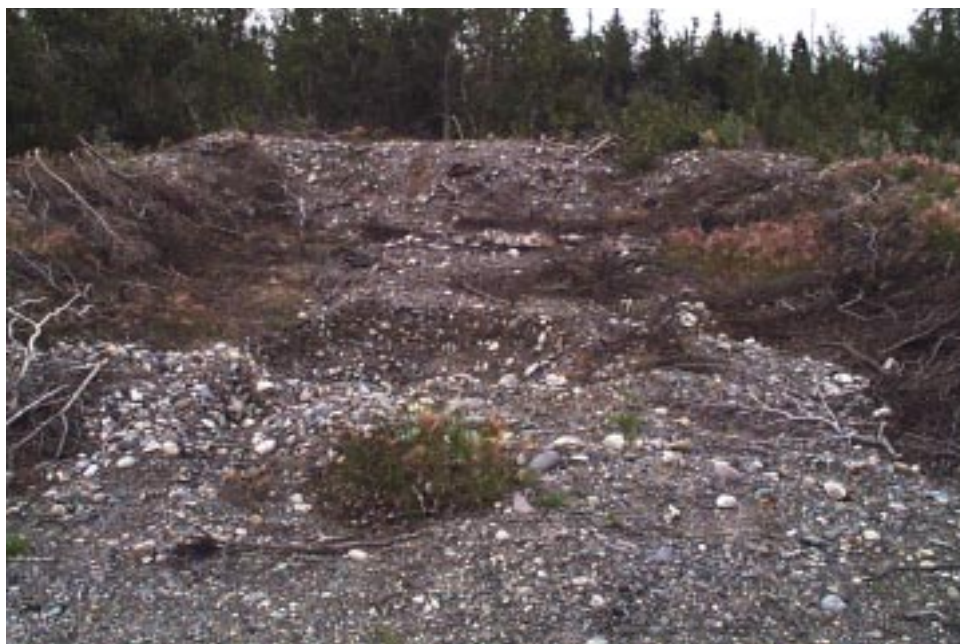
**Figure 8. Revetment that concealed one of the tank targets used in SADARM tests. We collected one composite sample along the wall of the revetment and one from the floor of the revetment.**

We located a revetment (Fig. 8) that concealed one of the target tanks during the tests. We collected one composite sample along the wall of the revetment and one from the floor of the revetment. Each composite sample was formed by taking a surface soil sample at about 1-m intervals in a line along the wall and from an approximate 1-m × 1-m grid along the floor. Near the revetment, we found a crater from which we collected surface soils from the bottom and rim and two

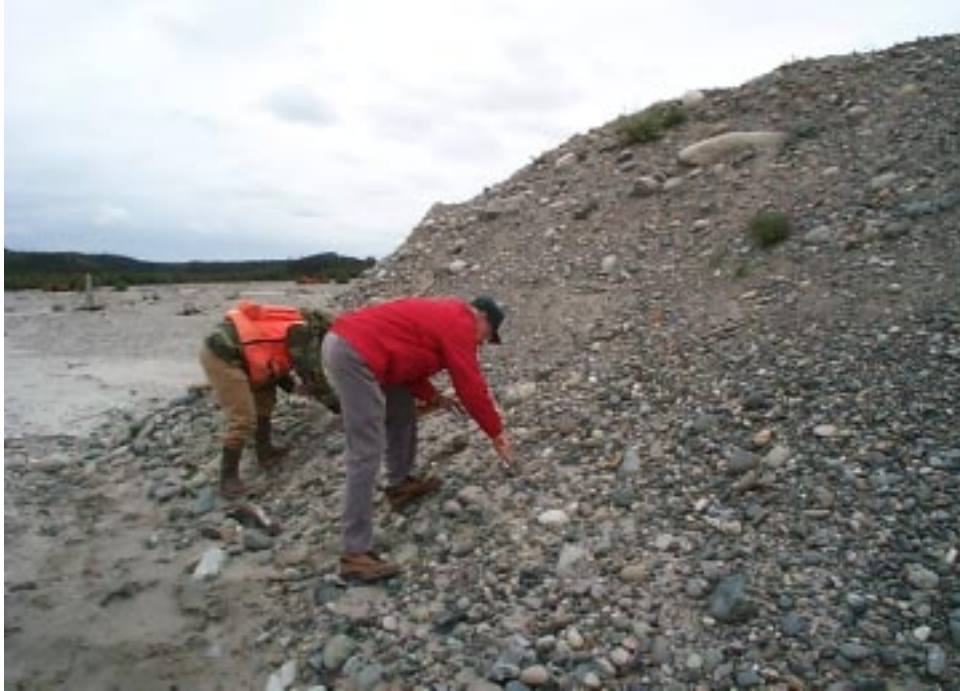
**Figure 9. Impact berm for 40-mm grenade test. In November 1998, 1800 rounds were fired into this berm on the Lampkin Range.**

surface soil and 0.011 to 1.7  $\mu\text{g/g}$  in the subsurface (Table 11). The highest concentrations were near the base of the berm. HMX was also detected above the method detection limit along the bottom half of the berm. Low concentrations of TNT and the amino-DNTs were also detected, probably associated with another firing event. A number of targets were located upstream from the berm (Fig. 9 and 10).

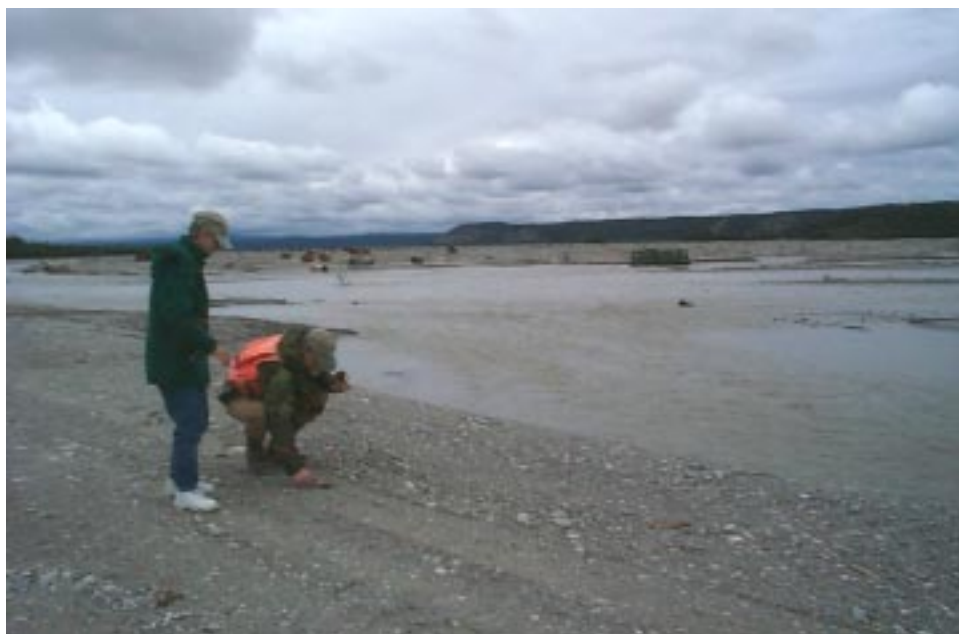
**Figure 10. Firing point for 40-mm grenade test. Targets for other firing events are seen in the background.**

A composite sample from the 40-mm firing point was formed by collecting surface soil at 2-m intervals. No explosive or propellant residues were found in the soil at this firing point.

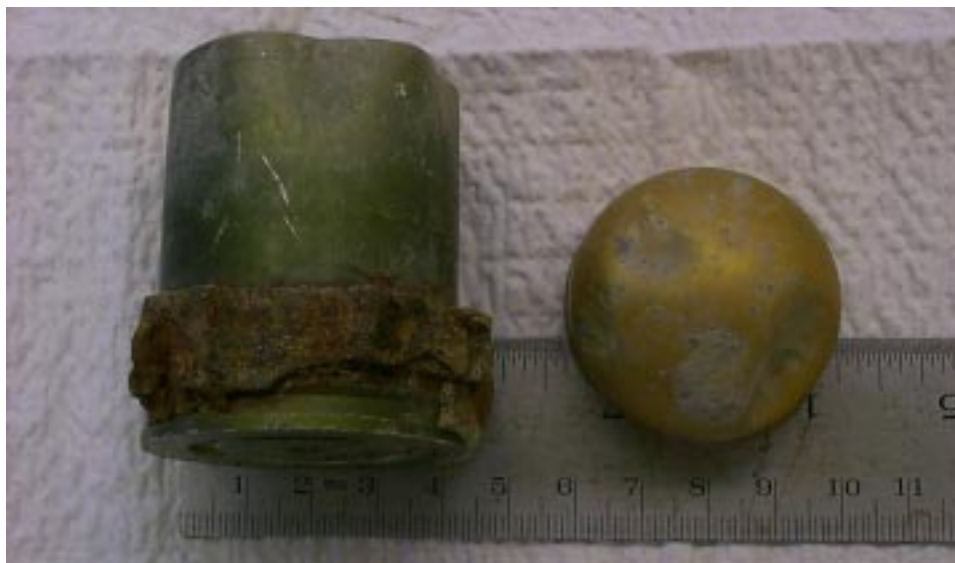
**Figure 12. Cartridge case and ogive of a 40-mm grenade that contained residues of RDX, HMX, and NG.**

We found an empty 40-mm cartridge (Fig. 12) from which we extracted RDX (0.52 µg), HMX (4.6 µg), and NG (650 µg) (Fig. 13).

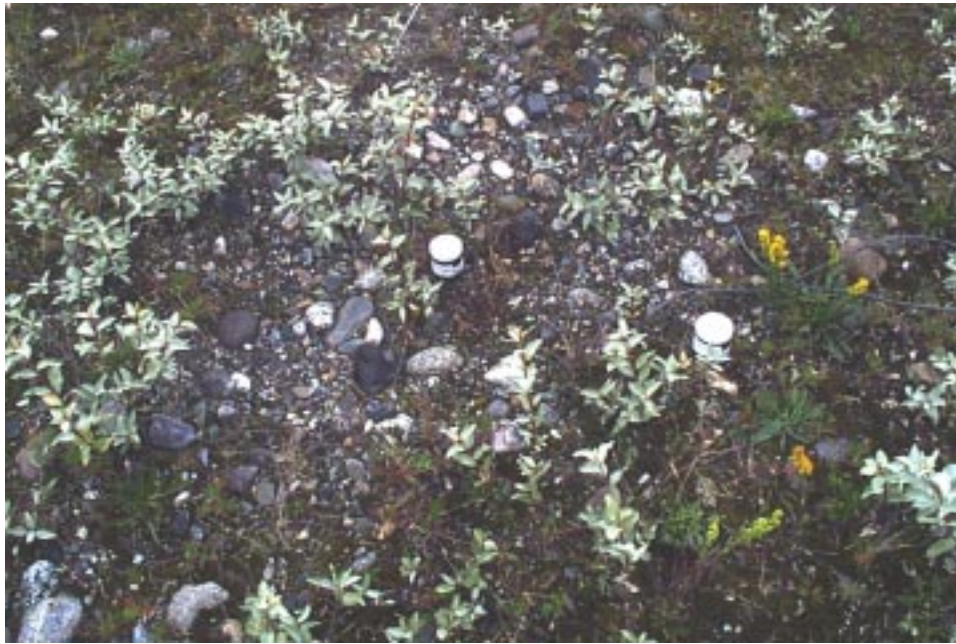
Figure 14. Range maintenance crater located near mortar test area.

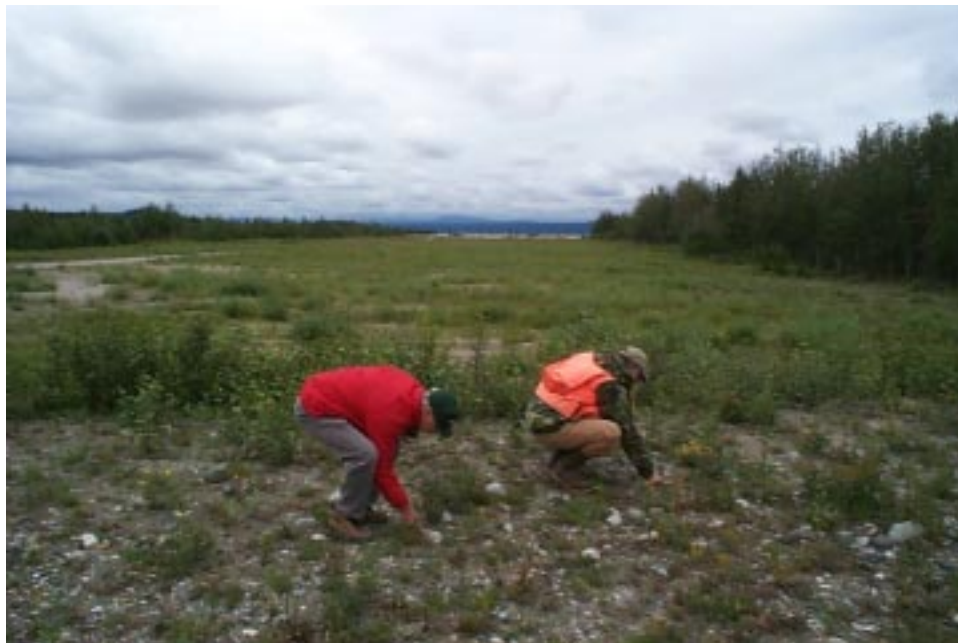
**Figure 16. Sampling soil at Lampkin Range firing point.**

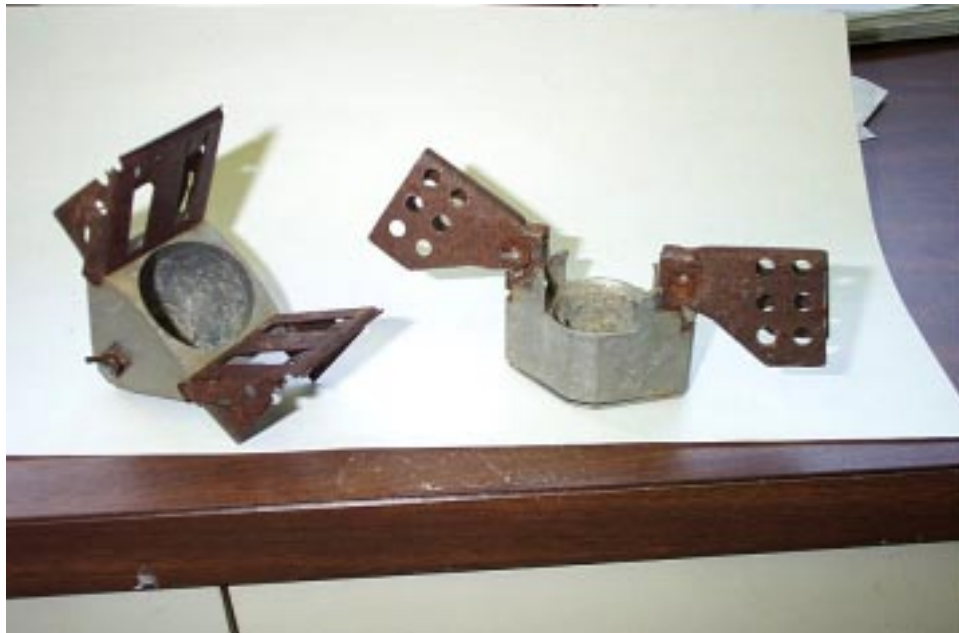
**Figure 18. Grenades (M43A1 and M39) found scattered on a gravel pad on the Washington Impact Area.**

charge. The expended grenades we found were air-burst antipersonnel munitions (Fig. 18). These types of grenades contain propellant (M5 81.95% NC and 15% NG) that shoots a steel ball filled with Comp A5 (RDX), which then detonates about 5 ft above the impact point (U.S. Army 1977).

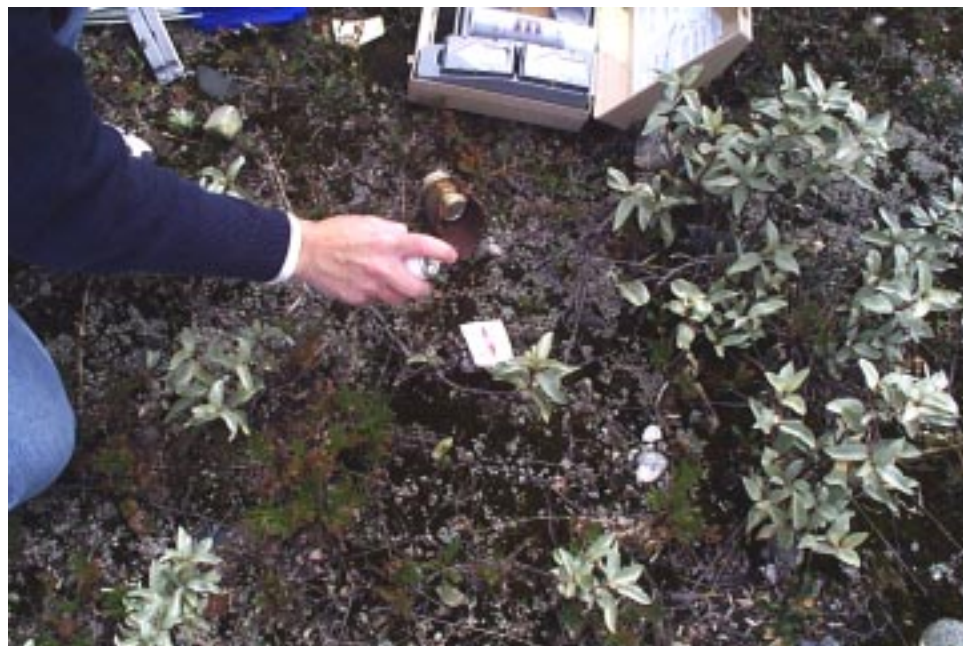
**Figure 20. Using the Expray kit to identify the explosive filler of a 2.75-in. rocket warhead as Composition B.**

Near the mortar test area, we found the remains of a 2.75-inch rocket warhead (U.S. Army 1981). We used the Expray kit to identify the explosive filler as Composition B (Fig. 20). Subsequent laboratory analysis showed that the composition was 57% RDX, 40% TNT, and 3% HMX.

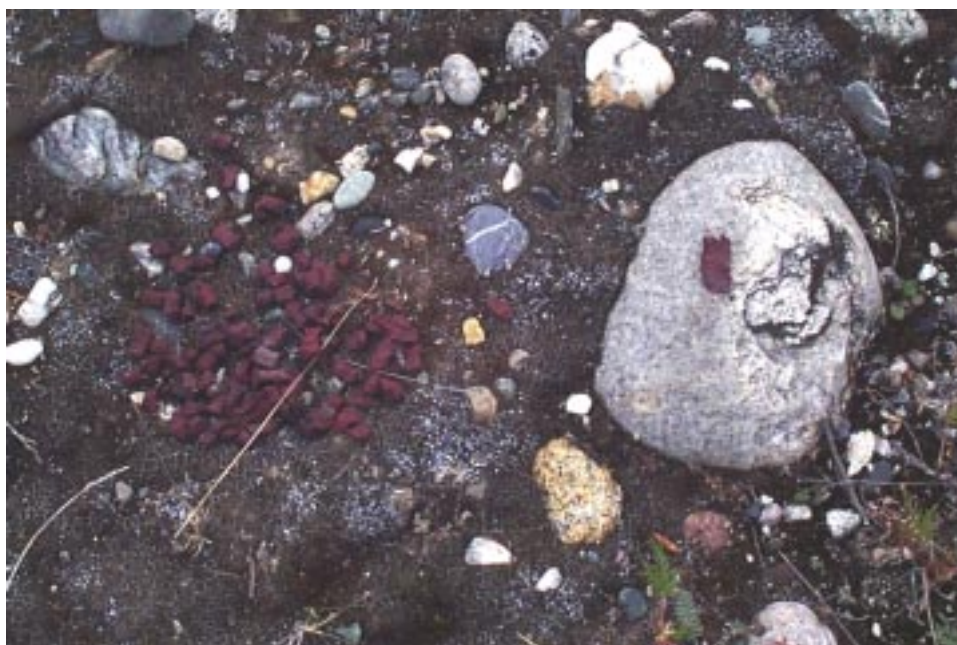
**Figure 22. Red phosphorus pellets from an L8A3 smoke grenade.**

We found a pile of red phosphorus pellets from a smoke grenade (Fig. 22). Nomenclature on the grenade was “GREN DSCHRG SMK SCR L8A3 VM GD 11/ 81 003.” This kind of grenade is used to “provide a self-screening smoke capability for armored/tactical vehicles” (TM 43-0001-29 [U.S. Army 1994]). The grenade is filled with 360 grams of red phosphorus/butyl rubber 95/5 that is supposed to be ignited by the

black powder burster charge. Red phosphorus is not toxic; however, it will contain traces of white phosphorus, which is very toxic by ingestion. We collected a few of the pellets and the surface soil under the pile of pellets. Using SW846 Method 7580, we performed a headspace SPME analysis of the pellets and analyzed the soil for white phosphorus residues. Although we detected white phosphorus in the vapor phase above the pellets, no white phosphorus residues were found in the soil.
