ERDC/EL TR-01-28

# **Design, Construction, and Operation of a Field Demonstration for In Situ Biodegradation of Vadose Zone Soils Contaminated with High Explosives**

Ken Rainwater, Justin Brown, Caryl Heintz,  
Tony Mollhagen, and Lance D. Hansen

September 2001

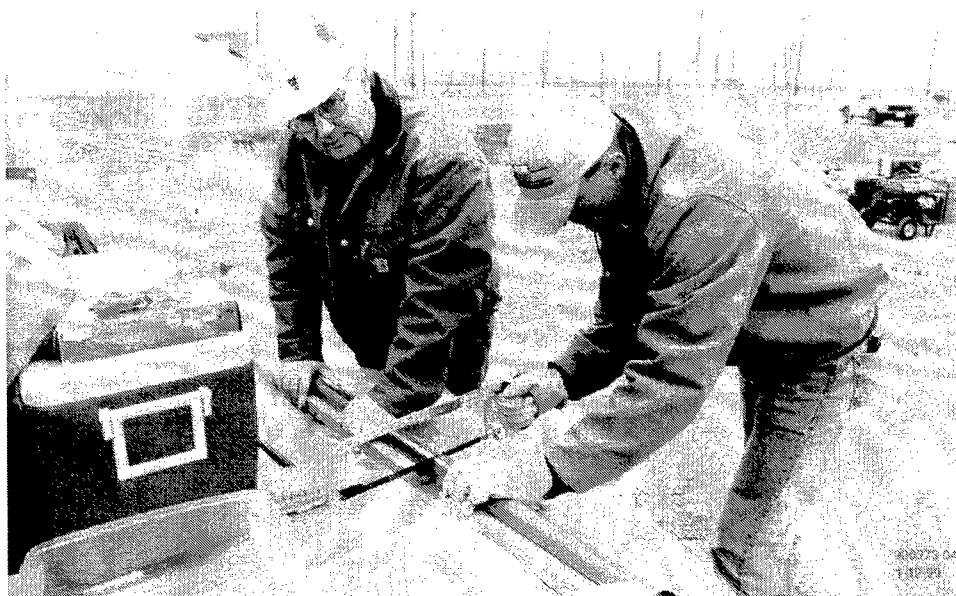
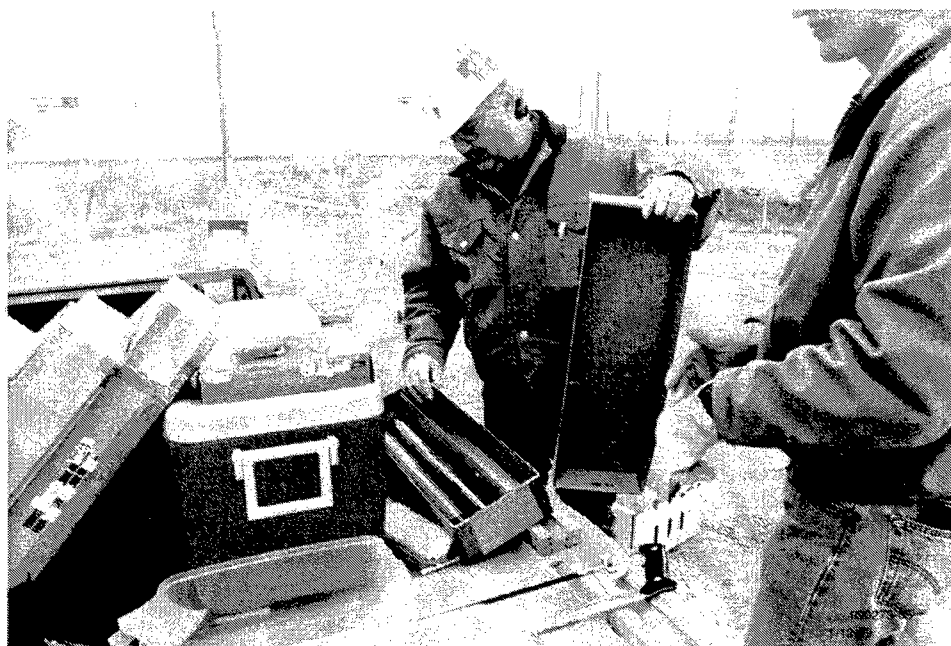
Figure 6. Preparing and handling of soil cores

As the holes were bored, 4-ft core samples were collected in clean plastic liners from the geoprobe rig. The ends of each section were sealed with rubber end caps to help maintain the original soil conditions. These samples were then cut into 2-ft sections using a sterile hacksaw blade and placed into core boxes to prevent direct contact with sunlight. Preparation and handling of core samples can be seen in Figure 6.

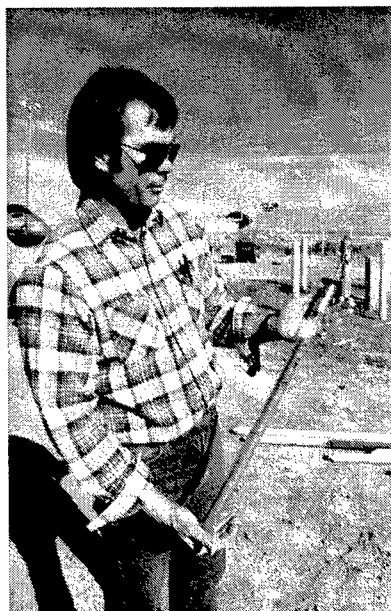
Figure 9. SPIES well and tube assembly

The strategically placed intermittent environmental samplers (SPIES) were used to monitor the amount of HE degradation occurring in the treatment zone. The SPIES soil samples were removed from the actual field site using a geoprobe rig, and the initial HE concentrations were determined for each end of the soil sample. Each soil sample was initially 2 ft long with a diameter of 1 in. The SPIES soil samples were each housed in a plastic tube that had 0.125-in.-diam holes drilled 1 in. apart on centers at 90, 180, 270, and 0 deg to allow adequate movement of gas into the soil

sample. The SPIES wells (shown as “S” in Figure 7) were constructed to have soil sample depths of 8, 15, or 25 ft (depth noted on Figure 7). The six SPIES wells were cased using 2.5-in. PVC pipe with screened sections in the bottom 2.5 ft of the well. The screened section of each well was sand-packed, and bentonite chips were used just above the screened section. A 0.25-in. copper tube was installed from the middle of the screened section to the manhole to monitor the composition of gasses in the well. A diagram of a SPIES well and picture of the SPIES tube assembly can be seen in Figure 9. The surface completions were the same as the injection and extraction wells.

Each soil sample was suspended in 2.5-in.-diam PVC screen by braided wire attached to the well cap. The SPIES soil samples were removed from their respective wells once a month for collection of a 15- to 20-g sample from each end of the soil core. The soil samples were then analyzed (using the method described in Chapter 3) for HE concentration to determine the amount of degradation occurring in the SPIES soil samples.

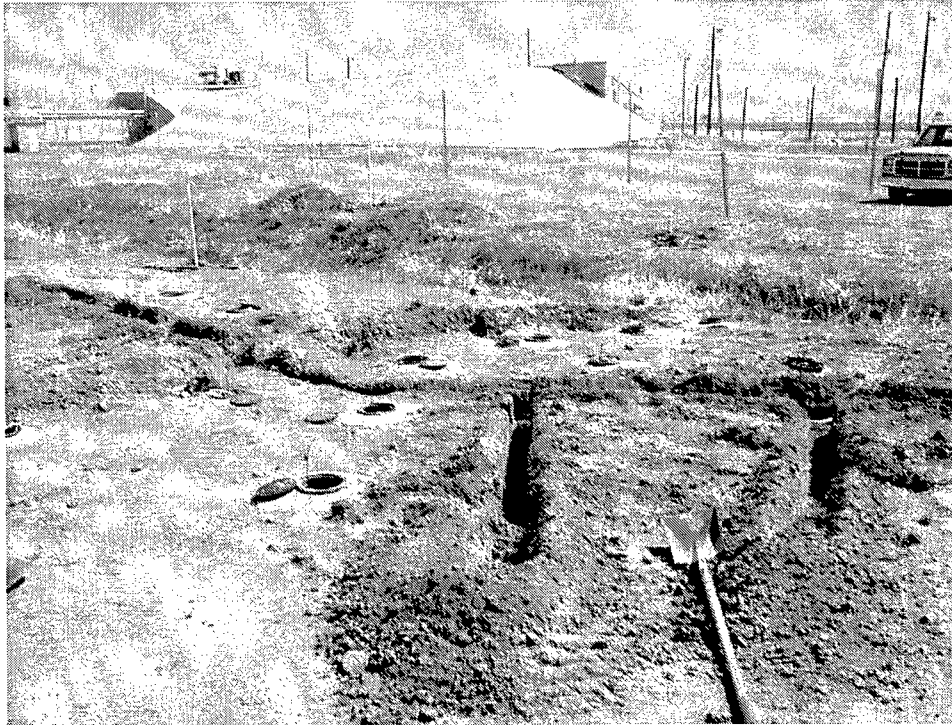
Figure 10. Installation of plumbing and control buildings

The 29 copper tubing lines were run from the finished field site to control buildings located approximately 150 ft southwest of the finished site. The tubing was buried approximately 11 in. below the ground surface to avoid any buried utility lines and to protect against freezing and inadvertent damage. Where the copper tubing crossed the road, the tubes were placed in three separate bundles and run through 2.5-in.-diam steel pipes to prevent the weight of passing vehicles from crushing the copper tubes. For aesthetic purposes, the copper tubes were then run through an 8-in. PVC pipe before entering the south wall of the control building. Photographs of

the plumbing work and control buildings can be seen in Figure 10. The two 10-ft by 10-ft control buildings were placed approximately 150 ft southwest of the field well site. One control building housed most of the plumbing work, valves, flow meters, and extraction pumps. The other control building housed the liquid nitrogen cylinder, water column, and gas-monitoring devices.
