Naval Research Laboratory

NRL/PU/6110- -99-388

Advanced Nontoxic Fouling Release Coatings

Environmental Security
Technology Certification
Program

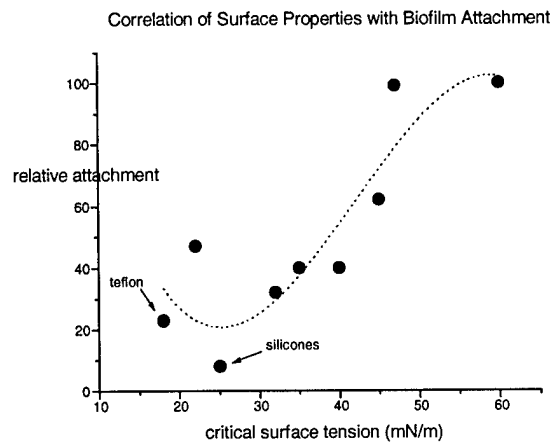
Figure 2-1. Graph illustrating the correlation between surface properties with biofilm attachment to those surfaces (from Baier⁹).

Silicone fouling release coatings present a surface unsuitable for strong adhesion of macrofouling organisms. The accumulation of macrofouling organisms on immersed substrates occurs after an initial conditioning film and subsequent layers of the algal or slime films are deposited. In spite of this layering it is evident that the surface properties of the substrate are key in determining macrofouling adhesion strength. Substrates having critical surface tensions in the 25 to 30 mN/m range optimally resist strong macrofouling attachment⁹. Silicone coatings typically exhibit surface free energies in this range and thus are uniquely suited for fouling release applications. Figure 2-1 shows that silicones, while not having the lowest possible critical surface tension, exhibit the least biofilm attachment⁹.

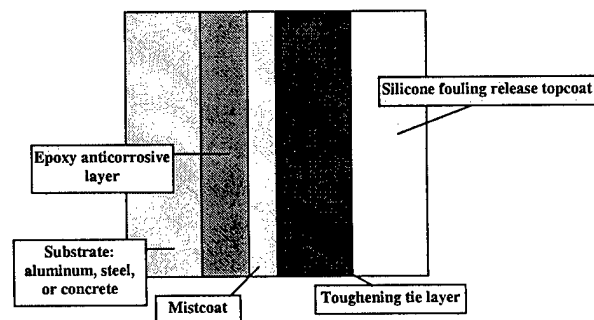
Figure 2-2. The NRL-GE duplex fouling release coating system.

The duplex coating system was designed for use on ship hulls. It is a multi-layered coating made up of one or more layers of epoxy AC paint, an epoxyamide mistcoat to ensure bonding of the Silgan J-501[®] tiecoat to the AC layer, the toughening Silgan J-501[®] tie layer, and the elastomeric silicone topcoat. GE Silicones products RTV11[®] or EXSIL2200[®] are suitable as fouling release topcoats with the duplex coating system. This system provides corrosion protection, excellent bonding of all coating layers, enhanced durability and toughness, and easy release of macrofouling. The fouling release properties of the silicone topcoat may be enhanced by the addition of nonbonded polydimethyldiphenylsiloxane oils.

Figure 2-2 illustrates the system as it is applied to metal (steel or aluminum) and concrete substrates. Concrete substrates are coated similarly to metal surfaces except that a concrete sealer (such as Ameron Amercoat 105A) is used to prime the freshly blasted surface instead of a high-solids epoxy paint. The application procedures for each layer are described in Sections 2.1.1 through 2.1.4. Application of the entire system usually takes 3-4 days: 1 day for each layer of anticorrosive paint (usually the system requires two coats); 1 day for the mistcoat, tie layer, and topcoat; and 1 day for application of the coating system to block shift patches for small craft. Application specifications for each layer of the system are shown in Table 2-1.

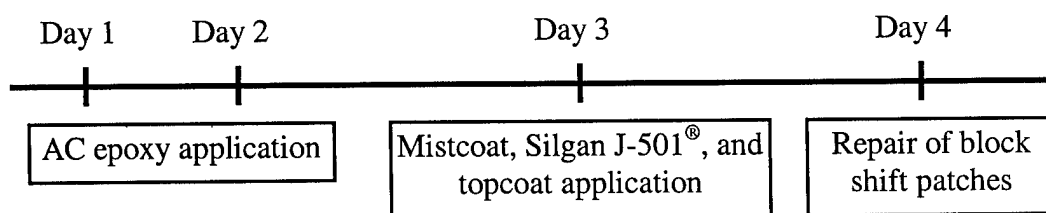
Figure 4-1. Timeline of duplex coating system application.

The time for the application of the duplex coating system to a boat or power plant is about four days. Figure 4-1 illustrates the timeline of the procedure. Assuming that the hull or concrete surface has already been cleaned and grit-blasted to the desired surface profile, the clean surface is wiped with naphtha to remove any residual moisture and dust; subsequent spray application of the initial coat of AC epoxy paint takes place on the first application day. The epoxy is allowed to cure overnight. A second coat of anticorrosive paint is applied on the second day and allowed to cure overnight.

On the third day, the duplex coating system itself is applied. The cured epoxy surface is wiped once again with solvent to remove any residual moisture and dust; once the mistcoat is prepared as described in Section 2.1.2 of this report, it is applied to the epoxy AC layer to a 0.002-0.003 inch wet-film thickness. When the mistcoat is slightly tacky, Silgan J-501[®] is applied to a 0.017-0.019 inch wet-film thickness. The silicone topcoat (either RTV11[®] or EXSIL2200[®]) is sprayed after the Silgan J-501[®] is tack-free. Seven days is required for complete cure of the system, but a minimum of three days is recommended before re-immersion of the boat once the system application is complete.

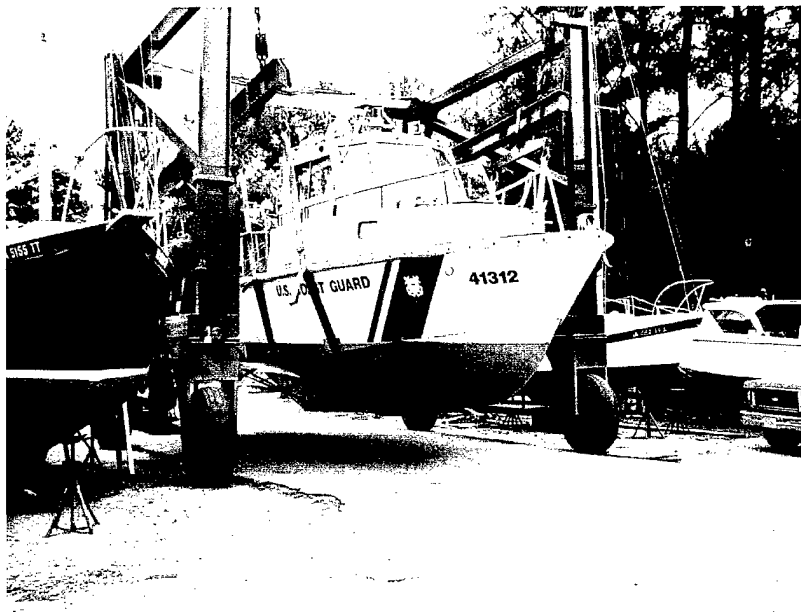
Figure 5-1. The duplex coating system as applied to UTB 41312.

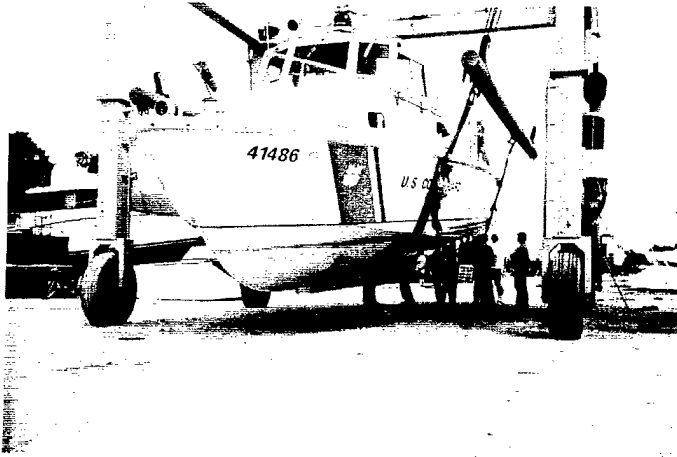
USCG UTB PENNSACOLA, FL.
(18 JULY 96)

Figure 5-2. Duplex system applied to UTB 41486 after one year of service.

UTB 41486 proved to be the first instance of delamination on a boat platform that required extensive repair. The duplex coating system had been rolled on prior to the development of spraying expertise. A dive inspection in the summer of 1996 reported that the coating was "peeling off" and the hull was severely fouled. When the boat was pulled from the water for repairs in September 1996, the damage was found to be much less extensive than reported; only 10 ft² of the original 400 ft² had delaminated, and no hard fouling was observed (except on exposed epoxy paint).

A photograph of the duplex system on the UTB 41486 after one year of service is shown in Figure 5-2. The damage was repaired with RTV11® catalyzed with SCM501C®, which contains a high percentage of adhesion promoter to adhere to many types of surfaces. Unfortunately, the repair to UTB 41486 was unsuccessful, mostly likely due to poor surface preparation of the repaired area, and the Duplex system was removed and replaced with a conventional marine paint. The EXSIL2200® coating system on UTB 41345 was also removed at the same time and replaced with a competitor's easy release coating.

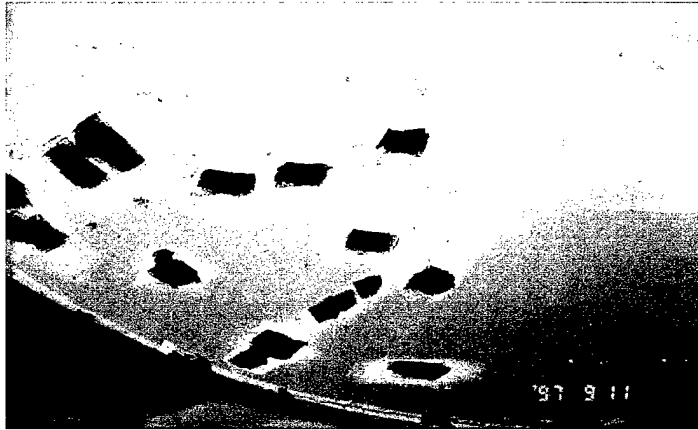
Figure 5-9. Application of toughening tie layer to deficient patches for repair of the NRL-GE duplex coating system.

GE has developed a repair package for the duplex coating system. The steps used to carry out the repair are illustrated in Figures 5-6 through 5-10. To our knowledge, competing fouling release coating systems do not have packages with which patches of abrasion damage may be repaired.

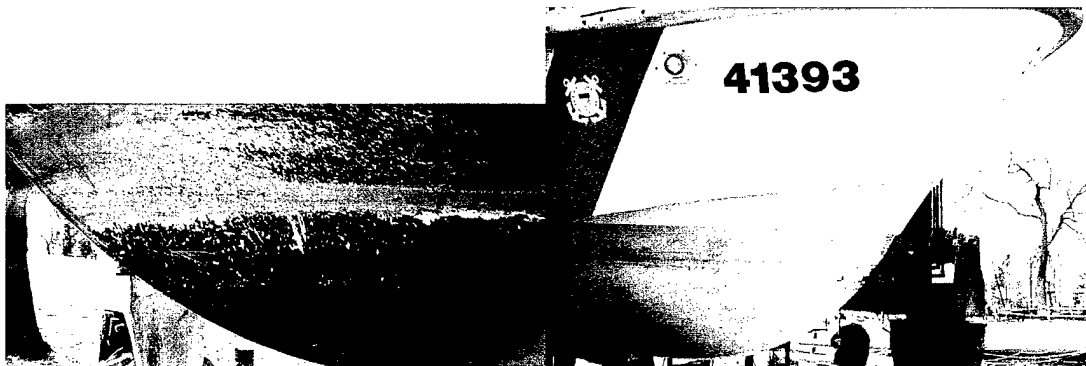
Figure 5-11. Comparison of ice damage to a competitor's fouling release coating (left) and the NRL-GE duplex fouling release coating system (right) on two 41' USCG UTB's.

One advantage of the NRL-GE duplex coating system is its durability and toughness relative to that of existing commercial silicone fouling release coatings. Ice abrasion damage on the U.S. Coast Guard UTB's 41312 and 41393 occurred to a much lesser extent than abrasion damage to a competitor's coating on a nearby 41' UTB. A comparison of the damage to these UTB's is shown in Figure 5-11.
