**WL-TR-94-4112**

**THE SURFACE PREPARATION OF  
ALUMINUM ALLOYS USING THE  
PHOSPHORIC ACID CONTAINMENT SYSTEM  
FOR REPAIR**

**SUSAN S. SALIBA**  
University of Dayton Research Institute  
300 College Park Avenue  
Dayton, OH 45469-0168

**INTERIM REPORT FOR PERIOD 01 JUNE 1992 – 31 DECEMBER 1993**

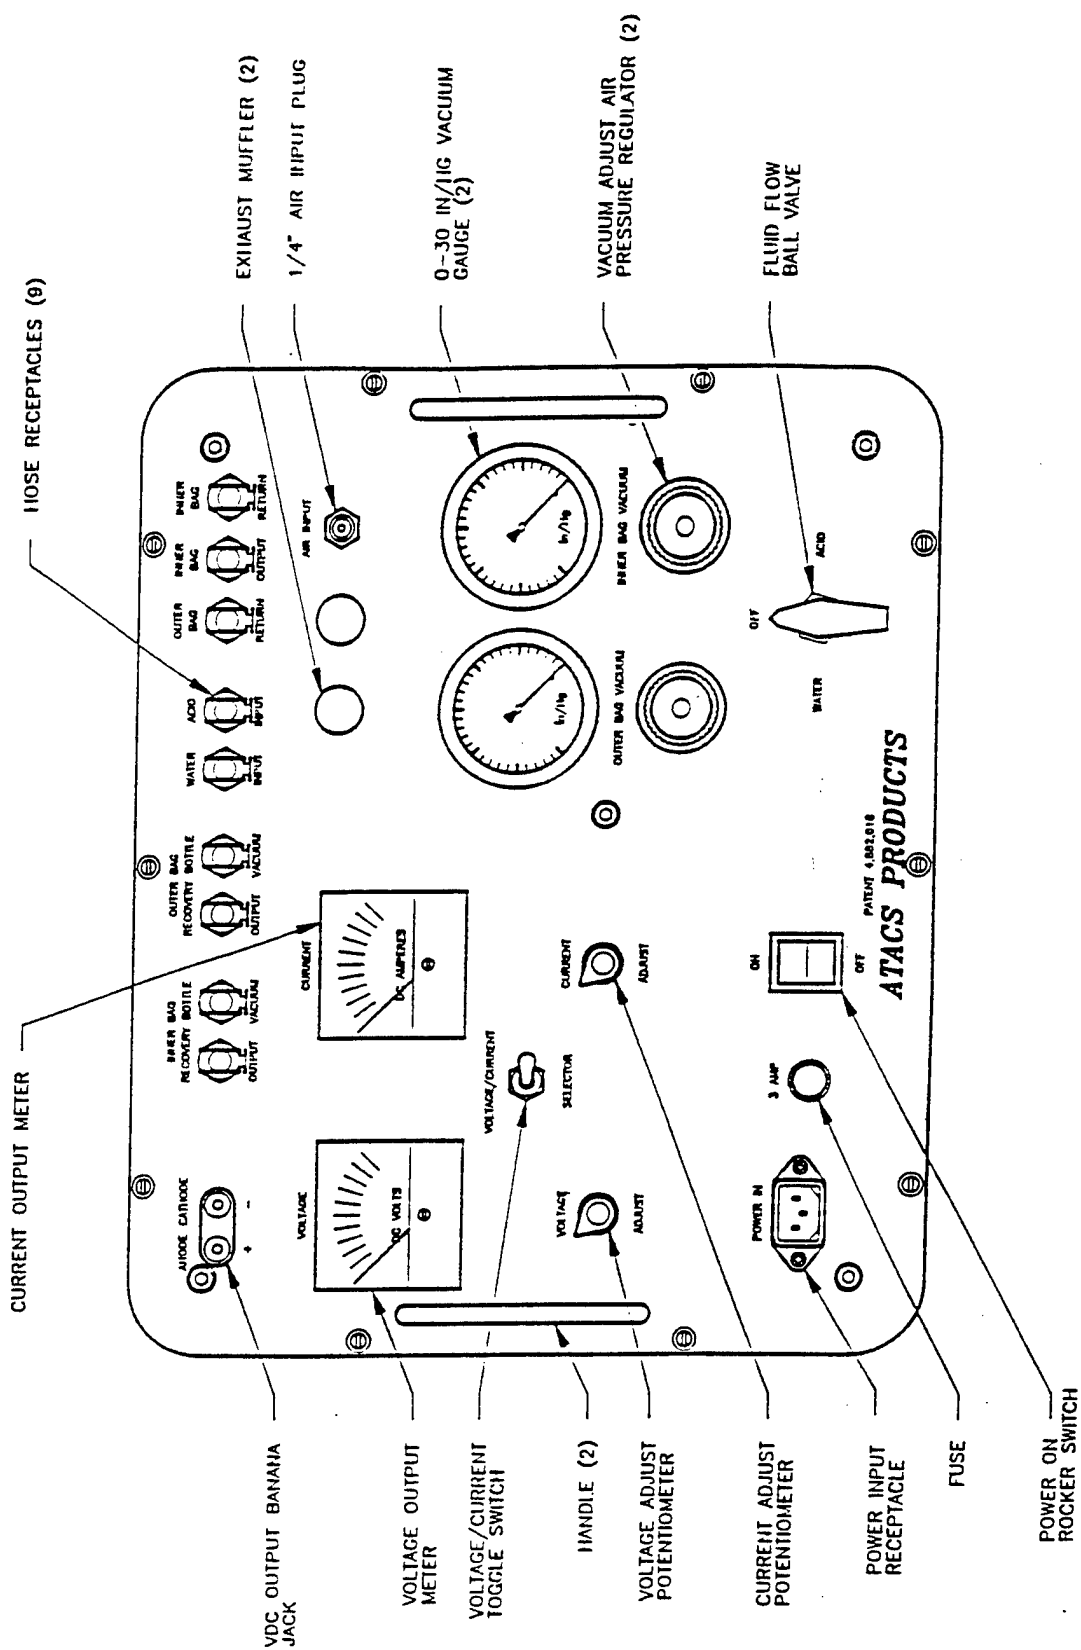
Figure 2. Phosphoric Acid Containment System (PACS) Control Panel

- A - Brown-Coded Inner Vacuum Bag Output Hose
- B - Green-Coded Inner Vacuum Bag Return Hose
- C - Yellow-Coded Outer Vacuum Bag Return Hose

Two types of tests were used for anodized aluminum surface evaluation: wedge tests and surface morphology characterization. Wedge tests were conducted to determine the integrity of the bond between the surface preparation and the adhesive. Surface morphology tests were conducted to compare the morphology of the standard phosphoric acid anodization (PAA) prepared surfaces with the morphology of the PACS prepared surfaces. Both oxide structure and thickness were documented. The sequence of activities used for this investigation is outlined in Figure 1. The PACS Model 0810 was utilized for all experimentation. This unit consists of a portable control panel which allows for the control of vacuum, voltage, and current. In addition, acid and water recovery bottles as well as connective tubing are utilized to contain the acid medium during anodization. Figure 2 illustrates the PACS Model 0810 control panel.

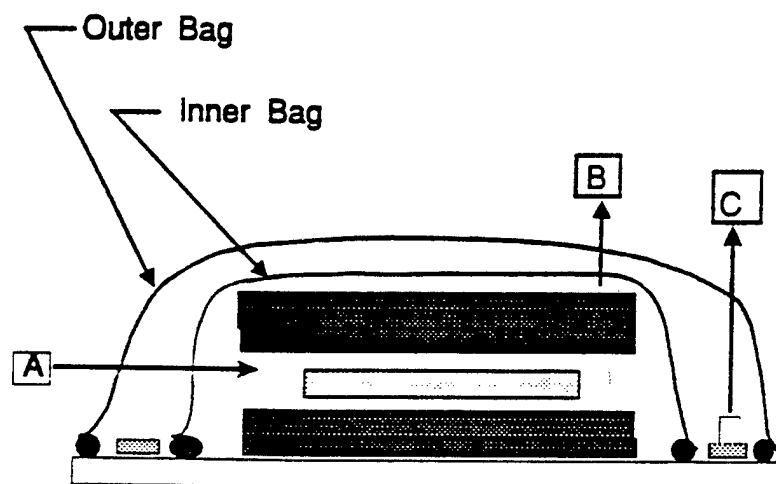
**Figure 3. Stacking Sequence of Repair Area Lay-Up**

- Aluminum Panel (Anode)
-

- 10 oz Airweave N10 Polyester Breather Cloth
-

- Stainless Steel Screen (Cathode)
-

- 1 " Fiberglass Breather Cloth
-

Prior to the anodization procedure the area to be repaired was abraded with 3M Company Scotchbrite (fine) under tap water and solvent wiped until a water break-free surface was obtained. The area was then vacuum bagged. The stacking sequence which is illustrated in Figure 3, included the area to be repaired, four layers of breather material, and inner and outer vacuum bag. The inner bag contains the phosphoric acid during the anodization and the outer bag provides protection in the event of a leak in the inner bag. An inlet acid hose was placed in the lower right corner of the inner bag and was then attached to the control panel in accordance with the operating manual supplied by ATACS Products, Inc. [4]. An outlet acid hose was placed in the upper left corner and was then attached to the unit. Note that all hoses are color coded making it nearly impossible for the operator to improperly connect them. Subsequently, the anode wire was connected from the aluminum panel to the control panel while the cathode wire was connected from the screen to the control panel.

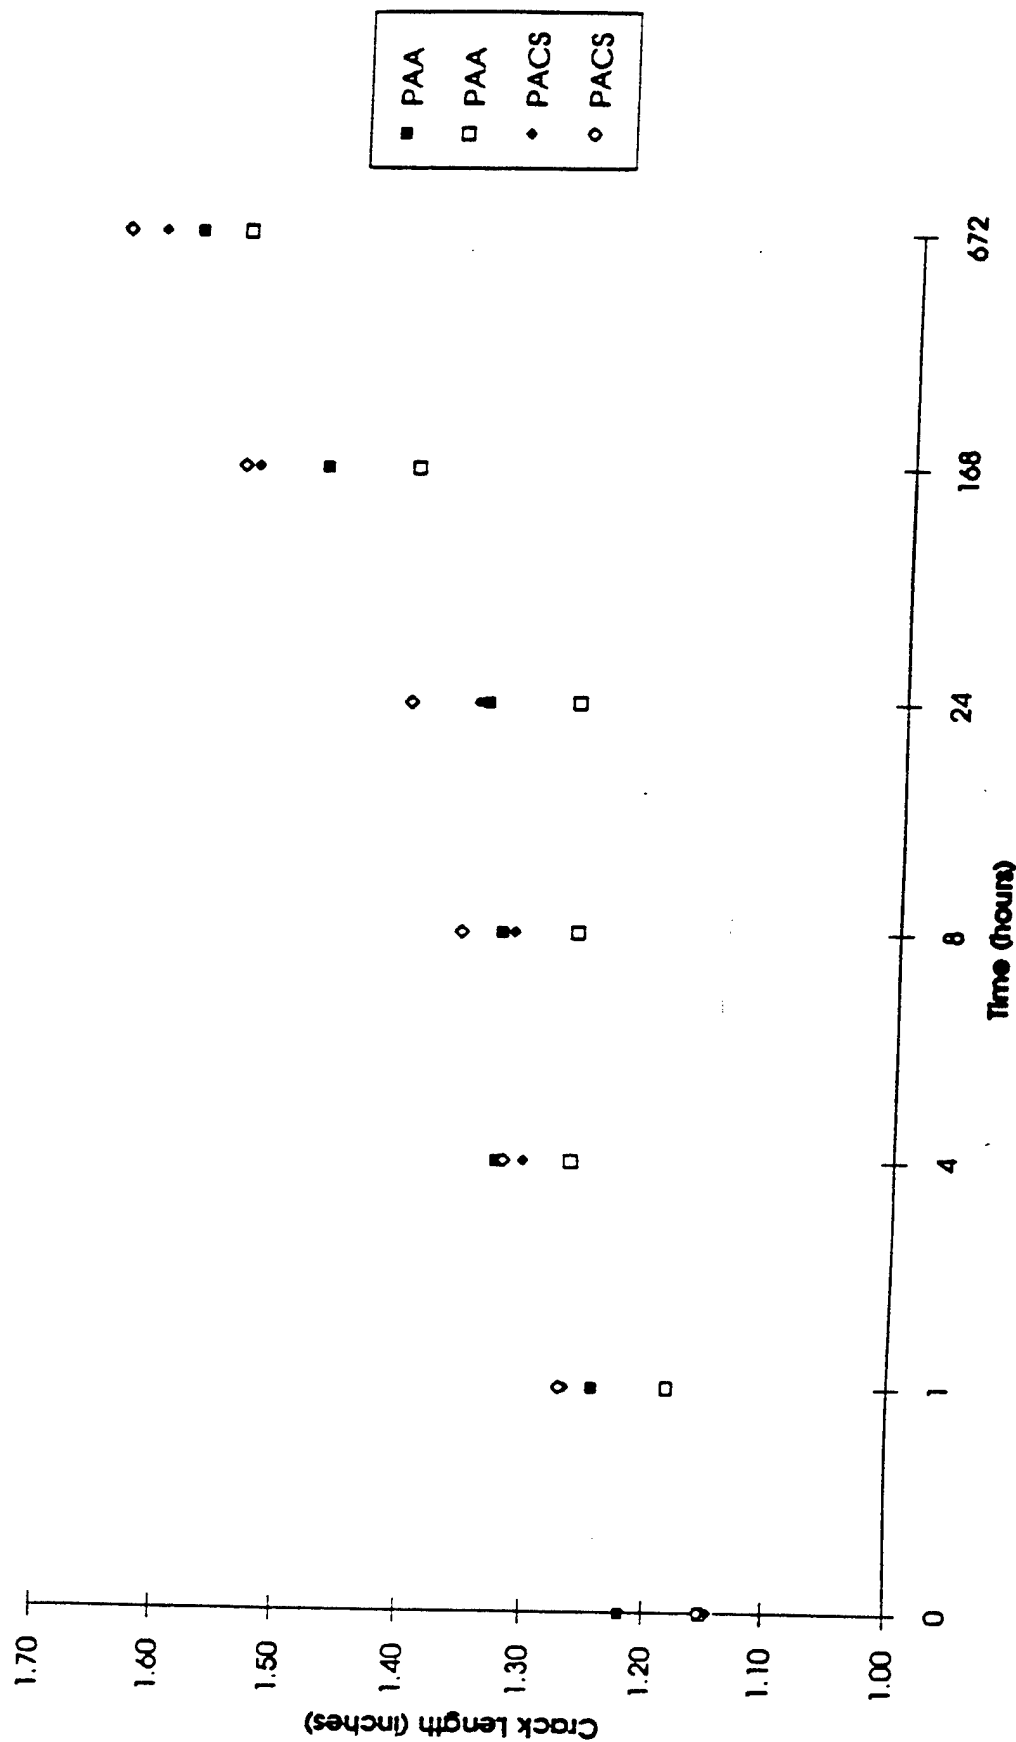
Figure 4. Average Crack Growth Curves Comparing PAA and PACS Anodized AI 2024-T3 Fabricated Using BR 127 Primer and AF 163-2 Adhesive

\* All curves are an average of five specimens

Wedge test panels were prepared and tested as discussed in Section 2.2. All the panels were primed with BR 127 and bonded with either FM 73 or AF 163-2. The wedge test results for the 2024-T3 bare aluminum specimens that were anodized by either the PAA or PACS techniques are presented in Tables 2 and 3. Graphical representations of these results are illustrated in Figures 4 and 5. For both adhesives, the specimens that were anodized using the PACS technique showed crack growths similar to the baseline PAA prepared surfaces. Wedge test results for 7075-T6 bare aluminum specimens that were anodized by either the PAA or PACS techniques are presented in Tables 4 and 5. Graphical representations of these results are illustrated in Figures 6 and 7. For both adhesives, the specimens that were anodized using the PACS technique showed crack growths similar to the baseline PAA prepared surfaces.

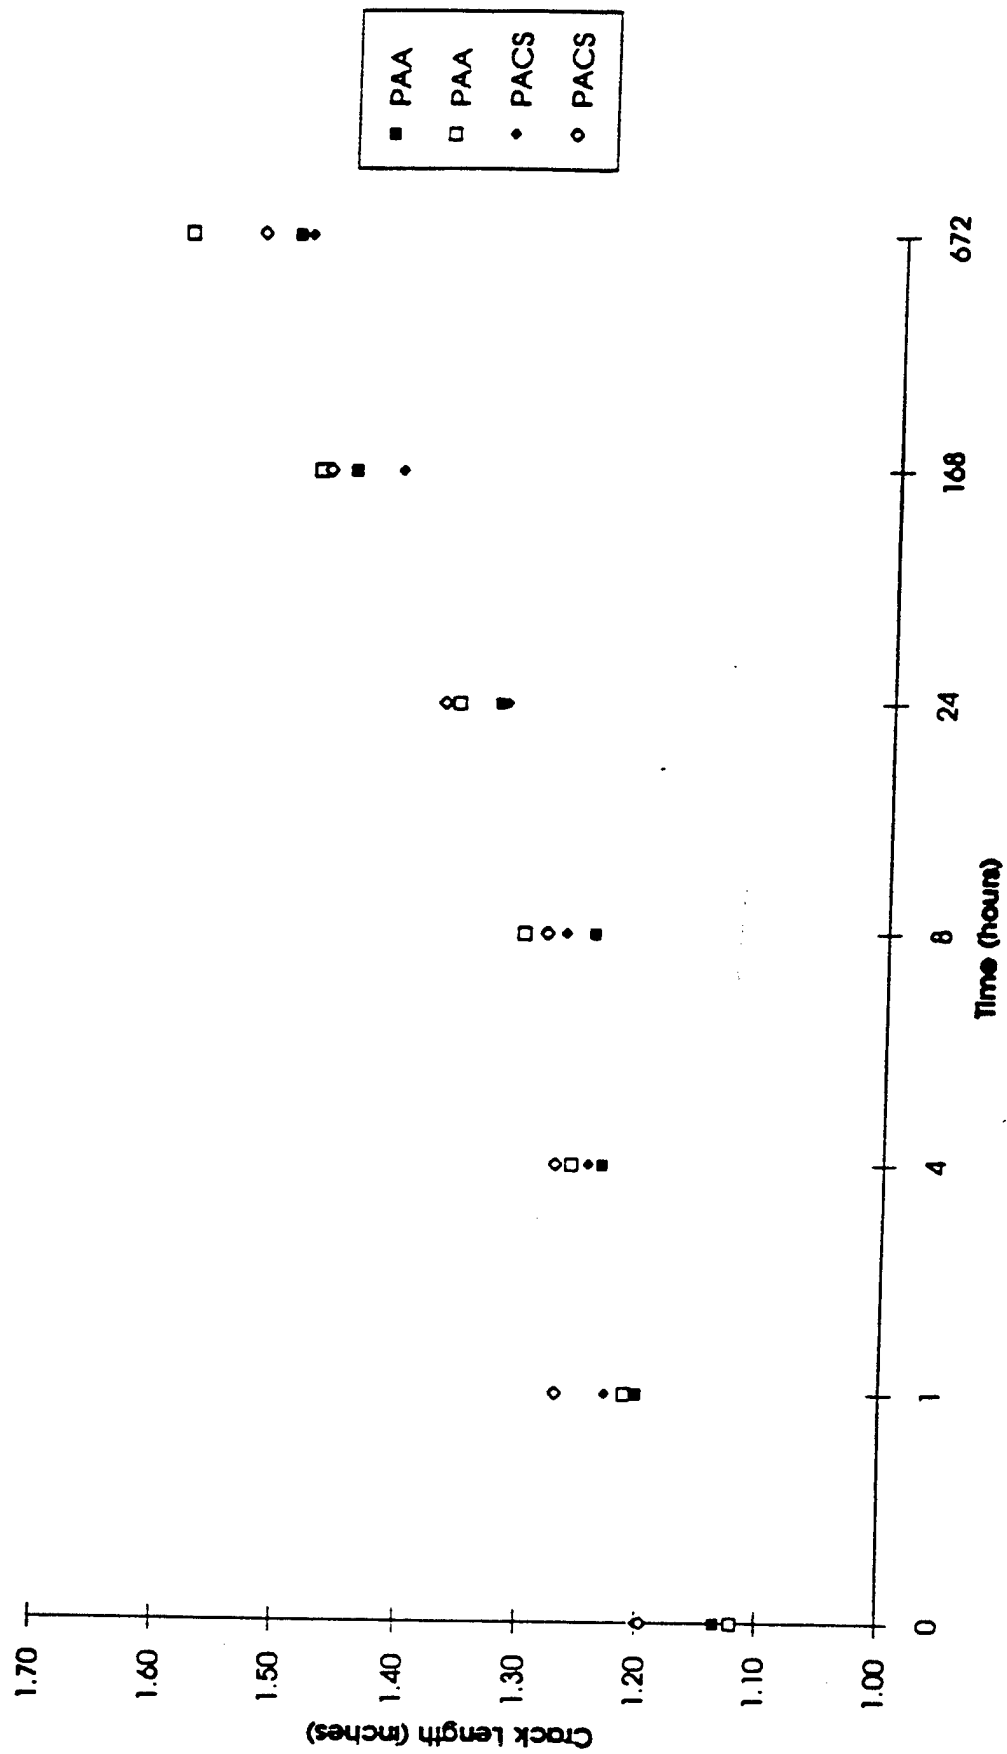
Figure 5. Average Crack Growth Curves Comparing PAA and PACS Anodized Al 2024-T3 Fabricated Using BR 127 Primer and FM 73 Adhesive.

\*All curves are an average of five specimens

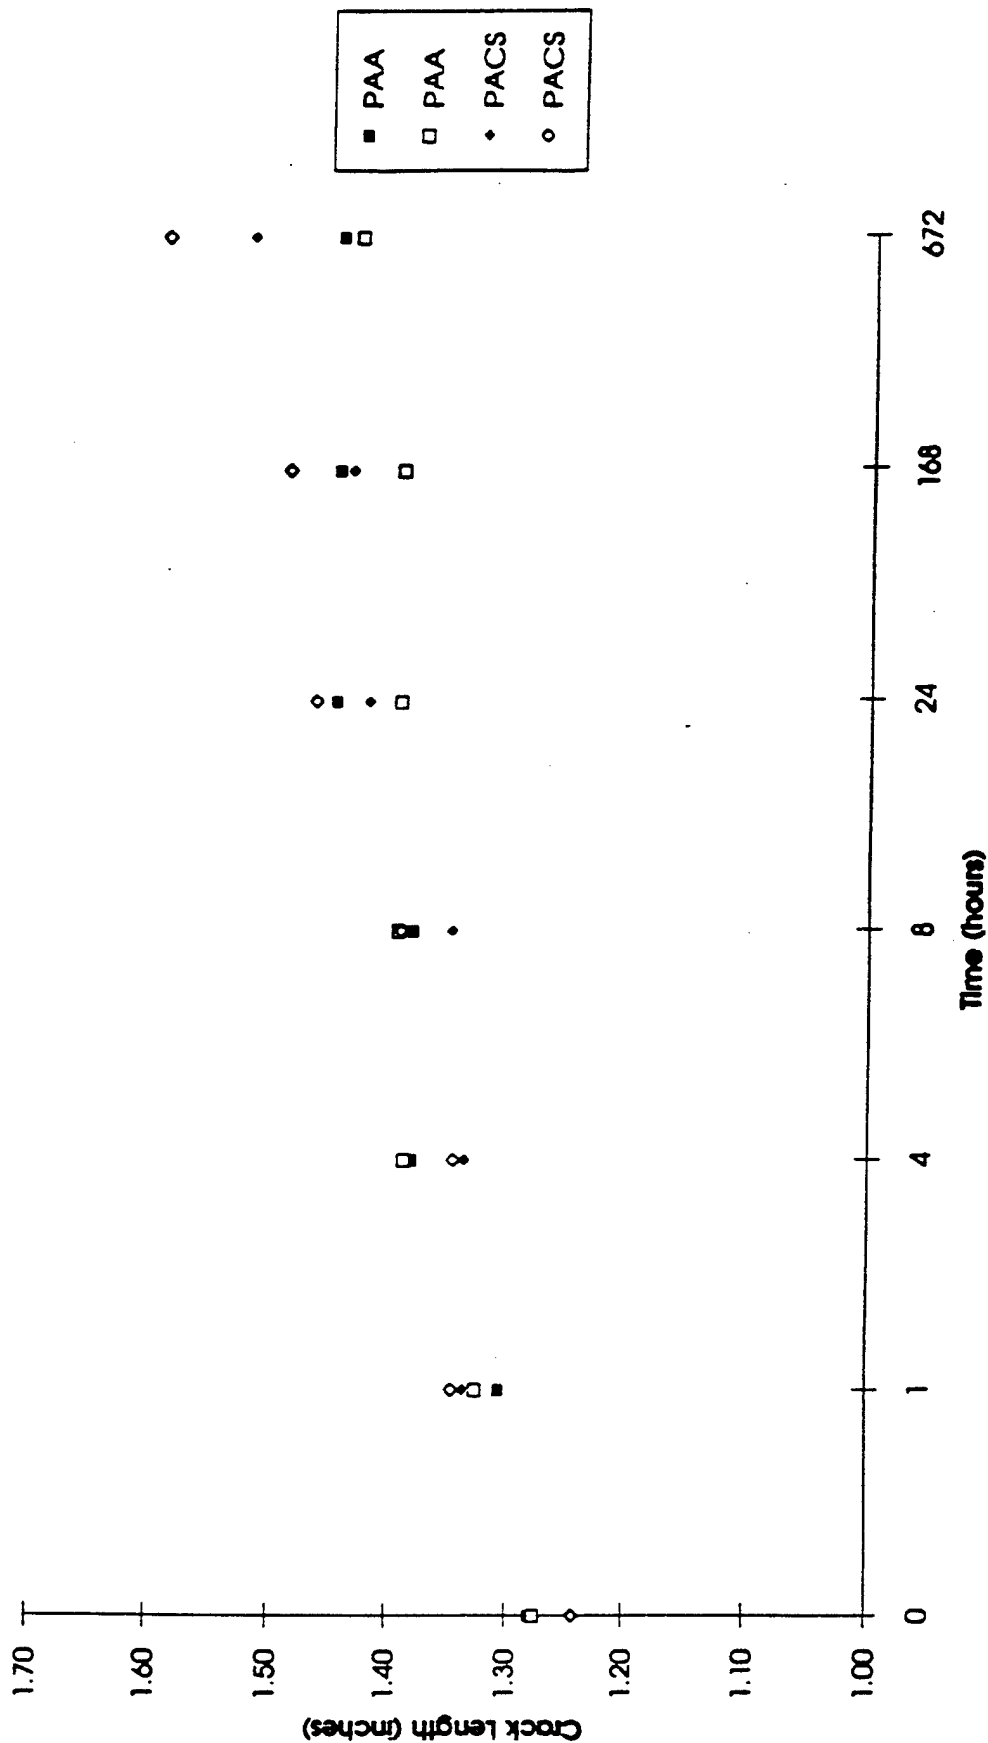
Figure 7. Average Crack Growth Curves Comparing PAA and PACS Anodized Al 7075-T6 Bare Fabricated Using BR 127 Primer and FM 73 Adhesive.

\*All curves are an average of five specimens

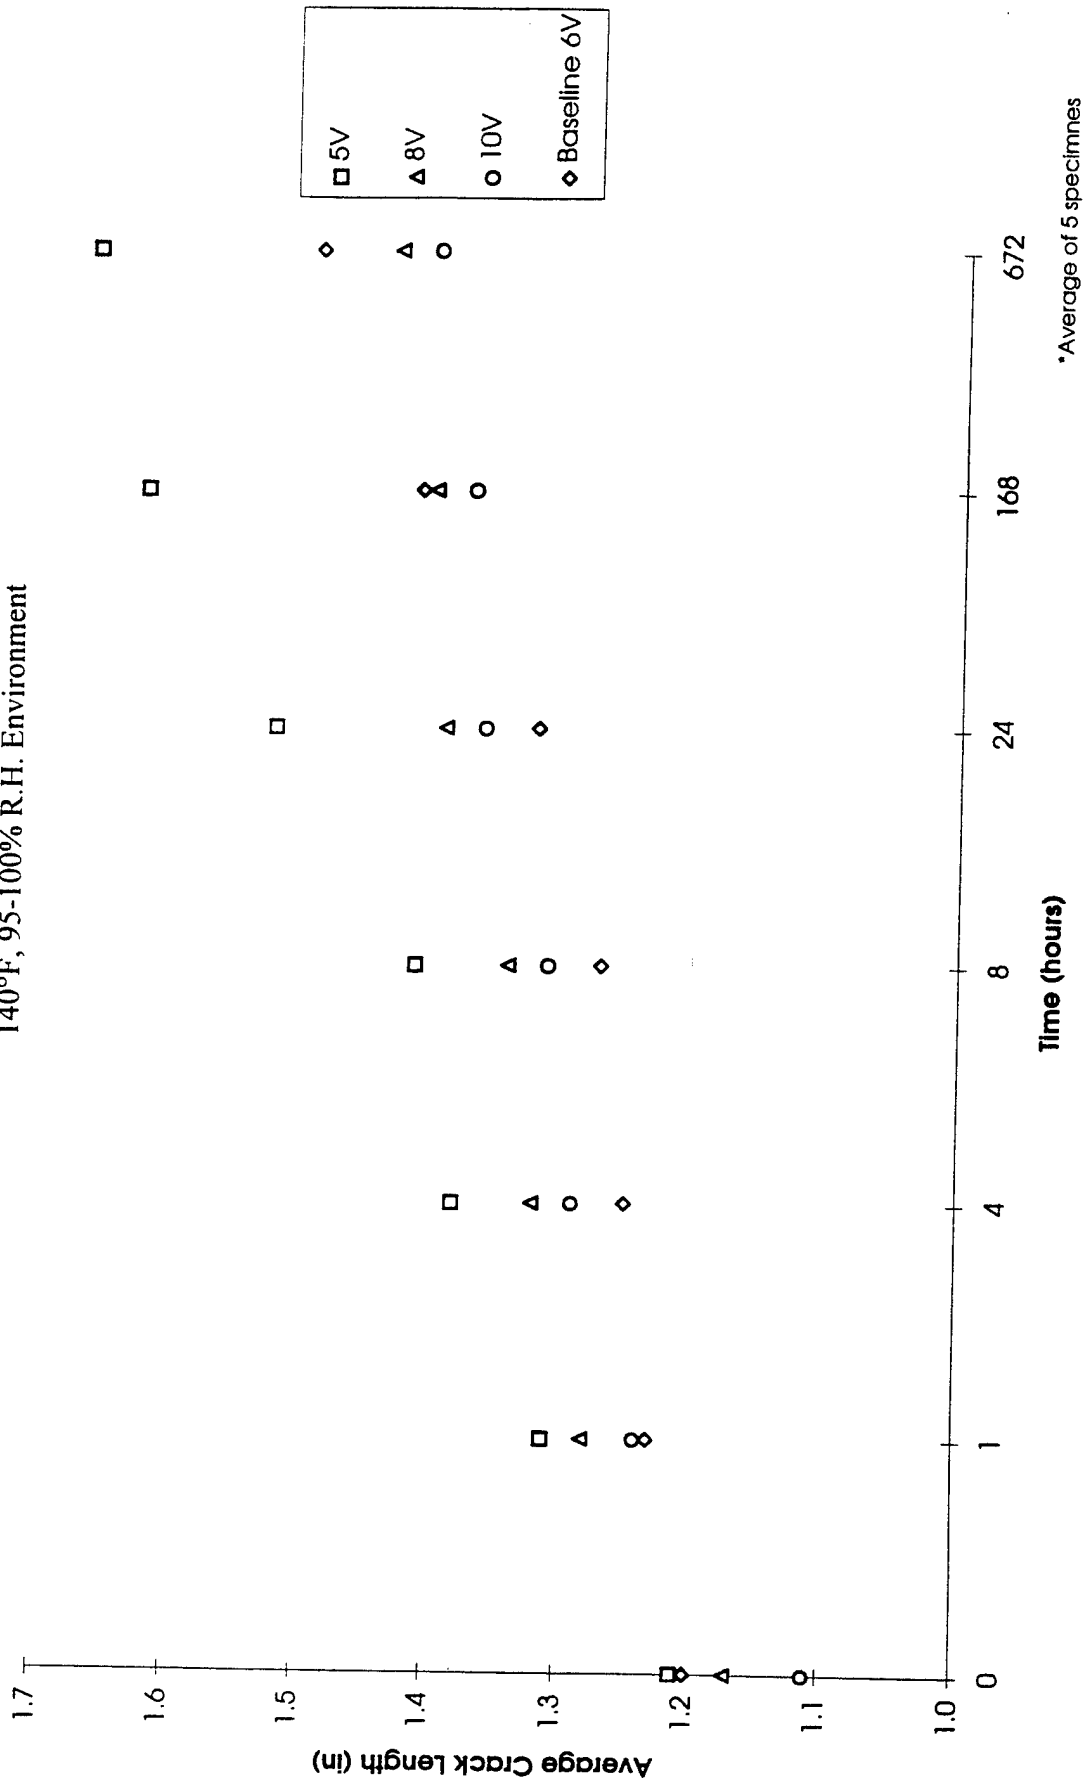
**Figure 8. Effect of Voltage on Crack Growth Behavior**

**Cumulative Wedge Test Results**  
 Al 2024-T3 Bare/BR 127/FM 73  
 140°F, 95-100% R.H. Environment

Several wedge test panels have been made with nonstandard voltage. Operational limits of the PACS unit ranged from a low of 5 to a high of 10 volts. Figure 8 presents wedge crack growth results for panels anodized at 5V, 8V, and 10V. Results indicate higher crack growth rate for those specimens anodized at 5V, which is out of the 6-10 VDC range recommended in the operating procedure.

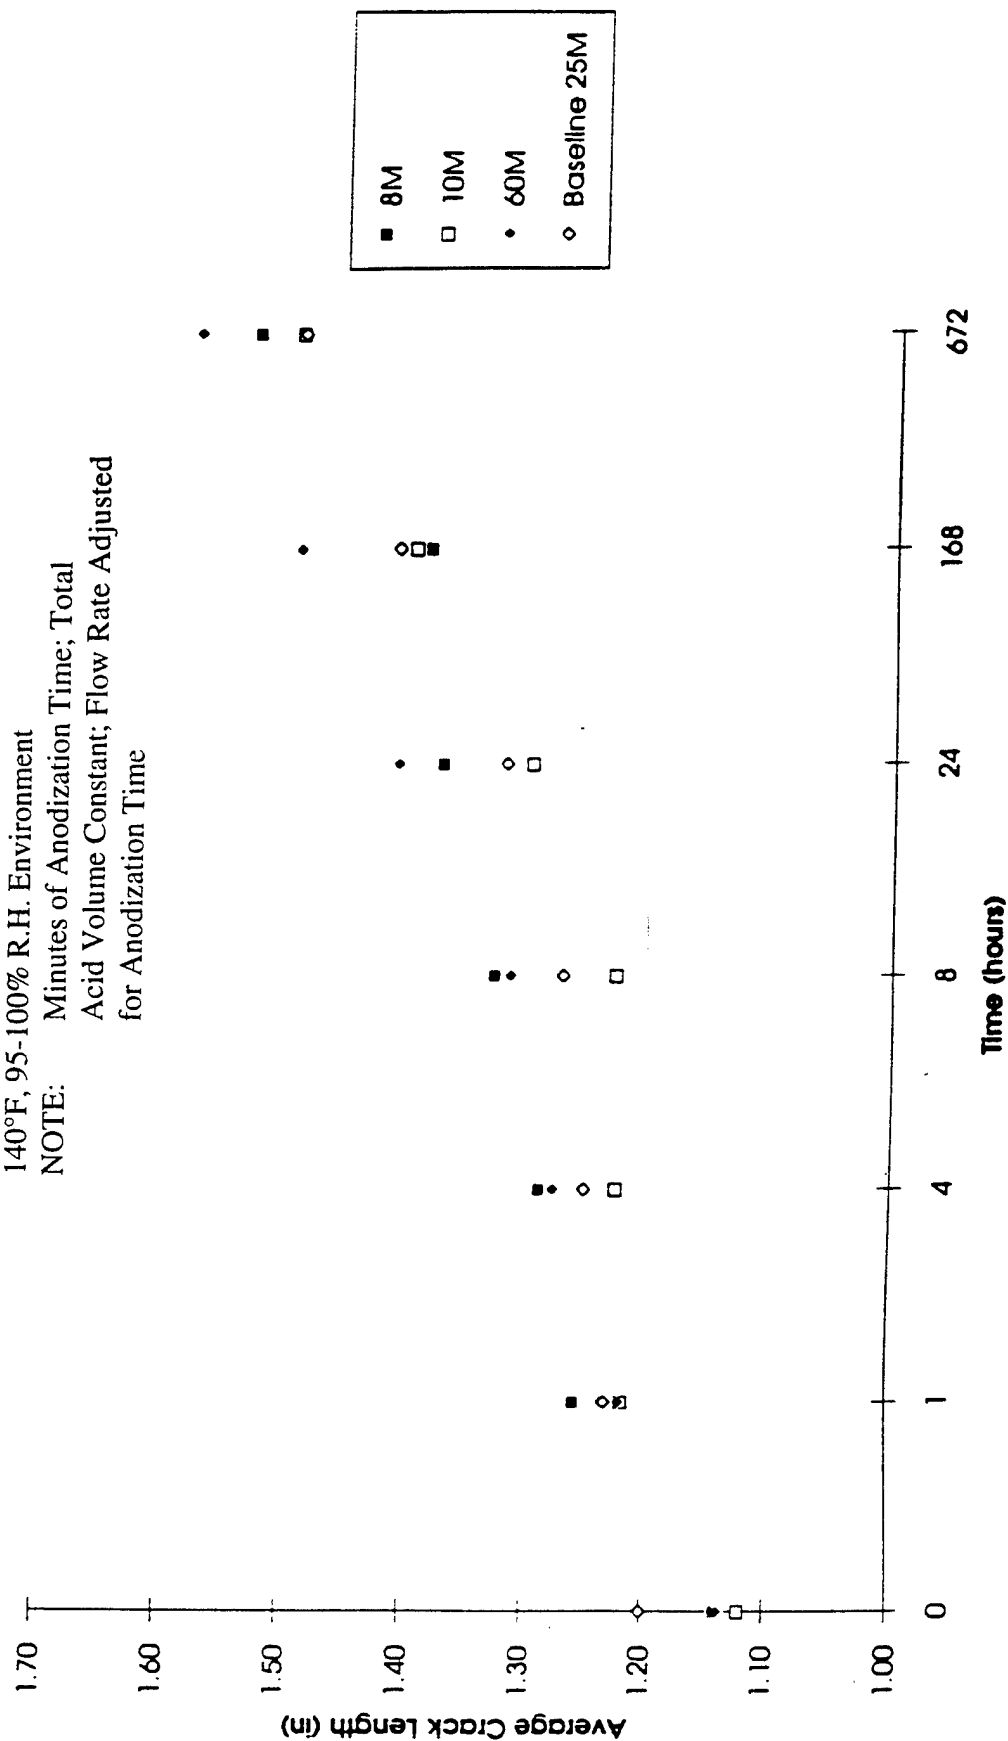
Figure 9. Effect of Anodization Time on Crack Growth Behavior of PACS Prepared Surfaces.

Minutes of Anodization Time; Total

Acid Volume Constant; Flow Rate Adjusted  
for Anodization Time

\*Average of 5 specimens

Several wedge test panels were made varying the anodization time. Anodization times ranging from 8 minutes to 60 minutes were utilized to anodize panel surfaces with the PACS unit. The acid flow rates for these panels were adjusted appropriately so that the 2-liter supply would last just long enough to complete the anodization. Thus higher flow rates were used for shorter anodization times and lower flow rates for longer times. Figure 9 presents wedge crack growth results for panels anodized for 8 min, 10 min, and 60 min. Figure 9 illustrates that although 25 minutes is recommended, an anodization time of 10 minutes would be sufficient to successfully anodize the surface. Also, extending the anodization time to 60 minutes does not significantly affect the surface quality.

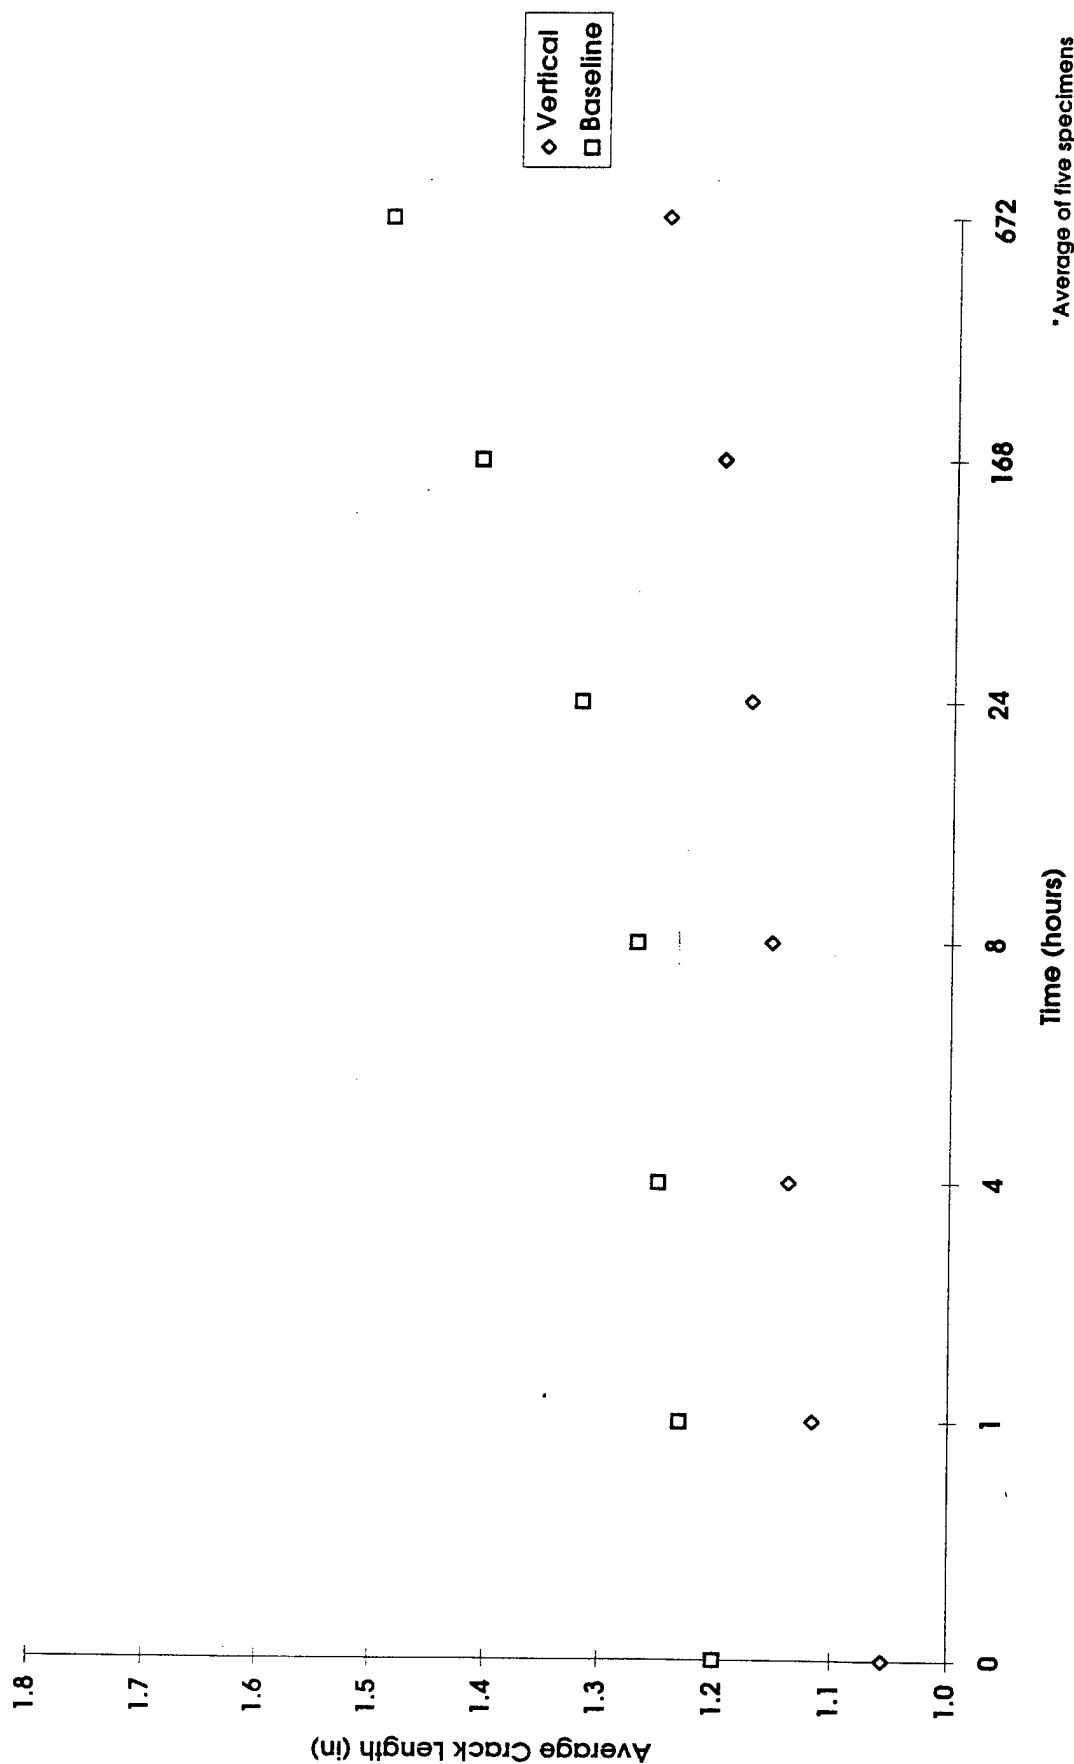
**Figure 11. Effect of Panel Position on Crack Growth Behavior of PACS Prepared Surfaces**

\*Average of five specimens

NOTE: Blackened symbols indicate adhesive failure, while open symbols indicate cohesive failure. Symbols that cannot be blackened indicate cohesive failure.

All baseline data was generated by performing a PACS anodization on a horizontal surface. For comparison purposes, aluminum panels were also anodized in both the vertical and inverted positions. It was observed that in order to achieve good anodization over the entire surface of a vertical panel, the flowrate must be reduced and the acid inlet must be at the bottom of the panel. On a 6" X 6" panel, for example, the flow rate had to be reduced until anodization time lasted for 35 minutes, as compared to the standard 25 minutes on a horizontal surface. The reduced flow rate permits gravity to force acid into all parts of the bagged surface area, and a uniformly anodized surface results. If the flow rate is too fast, lower corners of the bagged surface area will be bypassed as the acid "channels" through only the central region of the bagged surface. Figure 10 illustrates this phenomena. Similarly, a 16" X 16" panel required 45 minutes of anodization time to obtain a uniformly anodized surface. Figure 11 illustrates wedge test results for anodization of a vertical surface. The crack growth for the vertically anodized panels was slightly lower than that for the horizontal panel and both exhibited cohesive failure. Since the crack growth values for the vertical panels are only slightly less than those for the horizontal panels, no significant distinction should be made in terms of anodization effectiveness for each of these orientations.

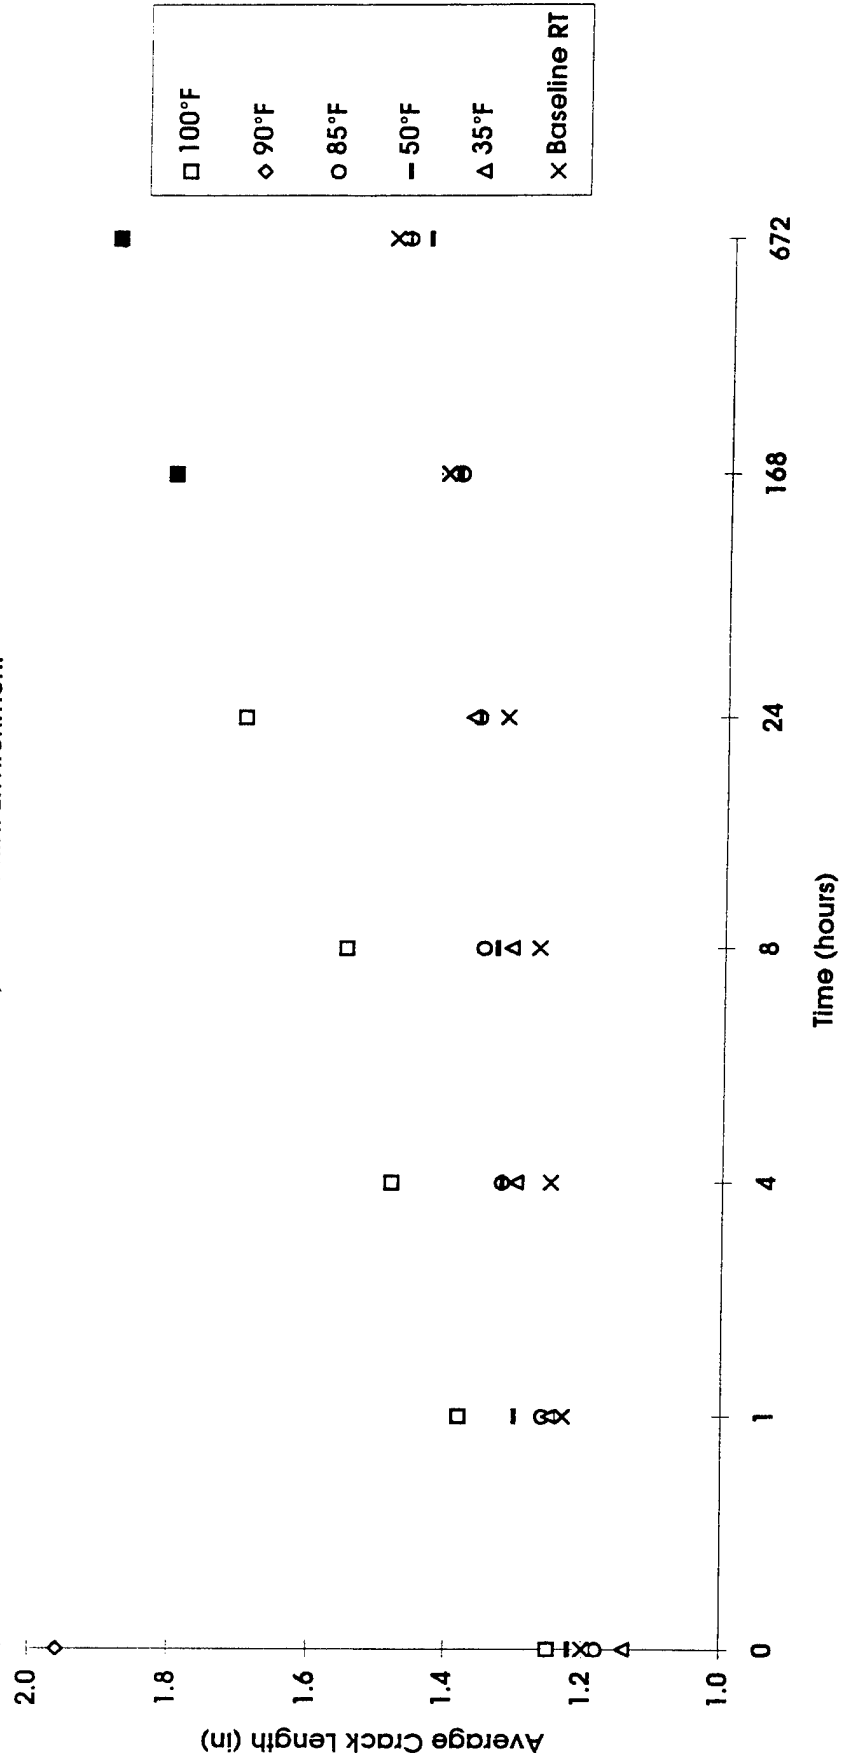
Figure 12. Effect of Processing Temperature on Crack Growth Behavior of PACS Prepared Surfaces

AI 2024-T3 Bare/BR 127/FM 73  
140°F, 95-100% R.H. Environment

The effect of temperature on the surface being anodized was evaluated. Wedge test panels were anodized at temperatures ranging from 35°F to 100°F using the PACS unit. Figure 12 indicates that although the panel prepared at 50°F resulted in acceptable crack growth, the panel prepared at 100°F resulted in a significantly increased rate of crack growth. Multiple panels were tested at the various temperatures to confirm the upper temperature limits.

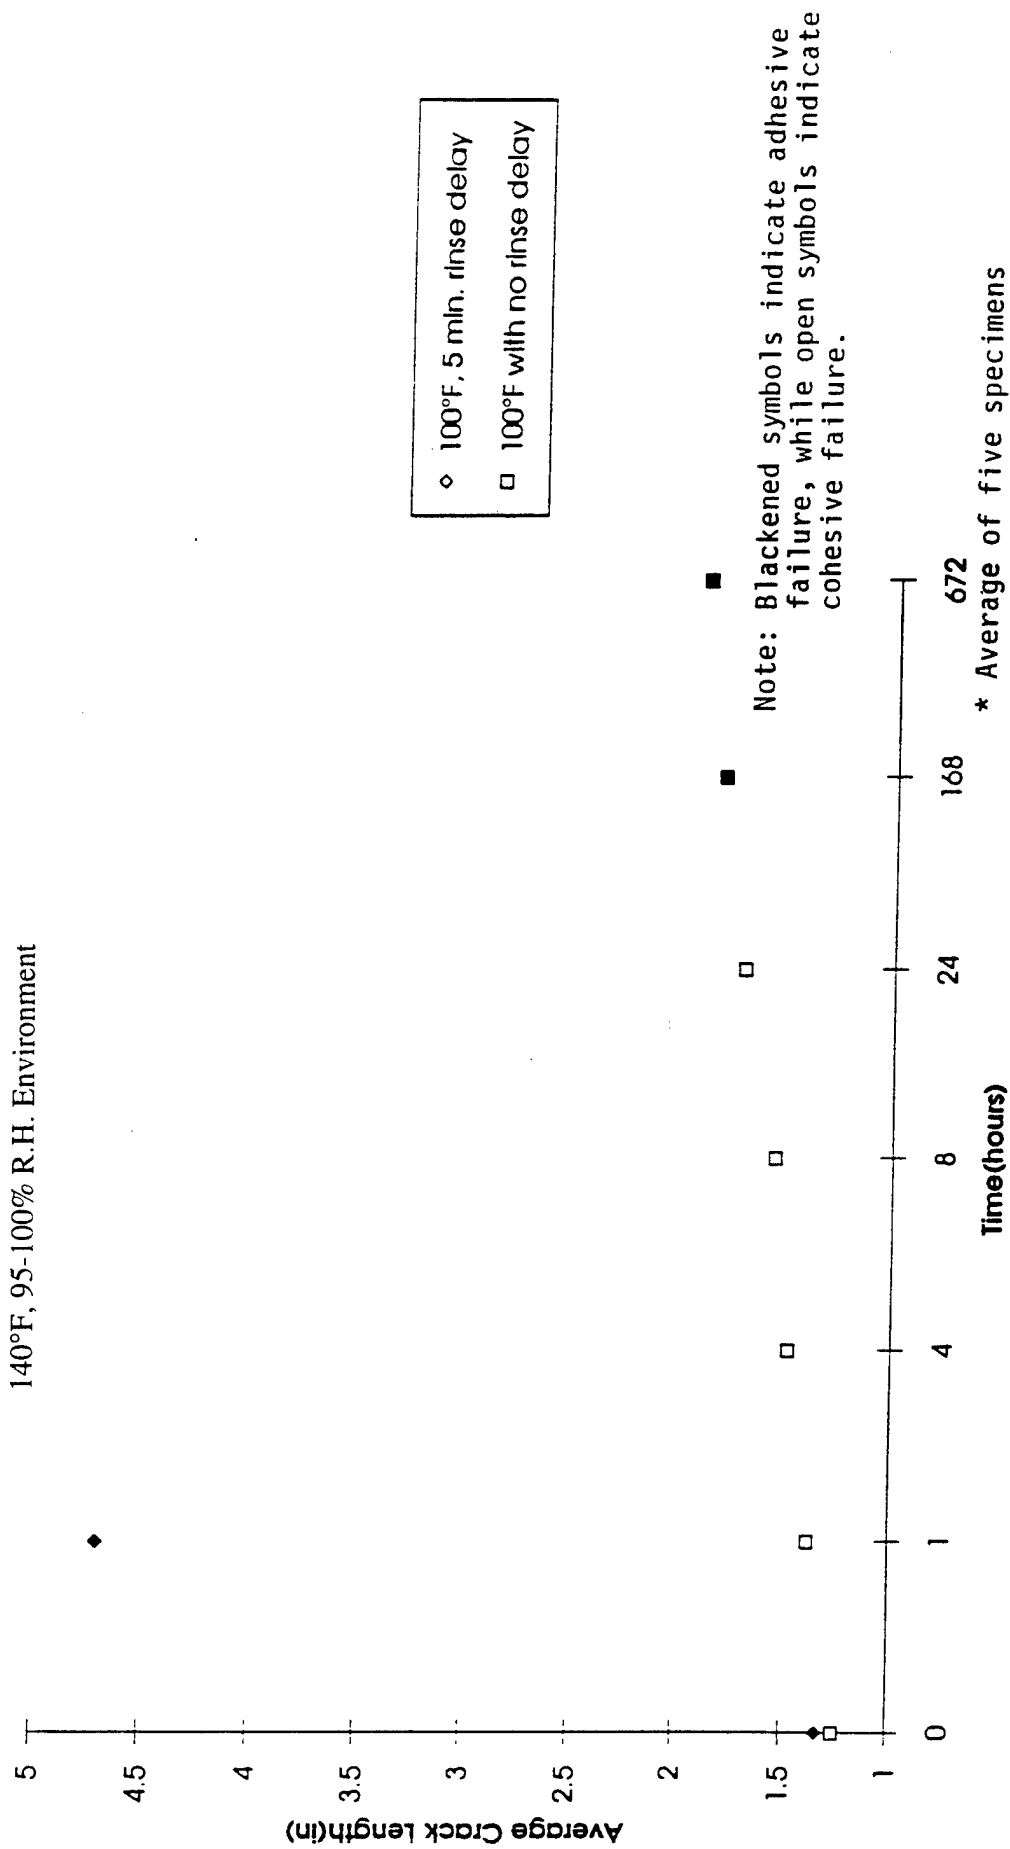
**Figure 13. Effect of Five Minute Water Rinse Delay on Crack Growth Behavior of PACS Prepared Surfaces at 100°F**

Al 2024-T3 Bare/BR 127/FM 73

140°F, 95-100% R.H. Environment

Figure 13 illustrates the effect of a 5 minute water rinse delay on crack growth behavior of a panel that was at 100°F while being PACS anodized. Adhesive failure occurred almost immediately for all wedge test specimens prepared at 100°F with a 5 minute rinse delay. Figure 14 illustrates the effect of a 5 minute water rinse delay on crack growth behavior of a panel that was anodized at room temperature (RT). Adhesive failure occurred almost immediately for all wedge test specimens prepared at RT with a 5 minute water rinse delay.

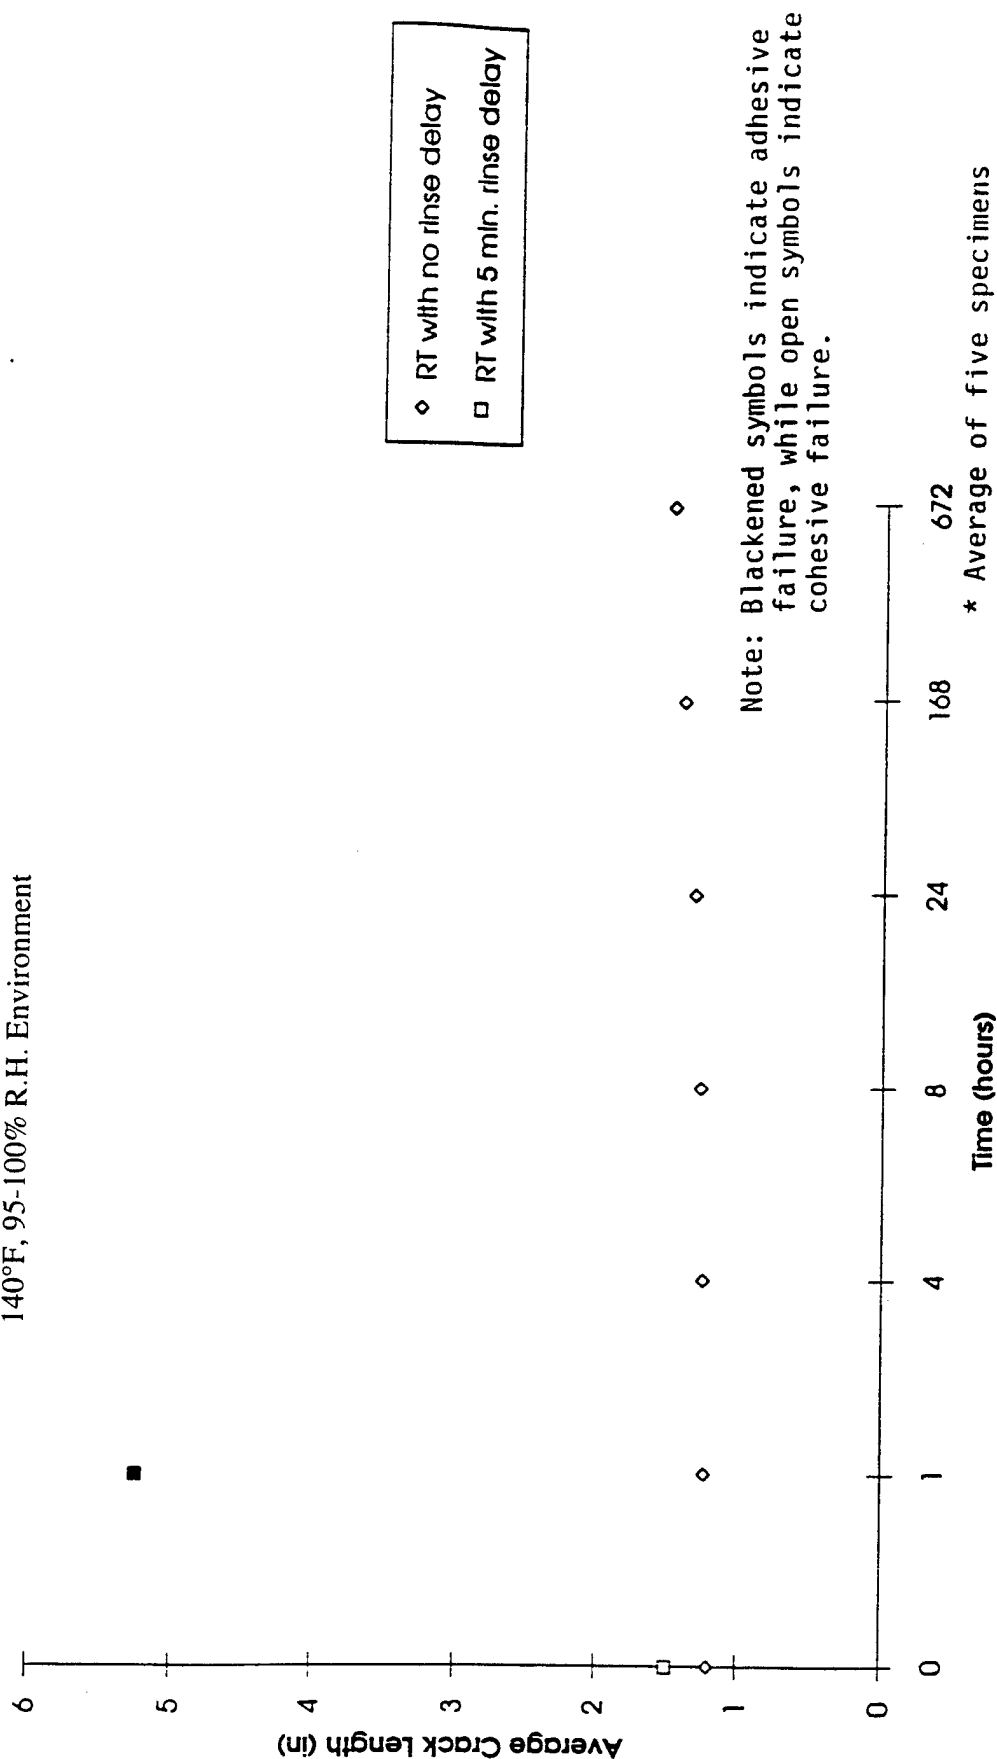
Figure 14. Effect of Five Minute Water Rinse Delay on Crack Growth Behavior of PACS Prepared Surfaces at RT

Al 2024-T3 Bare/BR 127/FM 73

140°F, 95-100% R.H. Environment

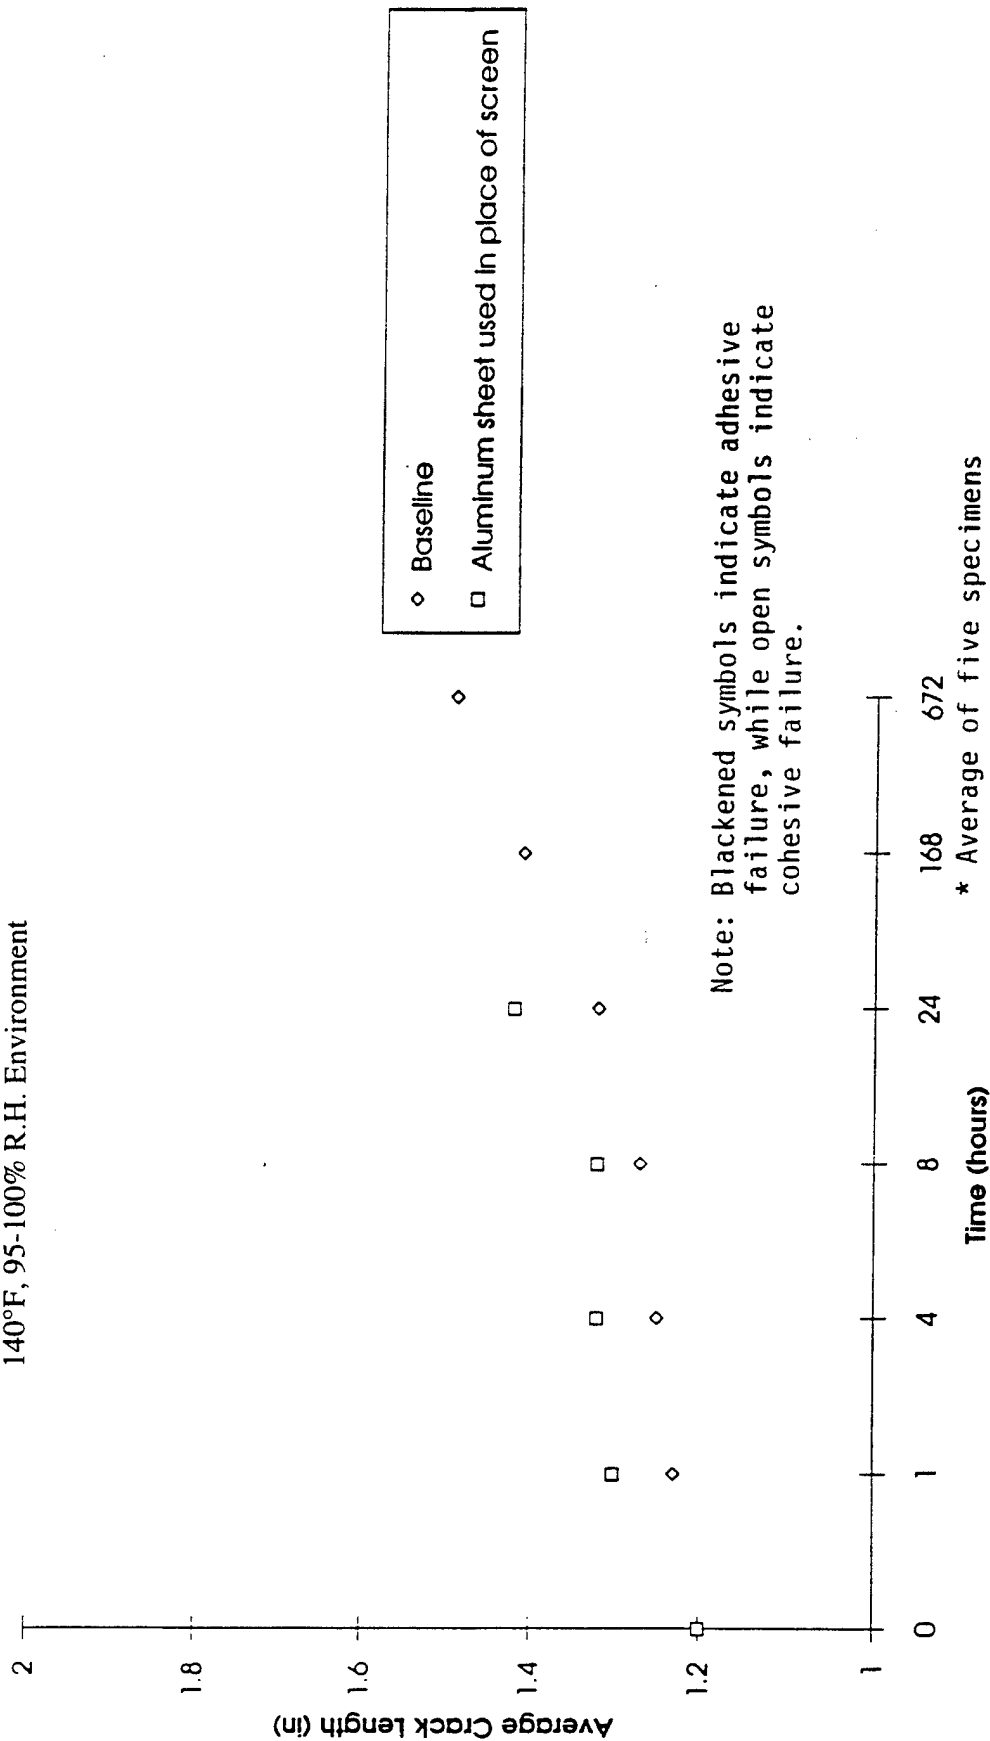
**Figure 15. Effect of the Screen Type on Crack Growth Behavior of PACS Prepared Surfaces**

Al 2024-T3 Bare/BR 127/FM 73  
140°F, 95-100% R.H. Environment

Figure 15 illustrates the effect of screen type on crack growth behavior of PACS anodized surfaces. The screen supplied with the PACS kit was a stainless steel screen. Two alternative materials were utilized in place of the stainless steel screen: 0.063-inch aluminum sheet and aluminum foil. Although the aluminum foil was securely attached to the electrical lead, no current could be drawn and therefore, anodization was impossible. However, the aluminum sheet is a viable replacement for the stainless steel screen if needed.
