**WL-TR-94-4112**

**THE SURFACE PREPARATION OF  
ALUMINUM ALLOYS USING THE  
PHOSPHORIC ACID CONTAINMENT SYSTEM  
FOR REPAIR**

**SUSAN S. SALIBA**  
University of Dayton Research Institute  
300 College Park Avenue  
Dayton, OH 45469-0168

**INTERIM REPORT FOR PERIOD 01 JUNE 1992 – 31 DECEMBER 1993**

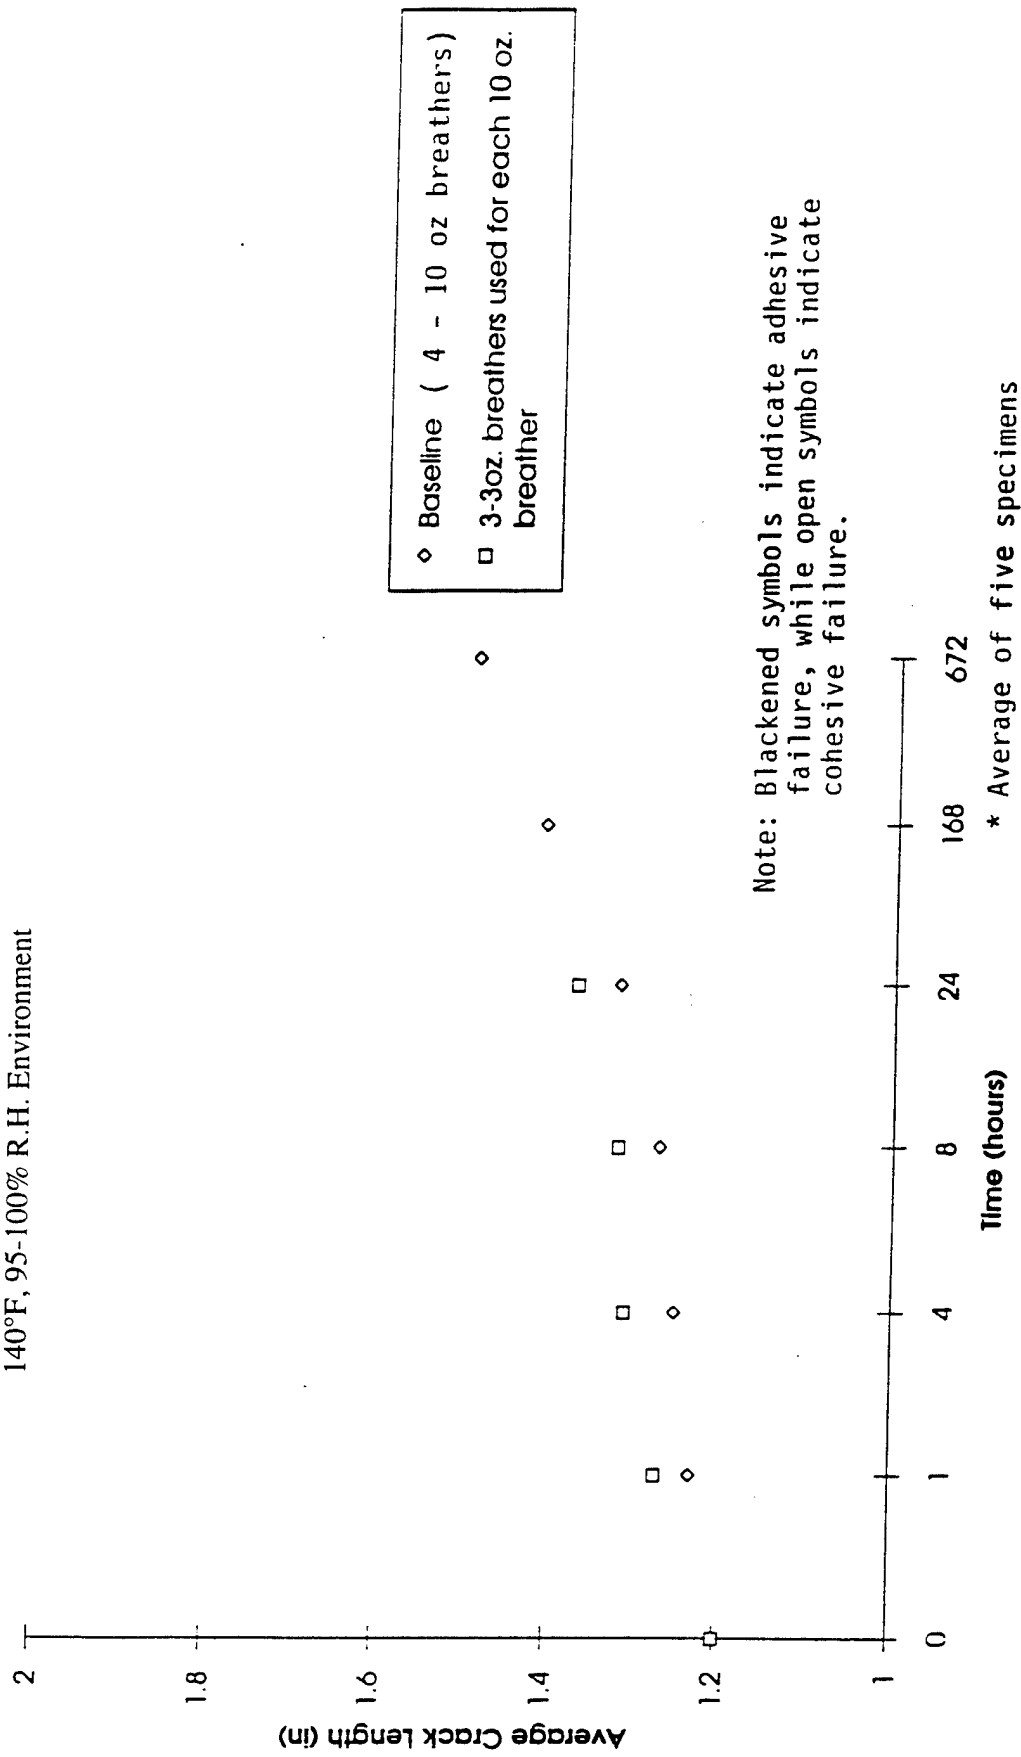
**Figure 16. Effect of Type and Amount of Breather Material on Crack Growth Behavior of PACS Prepared Surfaces**

AI 2024-T3 Bare/BR 127/FM 73  
140°F, 95-100% R.H. Environment

The effect of breather material on the surface being anodized was evaluated. The current layup procedure requires the use of two 10-oz breather plies between the aluminum surface to be anodized and the screen and two 10-oz breather plies on top of the screen. Three 3-oz breather plies were substituted for each of these four 10-oz breather plies. The results presented in Figure 16 indicate essentially equivalent wedge crack growth behavior.

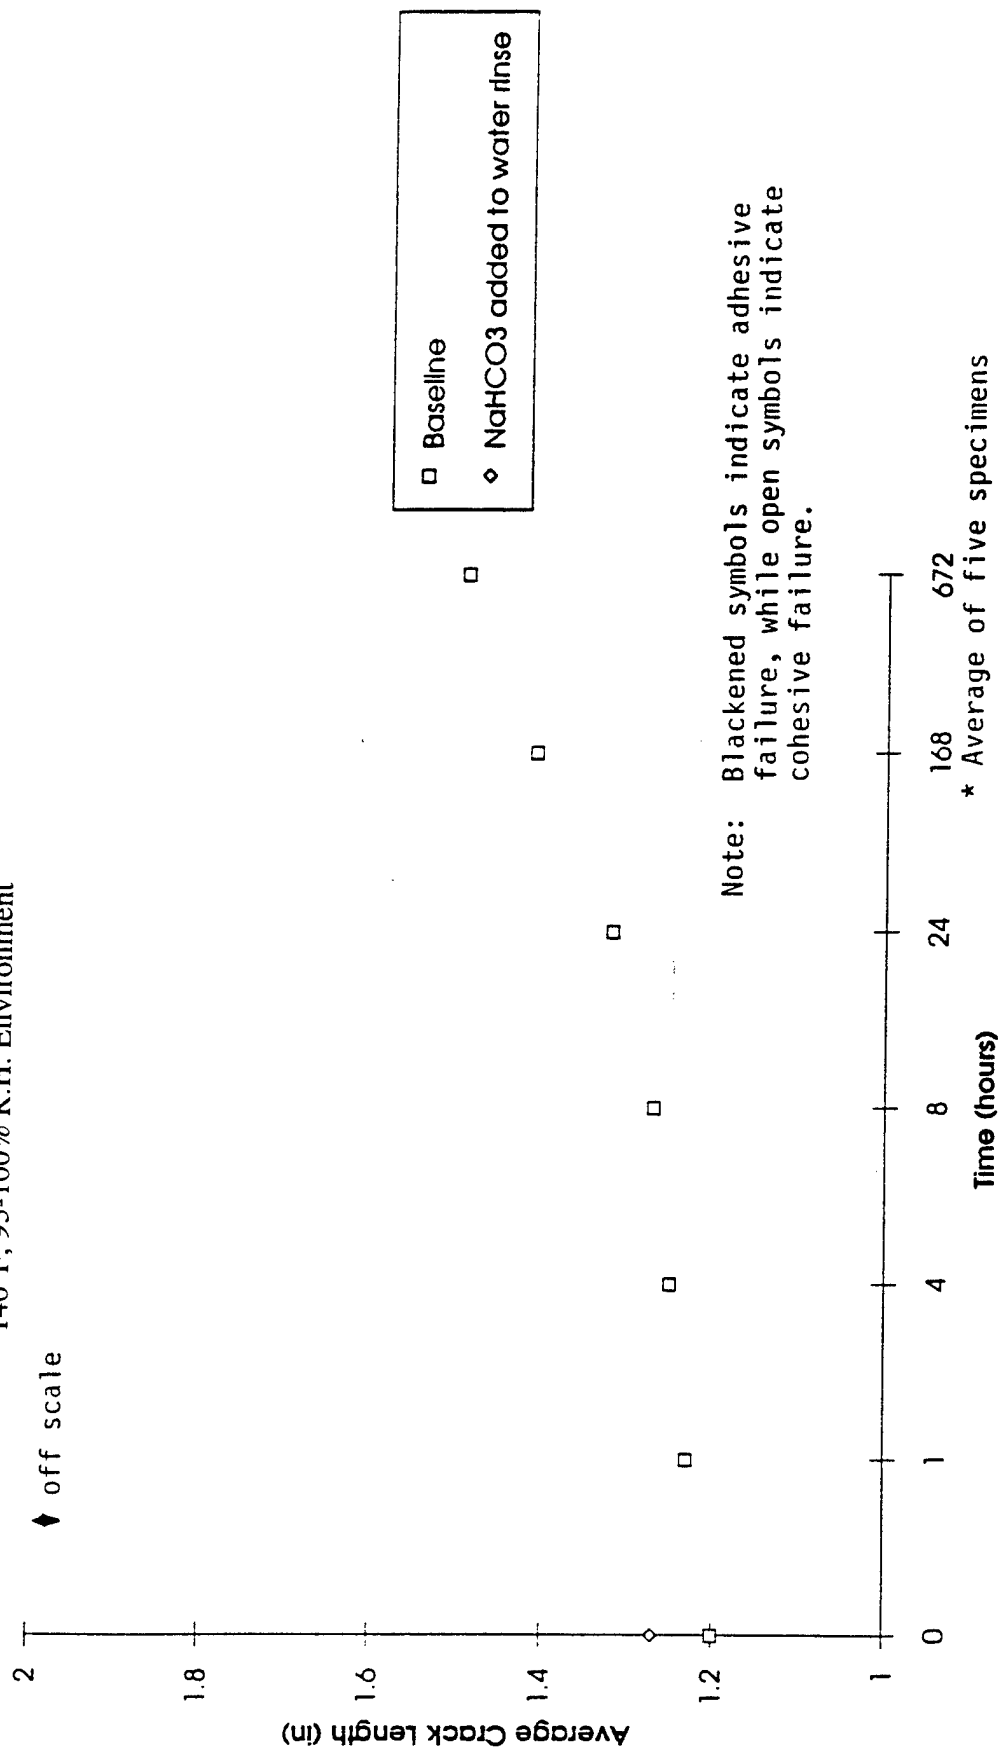
**Figure 17. Effect of Sodium Bicarbonate (NaHCO<sub>3</sub>) Added to Water Rinse on Crack Growth Behavior of PACS Prepared Surfaces**

Al 2024-T3 Bare/BR 127/FM 73

140°F, 95-100% R.H. Environment

Figure 17 illustrates the effect of the addition of sodium bicarbonate to the last bottle of rinse water. The addition of sodium bicarbonate to the rinse water cycle resulted in unacceptable crack growth. This was investigated as a means of insuring neutralization of the liquid left in the bagged setup after completion of the process. It has been found that use of water alone for rinsing results in a final pH of 3-4 if one container of water is used and a pH of about 5 if two containers are used. Since a pH level of 5 is not considered hazardous to human contact, the recommended rinse/neutralization procedure is to use two containers of water.

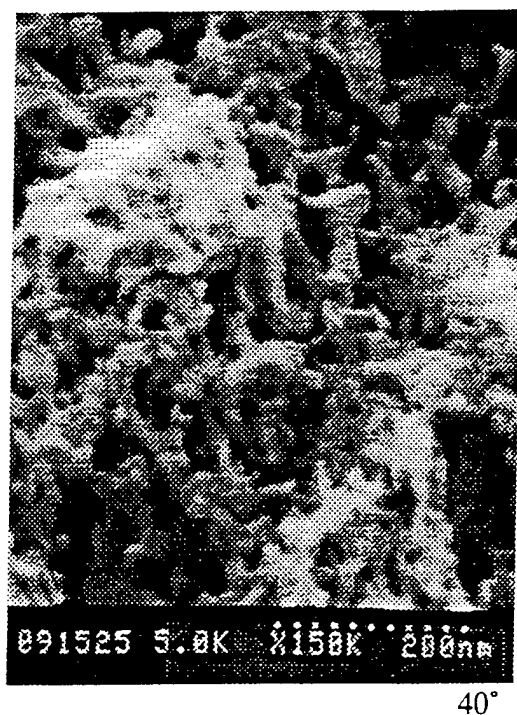
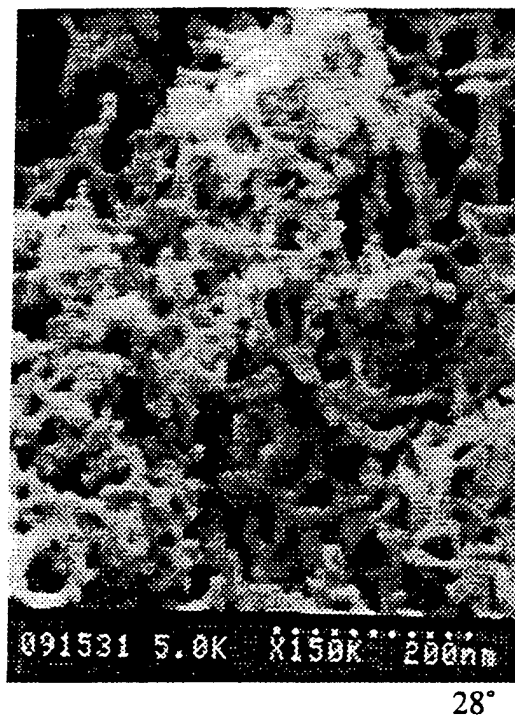
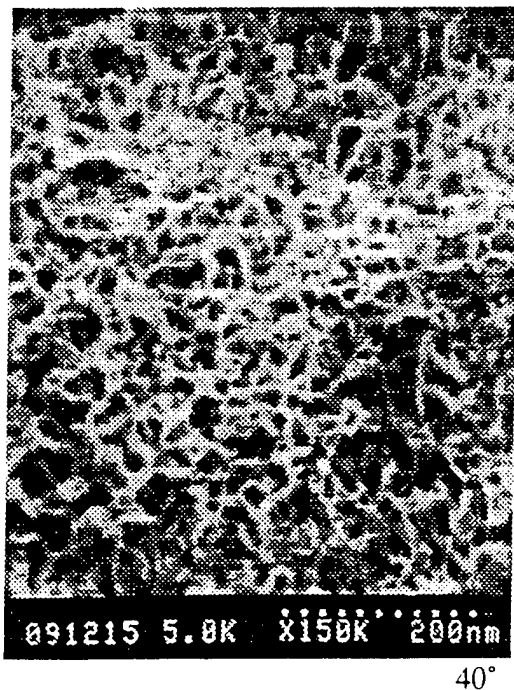
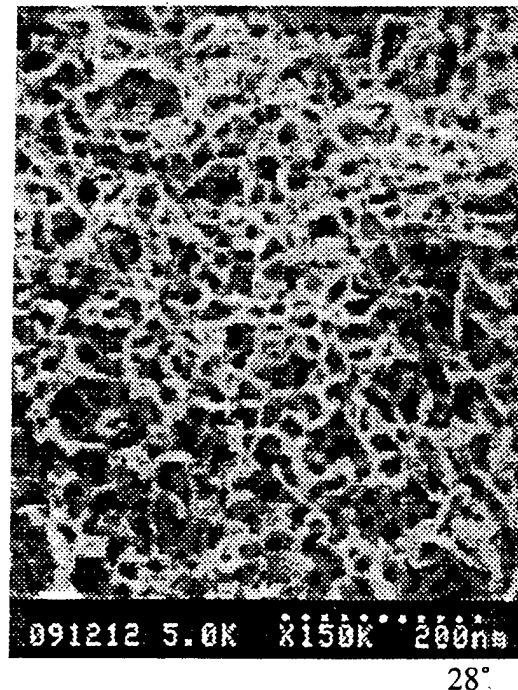
**Figure 18. SEM Stereo Pairs of Anodized 2024-T3 Clad Aluminum (150,000X)**

(a) Anodized with Tank PAA Procedure

(b) Anodized with PACS Procedure

Aluminum panels for surface morphology comparisons were anodized utilizing both the PAA and PACS surface preparation techniques. Stereo pair photographs of the anodized surfaces were obtained to determine and quantify surface morphological features. Comparison of the PAA and PACS oxide structures by this means indicated that while they are similar, the PACS structure exhibits finer features than the PAA prepared surfaces. Stereo pairs of PAA and PACS prepared 2024-T3 clad surfaces are presented in Figure 18. Very similar structures were observed with 7075-T6 bare and 2024-T3 bare. Examination of the oxide layer on both PAA and PACS prepared surfaces indicate a honeycomb structure with finger-like protrusions emanating from the corners of each cell. Visually, the differences seem limited to the diameter of the honeycomb cell. Figure 19 illustrates an isometric drawing of the oxide layer formation for both surface preparation techniques. Similar structures have been reported previously for the PAA surface preparation techniques. Although the structure is similar, the magnitudes of X, Y, and Z are different for the two techniques. Table 7 lists the dimensional measurements of the oxide layer including the values of X (Finger Height), Y (Finger Thickness), and Z (Honeycomb Cell Width) for both the PAA and PACS prepared surfaces. This table includes dimensions for not only the standard PACS and PAA prepared surfaces, but also PACS prepared surfaces where selected processing variables were changed. The results in Table 7 indicate that in general, the finger height is slightly longer for the PAA prepared surfaces, the PAA finger thickness is two times that of the PACS, and the PAA honeycomb cell width is 1.5 times that of the PACS. Two PACS anodized surfaces, 100°F and 100°F with a 5 minute water rinse delay, exhibited alterations of the oxide layer formation on the aluminum surface in addition to poor wedge crack properties previously reported. It was noted that there were significantly fewer honeycomb areas on the specimen anodized at 100°F than the standard specimen. In addition, there were no distinguishable features on the surface of the aluminum anodized at room temperature with a 5 minute water rinse delay.

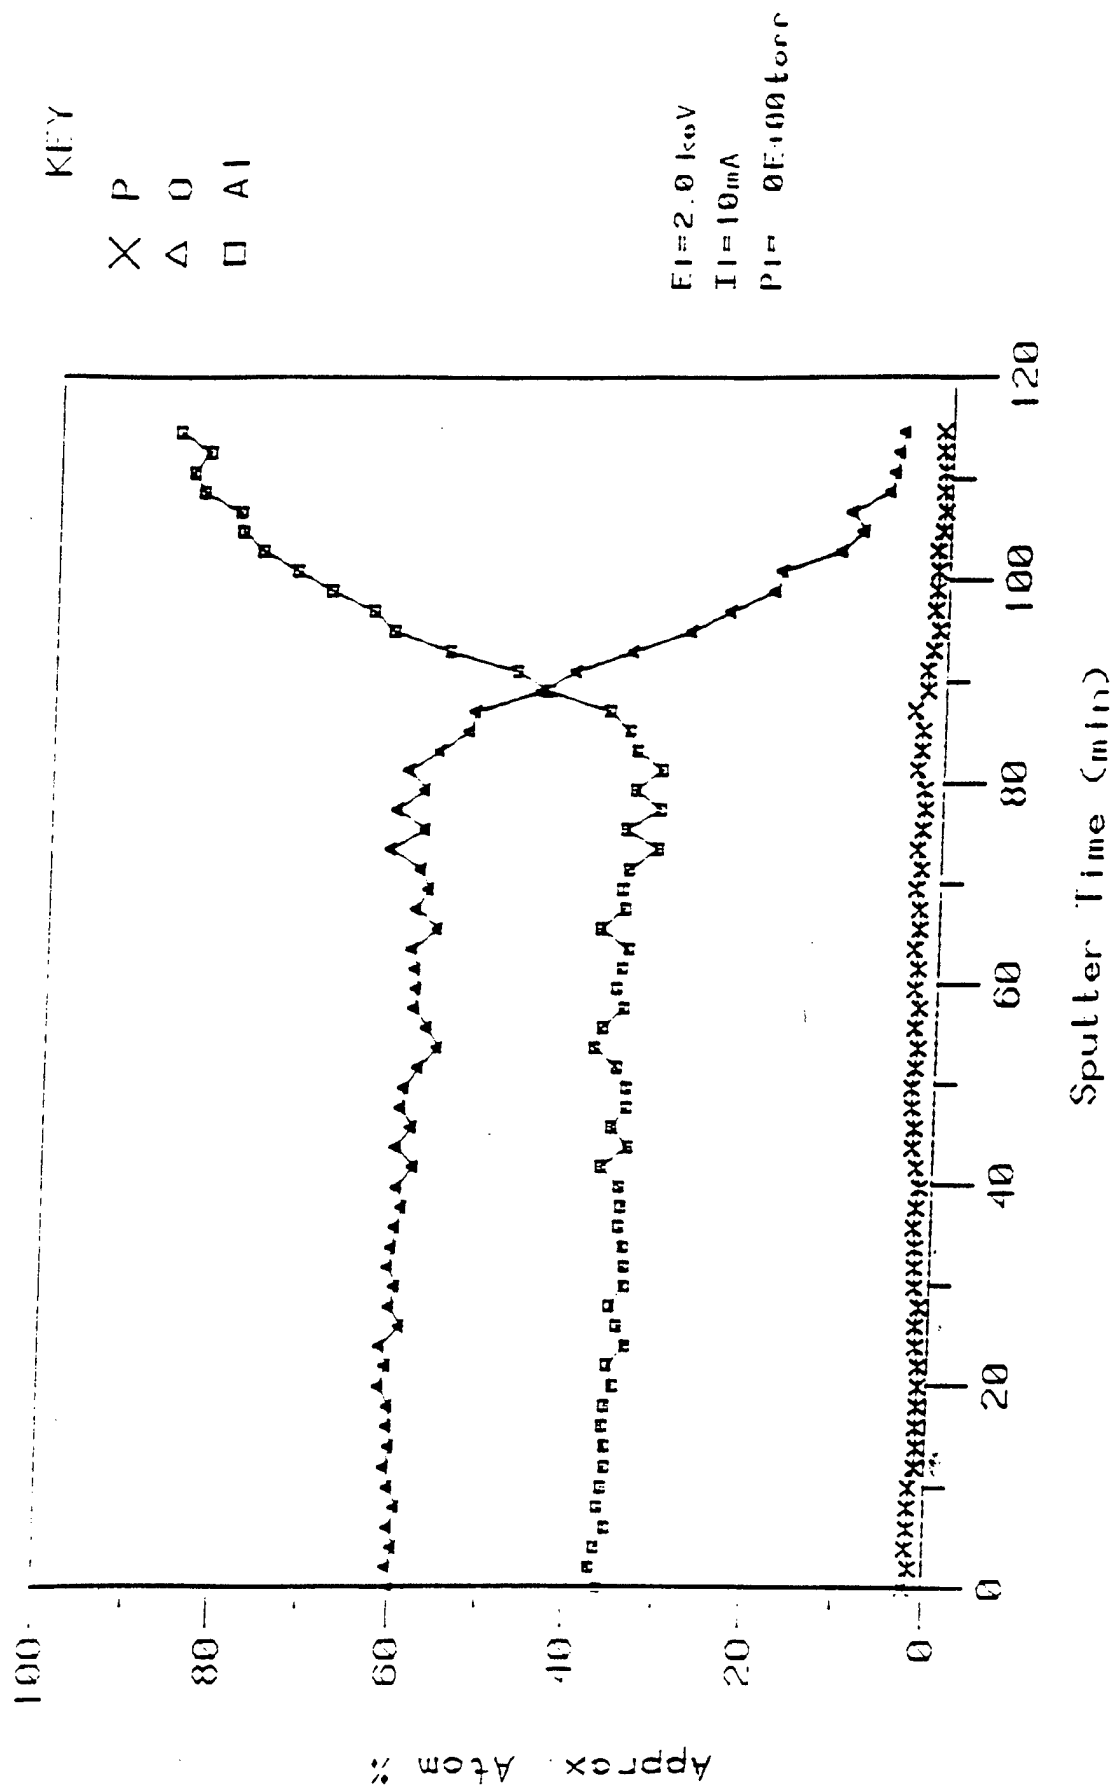
Figure 20. Depth Profile Analysis Using Auger Electron Spectroscopy for PAA Prepared Aluminum Surface

The sputter rate used for this analysis was 5 nm/min. The point at which the curve for aluminum and the curve for the oxygen cross indicates the time required to remove the oxide layer. With a crossover point at 90 minutes, the calculated overall thickness of the oxide layer is 450 nm ( $\approx 4500$  Å). Similarly, Figure 21 illustrates the depth profile analysis for a PACS prepared aluminum surface. With a crossover point at 18.5 minutes and a sputter rate of 5 nm/min, the calculated overall thickness of the oxide layer is 92.5 nm (925 Å).

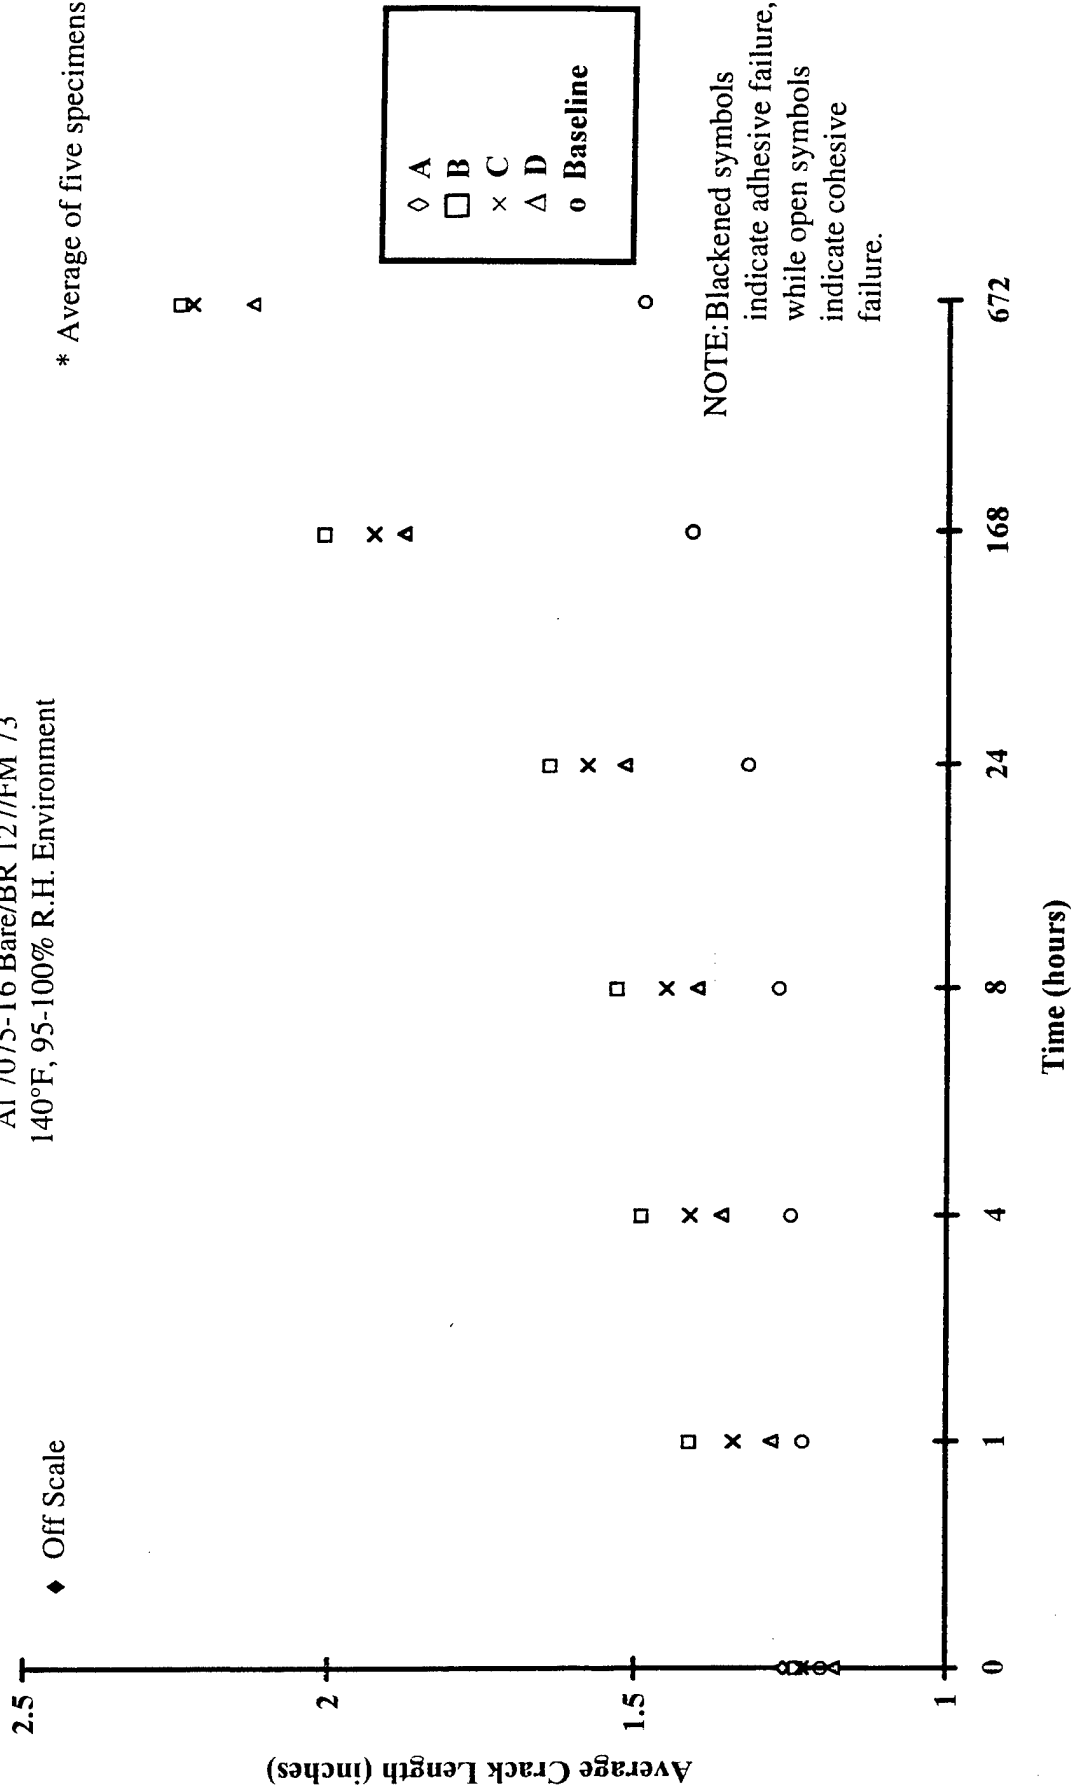
Figure 22. Average Crack Growth Curves Comparing PACS Prepared Surfaces by Specific Depots.

♦ Off Scale

\* Average of five specimens

Wedge test panels were prepared and tested as discussed in Section 2.2. 7075-T6 aluminum was used for all panels. All the panels were primed with BR 127 and bonded with FM 73. The wedge test results are presented in Table 9. Graphical representation of these results is illustrated in Figure 22. With the exception of specimens removed from Panel A, all specimens exhibited cohesive failure.
