June 2002

DEFENSE
INFRASTRUCTURE

Most Recruit Training
Barracks Have
Significant
Deficiencies

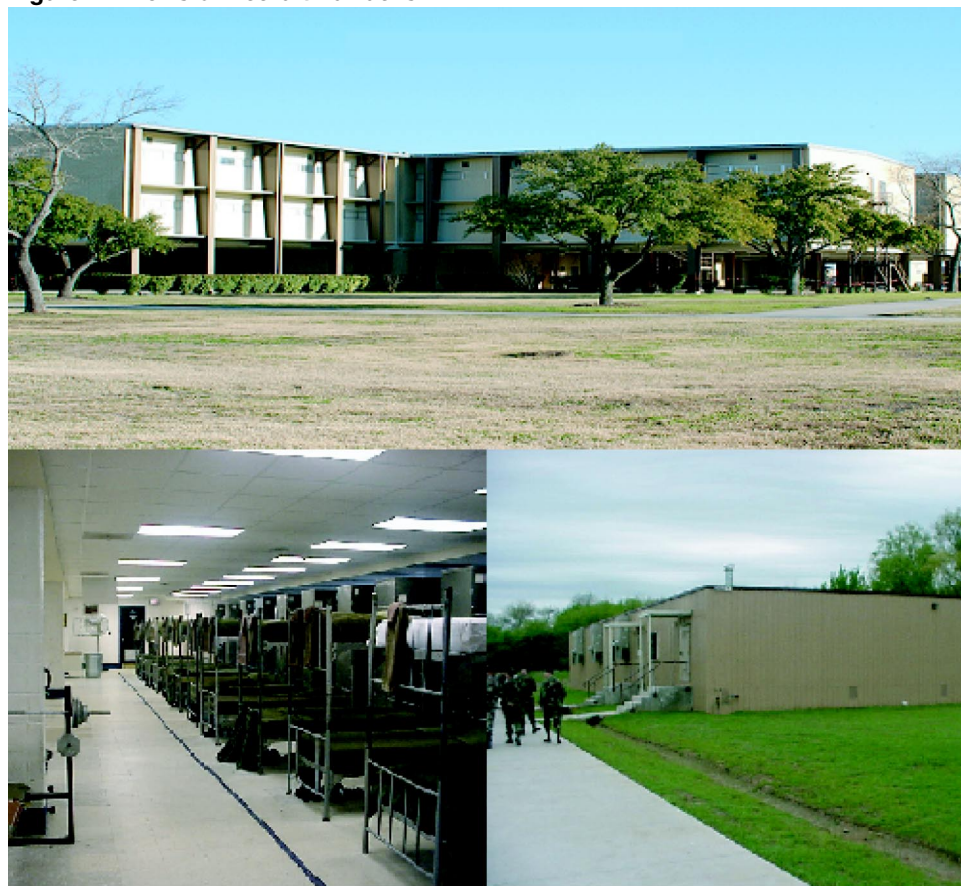
The Army also uses temporary barracks, referred to as “relocatables,” to accommodate recruits at locations where capacity is an issue. Figure 1 depicts an exterior view of recruit barracks at Lackland Air Force Base, Texas, an “open bay” living space at the Marine Corps Recruit Depot at Parris Island, South Carolina, and an Army temporary (relocatable) barracks at Fort Sill, Oklahoma.

Figure 1: Views of Recruit Barracks

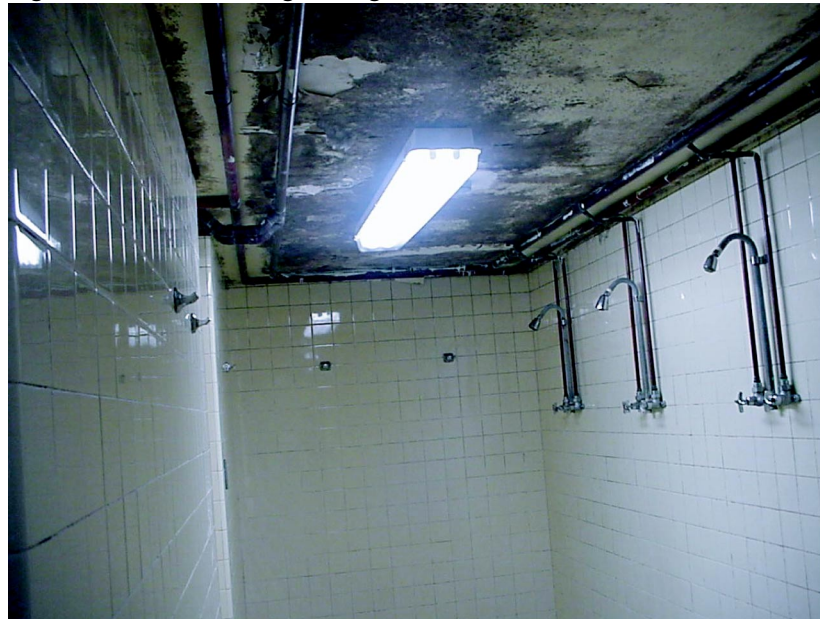
Inadequate ventilation in recruit barracks, especially in central bathing areas that were often subject to overcrowding and heavy use, was another common problem across the services. Many of the central baths in the barracks either had no exhaust fans or had undersized units that were inadequate to expel moisture arising from shower use. As a result, mildew formation and damage to the bath ceilings, as shown in figure 2, were common. In barracks that had undergone renovation, however, additional ventilation had been installed to alleviate the problems.

Figure 2: Shower Ceiling Damage at Fort Jackson Recruit Barracks

Base officials at most of the locations we visited attributed the deteriorated condition of the recruit barracks to recurring inadequate maintenance, which they ascribed to funding shortages that had occurred over the last 10 years. Without adequate maintenance, facilities tend to deteriorate more rapidly. In many cases that officials cited, they were focusing on emergency repairs and not performing routine preventative maintenance. Our analysis of cost data generated by DOD's facility sustainment model⁶ showed, for example, that Fort Knox required about \$38 million in fiscal year 2002 to sustain its base facilities. However, base officials told us they received about \$10 million, or 26 percent, of the required funding. Officials at other Army basic training sites also told us that they receive less funding, typically 30 to 40 percent, than what they considered was required to sustain their facilities. Army officials told us that, over time, the maintenance funding shortfalls at their training bases have been caused primarily by the migration of funding from maintenance accounts to support other priorities, such as the training mission.

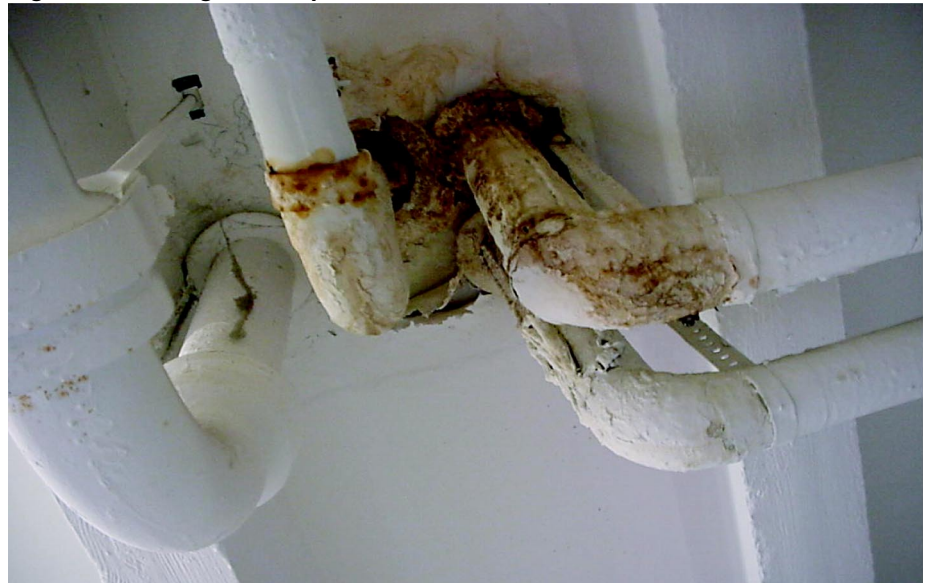
Plumbing deficiencies were also a common problem in the barracks across the services. Base officials told us that plumbing problems—including broken and clogged toilets and urinals, inoperable showers, pipe leaks, and slow or clogged drainpipes and sinks—were recurring problems that often awaited repairs due to maintenance-funding shortages. As shown in figures 3 and 4, we observed leaking drainpipes and broken or clogged bath fixtures in many of the barracks we visited. In regard to the broken fixtures, training officials told us that the problems had exacerbated an undesirable situation that already existed in the barracks—a shortage of fixtures and showers to adequately accommodate the demands of recruit training. These officials told us that because of the inadequate bath facilities for the high number of recruits, they often had to perform “workarounds”—such as establishing time limits for recruits taking showers—in order to minimize, but not eliminate, adverse effects on training time.

Figure 3: Leaking Drain Pipe at Ft. Knox Recruit Barracks

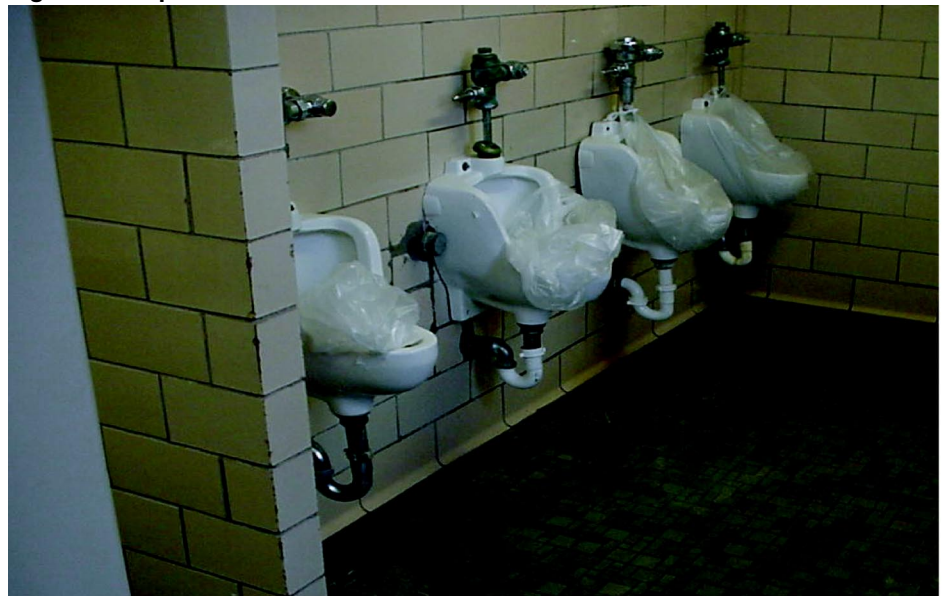
Figure 4: Inoperable Bath Fixtures at Parris Island Recruit Barracks

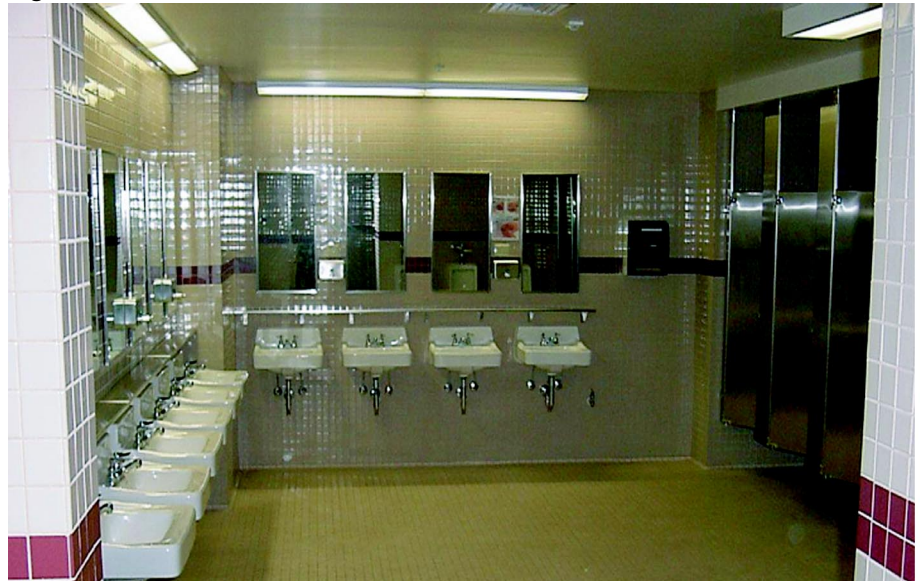
While most barracks across the services had significant deficiencies, others were in better condition, primarily because they had recently been constructed or renovated. Those barracks that we observed to be in better condition were scattered throughout the Army, Air Force, and Marine Corps locations. Even at those locations where some barracks were in very poor condition, we occasionally observed other barracks in much better condition. For example, at Parris Island, the Marine Corps recently completed construction of a new female recruit barracks. At Fort Jackson, the Army repaired windows, plumbing, and roofs in several "starship" barracks and similar repairs were underway in two other starships. Figures 5 and 6 show renovated bath areas at Lackland Air Force Base in Texas and the Marine Corps Recruit Depot at San Diego.

Figure 5: Renovated Recruit Barracks' Bath at Lackland Air Force Base

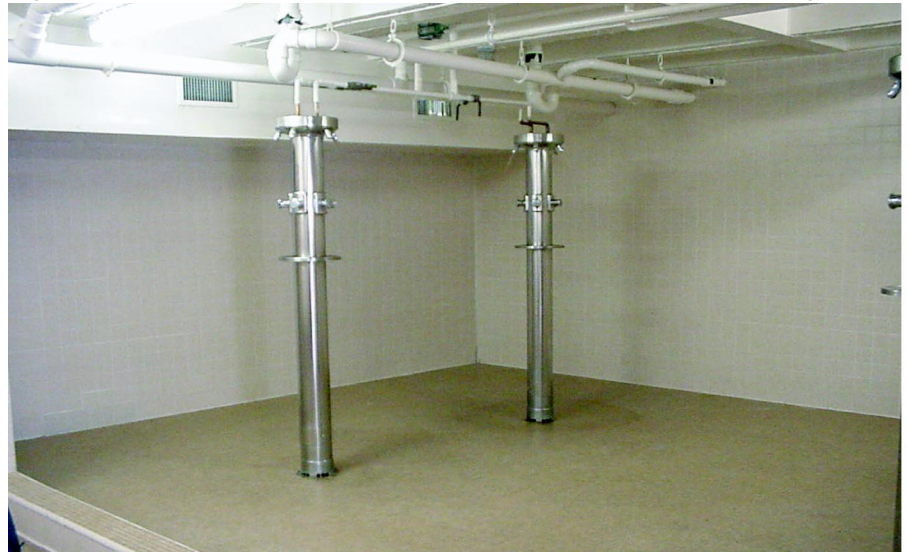
Figure 6: Renovated Showers at Marine Corps Recruit Depot, San Diego

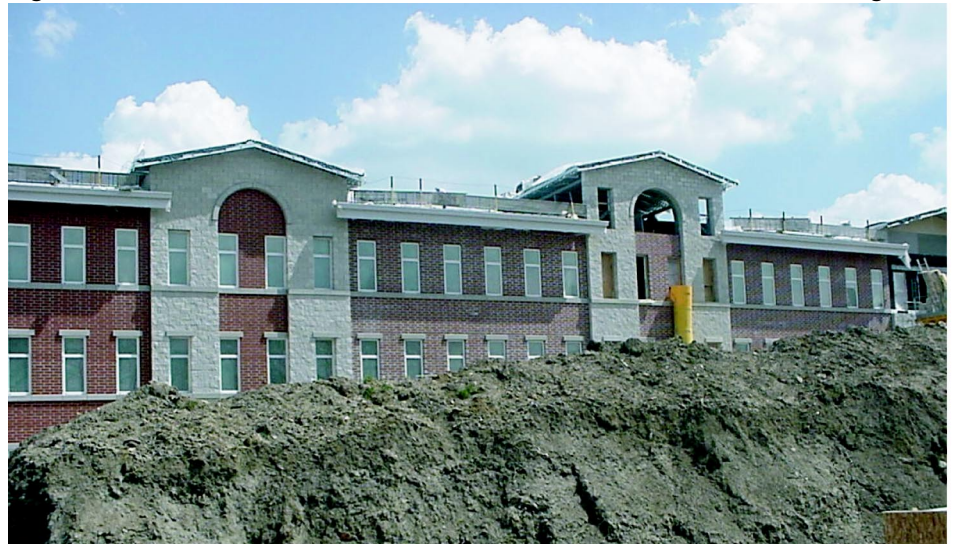
The Navy has placed a high priority on replacing its 16 recruit barracks by fiscal year 2009 at an estimated cost of \$570 million using military construction funds.⁷ The Navy recently completed a new recruit reception barracks, and the Congress has approved funding for four additional barracks. Two barracks are under construction with occupancy expected later this year (see fig. 7), and the contract for 2 more barracks was awarded in May 2002. The Navy has requested funds for another 2 barracks in its fiscal year 2003 military construction budget submission and plans to request funds for the remaining 9 barracks in fiscal years 2004 through 2007. The Navy expects construction on the last barracks to be completed by 2009. Navy officials told us that other high-priority Navy-wide efforts

Figure 7: Recruit Barracks under Construction at Great Lakes Naval Training Center
