ARMY GROUND RISK MANAGEMENT INFORMATION

VOL 23 NO 5

MAY 2002

HALFTIME REPORT

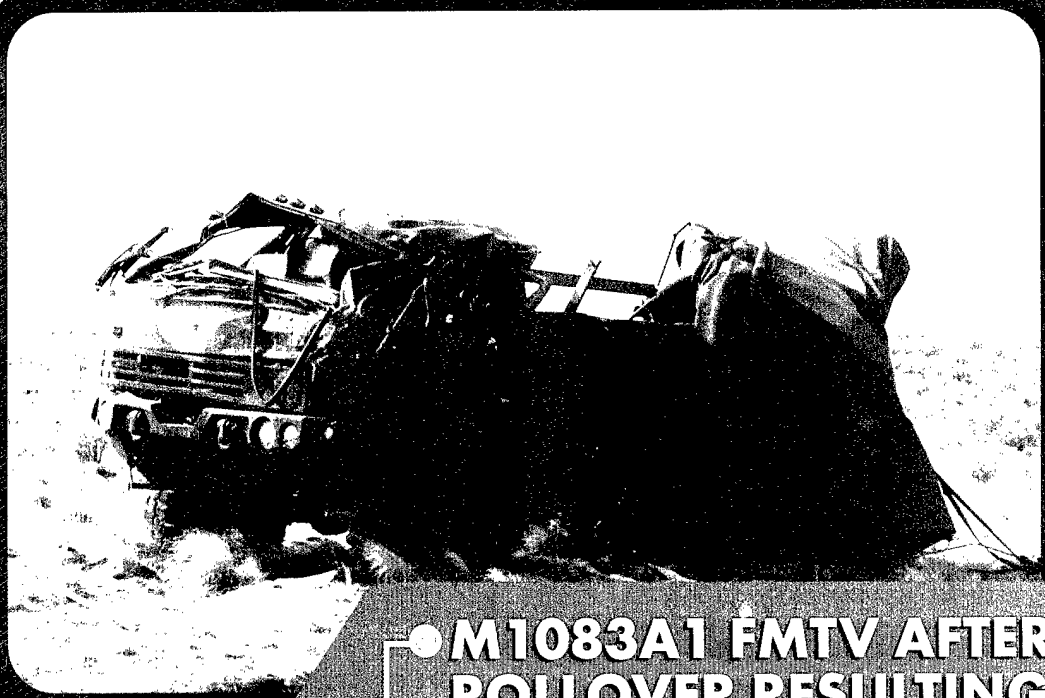
● **M1083A1 FMTV AFTER A ROLLOVER RESULTING FROM SPEED AND FAILURE TO PAY ATTENTION.**

A range detail consisting of 10 soldiers were traveling along a dirt/gravel road in an M1083A1 Family of Medium Tactical Vehicles (FMTV), when the driver lost control of the vehicle, resulting in a rollover. During the accident, one soldier was fatally injured, one soldier sustained internal injuries, and six soldiers sustained minor injuries. Damage to the vehicle was extensive.

The driver departed the range with the nine other soldiers and traveled approximately 4 kilometers when the accident occurred. Specifically, the driver failed to make a left turn at a "Y" intersection, traveled over a dirt berm between the two roads, and back onto the shoulder of the road. The driver then over-steered the vehicle in an attempt to bring the vehicle back on the road. As a result, the

During the rollover, the brake pedal bent over the driver's foot, pinning it to the accelerator. The steering wheel and cab of the vehicle pinned the driver in such a way that he was unable to control the vehicle after it rolled over. The vehicle continued to travel another 700 meters and finally came to rest when the vehicle commander was able to engage the emergency brake and activate the engine shut-off switch. Unfortunately, all 10 soldiers had their Kevlar helmets come off their heads during the accident.

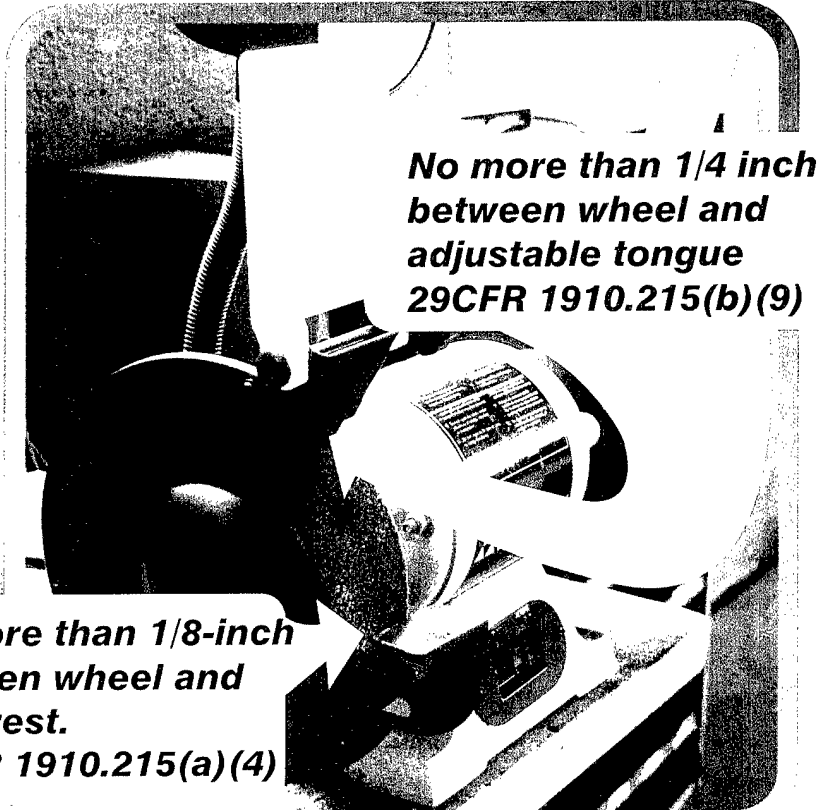
**No more than 1/4 inch
between wheel and
adjustable tongue
29CFR 1910.215(b)(9)**

**No more than 1/8-inch
between wheel and
work rest.
29CFR 1910.215(a)(4)**

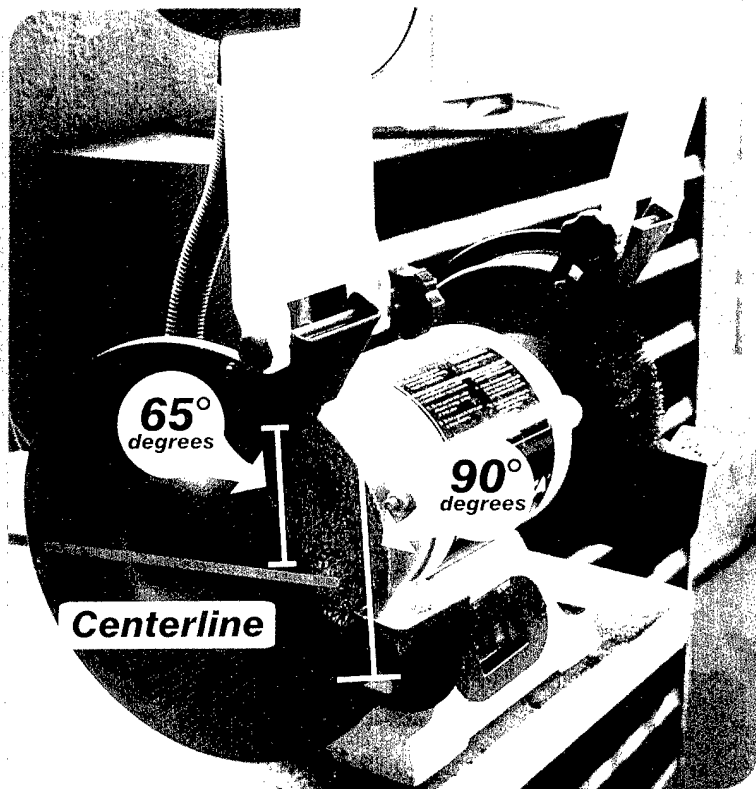
CFR 1910.215(b)(3)

Bench and floor stands. The angular exposure of the grinding wheel periphery and sides for safety guards used on machines known as bench and floor stands should not exceed 90 degrees or one-fourth of the periphery. This exposure shall begin at a point not more than 65 degrees above the horizontal plane of the wheel spindle.

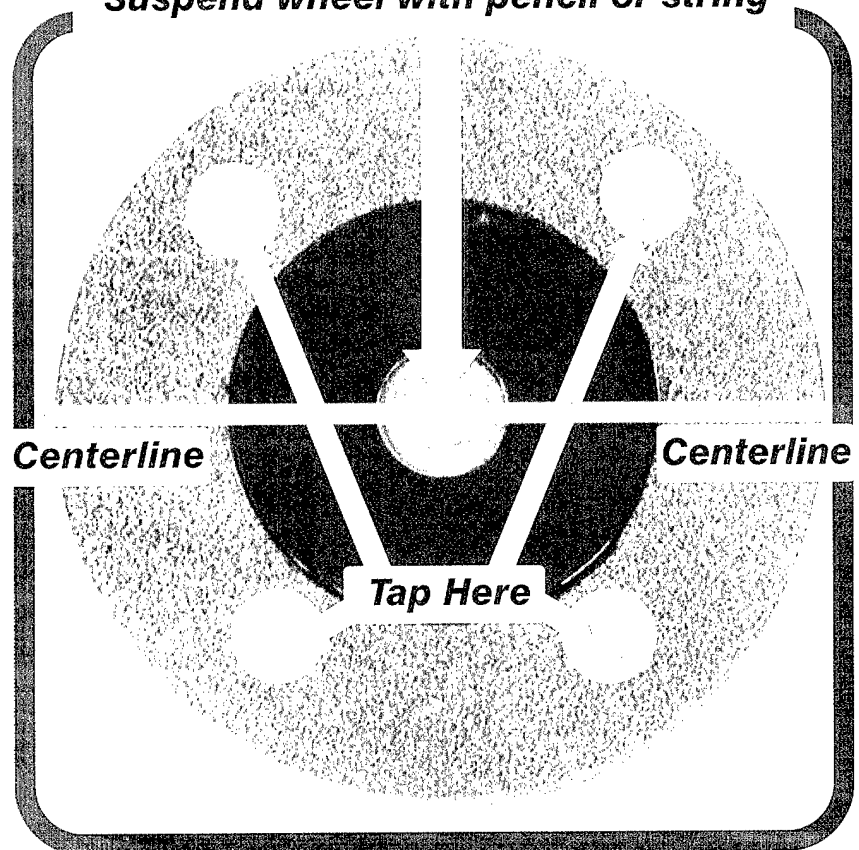
29CFR 1910.215(d)(1)

Inspection. Immediately before mounting, all wheels shall be closely inspected and sounded by the user (ring test) to make sure they have not been damaged in transit, storage or otherwise. The spindle speed of the machine shall be checked before mounting of the wheel to be certain that it does not exceed the maximum operating speed marked on the wheel. Wheels should be tapped gently with a light, nonmetallic implement, such as the handle of a screwdriver for light wheels, or a wooden mallet for heavy wheels. If they sound cracked (dead), they shall not be used.

Suspend wheel with pencil or string

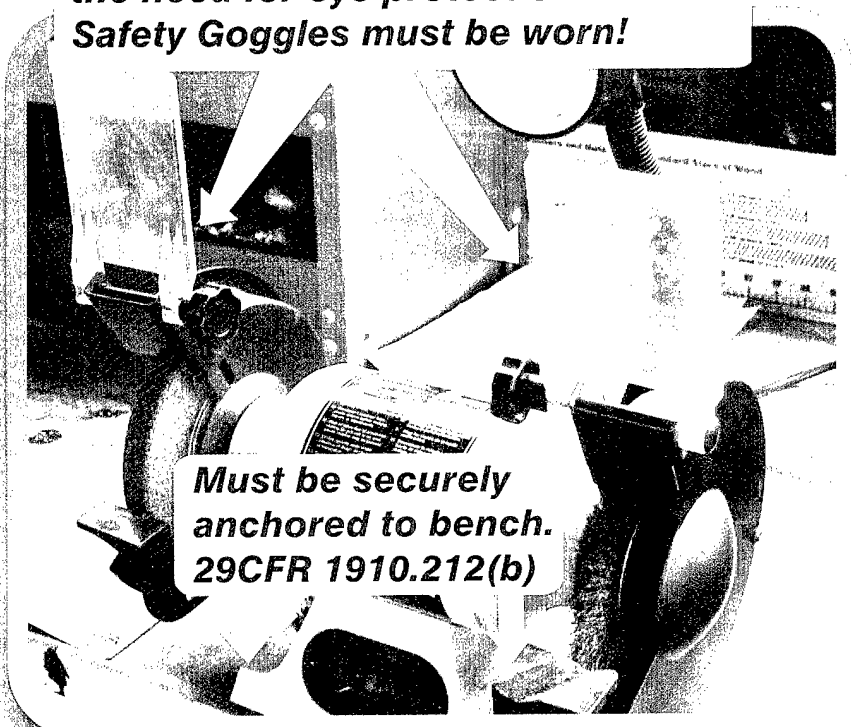
These eye shields DO NOT eliminate the need for eye protection! Safety Goggles must be worn!
