## **Low-Maintenance Remotely Monitored Cathodic Protection Systems**

### **Requirements, Evaluation, and Implementation Guidance**

ERDC/CERL TR-01-73

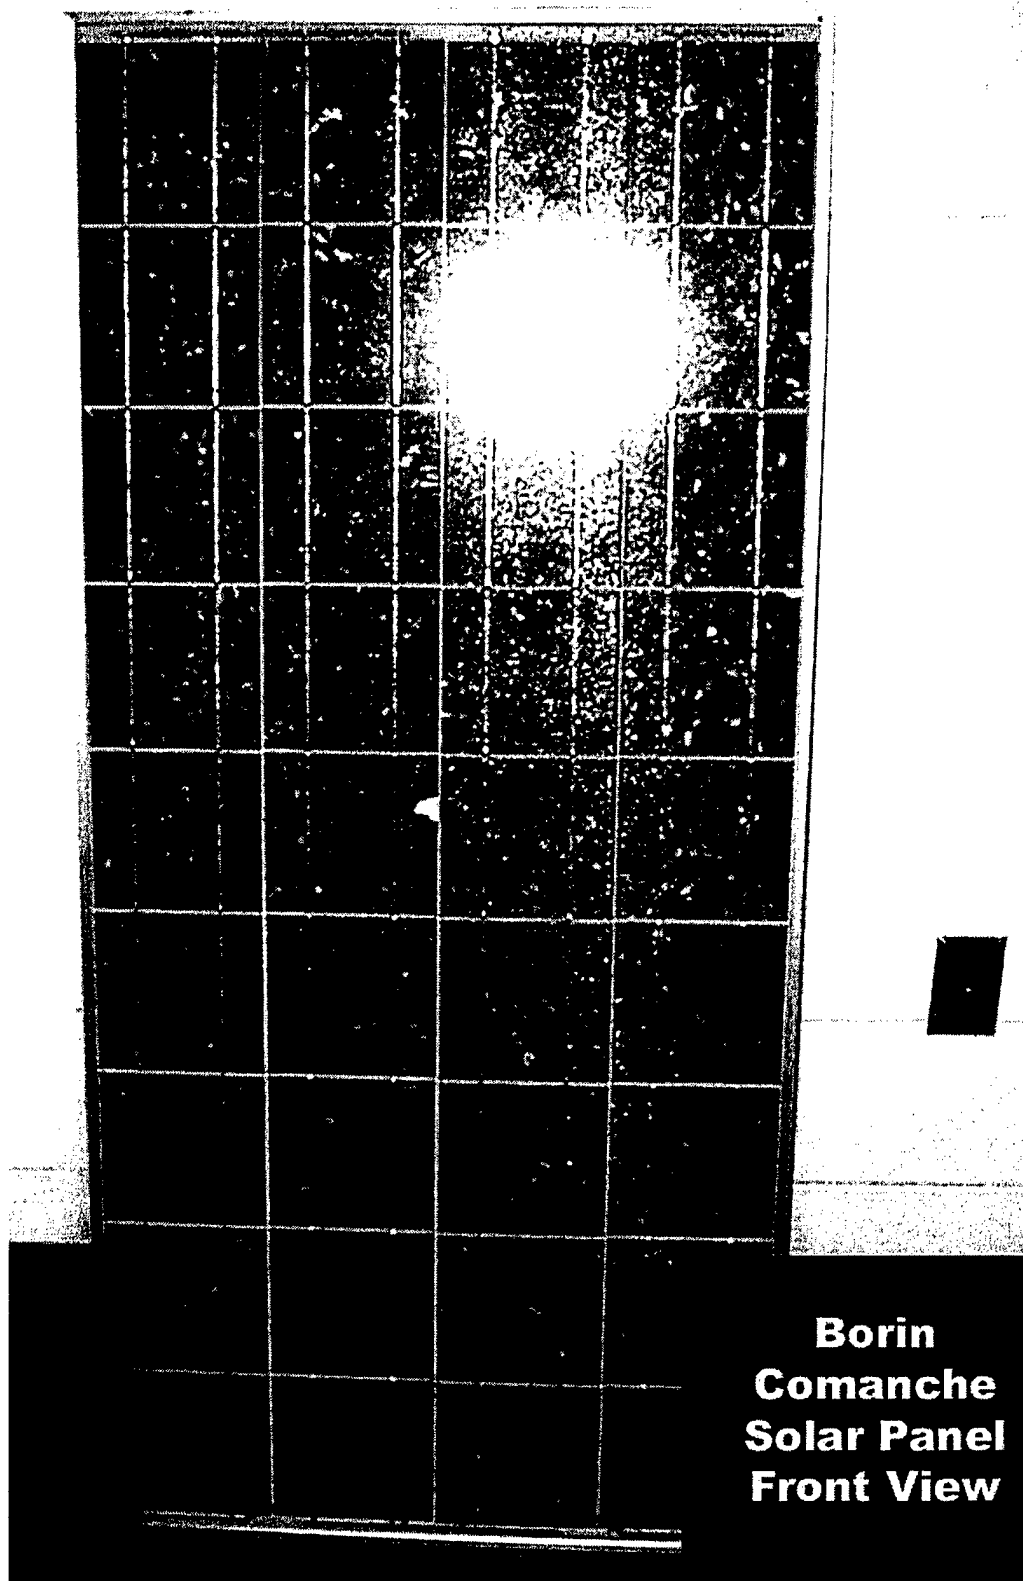
Figure 16. Borin Comanche solar panel.

**Borin  
Comanche  
Solar Panel  
Front View**

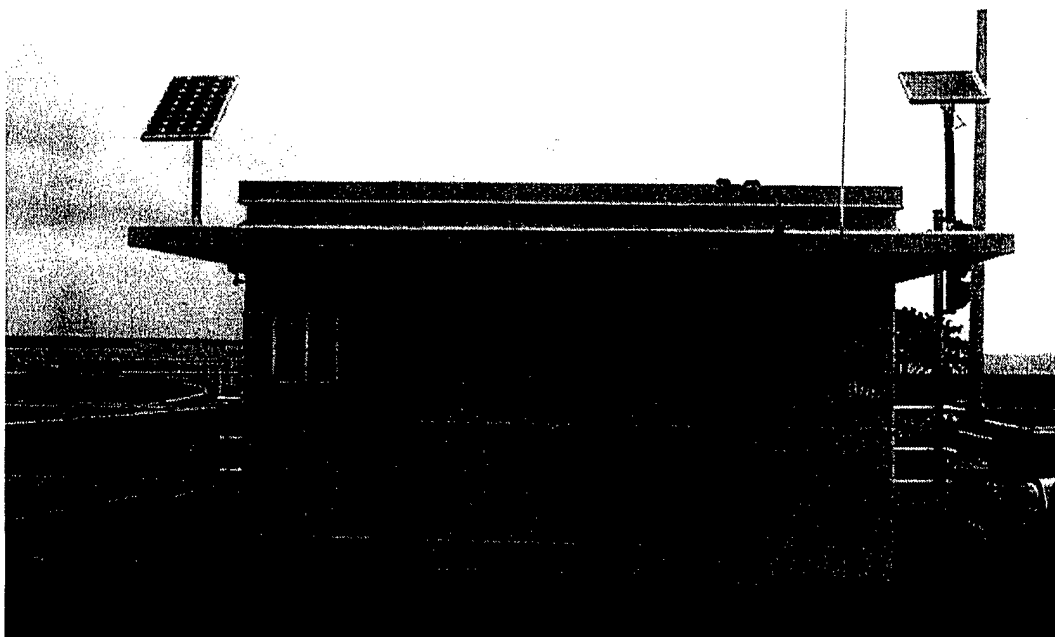
**Figure 26. Overview of equipment installed at Machine House 1.**

The last site visit for this project was performed in late September 2000. Loftus Electric had completed the site work by this time. The completed site is shown in Figures 26 and 27. Detailed photos and diagrams are shown in the Appendix.
