| 4. TITLE AND SUBTITLE<br>RESEARCH AND EDUCATIONAL ACTIVITIES AT THE FAST CENTER FOR<br>STRUCTURAL INTEGRITY OF AEROSPACE SYSTEMS | | | | 5a. CONTRACT NUMBER | |
| 6. AUTHOR(S)<br>Roberto A. Osegueda and Carlos M. Ferregut | | | | 5d. PROJECT NUMBER | |
| 7. PERFORMING ORGANIZATION NAME(S) AND ADDRESS(ES)<br>FAST Center for Structural Integrity of Aerospace Systems<br>The University of Texas at El Paso<br>Burges Hall, Room 206<br>El Paso, Texas 79968 | | | | 8. PERFORMING ORGANIZATION REPORT<br>NUMBER | |
| 15. SUBJECT TERMS<br>Aircraft Structures, Global Vibrational NDE, Damage Detection, Large Area NDE, Corrosion, Ultrasonic Inspection, Lamb Waves | | | | | |

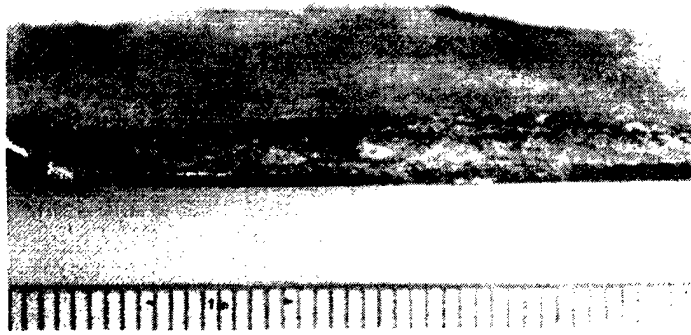
**Figure 4.4** Magnified view of exfoliated region.

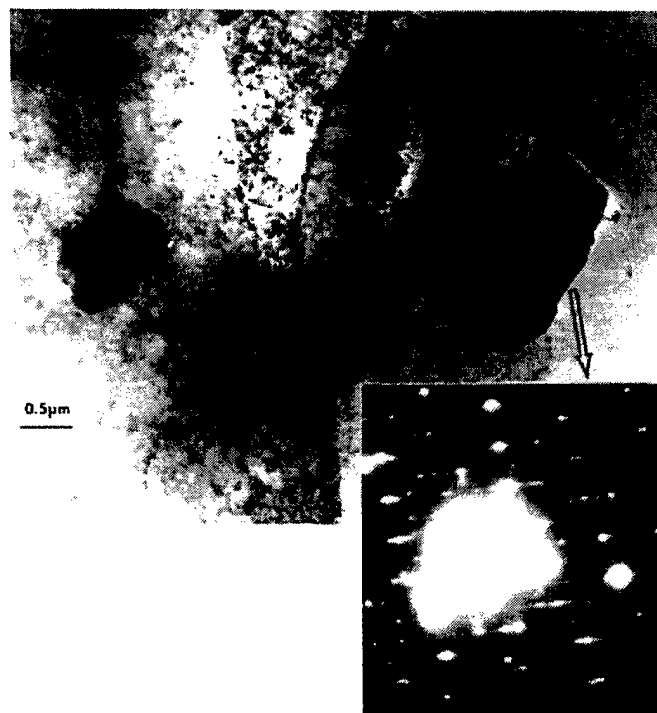
**Figure 4.7** Transmission electron micrographic bright-field image showing large inclusion layer structure possibly due to particle shear of faulting during continued sheet rolling. The SAD pattern inset shows the presence of regular domains perpendicular to the diffraction streaks.
