ERDC/CERL TR-02-8

# **Evaluation of Galvanized and Galvalume®/Paint Duplex Coating Systems for Steel Building Panels**

Timothy Race, L.D. Stephenson, and Ashok Kumar

February 2002

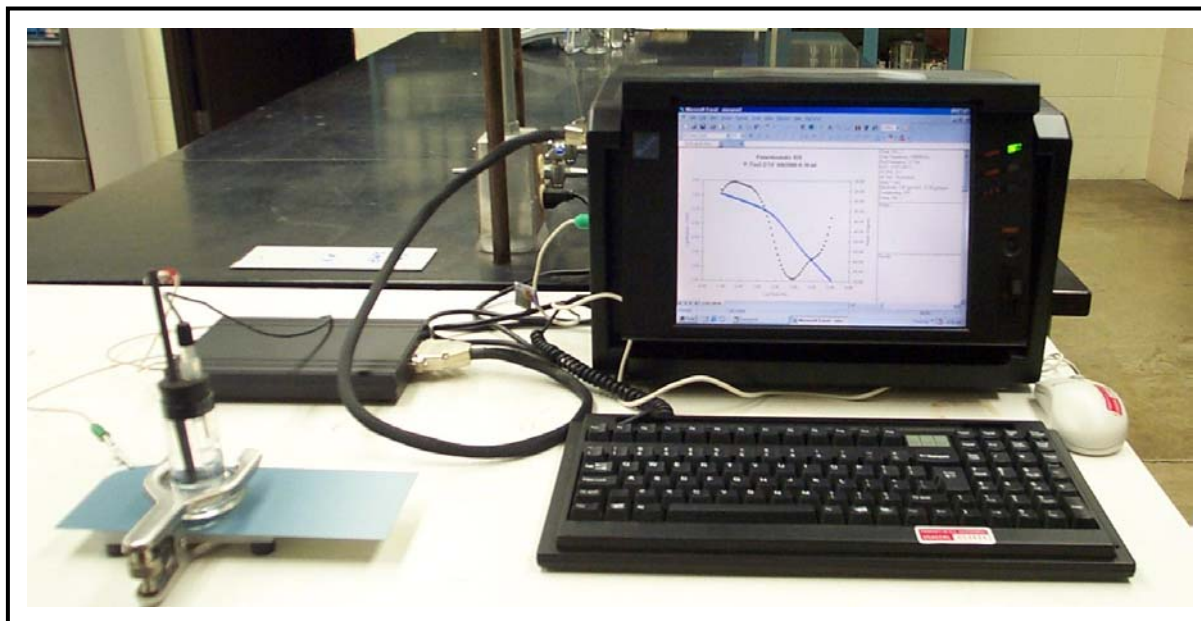
Figure 1 shows the EIS testing apparatus. EIS testing was conducted to determine the feasibility of predicting the long-term field service life based on short-term field exposure. EIS spectra were analyzed by equivalent circuit modeling, which simulates the behavior of properties of the electrochemical reaction at the coating/metal interface. Figure 2 shows the EIS spectra for an SMP-coated Galvalume® sample from Akzo-Nobel before and after salt spray/UV exposure (ASTM D 5894).

Figure 1. Electrochemical impedance spectroscopy testing of polymer-coated steel panels for corrosion assessment.
