**FINAL REPORT
NOVEMBER 2002**

REPORT NO. 02-23

**RAPID INTERNATIONAL STANDARDS ORGANIZATION
BRACING SYSTEM (RIBS)
TP-94-01,
“TRANSPORTABILITY TESTING PROCEDURES”**

**REPORT NO. 02-23
RAPID INTERNATIONAL STANDARDS
ORGANIZATION BRACING SYSTEM (RIBS)
TP-94-01, "TRANSPORTABILITY TESTING PROCEDURES"**

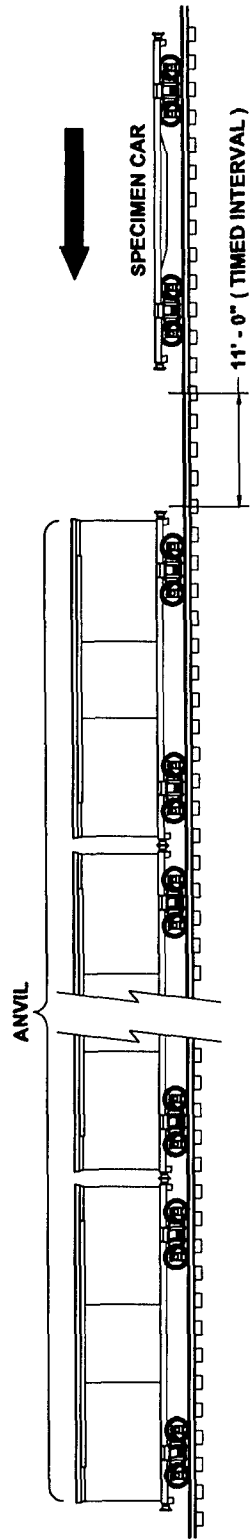
Figure 1. Rail Impact Sketch

4 BUFFER CARS (ANVIL)
WITH DRAFT GEAR COMPRESSED
AND AIR BRAKES IN A SET POSITION

ANVIL CAR TOTAL WT. 250,000 LBS (APPROX)

SPECIMEN CAR IS RELEASED BY SWITCH ENGINE
TO

ATTAIN: IMPACT NO. 1 @ 4 MPH

IMPACT NO. 2 @ 6 MPH

IMPACT NO. 3 @ 8.1 MPH

THEN THE CAR IS REVERSED AND RELEASED BY
SWITCH ENGINE TO ATTAIN:

IMPACT NO. 4 @ 8.1 MPH

A. RAIL TEST. RAIL IMPACT TEST METHOD. The test load or vehicle will be secured to a flatcar. The equipment needed to perform the test will include the specimen (hammer) car, four empty railroad cars connected together to serve as the anvil, and a railroad locomotive. The anvil cars will be positioned on a level section of track with air and hand brakes set and with draft gears compressed. The locomotive unit will push the specimen car toward the anvil at a predetermined speed, then disconnect from the specimen car approximately 50 yards away from the anvil cars allowing the specimen car to roll freely along the track until it strikes the anvil. This will constitute an impact. Impacting will be accomplished at speeds of 4, 6, and 8.1 mph in one direction and at a speed of 8.1 mph in the reverse direction. The speeds will have a tolerance of plus .5 mph and minus zero mph. The impact speeds will be determined by using an electronic counter to measure the time for the specimen car to traverse an 11-foot distance immediately prior to contact with the anvil cars (see Figure 1).

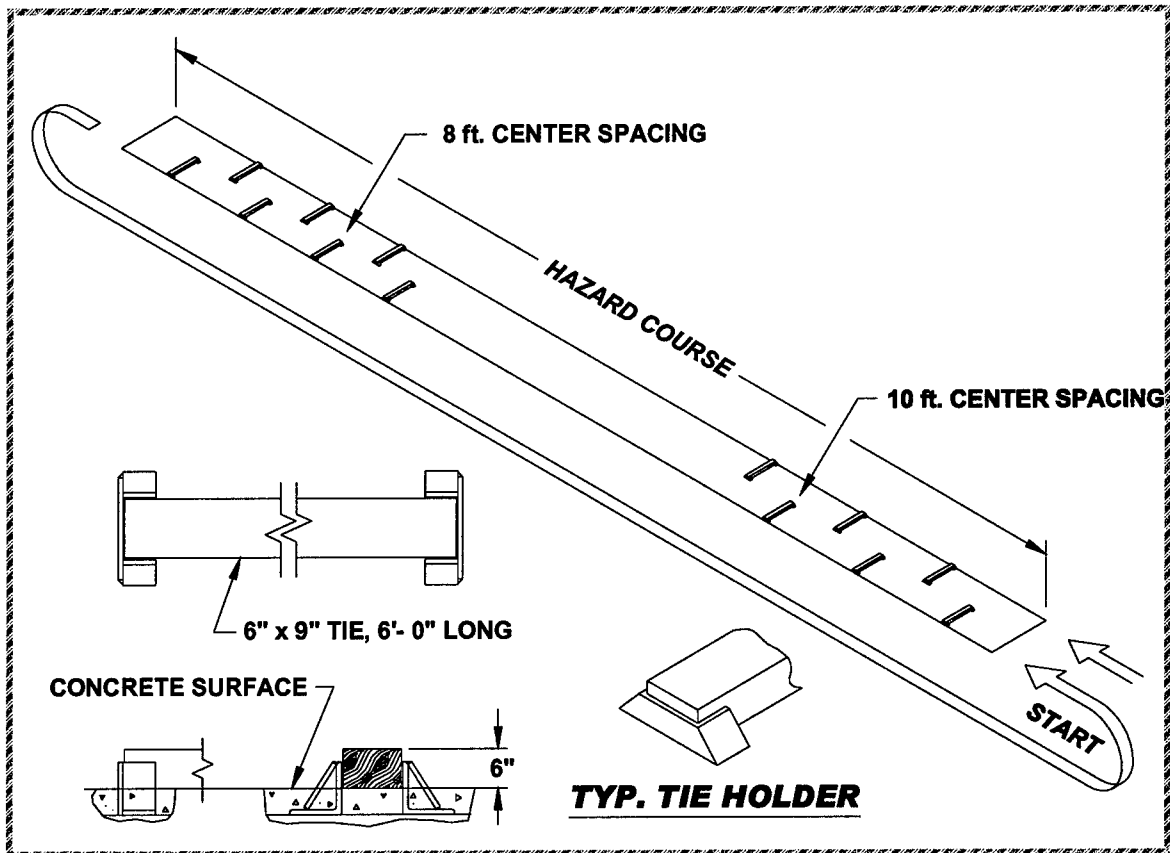
Figure 2. Hazard Course Sketch

- a. The first series of 6 ties are spaced on 10-foot centers and alternately positioned on opposite sides of the road centerline for a distance of 50 feet.
- b. Following the first series of ties, a paved roadway of 75 feet separates the first and second series of railroad ties.

c. The second series of 7 ties are spaced on 8-foot centers and alternately positioned on opposite sides of the road centerline for a distance of 50 feet.

d. The test load is driven across the hazard course at speeds that will produce the most violent vertical and side-to-side rolling reaction obtainable in traversing the hazard course (approximately 5 mph).

1. **HAZARD COURSE.** The test load or vehicle will be transported over the 200-foot-long segment of concrete-paved road consisting of two series of railroad ties projecting 6 inches above the level of the road surface. The hazard course will be traversed two times (see Figure 2).

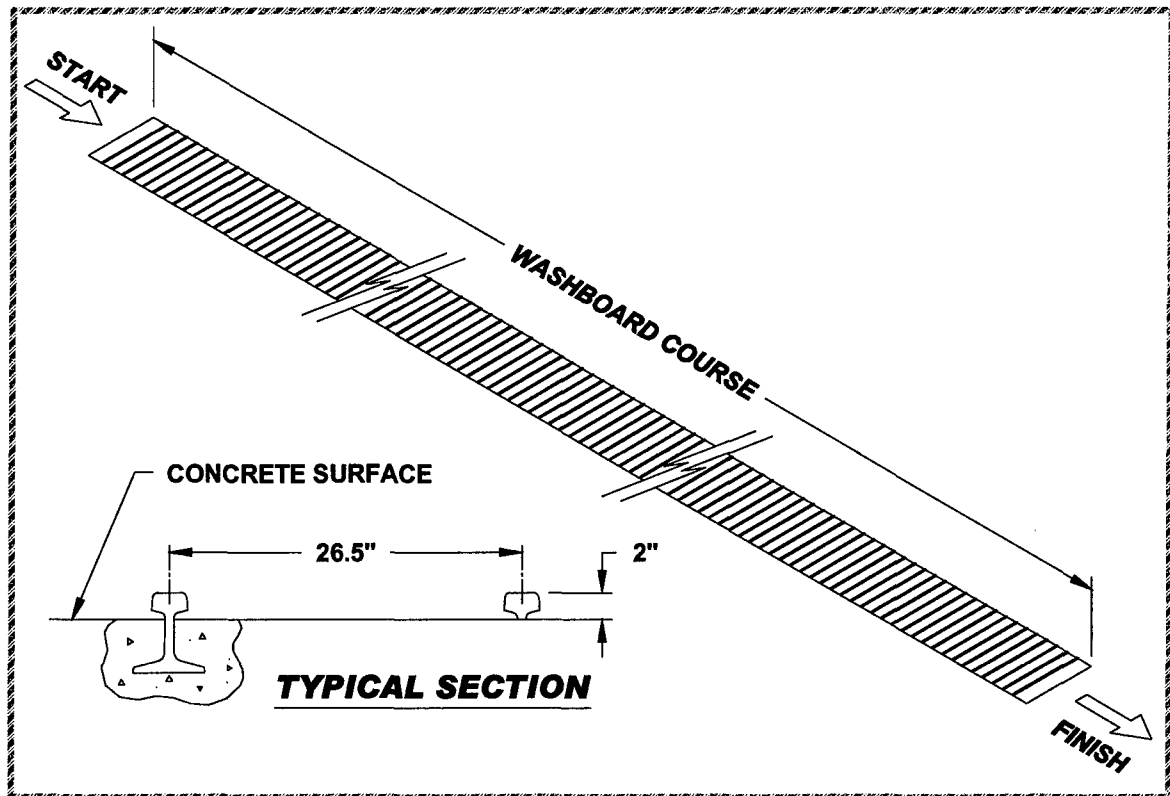
Figure 3. Washboard Course Sketch

4. WASHBOARD COURSE. The test load or vehicle will be driven over the washboard course at a speed that produces the most violent response in the vertical direction.

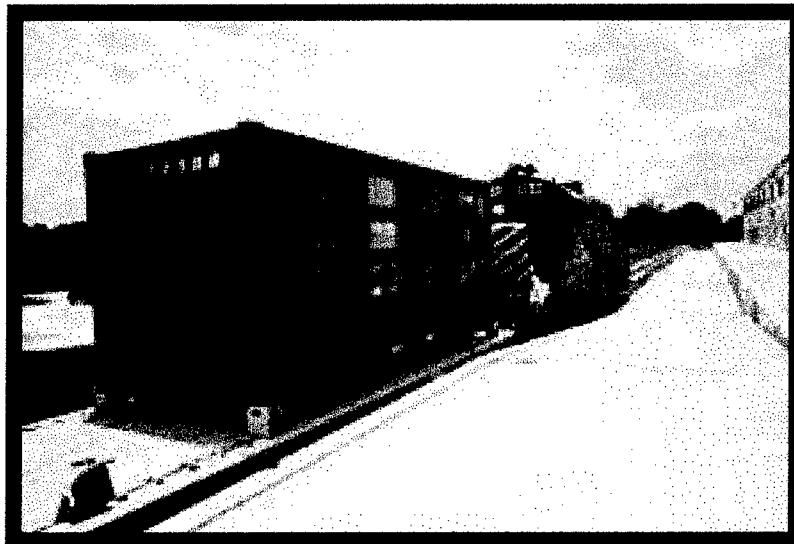
Photo 2: Rail Impact Testing of the RIBS

Remarks: Figure 4 lists the test components and weights of the items used during the Rail Impact Tests. The intermodal container, with the RIBS and payload, was secured on the Container-on-Flatcar (COFC) railcar. The M1 Flatrack, loaded with MLRS Pods was used as ballast for the test.

- Figure 5 lists the average speeds of the specimen car immediately prior to impact with the anvil. Impact #5 is the reverse impact.
- Impact #4 was determined to be a "no test" due to the impact speed was less than the required 8.1 mph. The test was repeated.
- Following impact #3 the payload compacted 0.125 inches in the direction of impact. The bombs in the center pushed the beams up slightly.

4. Following Impact #5 the beams at each end of the container moved 0.25 inches in each corner and 0.5 inches in the center. The center vertical stays moved 0.75 inches. All movement was in the direction of impact.

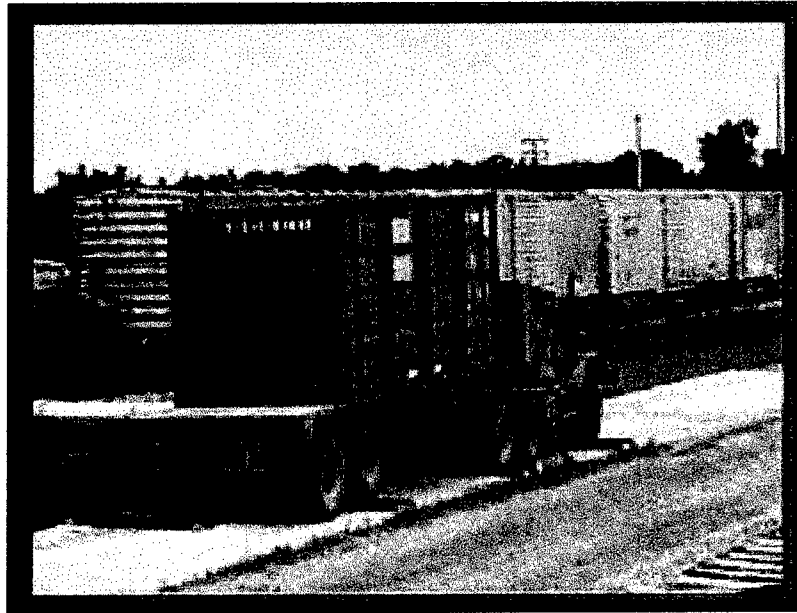
Photo 3: Hazard Course Testing of the RIBSs

1. Figure 6 lists the average speeds of the test load through the Hazard Course.
2. Inspection following Pass #1 revealed that the payload and beams moved to the original starting position. The cradle movement from the beginning of testing was 0.75 inches.

3. Inspection following Pass #2 revealed that the cradle at the rear of the trailer had moved an additional 0.25 inches.

4. No damage or excessive movement occurred with the payload or the RIBS during Passes #1 and #2.

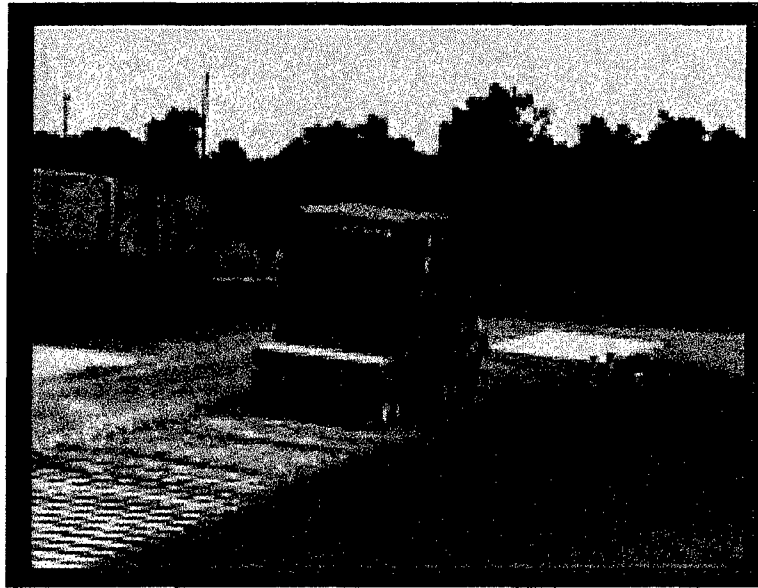
Photo 4. Washboard Course Testing of the RIBS

1. The total movement of the cradle was 0.75 inches at the trailer end of the container and 1.5 inches at the tractor end of the container. The movement was at the top of the cradles and not at the base.
2. No damage or excessive movement occurred with the payload or the RIBS during testing.

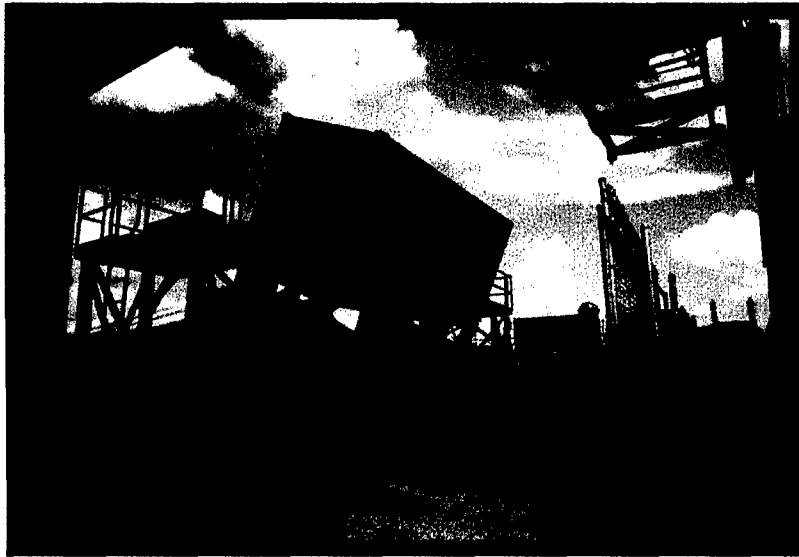
Photo 5: STS Testing of the RIBS

1. The beams moved 0.25 inches toward the container door.
2. The cradle movement from the beginning to the end of testing was 1.25 inches at the top beam of the cradle and 0.5 inches at the base of the vertical stays.
3. No damage or excessive movement occurred with the payload or the RIBS during testing.

D. CONCLUSION. The Rapid International Standards Organization Bracing System (RIBS), as tested, is adequate to transport ammunition in intermodal side-opening containers. Additionally, the clips adequately held the vertical stays in the extended position.

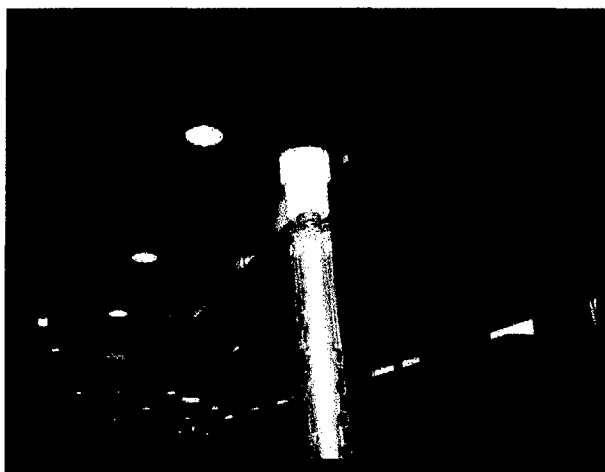
Photo 6. Retainer Clip

Photo 7. Installed Retainer Clip

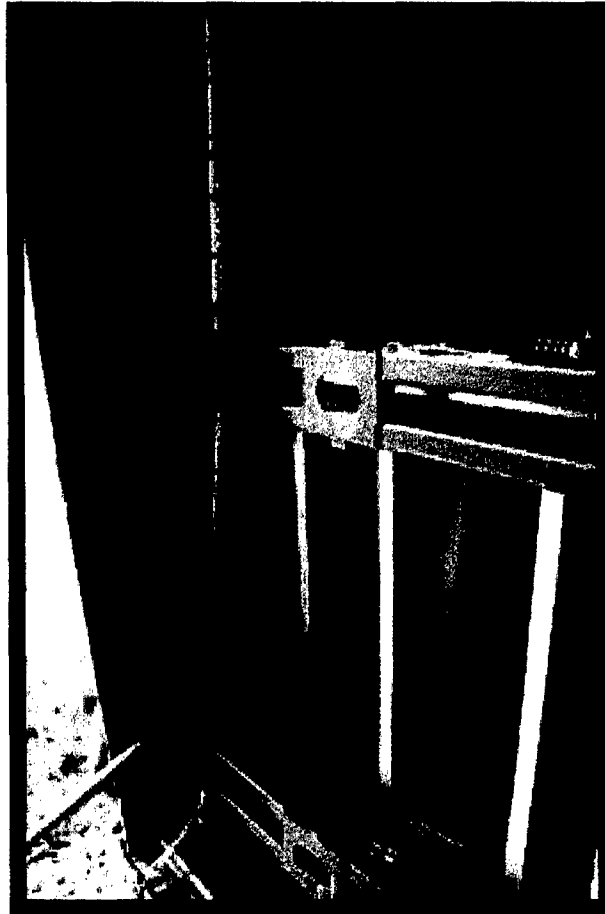
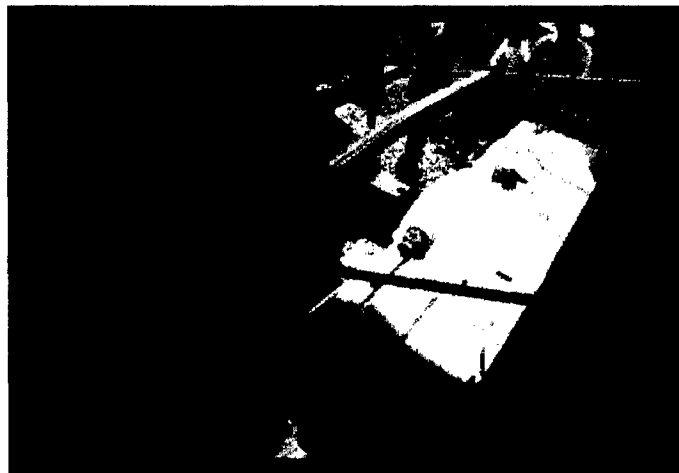
Photo 10. Damaged RIBS

5. Following Impact #4 the beams and vertical stays at the door end failed and came out of the container upon impact. The forces imposed during impact permanently damaged the horizontal beams and vertical stays.

6. Testing was stopped due to the failure of the horizontal beams and vertical stays.

B. CONCLUSION. The RIBS, as tested, is not adequate for use in intermodal end-opening containers.

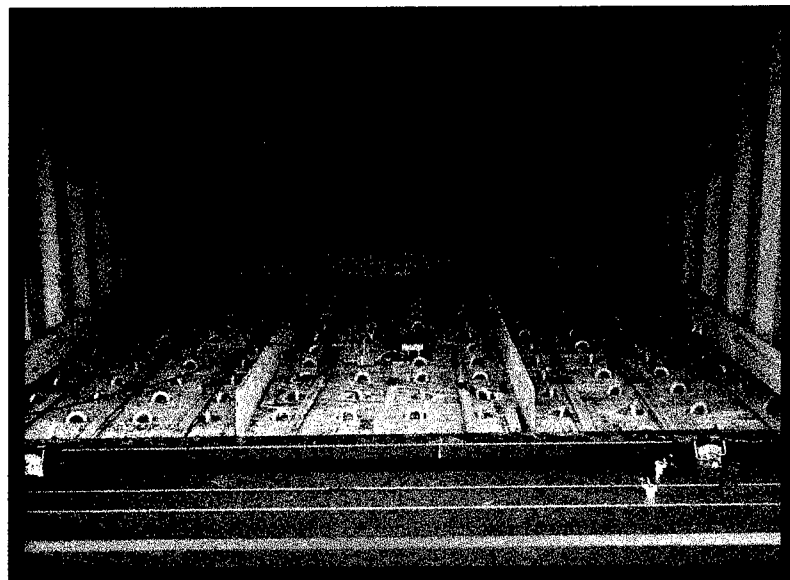
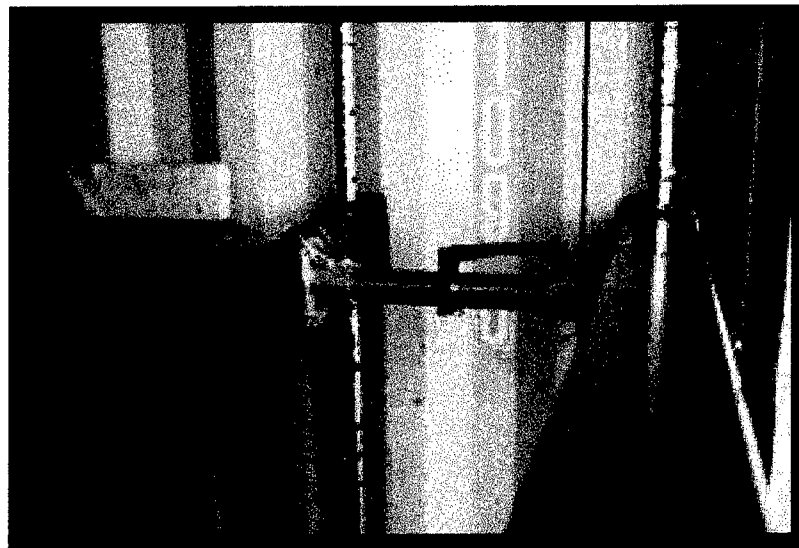
Photo 12. Doubled Horizontal Beams

Note: The beams at the door end of the container were doubled from that which was previously tested. (See 5.2).

Photo 13. Single Horizontal Beams (Tested 4 June 2002)

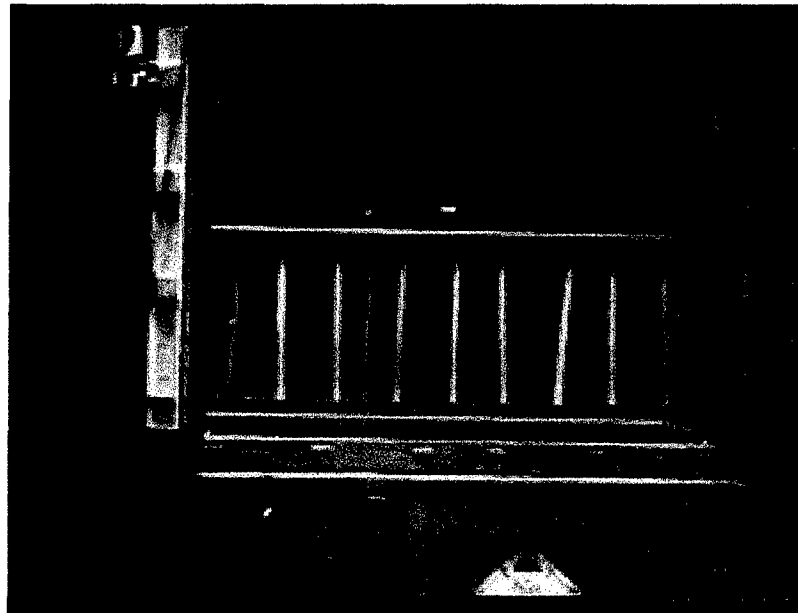
Photo 22: Hazard Course Testing of the RIBS

1. Figure 14 lists the average speeds of the test load through the Hazard Course.
2. Inspection following Pass #1 revealed that the vertical stays had moved down from the original starting position.
3. No damage or excessive movement occurred with the payload or the RIBS during Passes #1 and #2.

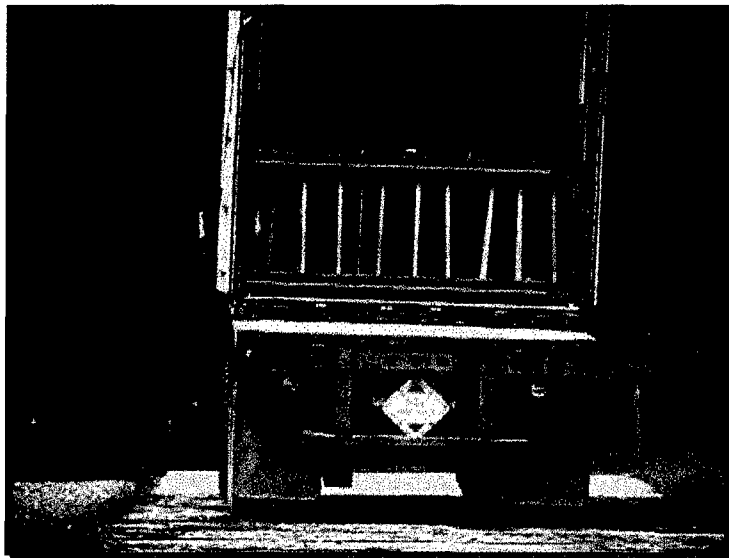
Photo 23. Washboard Course Testing of the RIBS

Remarks: No damage or excessive movement occurred with the payload or the RIBS during testing.

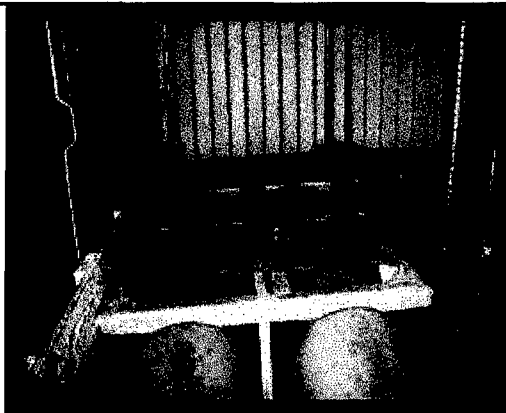
**Sensor Location for the MK-84,
2000-Pound Bomb RIBS Testing**

The accelerometers were located on the test specimen. The location of the accelerometers is shown in the photos. Also following are the graphic depictions of each of the railcar impacts, hazard course, road course, and washboard course. The axial orientation of the accelerometers is as follows:
