ERDC TR-02-7

# **Biaxial Loading and Failure Behavior of Brick Triplets with Fiber-Reinforced Polymer Composite Upgrades**

December 2002

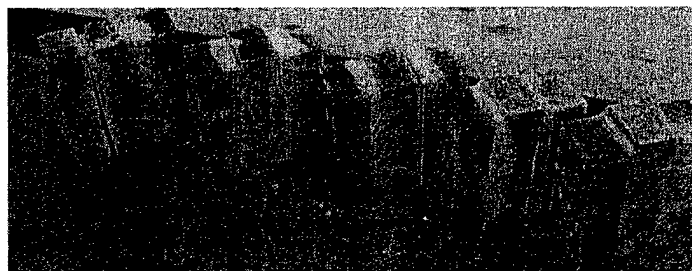
Figure 5. Modes of failure for Series 0.

The failure modes of the various triplet series were captured in Figures 5 – 8 and discussed in detail in Tables 4 – 7. The resulting normal load versus shear load failure envelopes, along with their associated standard deviations, are provided for Series 0, I, and II in Figures 48, 49, and 50, respectively. One item to observe is that near the lower normal load levels, sometimes two points are plotted for a given normal load. This represents deviations in bilinear yield and ultimate failure loads. The reasoning for this difference is discussed below.

| Group | Sample | Modes of Failure |
|---|---|---|
| 0-0 | AI | A shear crack was visible along one mortar joint in the xz-plane |
| 0-12.5 | All | Shear cracks formed in both mortar joints. Tension cracks passed through the holes in the brick in the xy-plane. A single tension crack also appeared in the yz-plane of one exterior brick unit. |
| 0-25 | All | Shear cracks formed in each mortar joint in the xz-plane. Tension cracks appeared in the exterior brick units. |
| 0-75 | All | Partial spalling was observed at the loading end of the center brick. The confining pressure on the sample was high causing local failure at the loaded end. Several tension cracks also appeared in the yz-plane of one exterior brick unit. |
| 0-100 | All | Several tension cracks formed in the yz-plane along with spalling of the overhangs. (Note: Overhangs are not considered part of the prism area) |

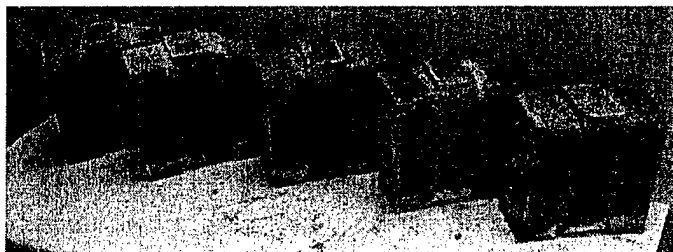
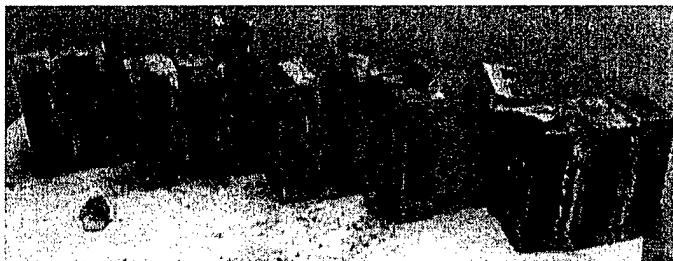
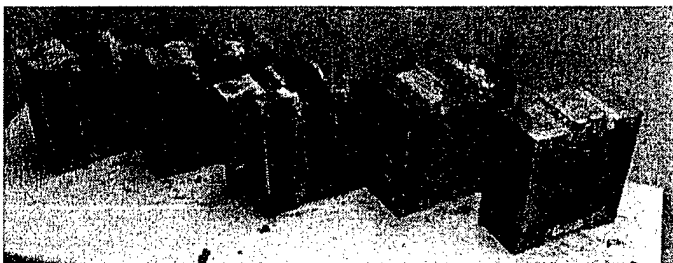
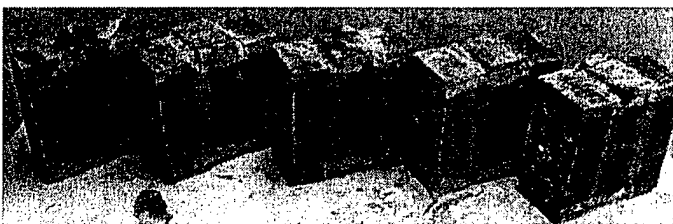
Figure 6. Modes of failure for Series I.

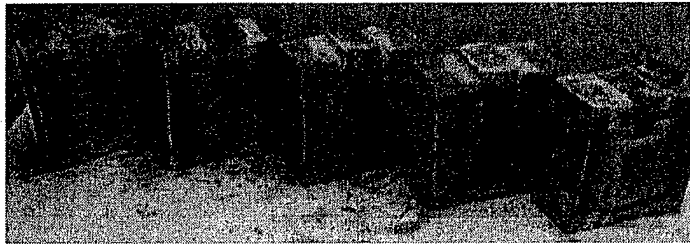
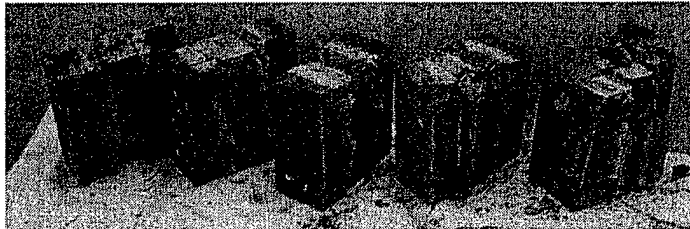
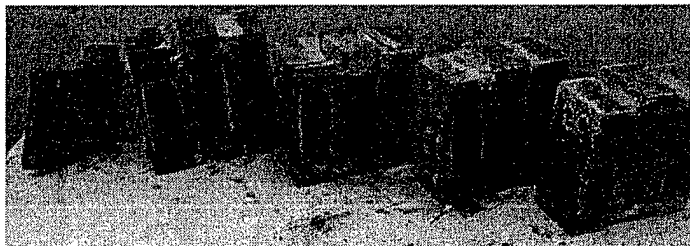
Figure 7. Modes of failure for Series II.
