**AFRL-IF-RS-TR-2003-138**  
**Final Technical Report**  
**June 2003**

# **FOCAL PLANE ARRAY-BASED MILLIMETER WAVE IMAGING RADIOMETER**

**Lockheed Martin Corporation**

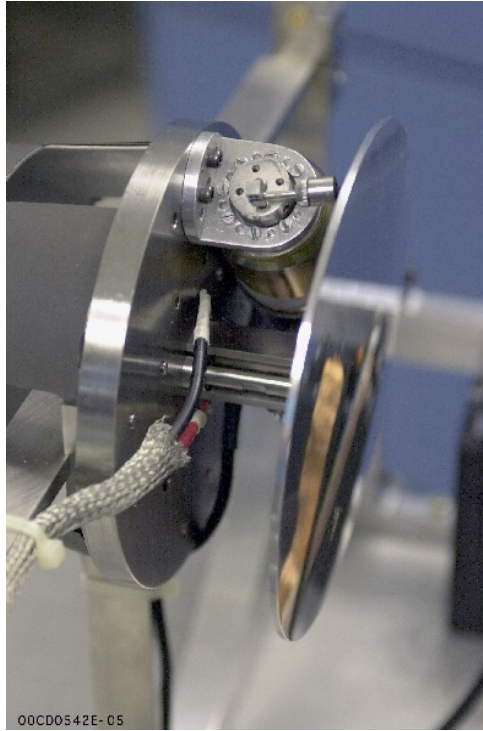
The vertical scan is more critical since the image formatting circuitry relies on timing to assign values to the pixels in the matrix and any variation in the motor speed, binding of the linkage or flexing of the secondary will result in misalignment of the pixels in the upwardly going columns as compared to the interleaved downwardly going columns. Additionally, any vibration will result in a frame-to-frame misalignment. All of these problems were evident in the original brassboard. Figure 2.2-1 shows the original mechanism.

**Figure 2.2-1. Micromoe Motor  
Drives Secondary  
(High voltage wires lead to the  
Piezo electric driver  
for horizontal displacement)**

The system operation requires the secondary mirror of the Cassegrain optics to perform a narrow rectangular scan to sweep the image over two 1 by 17 arrays of MMW horns (see Figure 2.5-2) at the entrance to the detector manifold. This was implemented with a small motor linked to the mirror to provide vertical scanning and a piezoelectric device to offset the mirror horizontally every half cycle so as to move the image over one half wavelength at the focal plane. This system design provided for Nyquist sampling using horns spaced at one wavelength. Problems arose from the tight coupling of the vertical scan linkage and the mirror mass that loaded the motor and caused irregular motion and from the near-zero tolerance for wear in the horizontal displacement mechanism.

These problems led to an effect referred to as an image comb since the dark image of a weapon would be displaced up and down on adjacent columns. Since the amount of displacement varied from frame-to-frame the image could not be completely corrected in the display software. The severity of the displacement also varied with the frame rate.

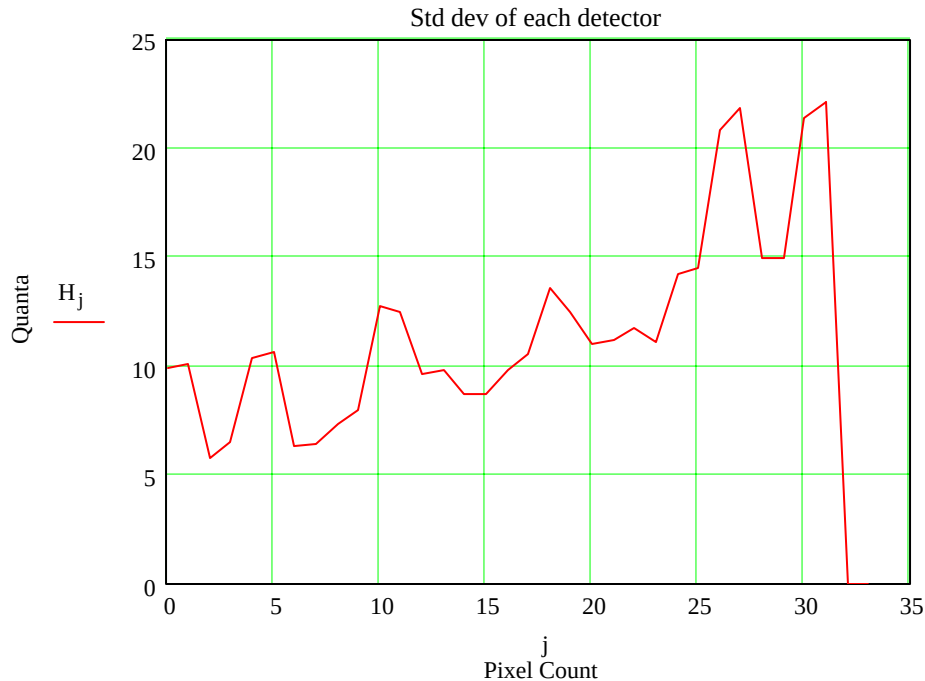
We now need to know the fluctuations of the pixel output when staring at a constant temperature. A sequence of 25 scans was used to calculate statistics by determining the mean and standard deviation for each pixel (Figure 2.6-1). Since each pixel can be related to a specific detector, we can then group the statistic of many pixels to individual detectors. Even as the observed temperature changes, we are most interested in the standard deviation of each detector.

**Figure 2.6-1. Standard Deviation**

The product of the sensitivity and the fluctuations gives the minimum detectable temperature difference, assuming we can discern a 1-sigma difference.
