# **U.S. Coast Guard Research and Development Center**

**Report No. CG-D-05-03**

## **Cape Henry Lighthouse Fuel Cell Evaluation**

**FINAL REPORT  
March 2003**

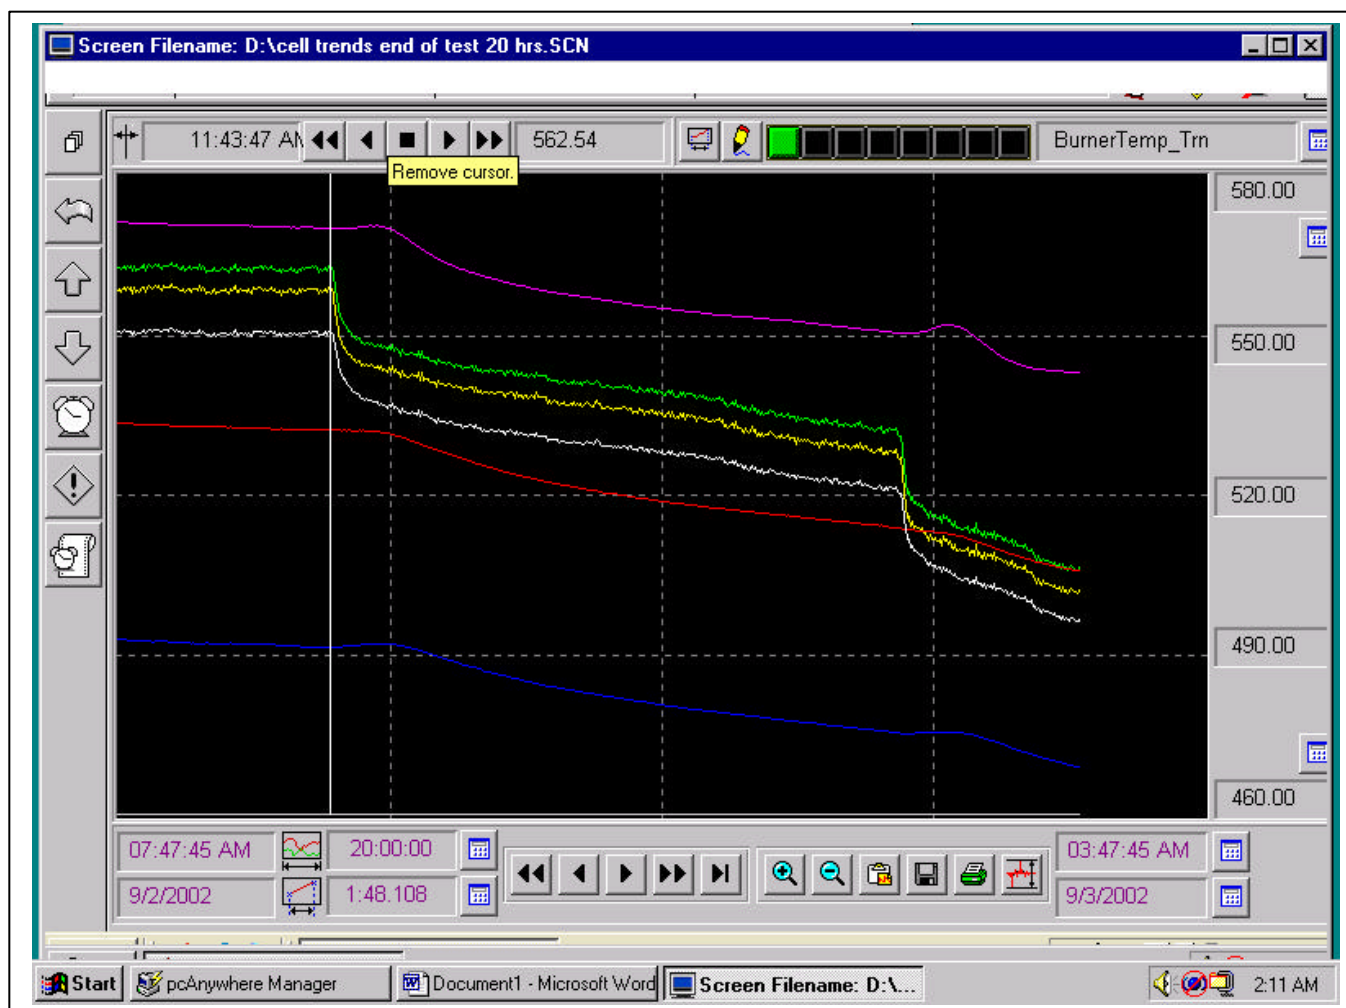
Figure 11. Low temperature shutdown plot.

During the six-month operation of this test system, many outages were experienced. Initially there were multiple problems with the fuel mixture and bubbles within the fuel lines created by the daily heating and cooling of the fuel lines from the storage tank to the fuel cell. In one case, the UPS overheated and shut down due to heat buildup in the building. One of the Programmable Logic Controllers overheated and caused a shut down of the system. One failure was caused by a fuel injector failure in the system. There were two instances of operator errors. All of these failures were overcome and corrected; many were growing pains of a prototype system of new technology. A complete description of these failures can be found in Appendix E. Figure 11 is a screen print showing a low temperature system failure, like that of the fuel injector failure. In all cases, the remote DAS enabled both FCE and the USCG to diagnose problems and expedite corrective action.
