Recent Advances in Matting Technology for Military Runways

Maj. Dov Dover, P.E.¹
Mark Anderson, Ph.D., P.E.²
Randall W. Brown, Ph.D., P.E.³

Abstract

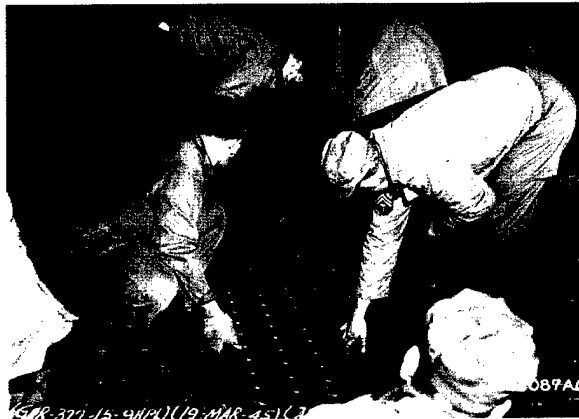
Figure 1. Pierced Steel Planking (PSP) being installed at night by men of the IX Engineer Command at an Air Force Base in Germany (circa 1945).

Pierced Steel Planking (PSP), also known as Marston Matting, was initially tested at Langley Field, Virginia, in 1940 and was in wide use even through the Korean War. Installation of PSP is shown in Figure 1. PSP proved to be very versatile. It was comparatively light, yet fairly rigid and very transportable. The simple hook design on the plank edges made assembly a fast and relatively easy undertaking, and minor replacement repairs usually ended up requiring only two men to accomplish. When major repairs were necessary, large sections of planking could actually be rolled up and removed and replaced as appropriate. A major drawback that eventually brought about its replacement was the development of drainage problems. The holes in the planking served to reduce weight but also resulted in an undesirable "pumping" action that caused rapid base course failures in wet climates (such as Southeast Asia). By the end of World War II, enough PSP had been manufactured to construct nearly a thousand 46 m x 1.5 km (150 ft x 5,000 ft) runways (as shown in Figure 1).

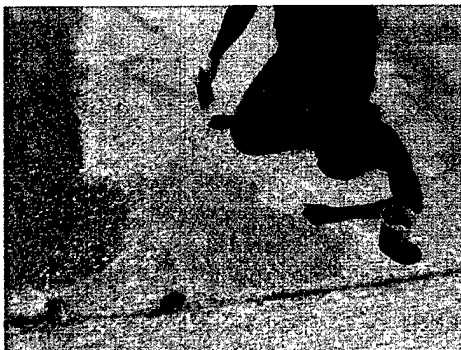
(c) Priming repair shoulders

Test Case 1 Procedure. Figure 5 illustrates the entire procedure for Test Case 1, including the installation of the unreinforced ESC FOD cover, and testing to determine the capability of the ESC FOD cover to withstand loading by the F-15 aircraft. Figure 5a shows a test crater which has been repaired by standard Air Force procedures (*Rapid Runway Repair, 1999*), but just before a FOD cover would normally be applied. Figures 5b and 5c show special preparation needed to assure a good bond between the existing crater shoulder and the ESC, i.e., cleaning the shoulder with compressed air and then applying primer. Figure 5d shows the AFRL ESC equipment previously shown in schematic form in Figure 4. The ESC equipment is trailer mounted for easier use. Figures 5e and 5f show spraying the ESC to a thickness of 6 mm (1/4"), up to and including the crater shoulders, to create a monolithic, anchored FOD cover. Figure 5g shows the F-15 load cart (configured as previously discussed). Figure 5h shows the unreinforced ESC FOD cover after 150 passes of the F-15 load cart.

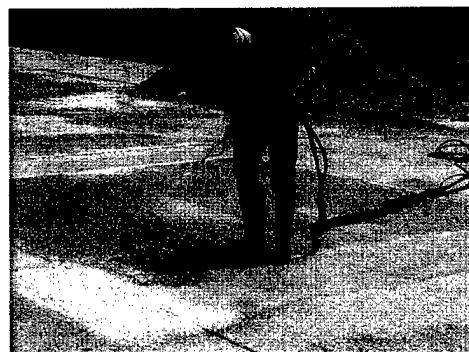
(e) Spraying to 6-mm ($\frac{1}{4}$ ") thickness

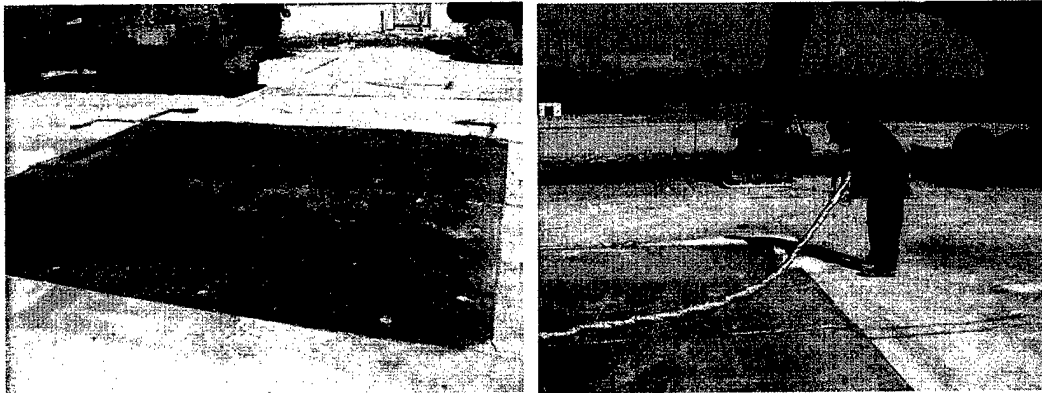
(a) Unanchored FFM FOD cover

(b) ESC used to anchor FFM

Figure 7. ESC used to anchor folded fiberglass mat (FFM)

Test Case 3 Procedure. The third case examined did not use ESC as a FOD cover, but rather as an expedient anchor system for folded fiberglass mats (FFMs). In this case a standard Air Force FFM was used, except that the size of the FFM was cut to just larger than the crater. As with the previous Test Cases, the crater was prepared in accordance with standard Air Force procedures up to the point of applying a FOD cover (*Rapid Runway Repair, 1999*). At that point, the "cut down" FFM was placed to the prepared crater (as shown in Figure 7a). Then, ESC was sprayed on the edges of the FFM and across to the crater shoulder, to a thickness of 6 mm ($\frac{1}{4}$ ") (as shown in Figure 7b). The total width of the ESC layer was 0.6 m (2'), with 0.3 m (1') on the FFM and 0.3 m (1') on the crater shoulder. No other anchor was used to hold the FFM in place. Subsequently, the ESC-anchored FFM was trafficked with 150 passes of the F-15 load cart, and the results were compared to a standard FFM repair system.

Test Case 3 Results. FFM performed better under the prescribed test loading than a

standard FFM system. With the smaller sections, anchored by ESC, the FFM had dramatically reduced “wave” size (i.e., the reaction to horizontal loading) in front of the moving load cart wheel, compared to a standard FFM repair. Both the standard FFM system and the ESC-anchored FFM system had relatively small deflections under the vertical load.
