AFRL-VA-WP-TR-2003-3073

**SURVIVABILITY OF AFFORDABLE
AIRCRAFT COMPOSITE
STRUCTURES**

**Volume 3: Characterization of Affordable
Woven Carbon/Epoxy Composites Under Low-
Velocity Impact Loading**

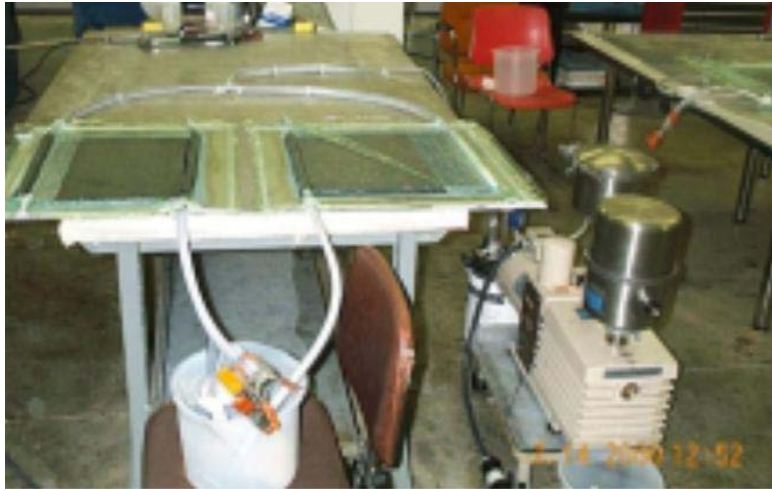
Figure 1. Fabrication of Laminate by VARIM Process

completely wetted the preform and reached the suction side. The wet laminate was left to cure at room temperature. Vacuum was maintained until the end of cure to remove any volatiles generated during the polymerization, and also to maintain the pressure. Figure 1 illustrates the arrangements for the fabrication process.

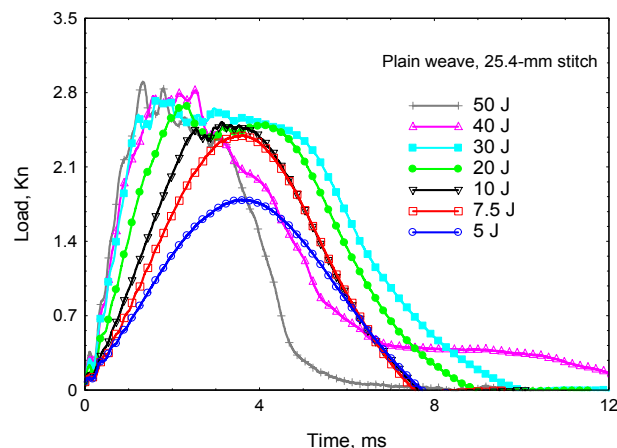
Figure 5. Load-Time Response for 25.4-mm Stitched Plain Weave Laminate Samples

Figure 5 exhibits the impact response plot and Figure 6 a-d (for energies 10, 20, 40, and 50 J respectively) illustrates front and back surface pictures with the ultrasonic c-scan images for 25.4-mm plain weave stitched carbon/epoxy laminates. Table 2 presents the summary of response in terms of peak load, absorbed energy, and damage area. In this case, the laminate seems to absorb a higher load as compared to unstitched laminates for a given impact energy. As can be seen from the table, there is no visible or ultrasonic indication of damage upto 10 J. The first sign of damage is seen at 15 J as a linear crack along the stitch line. This is true even at 20 J. At these two energy levels the damage is very little and all the energy (50 percent of impact energy) absorbed is taken up by the stitch line. At 25 J there is splitting damage along the stitch line, but the areal damage is again very small. Only at 30 J, there is visible dent at the impact point with splitting along stitch line at the back surface. The splitting along the stitch line is typical of stitched laminates, as the stitch locally damages the fabric, which gives away at impact energy in the range of 25–30 J. However, the overall effect on the laminate is the suppression of the damage due to stitching. At 35–50 J range of impact energy, the penetration of laminate takes place, with the damage being confined within the grid of the stitch line. With 25.4-mm stitch spacing, the damage is reduced by 1/3 as compared to unstitched laminate.

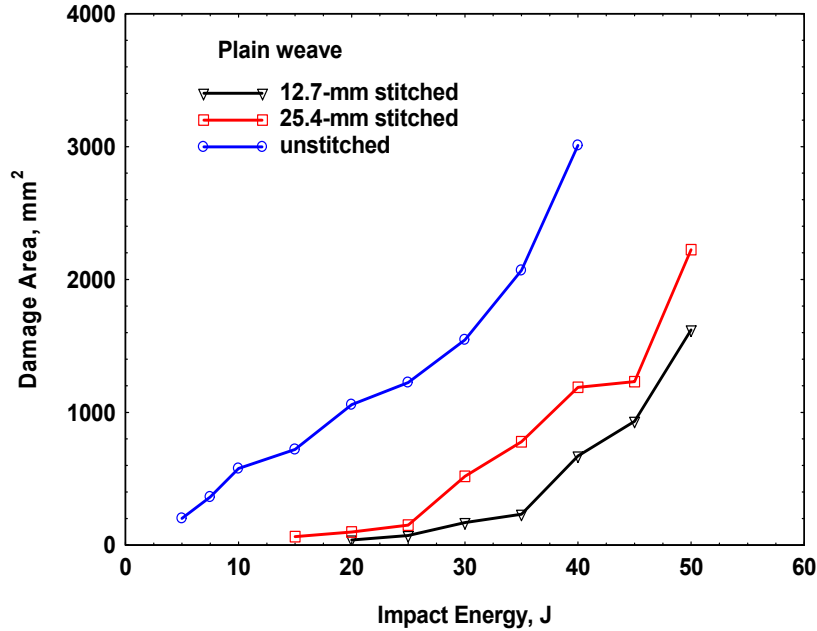
Figure 9. Damage Area Versus Impact Energy for Unstitched, 25.4-mm Stitched and 12.7-mm Stitched Plain Weave Carbon/Epoxy Laminates

A comparison of the response of three types of laminates discussed in this study is best illustrated by plotting the damage area in a single graph as shown in Figure 9. In this graph the damage area is plotted as a function of impact energy for unstitched, 25.4-mm stitched, and 12.7-mm stitched laminates. It is clearly evident from this plot that there is considerable advantage to be gained from stitching. Stitching restricts the size of the damage, as a large amount of energy has to be expended in overcoming the resistance offered by the stitches. Once the damage due to impact is reduced, then the residual properties are relatively improved over the unstitched laminates, thereby enhancing the scope of increasing design allowables. The size of the post-impact repair, if warranted, will be considerably reduced, thereby reducing the overall cost.

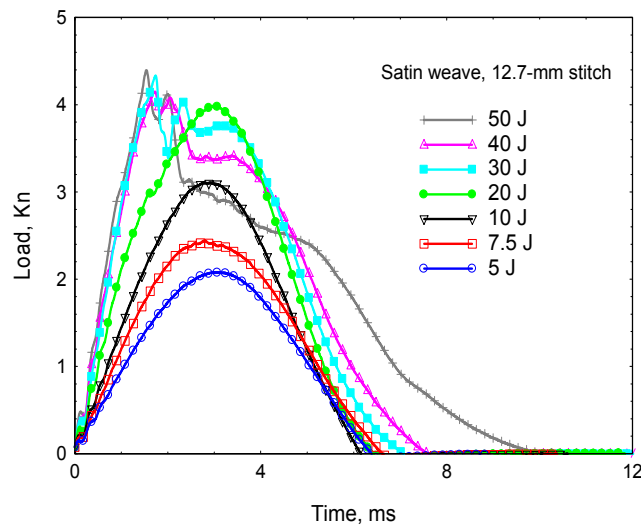
Figure 14. Load-Time Response of 25.4-mm Stitched Satin Weave Carbon/Epoxy Laminates

Figure 14 illustrates the impact response of 12.7-mm stitched satin weave laminates. Figure 15 a-d gives front and back surface pictures along with ultrasonic c-scan images of the samples impacted at 10, 20, 40, and 50 J, respectively. The impact parameters along with the remarks and projected damage area as measured from ultrasonic c-scan images are given in Table 6. From the transient response curves illustrated in Figure 14, it is seen that the peak load increases with increase in impact energy and also the time to peak load also decreases. The curves for 5, 7.5, and 10 J show symmetric loading-unloading response, indicating no damage in the laminate. The laminate in undergoing elastic deformation absorbs all the

energy. For the sample impacted at 20 J, there is small change in the slope of the curve at 3.0 Kn load. However, neither visible indications nor ultrasonic studies revealed any damage. First, quantitative damage was observed through ultrasonic evaluation at 25 J. The first visible indication of damage was seen at 30 J through backface splitting along the stitch line. Since the back surface gave away, there was a sudden drop in the peak load. However, there was a redistribution of load, as evident from the increasing load in the transient response curve. Since the damage was through linear splitting, the size of the damage was very much confined to the location along the stitch line. Even though there was increased energy absorption of about 50 percent, at 30- 45 J, the damage was again very much confined along the stitch line within the grid where the impactor hits the laminate. This was again reflected in the limited damage sizes. At 50 J, there was a partial penetration of the laminate with back surface splitting and breakage of thread. However, when compared to unstitched and 25.4-mm stitched laminates, it was seen that the damage size was considerably reduced.

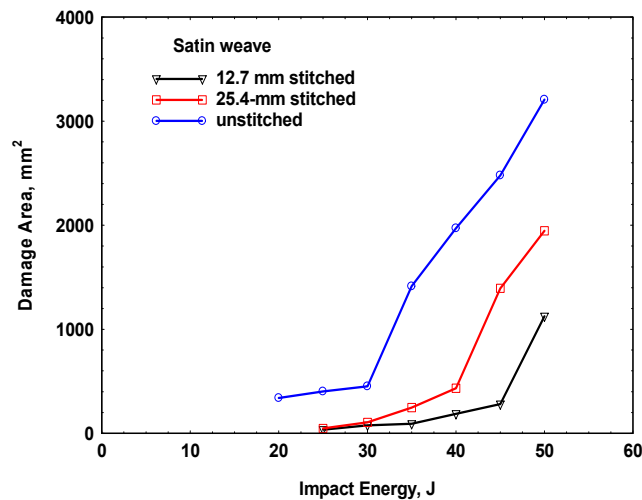
Figure 16. Damage Area Versus Impact Energy for Unstitched, 25.4-mm Stitched and 12.7-mm Stitched Satin Weave Carbon/Epoxy

Figure 16 illustrates the variation of projected damage area as determined through ultrasonic c-scan evaluation with impact energy for satin weave carbon/epoxy laminates. From this plot, it is again demonstrated that there is a considerable reduction in the impact damage area for stitched laminates. The closer the stitch spacing, the better the impact resistance and increased damage tolerance. Satin weave laminates exhibit better impact response as

compared to plain weave laminates. This is attributed to the fabric architecture. In the plain weave fabric, the fiber tow in the warp direction crosses over every other fiber tow in the fill direction, as shown in the schematic diagram in Figure 17. The angle made over the crossing, which is called crimp angle, is thus steep and is repeated for each tow in both fill and warp direction. Hence, there is a considerable reduction in the in-plane properties of the laminate made using plain weave architecture. In comparison, in eight-harness satin weave fabric, the fiber tow in the warp direction runs over seven fiber tows in the fill direction before crossing under the eighth tow in the fill direction, as shown schematically in Figure 18. This pattern is repeated over the entire width of the fabric. This will result in much straighter architecture without any apparent indication of the weave. The resulting laminate will be very close to unidirectional laminate, with much higher in-plane properties as compared to plain weave fabrics. Under impact loading, the tensile failure initiates through in-plane failure of the bottommost ply. The fabric with better in-plane properties would naturally sustain higher stresses, which in the current case is satin weave. Further, the failure initiation is more likely through tensile failure of the fiber tows. In the case of plain weave fabric, the failure initiation is more likely to be through shear fracture of the fiber tow.

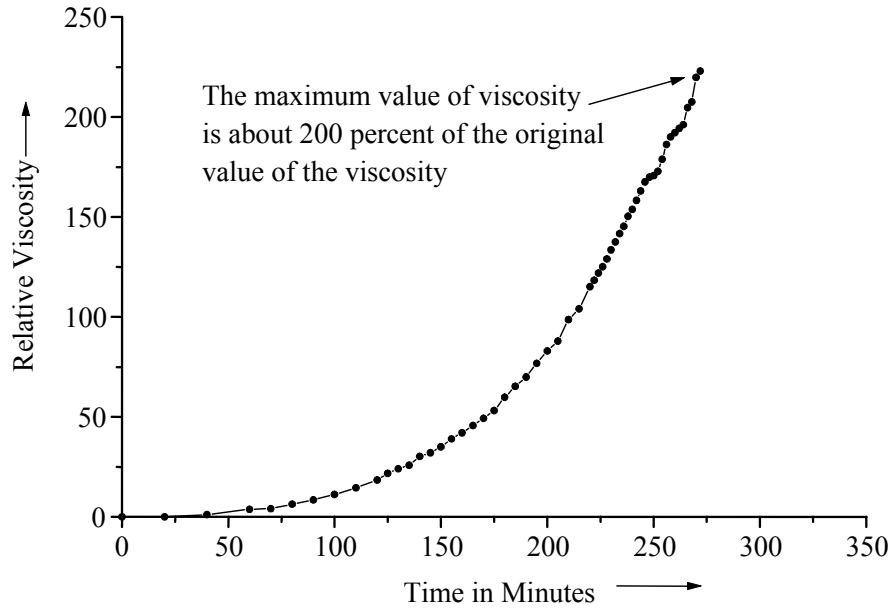
Figure 20. Relative Viscosity Versus Time for SC-15 Resin Mixture

The viscometer was used with the spindle number L2 and with a rotating speed of 30 rpm. The experimental set-up for the viscosity measurement test is shown in the Figure 19. First, the viscosity of resin versus the temperature was measured, so that the viscosity of mixture of resin and hardener could be determined while fabricating the composite panel. Consideration of this data, determines whether heat is to be applied to the mold while fabricating the panel or whether the process will be done at room temperature. Figure 20 gives the graph of viscosity versus time.

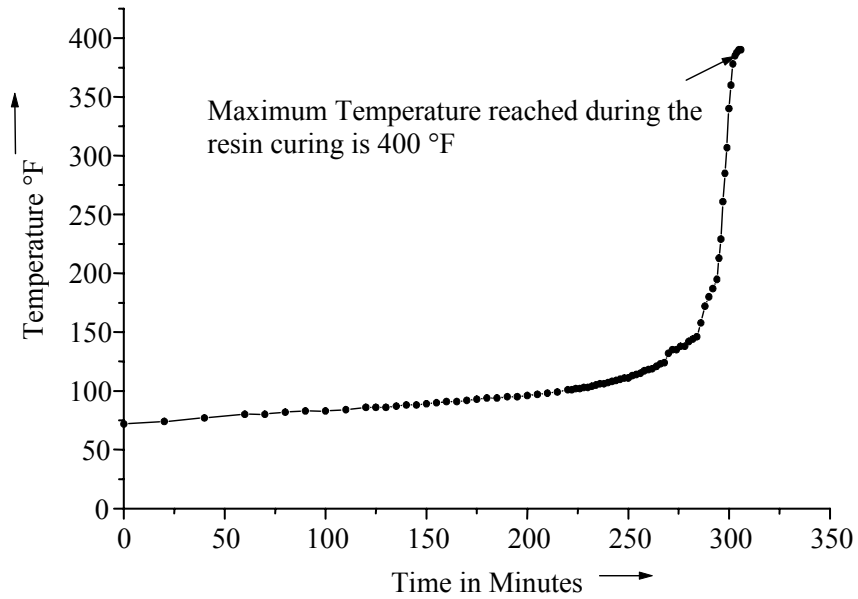
Figure 21. Temperature Versus Time Response for SC-15 Resin Mixture

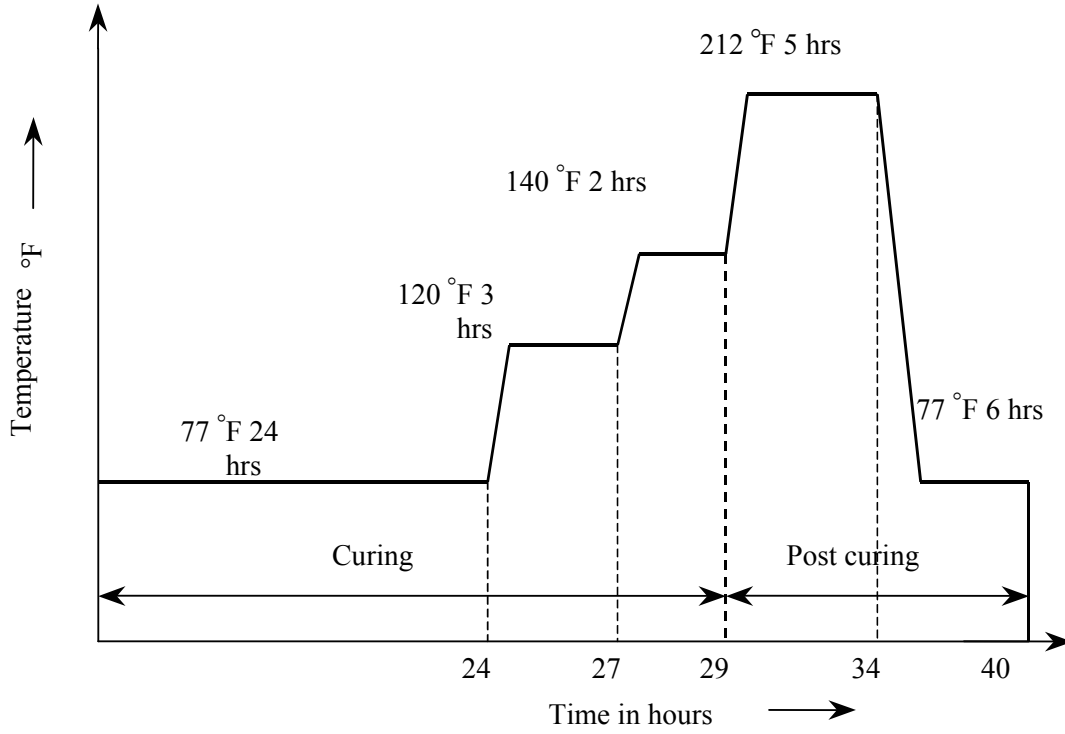
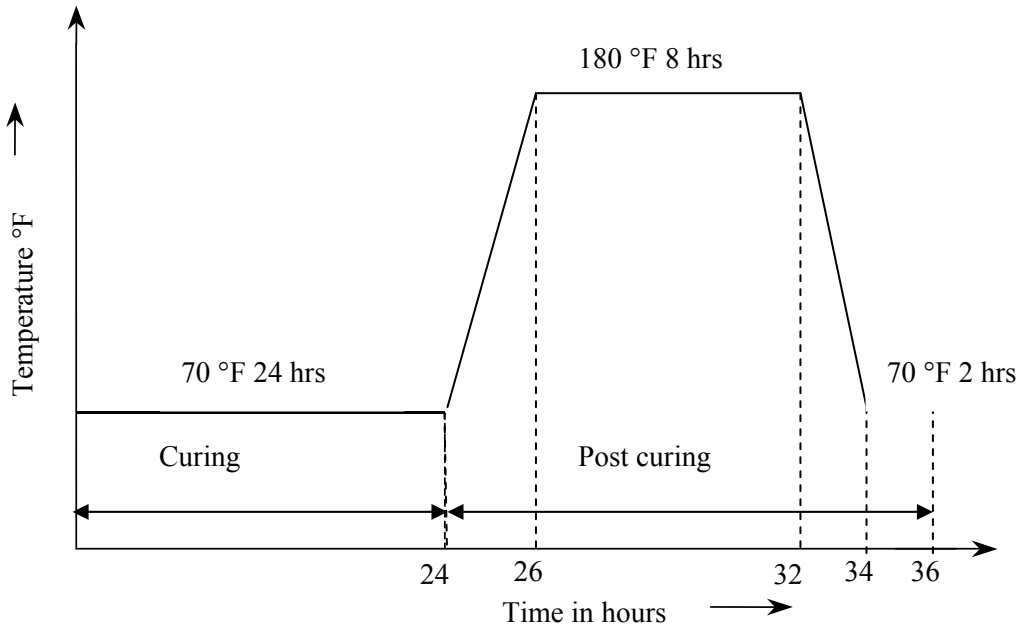
Figure 22. The Recommended Cure Cycles for SC-15 Epoxy Resin and Derakane 510 A-40 Vinyl Ester Resin

The correct post cure cycle has to be found for each resin to assure that the composite reaches to its optimum mechanical properties during the cure process. Figure 22 shows the curing cycle time for SC-15 resin. This cure cycle was developed with the data sheet provided by the manufacturer of the resin. The curing cycle for vinyl ester is heating at 187 ° F for 8 hours and then cooled to room temperature in the air. Figure 23 shows the overall arrangement of the fabrication process.

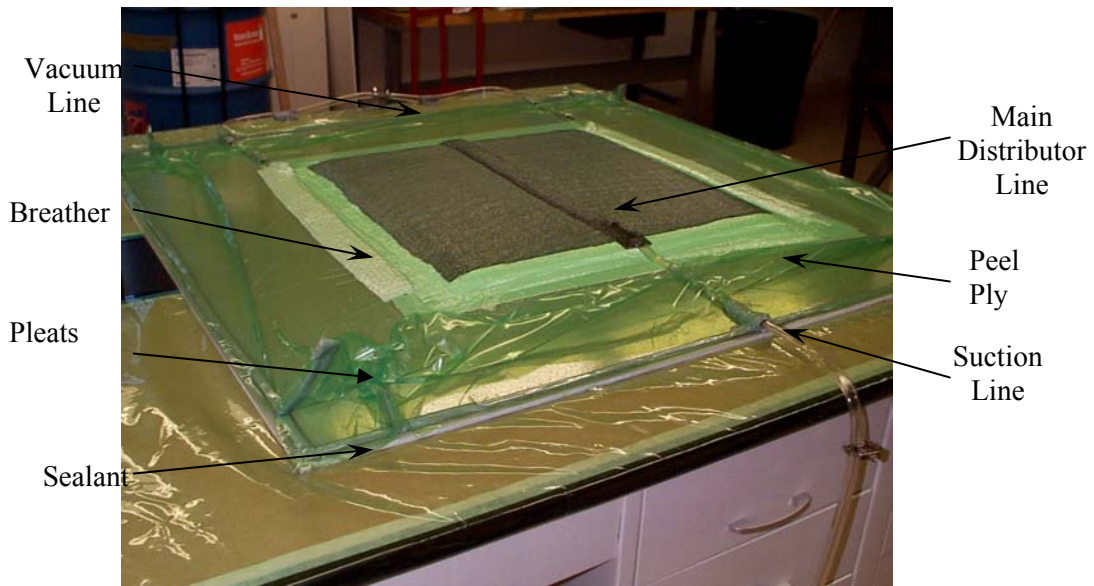
Figure 24. Approach With the Main Distributor in the Middle of the Panel

In the present fabrication, there were two set-ups used for the fabrication of the composite panels. In the first one, the main distribution channel goes on one side of the panel, and in the second set-up, the main distribution channel goes along the center of the panel. In the first set-up, the resin experiences a greater amount of resistance to flow as compared to the latter one. One of the rules of thumb is that for thick panels, the maximum distance that the resin travels should be less than 18 inches. This results in a better flow through the thickness and wets the whole of the panel before the resin reaches the gelation state. There were two approaches used in the fabrication of the panel. Both of the approaches have been shown in Figure 24 and Figure 25.

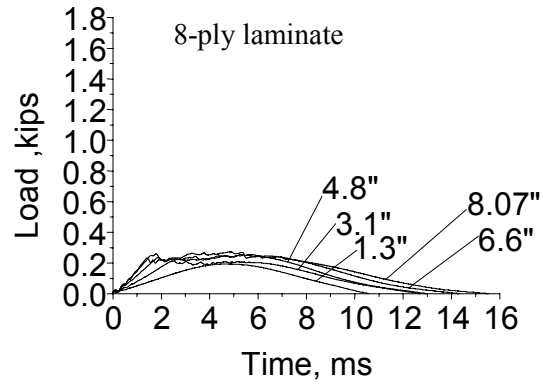
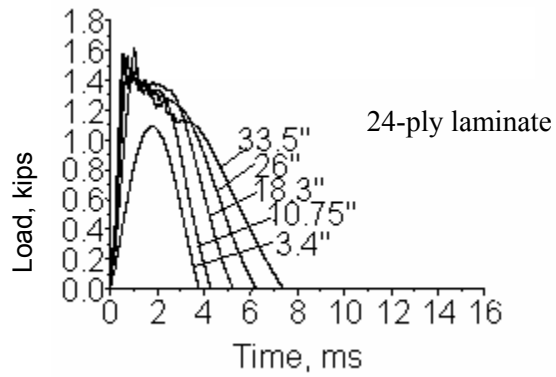
Figure 26. Impact Load Versus Time for Carbon/Epoxy Resin System (Sample Size 4 by 4 Inch)

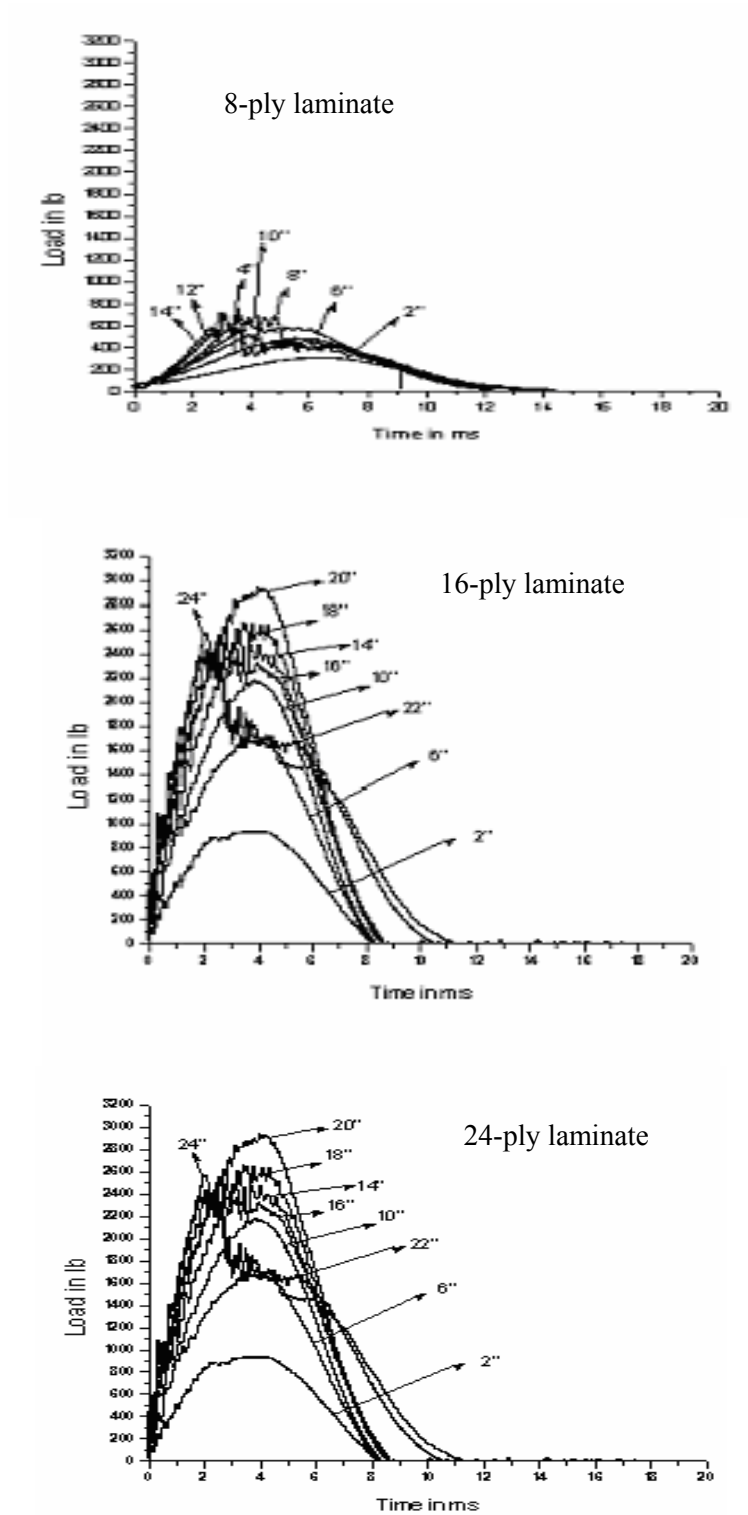
Figure 27. Impact Load Versus Time for Carbon/Vinyl Ester Resin System (Sample Size 6 inch by 6 inch)

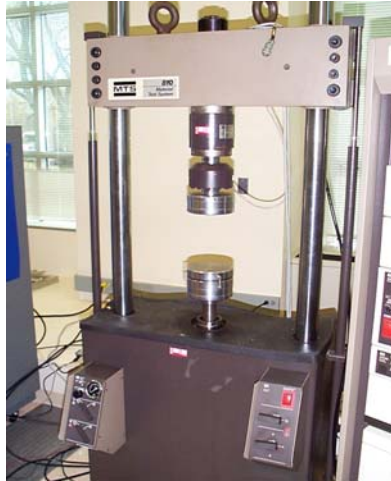
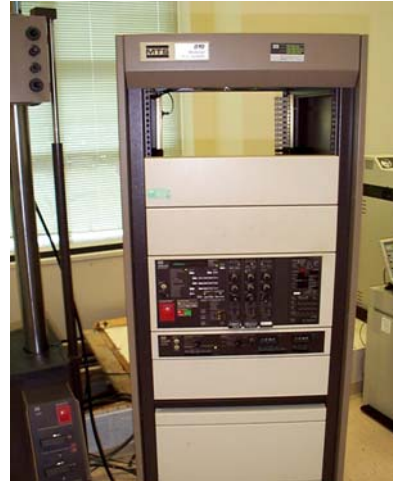
Figure 29. Load Frame for Compression Tests

designed by another Measurements Group; Inc. is used to design and monitor the tests. Figures 29 and 30 show the compression test set-up.

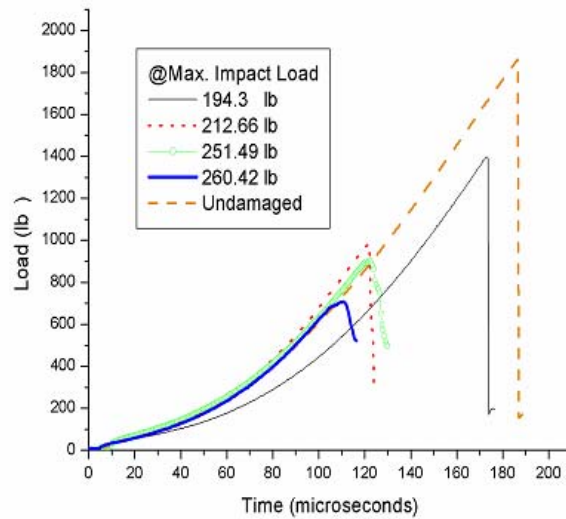
Figure 33. Compression Tests: Load Versus Time (8-ply)

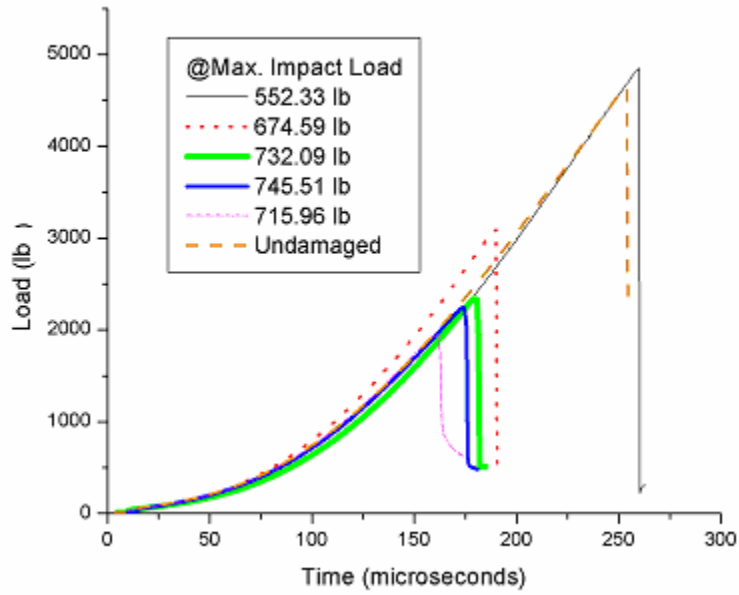
Figure 34. Compression Tests: Load Versus Time (16-ply)

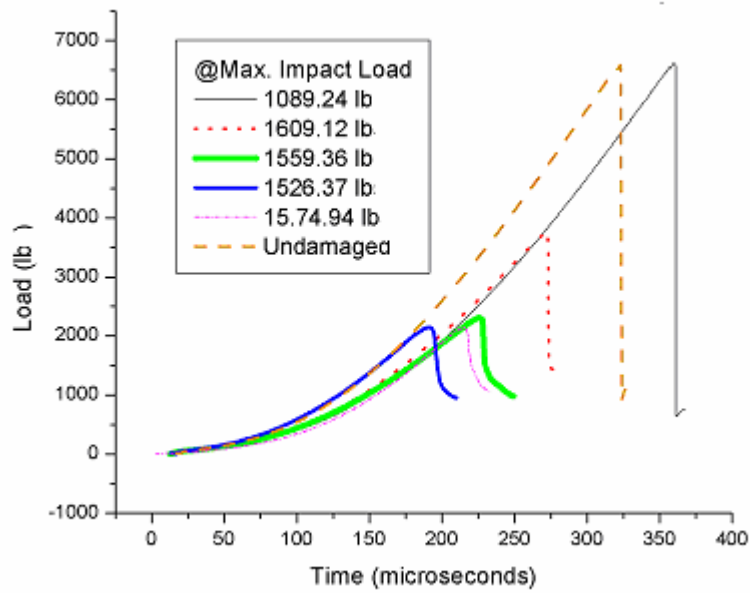
Figure 35. Compression Tests: Load Versus Time (24-ply)

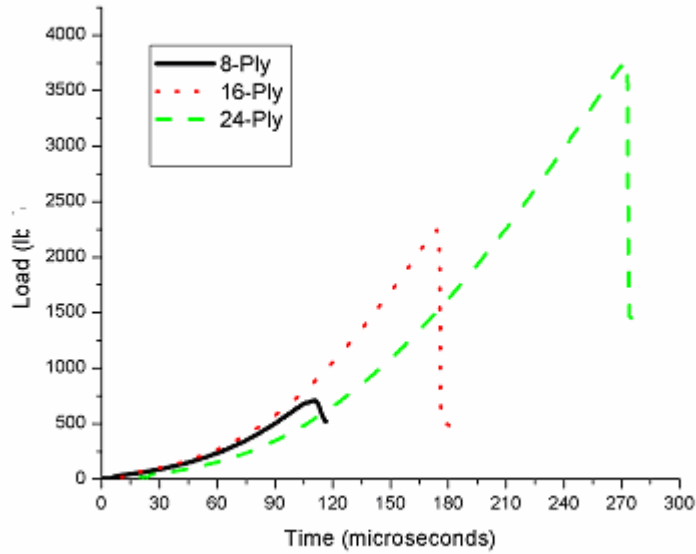
Figure 36. Compression Tests: Load Versus Time (8, 16, and 24-ply)
