## A Record of the Australian Mirage Wing Fatigue Test

DSTO-TR-1561

A full-scale fatigue test was completed in August 1974 on a Mirage III0 starboard wing utilising a loading spectrum as specified by the Royal Australian Air Force (RAAF). To satisfy a variety of RAAF missions, twelve (12) servo-hydraulic actuators situated at critical locations on the wing reproduced the measured flight strains. The fatigue loading flight-by-flight sequence was derived from fatigue meter data that was obtained from the Mirage fleet and from continuous records from an instrumented Mirage in the squadron service. The conduct and results of this innovative test are summarised here.

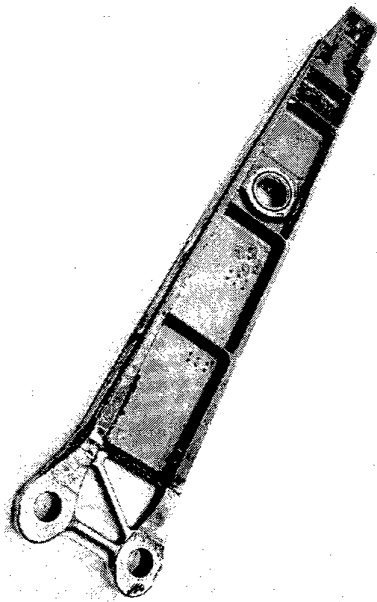
*Figure 9: Aft Side of Starboard Main Spar Showing Diagonal Brace*

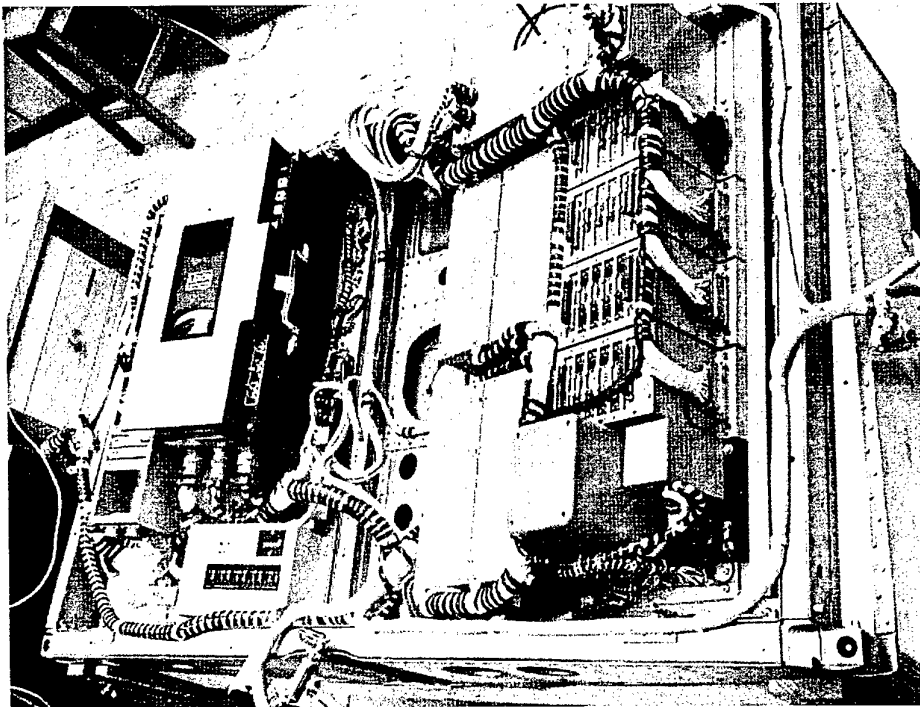
*Figure 12: The Mirage AFTRAS Unit shown in the Laboratory*

On-board data were collected using the DSTO developed Airborne Flight Trial Analogue System (AFTRAS), Figure 12 and Figure 13. The flight test data and analysis of the results were the basis for the derivation of the fatigue test loads [as stated in (c) above]. The data obtained from squadron usage of the aircraft were essential in the design of the laboratory fatigue test program.

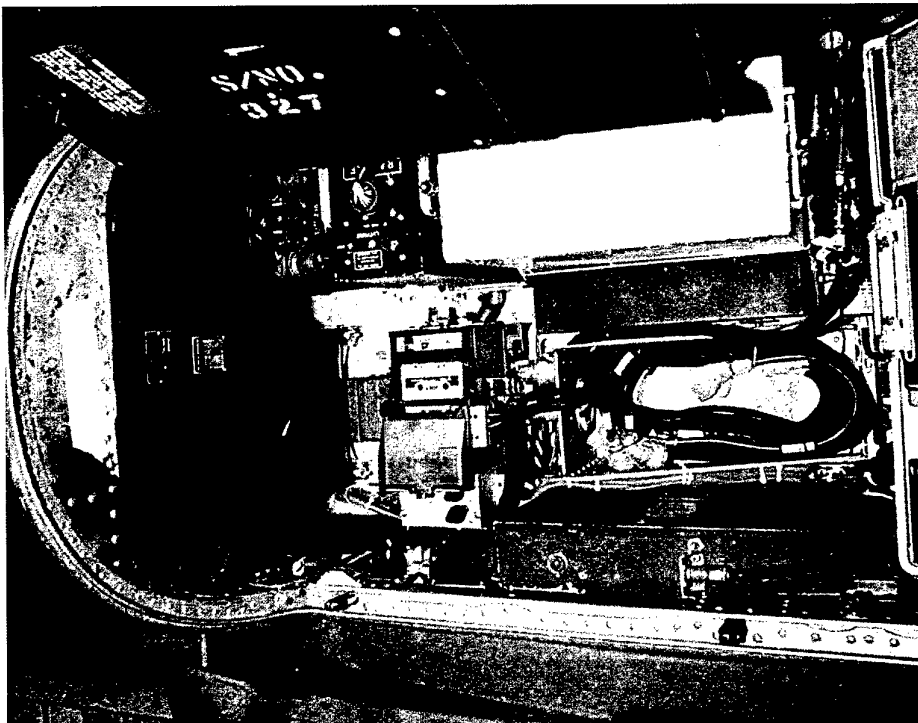
*Figure 13: AFDRAS Recorder in Rear Bay of Mirage*

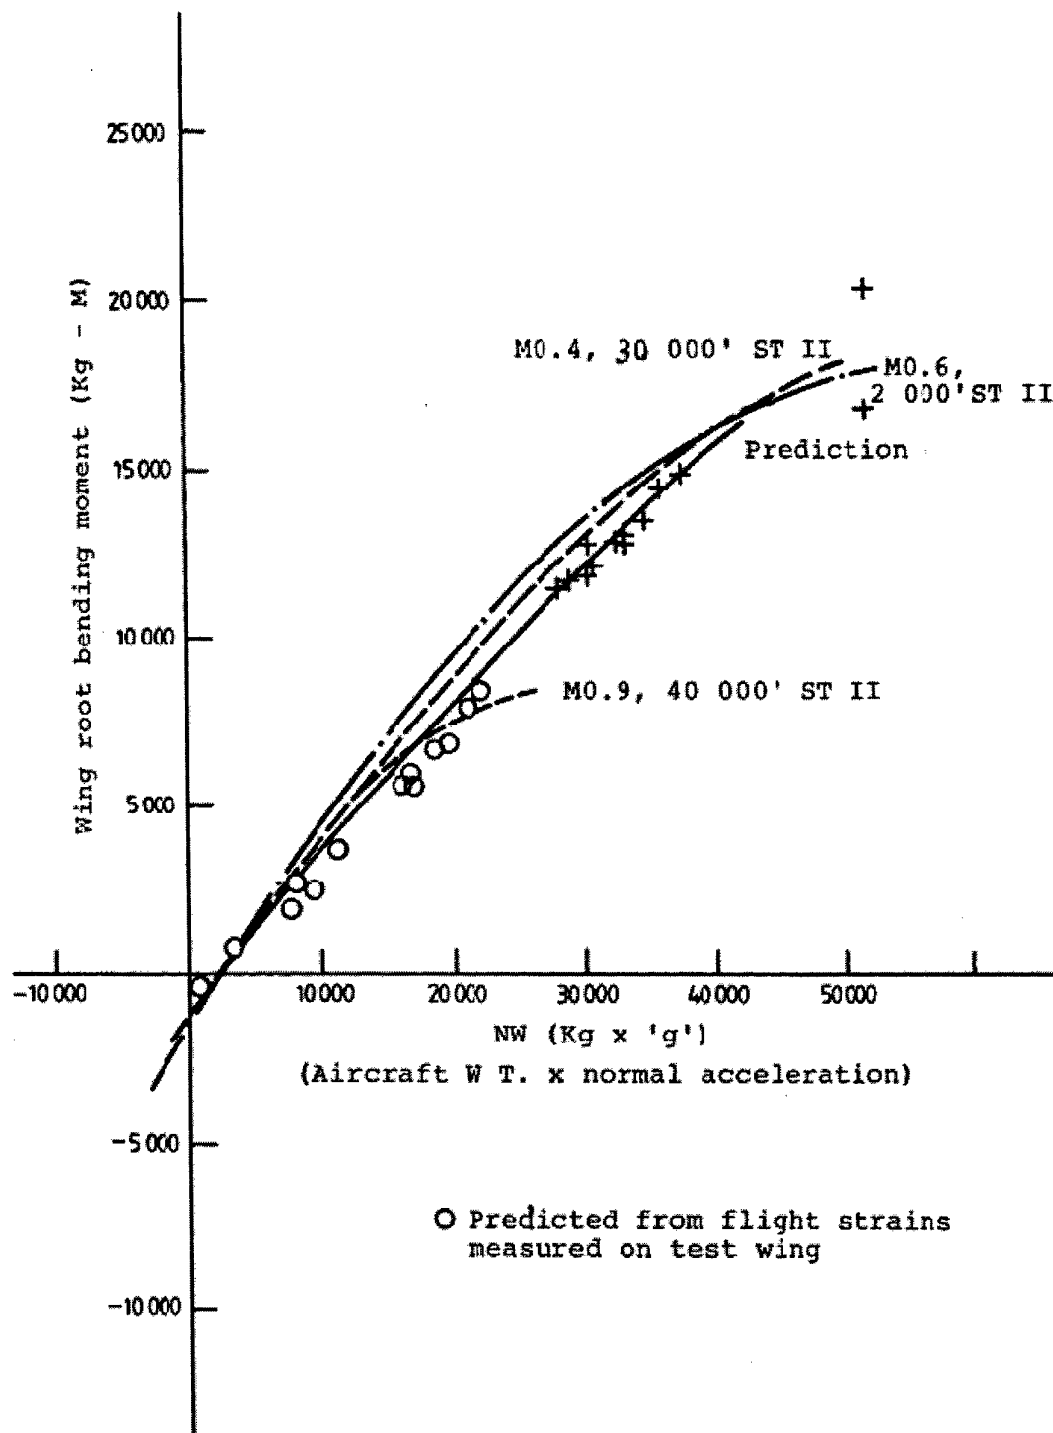
Figure 15: Wing Root Bending Moment Predictions

Figure 15 shows the wing root bending moment predictions (by the former process), to be in good correlation with flight test estimations. This figure also shows the bending moment predictions for various Mach number and altitude combinations.

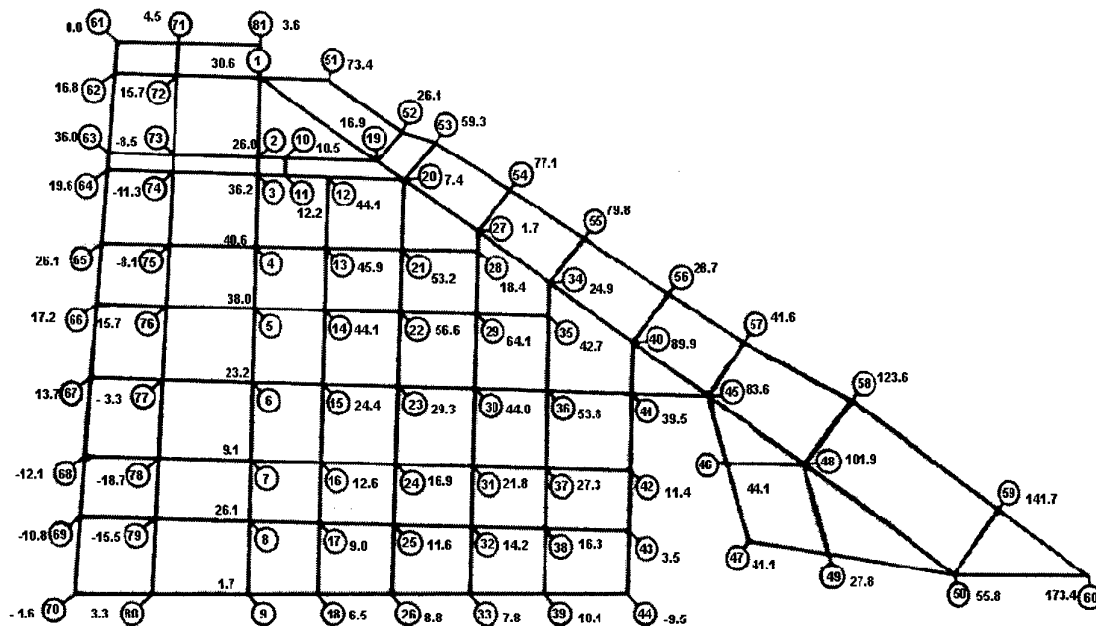
Figure 20: Load Distribution to Represent Wing Loads during Loading

Only one load distribution was applied to the wing during the application of landing and taxiing loads. This distribution (Figure 20), represented the loading for an aircraft carrying supersonic tanks and guns with an all-up-weight of 7,793kg. The landing speed was measured in knots (Mach number 0.24), and altitude at zero (sea level).

At the start of each flight, while the taxiing and take-off loads were applied [Figure 22], the fuel tank was pressurised and the wing loaded as shown in Figure 20. The load cycling commenced with gust and manoeuvre loads applied in a random sequence according to the particular flight being represented. On completion of those loads, the wing was again loaded as shown in Figure 20, while the landing loads were applied and followed by the "spring-back" load. The fuel tank was then de-pressurised, ready for the start of the next flight load sequence. Note that the "spring-back" load was applied at the end of the landing load sequence instead of the beginning of the sequence because it caused a shock to the loading system that could have introduced transient faults, resulting in the stoppage of the test rig.

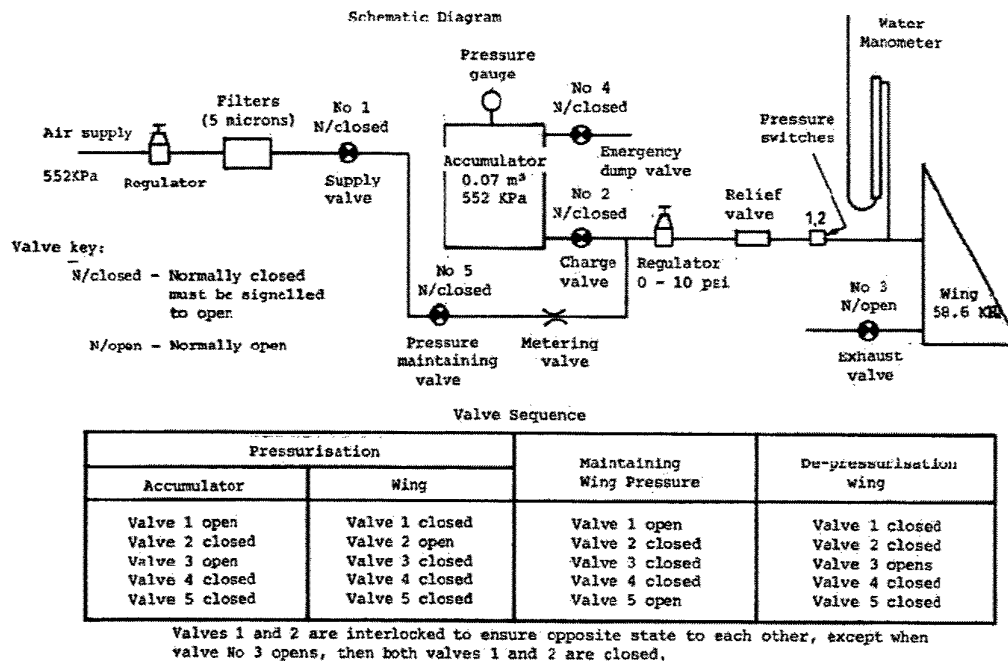
Figure 23: Pressurisation Schematic of Wing Fuel Tank

A schematic diagram of the system is shown in Figure 23. This figure lists the sequencing of the solenoid valves during the four stages of the pressure cycle. The starting and sequencing of these valves was under the management of the load control tape.

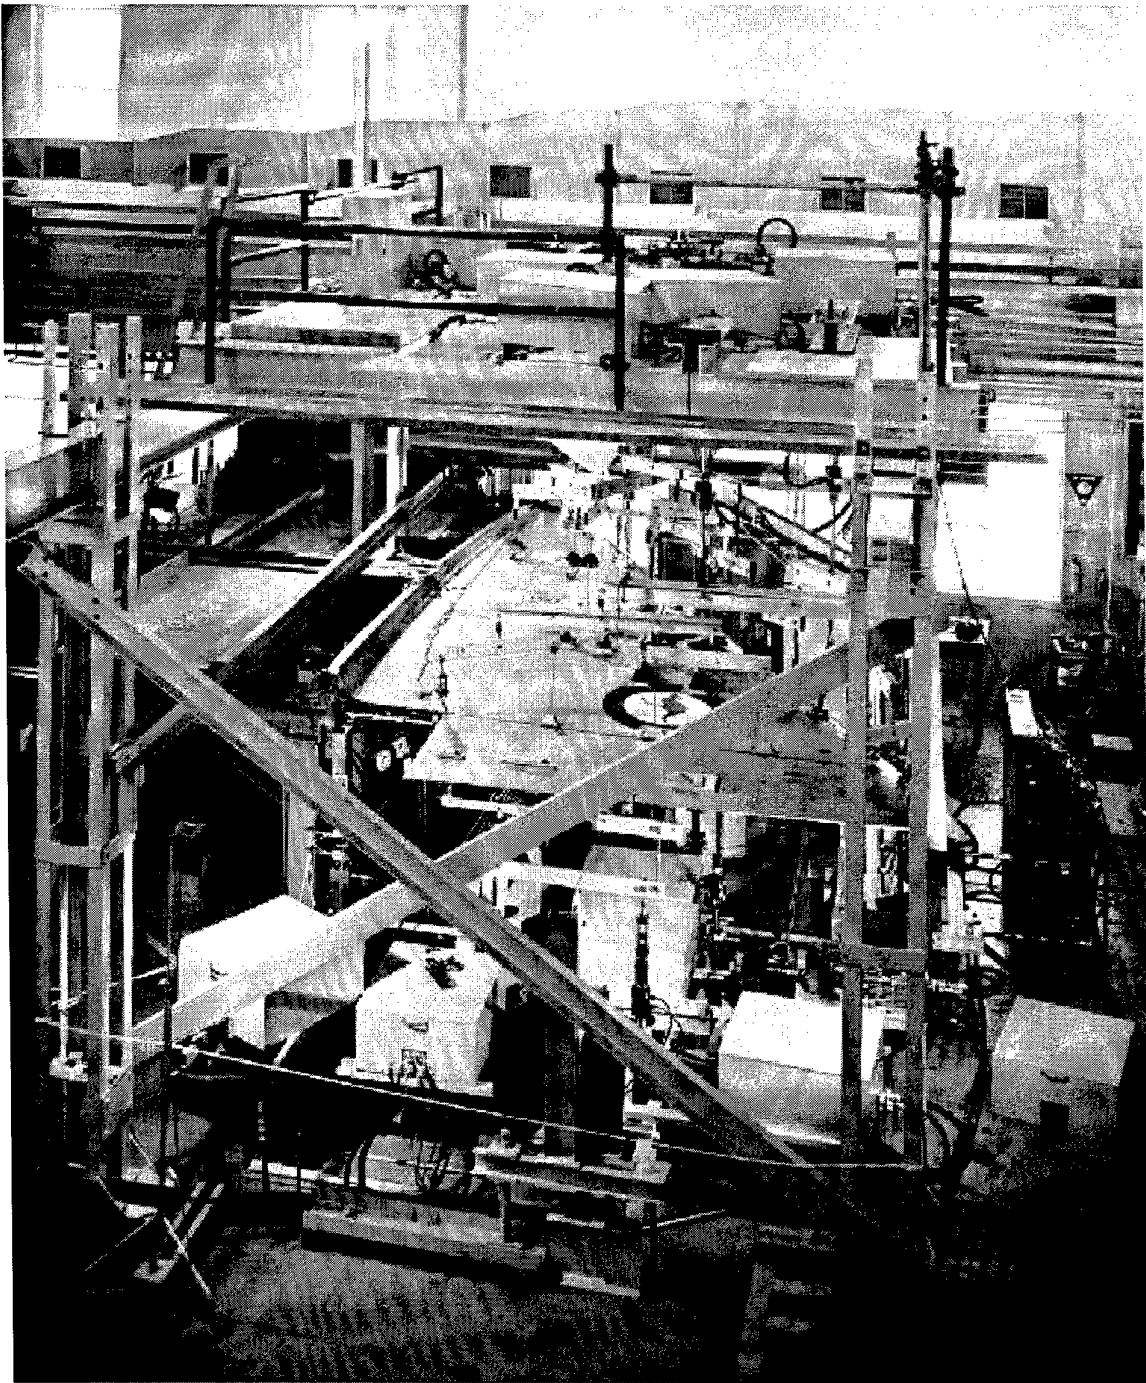
*Figure 24: General View of Test Rig*

The test rig (Figure 24) design and manufacture was divided between CAC and the GAF. CAC was tasked to handle all aspects of the dummy fuselage and derivation of theoretical wing load distributions. GAF was involved with the design, manufacture, and erection of the wing and undercarriage loading systems. 0outlines a description of the rig, together with the sources of data and the basis of the design.

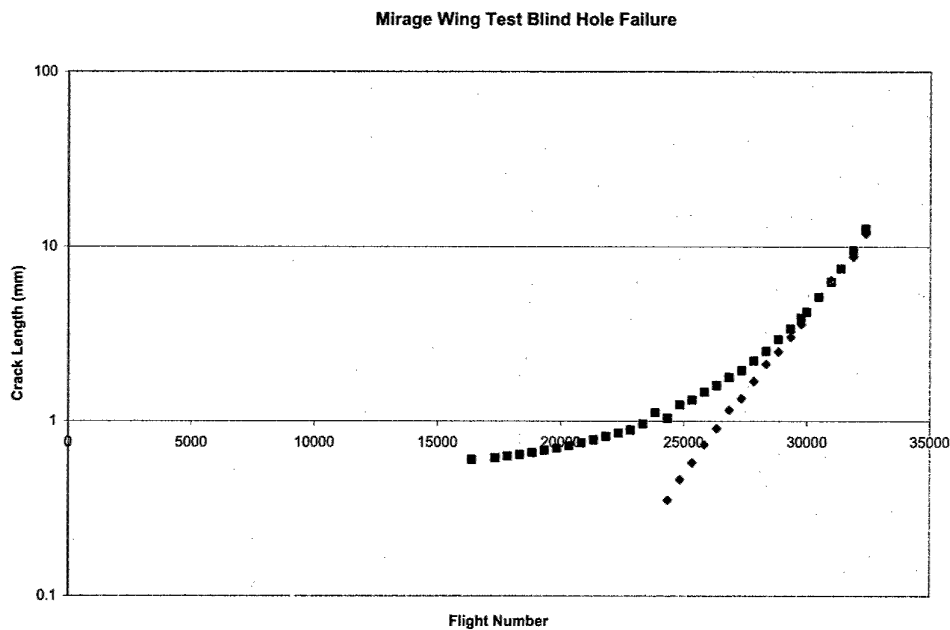
Figure 29: Fractographic Measurements versus Predicted Crack Growth (from Ref.37)

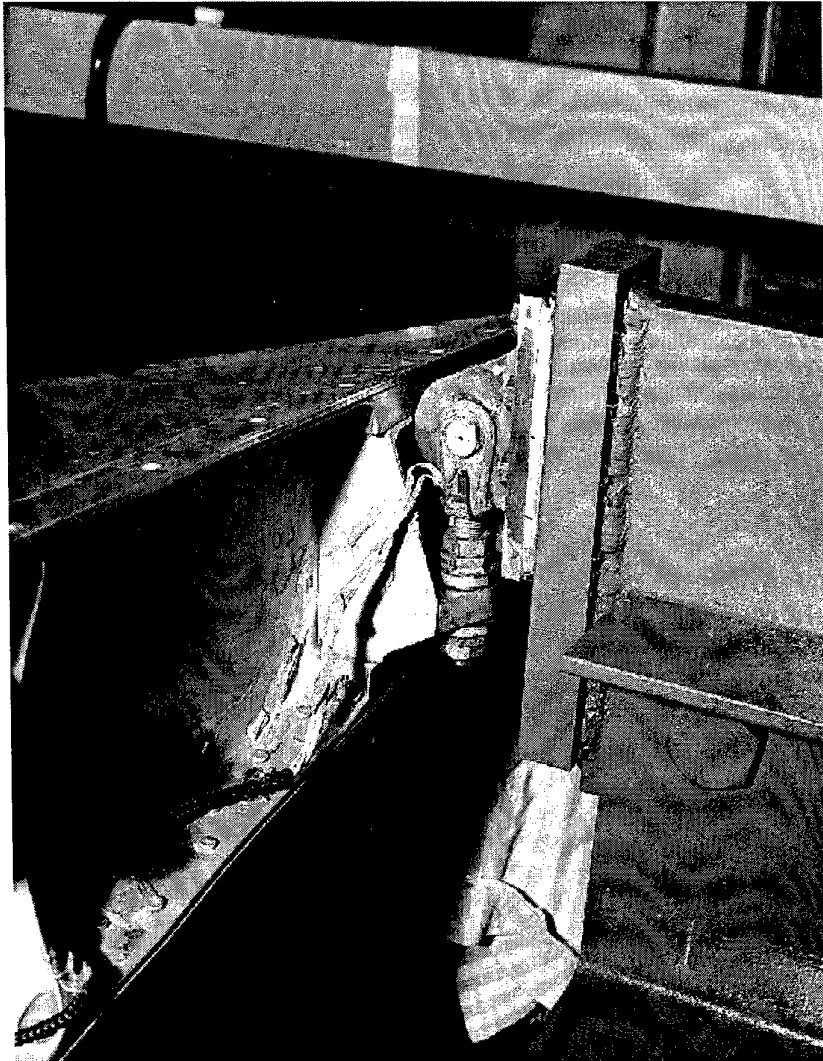
*Figure 33: Leading Edge Attachment to Dummy Fuselage*

The main spar wing-to-fuselage joint was designed to react bending, torsion and shear loads. Therefore it was the most critical design that was designed for a fatigue test life of 196,000 hours and consisted of two high tensile steel side plates that represented the split frame No. 26 of the fuselage, (Figure 32). The upper and lower attachment holes in these steel plates were bushed with an aluminium alloy similar to that used in frame No 26. The leading edge attachment points are shown in Figure 33.

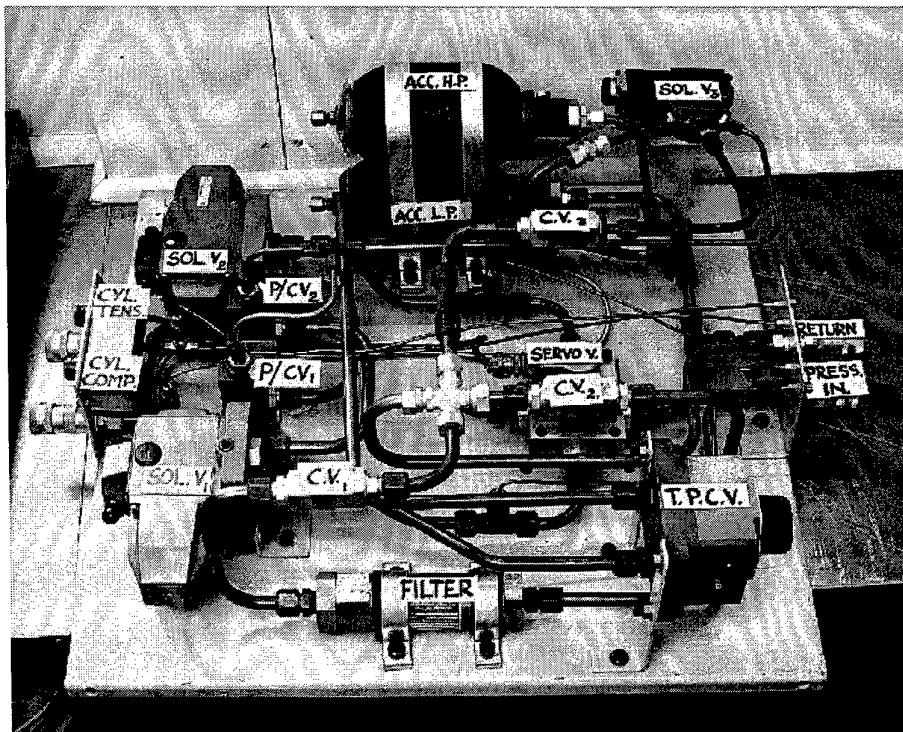
Figure 36: Actuator Control System (Valve Pack)

During normal load cycling, high-pressure hydraulic fluid from the main supply entered the valve pack through a "quick release" coupling. A woven mesh type stainless steel in-line filter strained the fluid as it passed to the electro-hydraulic servo valve (Figure 36). The servo valve distributed the fluid alternately to the tension and compression ends of the actuator (via the energised direction control valves (Sol V<sub>1</sub> and Sol V<sub>2</sub>) and through the energised pilot check valves (P/C V<sub>1</sub> and V<sub>2</sub>)). The servo valve was controlled by a varying command signal from the computer.
