**AFRL-ML-WP-TR-2004-4280**

**NONDESTRUCTIVE EVALUATION  
(NDE) TECHNOLOGY INITIATIVE  
PROGRAM (NTIP)**

**Delivery Order 0032: MAUS Implementation  
for Corrosion/Crack Detection in Wing  
Structure – Phase III**

**Final Report for 01 May 2002 – 30 September 2003**

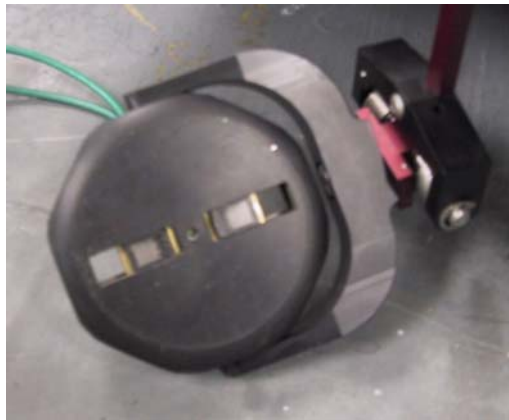
*Figure 5: Pitch/catch sensor fixture (a) top view and (b) contacting surface view*

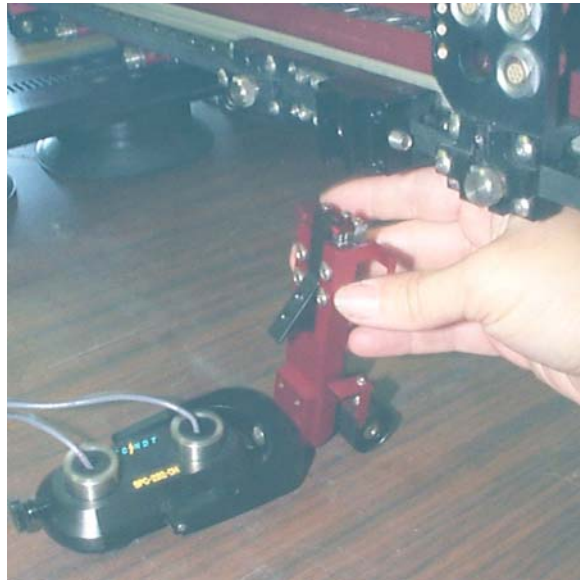
***Figure 7: Removable linear slide***

From a rotational scanning standpoint, a fixture adapter was developed to attach the fixture to the rotational scanner. The rotational scanner linear slide design was modified slightly to allow for quick removal of the mechanism after an inspection is completed. Figure 7 illustrates the screw adjustment that removes the mechanism from the scanner. The final rotational scanner configuration is shown in Figure 8.

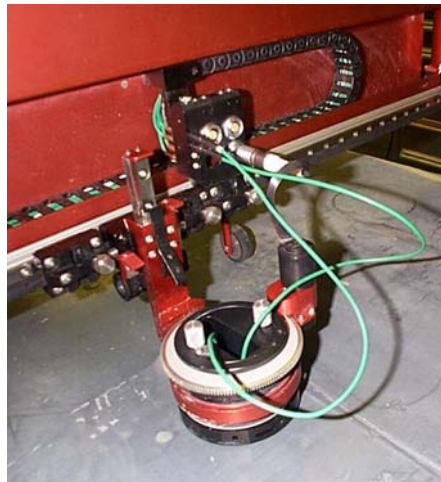
***Figure 8: Final sensor configuration for rotational scanner***

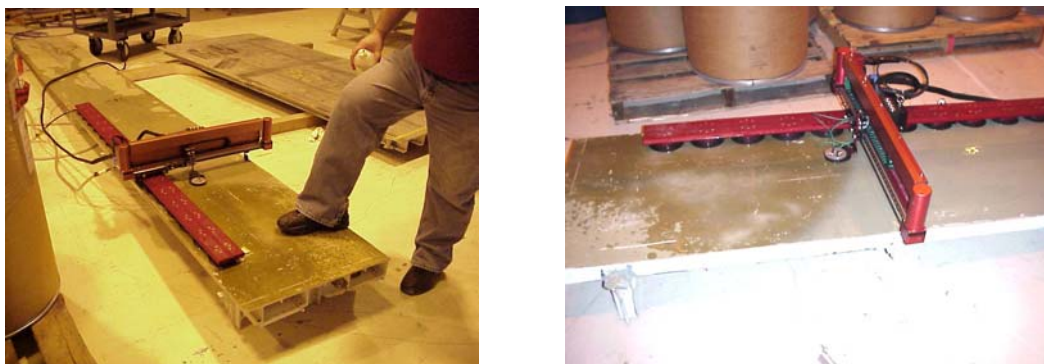
***Figure 14: MAUS second layer ultrasonic procedure preliminary validation at Boeing-Wichita***

Prior to validation of the spanwise splice inspection procedure at Tinker AFB, a procedure review and initial validation were conducted at Boeing-Wichita. Four sections of B-52 wing structure representing approximately 90 feet of wing splices were scanned using the draft procedure developed for the optimized MAUS. Inspection of one section of spanwise splice is shown in Figure 14. Scan data were consistent from panel to panel. Based on feedback from B-52 Engineering personnel at Boeing-Wichita, minor modifications were incorporated into the draft procedure.

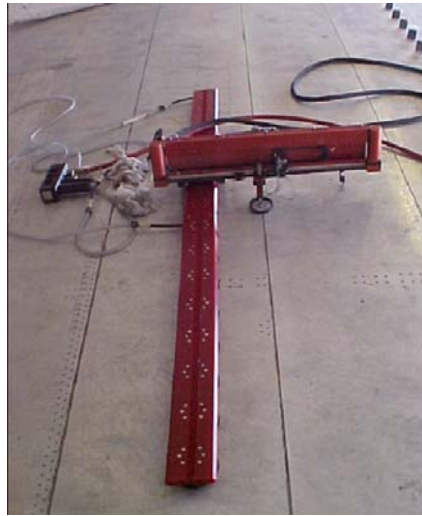
***Figure 15: MAUS attached to B-52 wing during process validation***

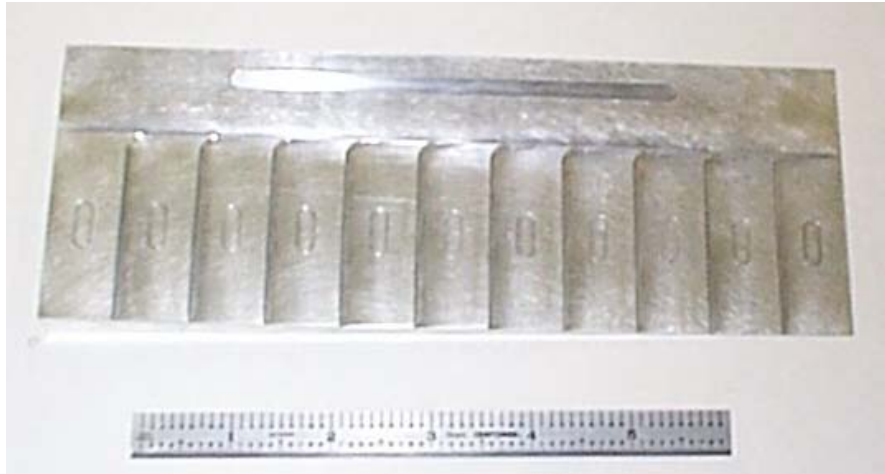
***Figure 19: Test standard for E-3 upper wing skin thickness gauging.***
