**AFRL-ML-WP-TP-2004-410**

**EFFECTS OF SURFACE TREATMENT  
ON FRETTING FATIGUE  
PERFORMANCE OF Ti-6Al-4V**

**November 2004**

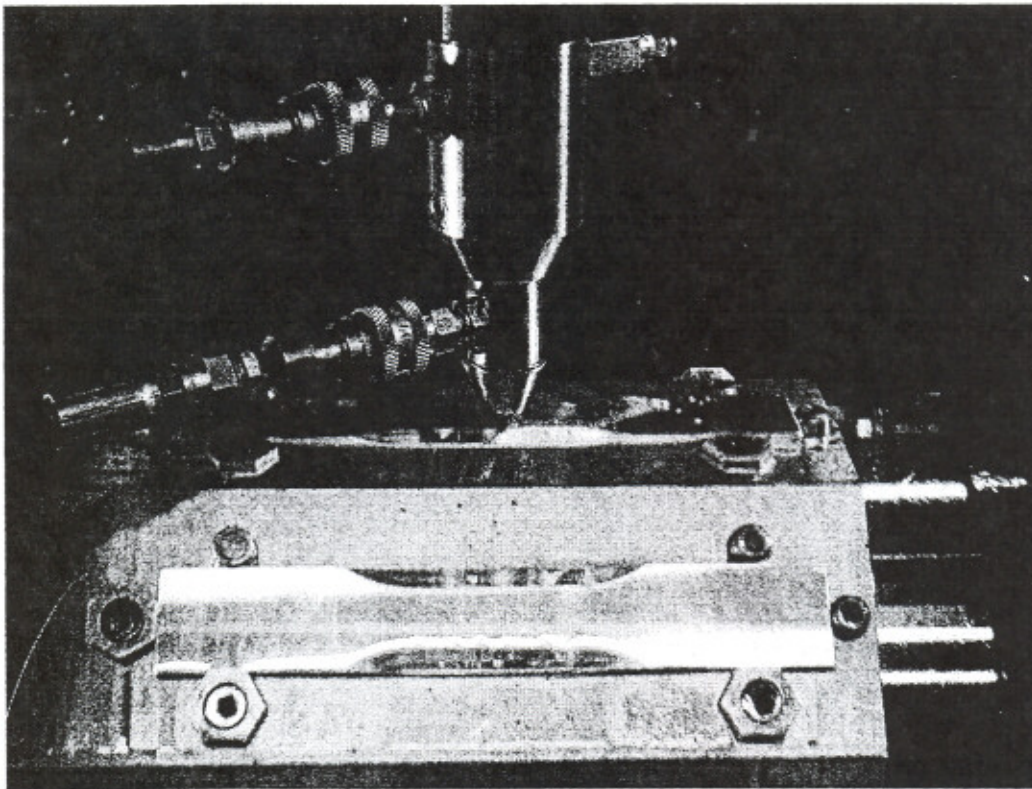
Figure 1. LPB Processing of the thick section fatigue specimen in the four-axis manipulator on the CNC milling machine

For the specimens subjected to LPB and shot peening, the entire gage section was treated. LPB parameters were optimized by Surface Enhancement Technologies, LLC to maximize the magnitude and depth of the compressive residual stresses, while minimizing cold work. Figure 1 depicts the LPB process being applied to a batch of specimens similar to those used in this study. Specimens subjected to shot peening were peened to a 6-8A Almen intensity, 125% coverage, with CCW14 shot. This level of shot peening is representative of that used for Ti-6Al-4V engine hardware.

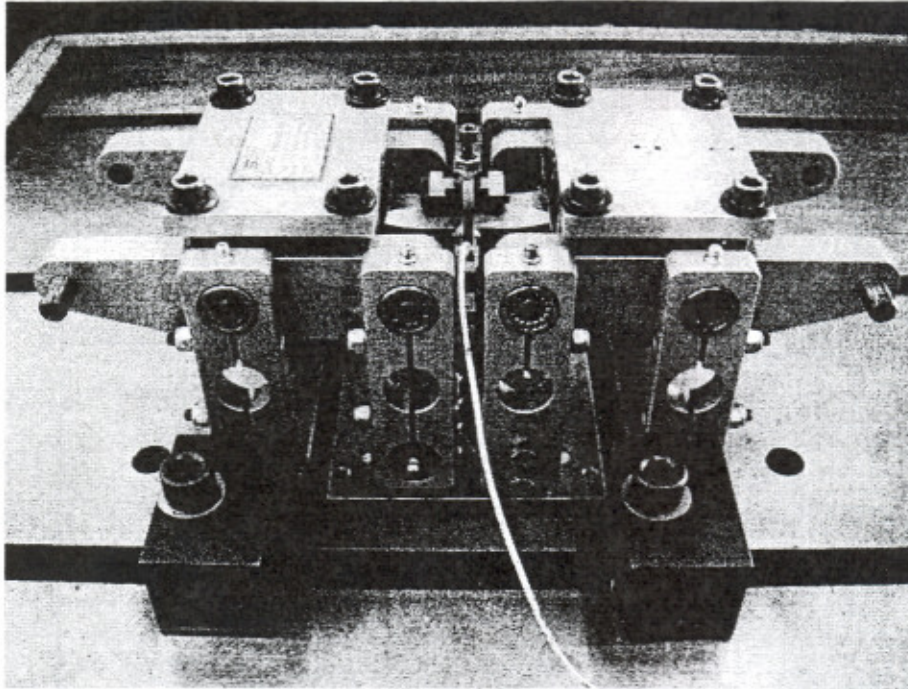
Figure 2. HCF (4-point bending) testing set up with the fretting fixture mounted on the specimen.

Fretting fatigue testing was conducted under constant amplitude 4-pt. bend loading on a Sonntag SF-1U fatigue machine. The SF-1U is modified for fretting fatigue testing by clamping a bridge-type fretting device to the gage section of the fatigue specimen using an instrumented loading ring clamp, similar to the apparatus described by Frost, Marsh, and Pook [16]. A photo of the fatigue test setup is shown in Figure 2.

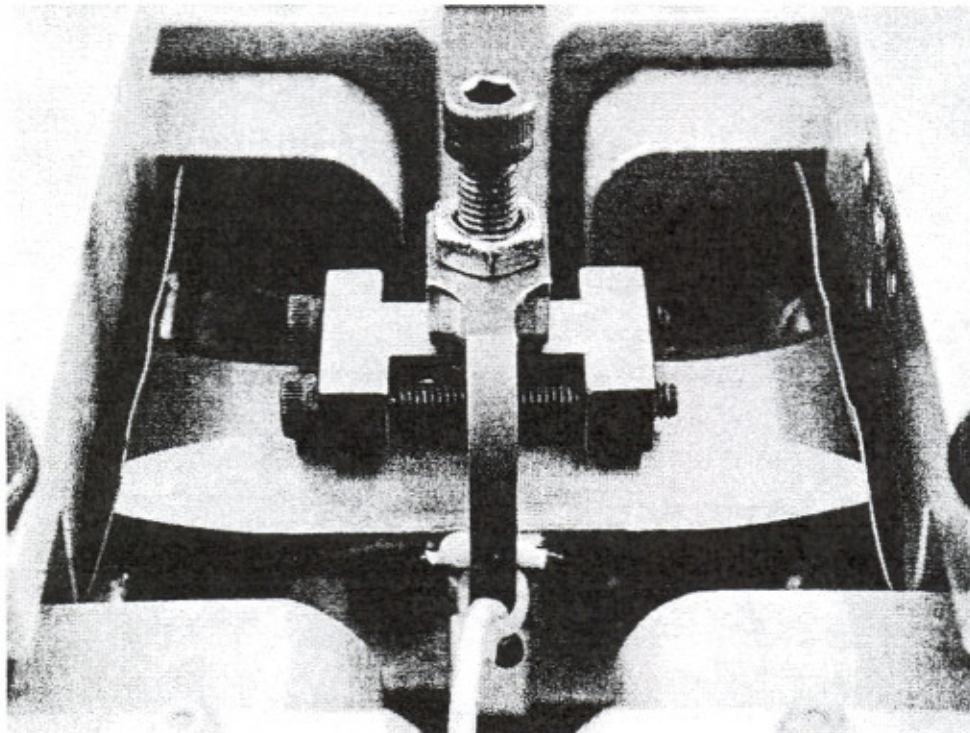
Figure 3. Fretting fixture with instrumented loading ring and bridge device to hold two fretting cylindrical pins clamped on to the fatigue specimen surface under a controlled normal force.

The fretting bridge contains two 0.25 in. diameter Ti-6Al-4V cylindrical pins, nominally 0.5 in. apart, yielding a cylinder-on-flat contact geometry. The cylindrical pins were not surface treated. The contact geometry was not selected to be representative of any particular engine geometry. The intent was to generate a significant debit in fatigue performance due to contact damage. A photograph of the assembled fretting fatigue fixture is shown in Figure 3.

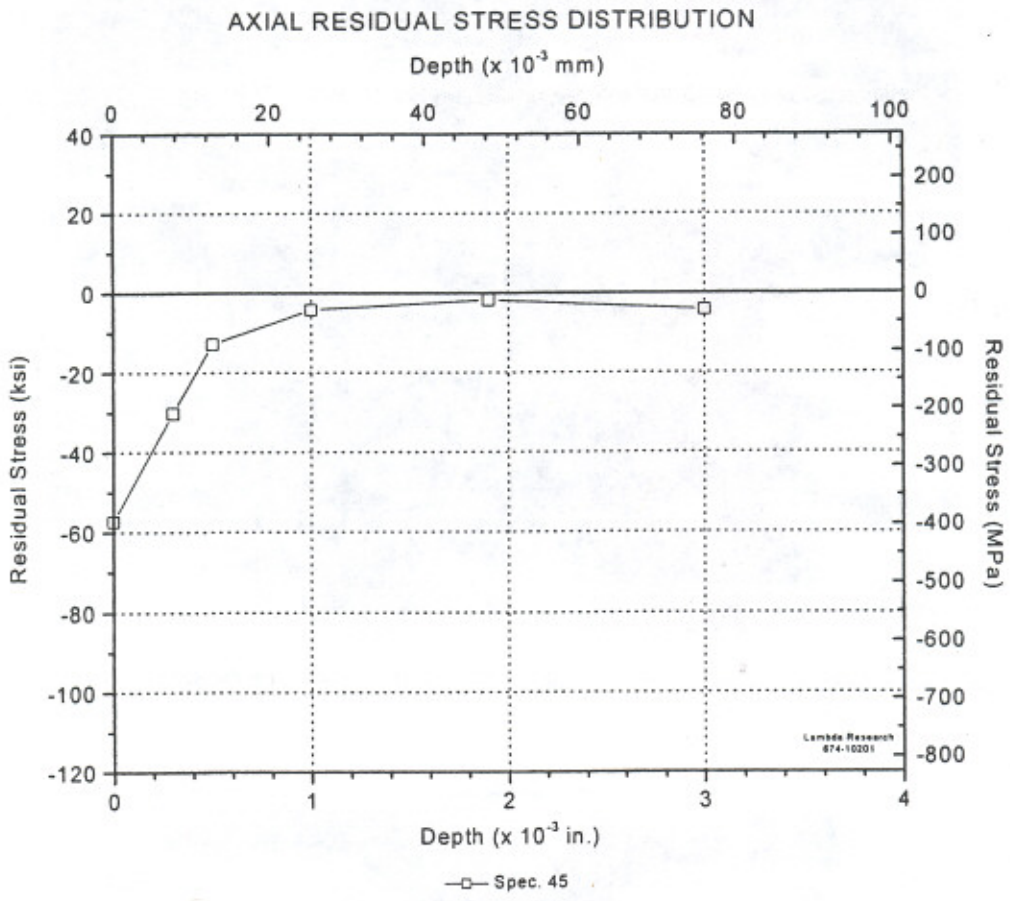
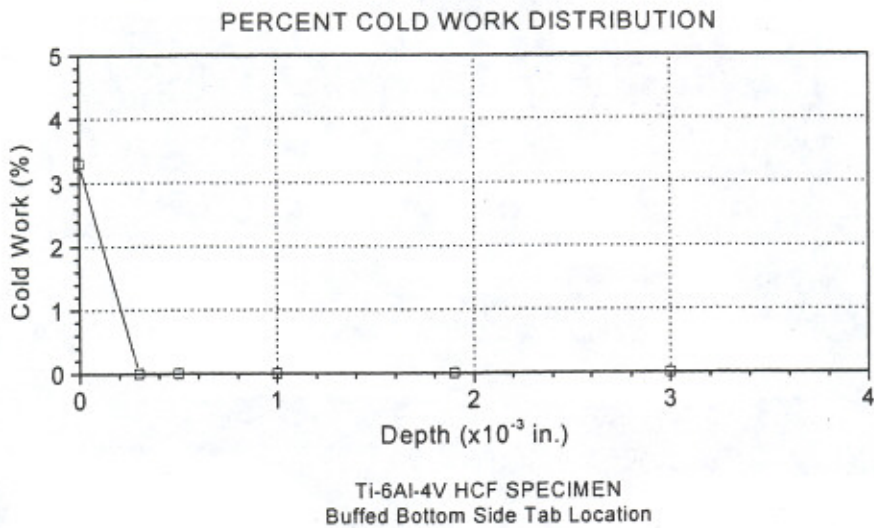
Figure 4 – RS & CW profile for Ti-6-4 finished with low stress grinding (LSG) and buffing showing the resulting depth of compression less than 0.001 in.

Figure 4 shows the RS and CW profiles of the specimen surface after a low stress grind (LSG) and buffing treatment. The surface is in compression at  $\sim$ 400 MPa with cold work of about 3.5%. The compression drops off to near zero within the first 25  $\mu\text{m}$ ., and the %CW drops off to zero within the first 8 $\mu\text{m}$ . depth.

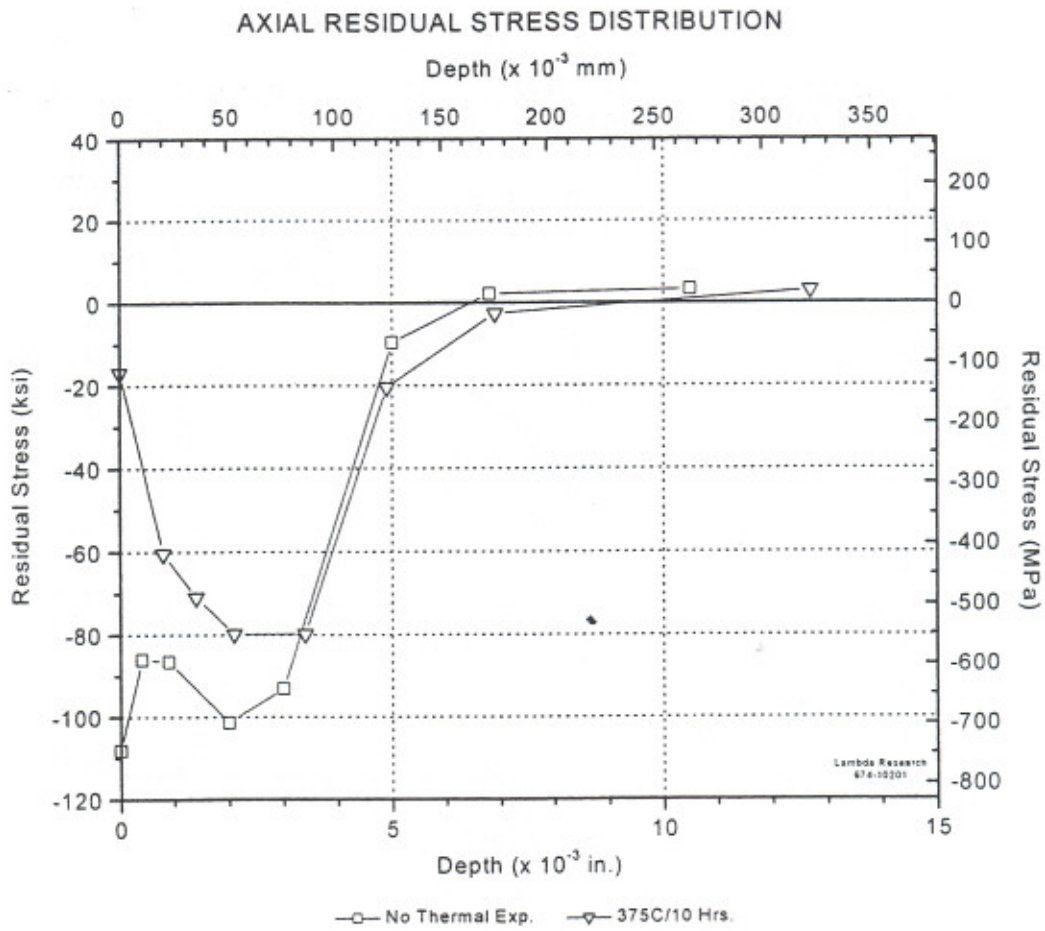
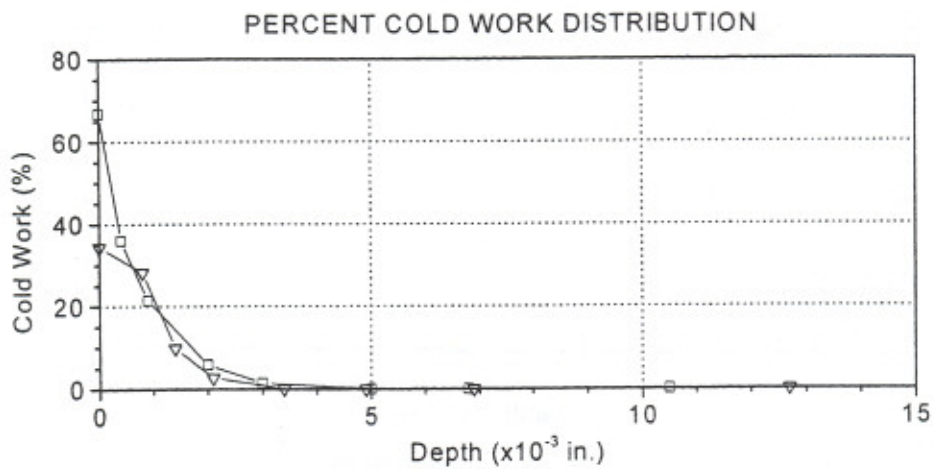
Ti-6Al-4V HCF SPECIMENS  
Shot Peened (125% Cov., 30 psi, 3lb/min., 8A Intensity)

Figure 5 – RS & CW profile for SP showing a depth of compression up to about 0.007 in. and loss of surface compression after thermal exposure

Figure 5 shows the RS and CW profiles for a shot peened surface. The SP surface compression is nominally  $\sim$ 750 MPa, and drops off to zero somewhat erratically over a depth of about 175  $\mu\text{m}$ . Upon thermal exposure to 375C for 10 hrs, the surface compression drastically changes to nominally  $\sim$ 100 MPa, as has been observed repeatedly for highly cold worked Ti and Ni alloys. Maximum subsurface compression of nominally  $\sim$ 550 MPa occurs at a depth of 100  $\mu\text{m}$ ., and drops off to zero at a depth of nominally 175  $\mu\text{m}$ . Correspondingly, %CW is a little over 65% on the surface, dropping off to zero at a depth of about 75  $\mu\text{m}$ . The high surface %CW decreases to 35% upon thermal exposure.

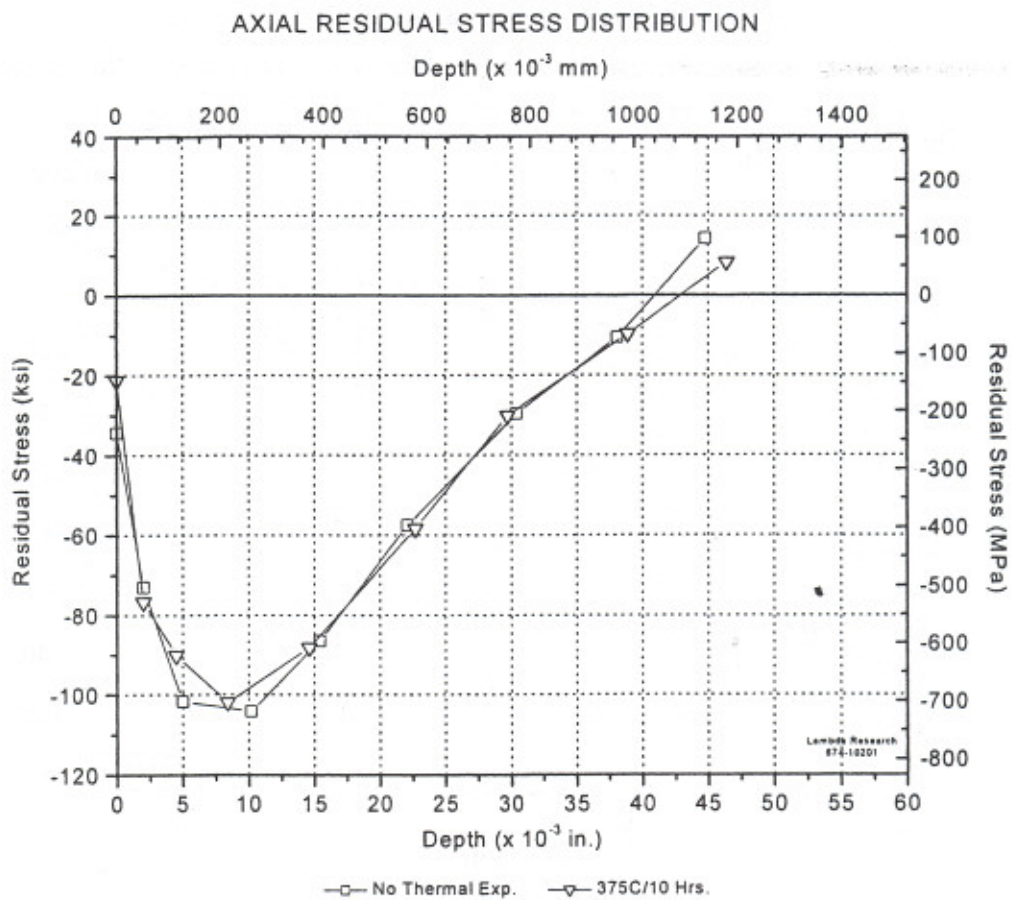
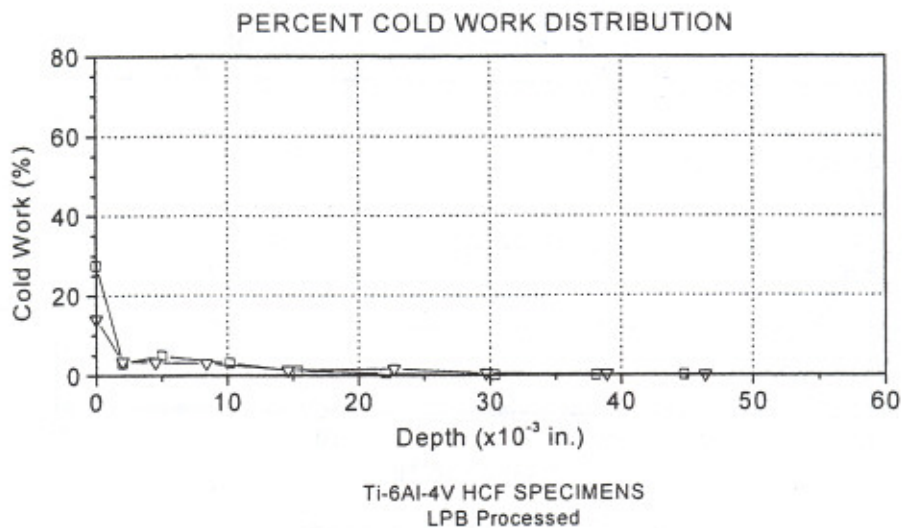
Figure 6 – RS & CW profile for LPB. Note the depth of compression is over 0.04 in. and is not significantly altered by thermal exposure to 375C for 10 hr.

The RS and CW profiles for LPB treated surface are shown in Figure 6. Surface compression is nominally -240 MPa. Maximum compression of  $\sim -725$  MPa occurs at a depth of  $\sim 250$   $\mu\text{m}$ ., and drops off to zero at a depth of over 1000  $\mu\text{m}$ . Upon thermal exposure to 375C for 10 hrs, the surface RS changes to about -140 MPa, but the subsurface maximum remains nearly constant at  $\sim -700$  MPa, and the depth is unaffected. Correspondingly, %CW is a little under 30% on the surface, and drops off to less than 5% at a depth of about 50  $\mu\text{m}$ ., and then gradually to zero at  $\sim 375$   $\mu\text{m}$ . The initial level of surface cold work is probably attributable largely to prior LSG preparation of the surface. The surface %CW decreases to 15% upon thermal exposure.

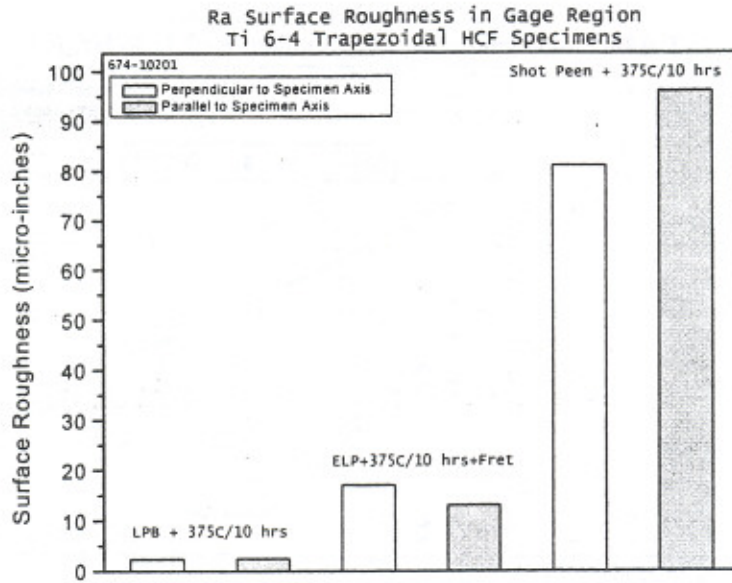
Figure 7. Comparison of surface roughness for ELP, SP and LPB treated specimens.

Surface roughness of LPB, electropolished, and Shot Peened surfaces are shown in Figure 7. A representative bar chart of the average surface roughness for LPB, baseline (electropolished - ELP), and shot peened surfaces are shown in Figure 7. The baseline electropolished samples had surface roughness values in the 15 to 20  $\mu\text{in}$  range. The surface roughness was less than 5  $\mu\text{in}$  for the LPB processed samples. This is considerably lower roughness than the surface produced by the shot peening operation, with surface roughness ranging from 80 to 100  $\mu\text{in}$ ., this surface was the roughest in the study.

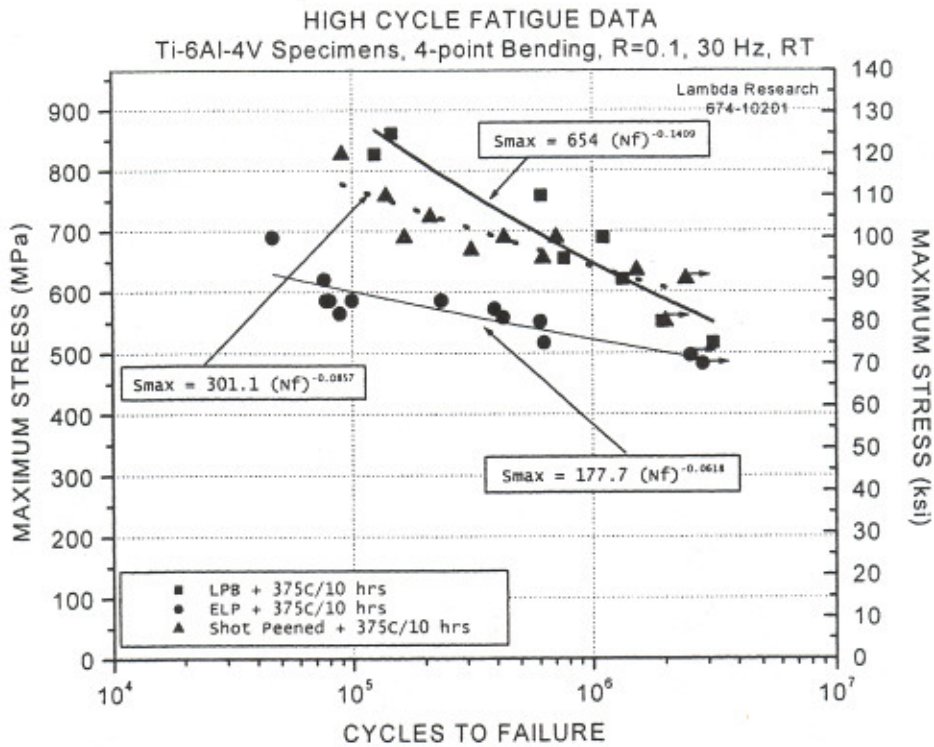
Figure 8. Baseline HCF data for ELP, SP and LPB treated specimens – Note that the HCF performance of LPB is superior despite the fact that sub surface crack initiation was dominant.

The HCF and fretting fatigue tests are presented graphically as S-N curves in Figures 8 and 9. The data are shown in a semi-log plot of maximum stress in units of ksi ( $10^3$  psi) and MPa vs. cycles to failure. Figure 8 contains the high cycle fatigue data (no-fretting) for the LPB'd, shot peened and electropolished specimens. The beneficial effects of both SP and LPB treatments are apparent. LPB clearly outperforms SP in the high stress, the finite life regime, where crack propagation is expected to dominate total life. This is likely due to crack growth retardation from the deeper compressive residual stresses associated with LPB. In the lower stress, longer life regime, where life is dominated by crack initiation, both SP and LPB showed similar HCF performance. For the ELP'd and SP'd specimens all observed failures originated from surface initiated cracks.

In the LPB treated specimens sub-surface initiation sites were the mode of failure. Initiation was invariably below the compressive residual stress layer near the sharp corners of the thick section fatigue specimens. Two reasons exist for this failure mode. First, the specimen surface, which is the usual fatigue crack initiation site, is considerably improved in terms of both surface finish and residual stress state. Secondly, subsurface residual stresses

must eventually transition to compensatory tension to equilibrate the nearer surface compressive residual stresses generated by the LPB process. These compensatory tensile stresses, in conjunction with the applied stresses, now act as the predominant failure driver. It should be emphasized, however, that even though subsurface initiation was predominant in the LPB'd specimens, their performance was at least equal to that of shot peened specimens, and in the finite life regime, was considerably better. These results, however, emphasize the potential importance of compensatory tensile stresses in the failure mechanisms of surface treated specimens and components.

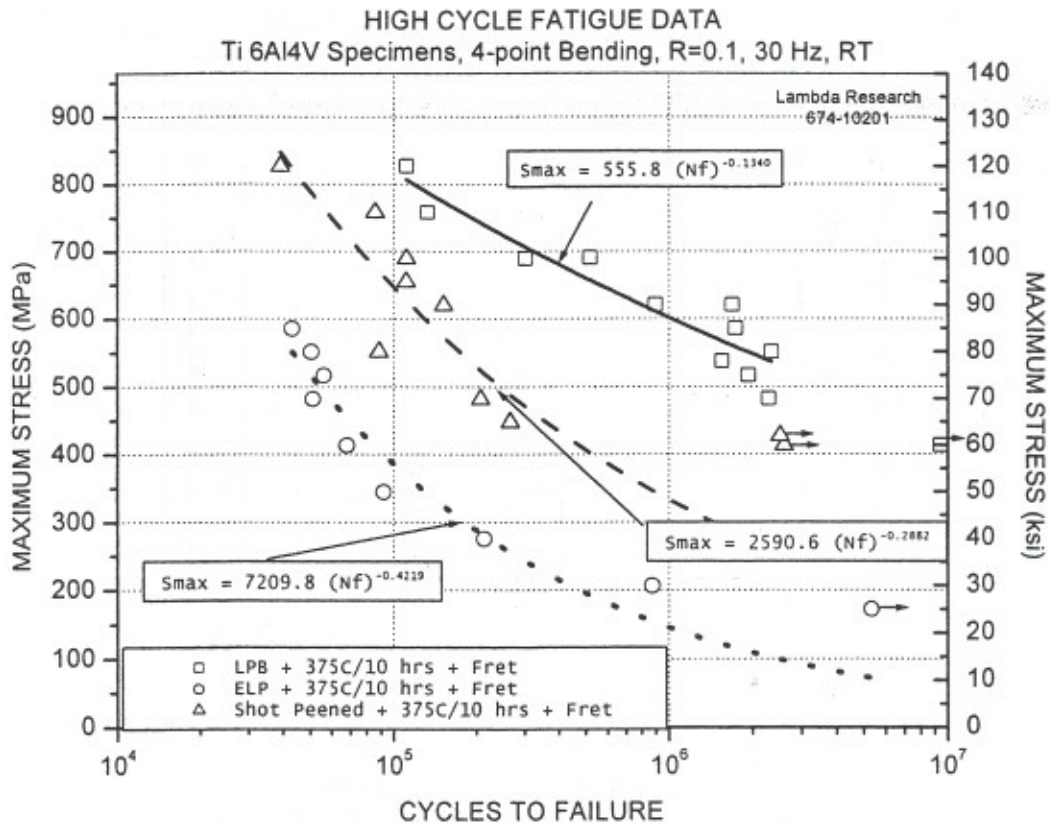
Figure 9. Comparison of fretting HCF data for ELP, SP and LPB treated specimens.

Figure 9 contains the fretting fatigue data for the LPB'd, SP'd and electropolished (ELP) specimens. The benefits of surface treatment, particularly LPB, for this fretting configuration are clear. In the baseline condition, fretting damage has dropped the  $2.5 \times 10^6$  cycle fatigue strength from nominally 500 MPa max stress to nominally 175 MPa max stress, and the fatigue life at all stress levels is drastically reduced. A typical fracture surface for the ELP condition, with multiple initiation sites at the fretting damage is shown in Figure 10. In the case of the SP treated specimens, the  $2.5 \times 10^6$  cycle fatigue strength decreased from nominally 575 MPa to 450 MPa, and similar to the baseline condition, at all stress levels the fatigue lives were considerably lower. A typical fracture surface for the SP'd condition is shown in figure 11. Similar to the ELP'd condition, multiple initiation sites are observed at the fretting damage. All initiation sites for the baseline and SP'd condition were observed to be associated with fretting damage.

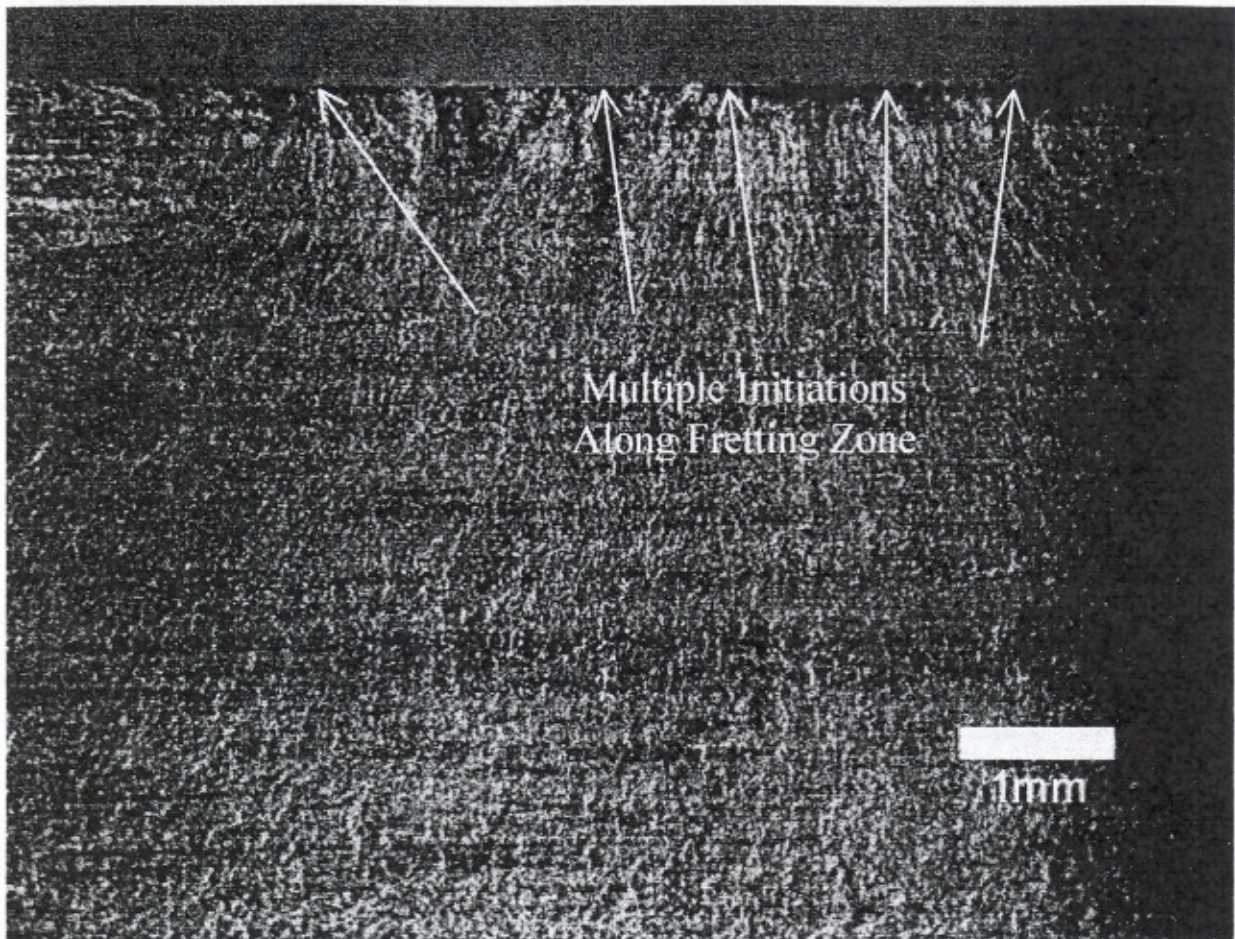
Figure 10. Low magnification optical fractograph of ELP treated specimen. Failure occurred from initiated cracks under the fretting scars. Note the dark band near the surface indicative of the fretting damage zone leading to multiple crack initiation sites. (ELP+Thermal+Fret Specimen 82,  $S_{max}=50$  ksi, and  $N_f=91,814$ )

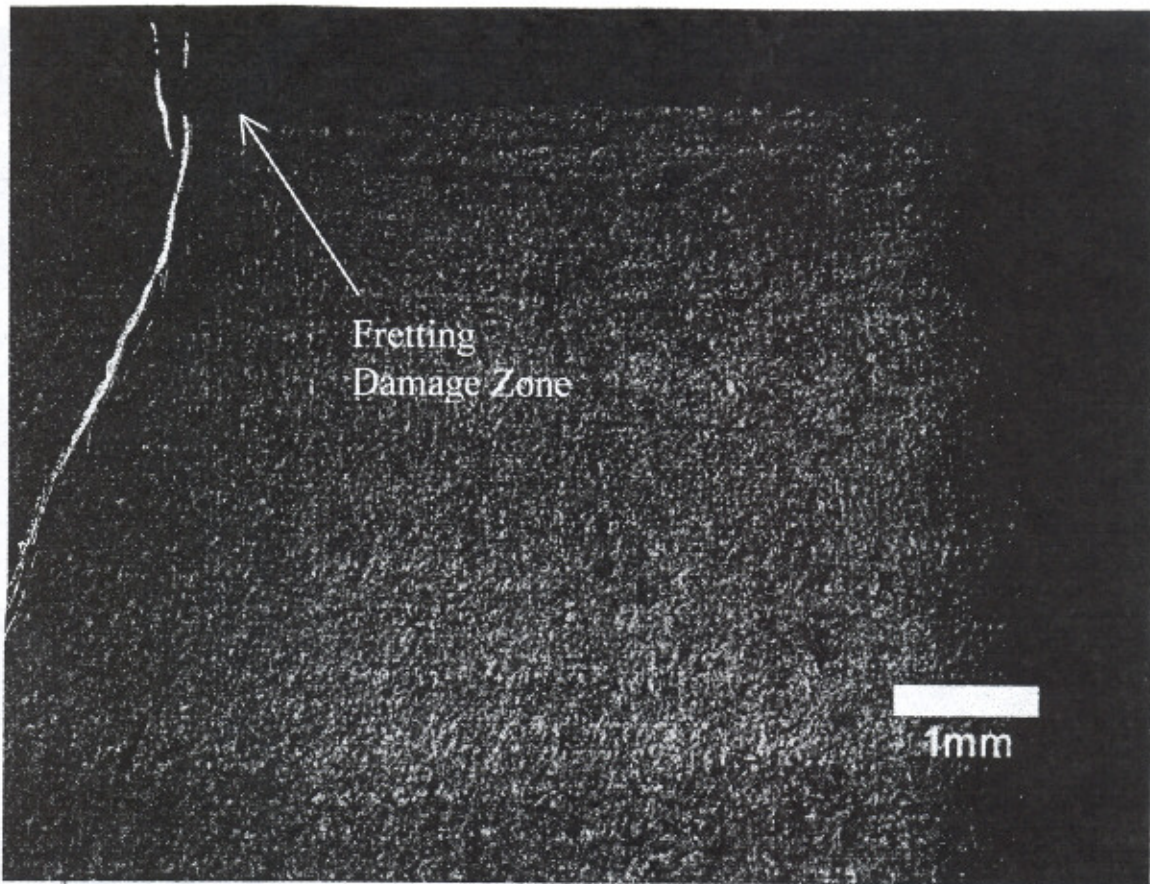
Figure 11. Low magnification optical fractograph of SP treated specimen. Failure occurred from initiated cracks under the fretting scars. Note the dark band near the surface indicative of the fretting damage zone leading to a crack initiation site. (SP+Thermal+Fret Specimen 76,  $S_{max}=95$  ksi, and  $N_f=111,093$ )

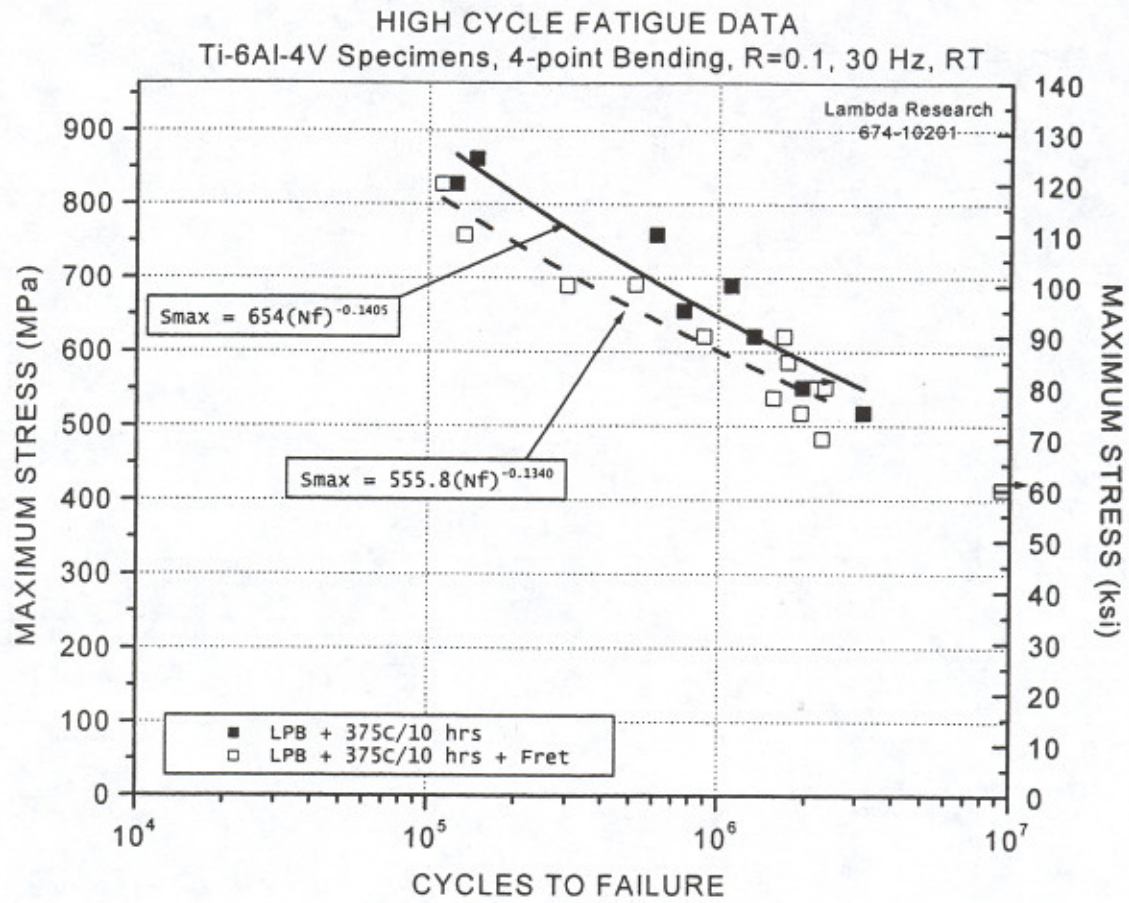
Figure 12. HCF data for LPB treated specimen with and without fretting. The effect of fretting on both HCF performance and the endurance limit is minimal

The performance of the LPB'd specimens subjected to fretting damage was largely identical to the performance without fretting damage. This is further born out by the fact that, as with the high cycle fatigue testing discussed earlier, all of the failure initiation sites in the LPB processed specimens were subsurface. Failures did not originate from the fretting damaged regions in the LPB'd specimens. This mitigation of the fretting fatigue damage by LPB is depicted more clearly in Figure 12. A typical fracture surface for the LPB'd + fretting condition is shown in Figure 13. Note that the initiation site is subsurface and occurred on a plane remote from the fretting fatigue damage.

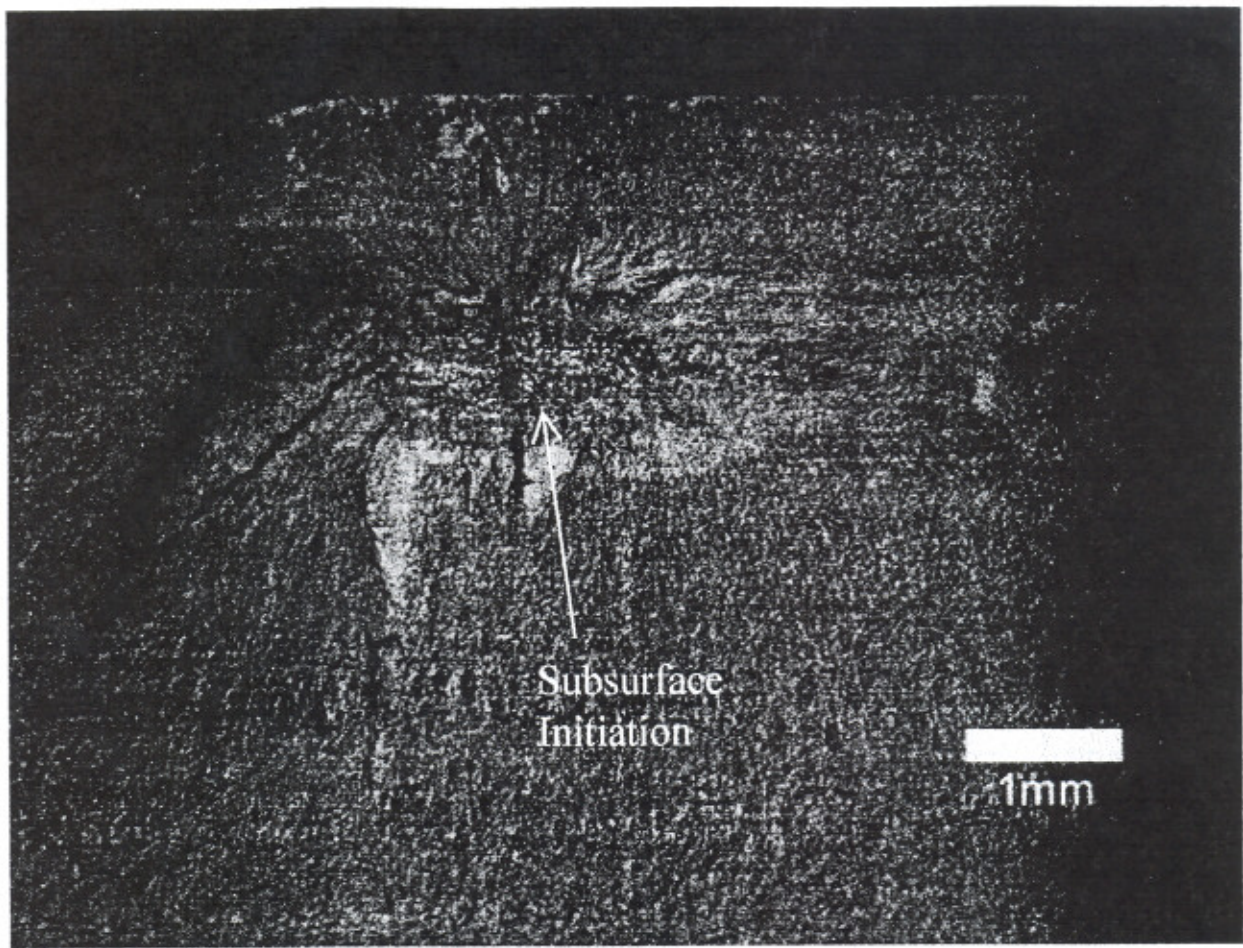
Figure 13. Low magnification optical fractograph of LPB treated specimen. Failure initiated subsurface, on a plane away from the fretting pads, with no regard for the fretting scars. (LPB+Thermal Specimen 6,  $S_{max}=85$  ksi, and  $N_f=1,303,823$ )

This fracture behavior suggests that the deep, high magnitude compressive residual stresses induced by LPB have prevented any critical crack growth from the fretting scars. In this way, the LPB induced compressive residual stresses have largely eliminated the debit in high cycle fatigue performance from fretting damage.
