Rapid Maximum-On-Ground (MOG) Enhancement Technologies

Report 1

Matting Systems for Contingency Helipads and C-130 Test Sections

January 2005

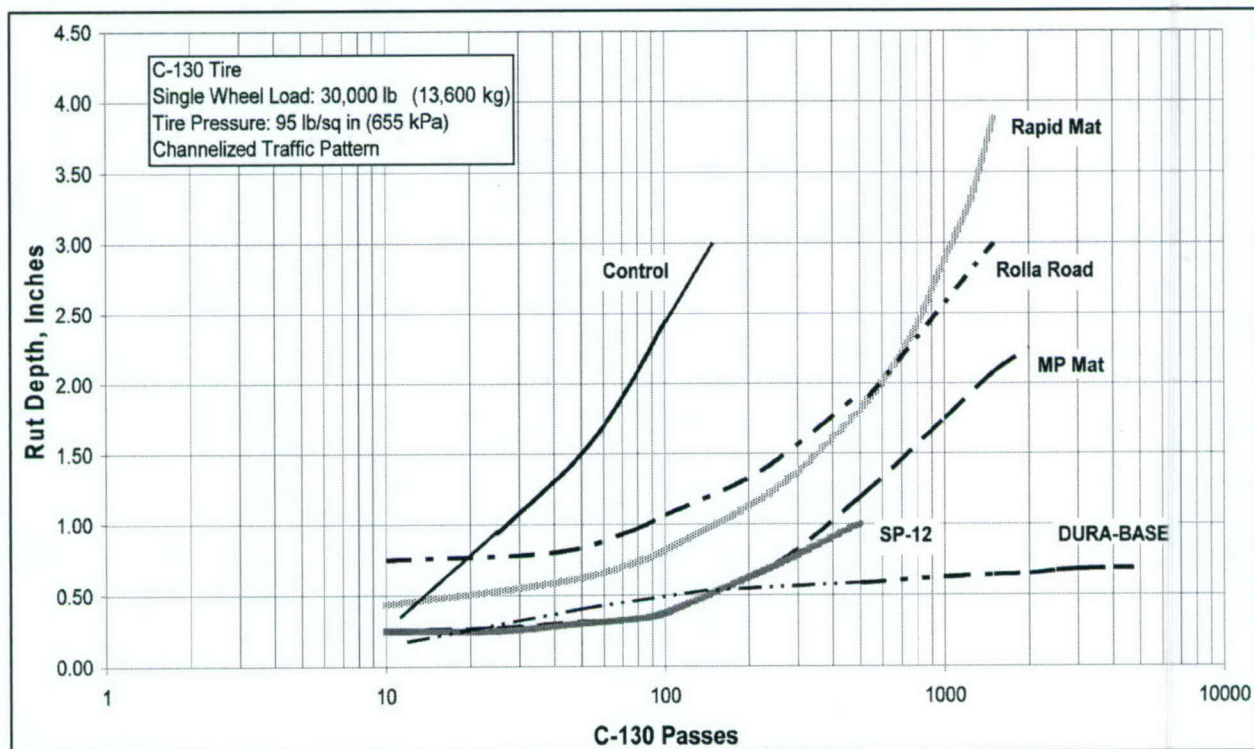
Figure 4. Rut depth for high-strength subgrade (40 to 50 CBR) test items

Failure was achieved once the total rut depth (crest to trough of the rut) reached a value of 76.2 mm (3 in.) or greater or when a minimum of 20 percent of the mat system experienced severe damage or breakage. This failure value was measured with the mat in place, using the rod and level and the rut bar, described in the following section. The mats were not removed from the subgrade until the failure condition was reached. Photo 34 shows measurement of the final rut depth after the removal of the Rapid Mat system from the clay gravel surface. The target for a mat to pass this evaluation was $\geq 2,000$ passes with less than 76.2 mm (3 in.) of total rut with the mat in place over the soil. The rut data for each test item are shown in Figures 4 through 6.

Both the Rapid Mat and Rolla Road failed during the first round (high-strength subgrade, 40 to 50 CBR) as the result of excessive bow-wave reactions during traffic tests. These two mats simply did not offer the structural rigidity and strength to prevent early excessive rutting. The SP-12 Mat showed great potential, but as discussed in Chapter 3 of this report, this mat failed because of mechanical problems and, at the time of testing, was still considered a prototype in the final stages of development. Only the DURA-BASE and the MP Mat succeeded in the first round of testing.

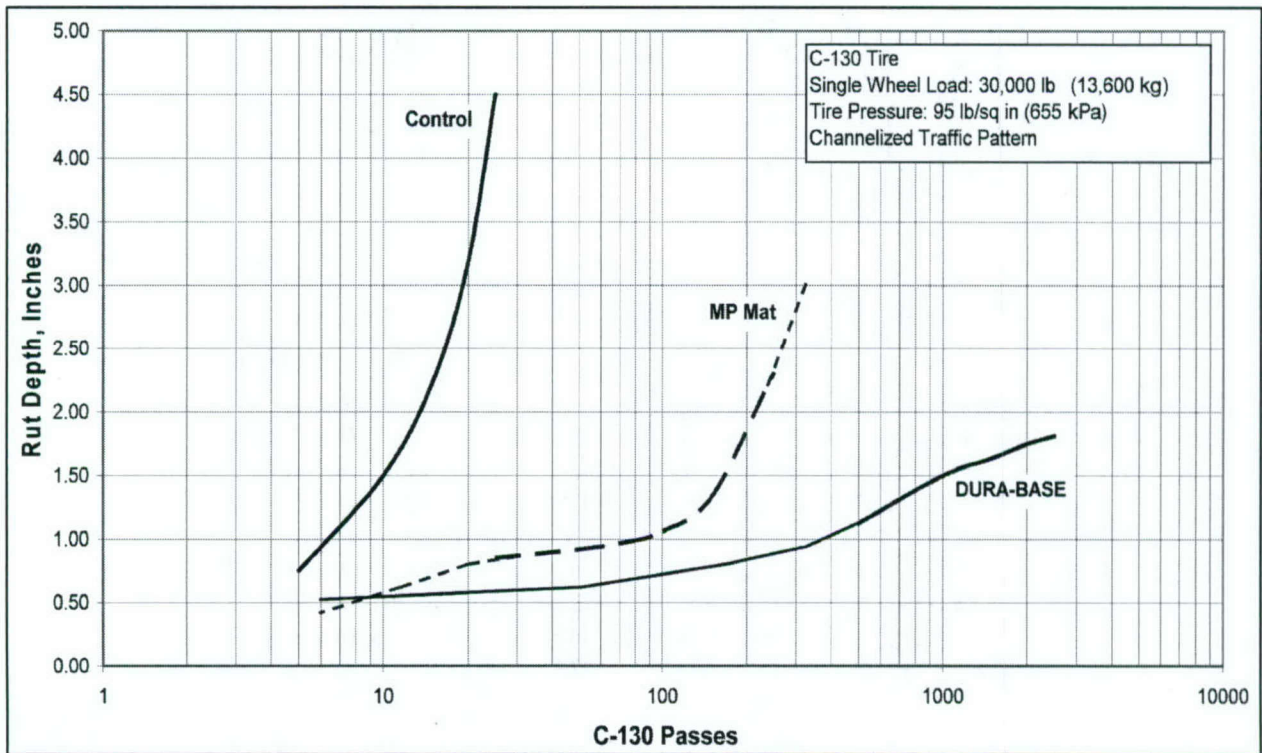
Figure 5. Rut depth for medium-strength subgrade (8 to 10 CBR) test items

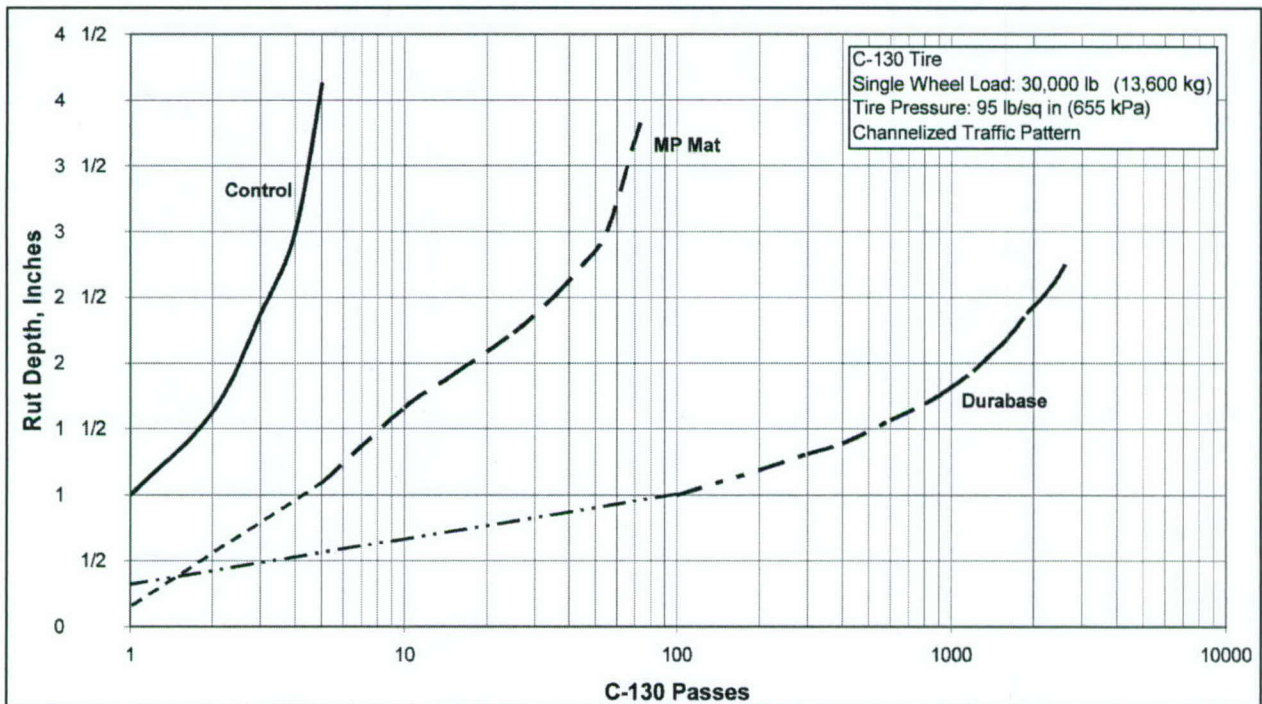
Figure 6. Rut depth for low-strength subgrade (3 to 5 CBR) test items

The third and final round of test section evaluations used a low-strength soil with a CBR of 3 to 5. The DURA-BASE, as expected, performed well even in this scenario of very low subgrade support. The MP Mat, as anticipated, did not allow for as many passes as the DURA-BASE did before reaching the rutting limit of 76 mm (3 in.), but the data gathered qualified this mat for a certain range of service in the field under low soil strength conditions.

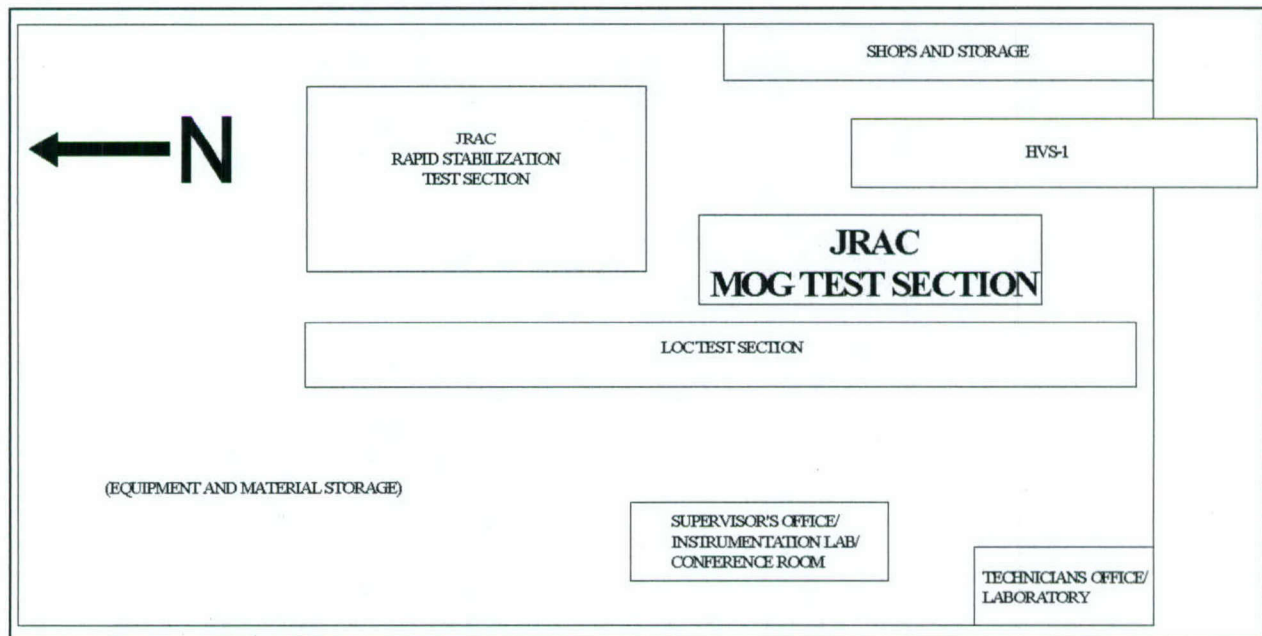
Figure 7. Hangar 4 Pavement Testing Facility test section layout

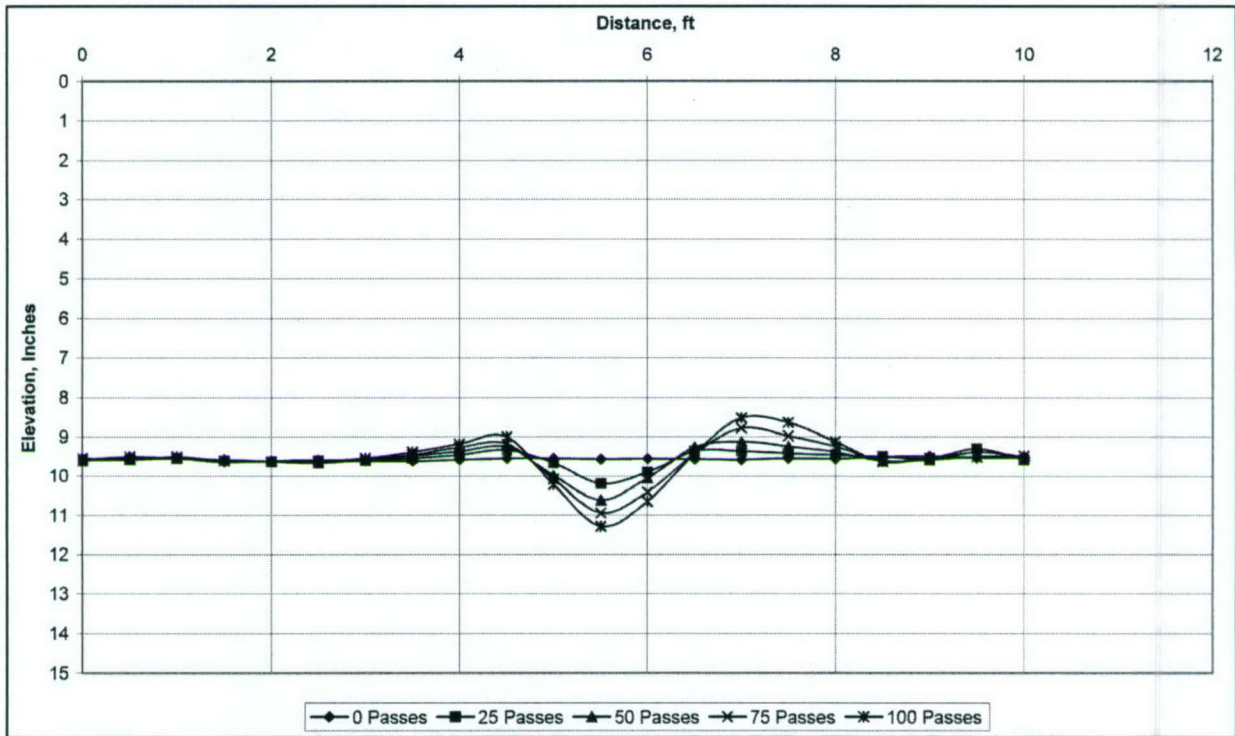
Figure 8. Permanent surface deformation cross section for control (no mat) on high-strength subgrade (40 to 50 CBR)

During each phase of testing, a control section was included to compare the rutting of the soil with no matting systems applied to that with matting systems applied. With a high-strength subgrade (40 to 50 CBR), the control section reached a rut failure (≥ 3 in. rut) at approximately 105 passes. During the medium-strength subgrade analysis (8 to 10 CBR), the control section failed at approximately 25 passes. Finally, using the low-strength subgrade (3 to 5 CBR), the control section achieved rut failure at approximately 5 passes of a C-130 wheel load.

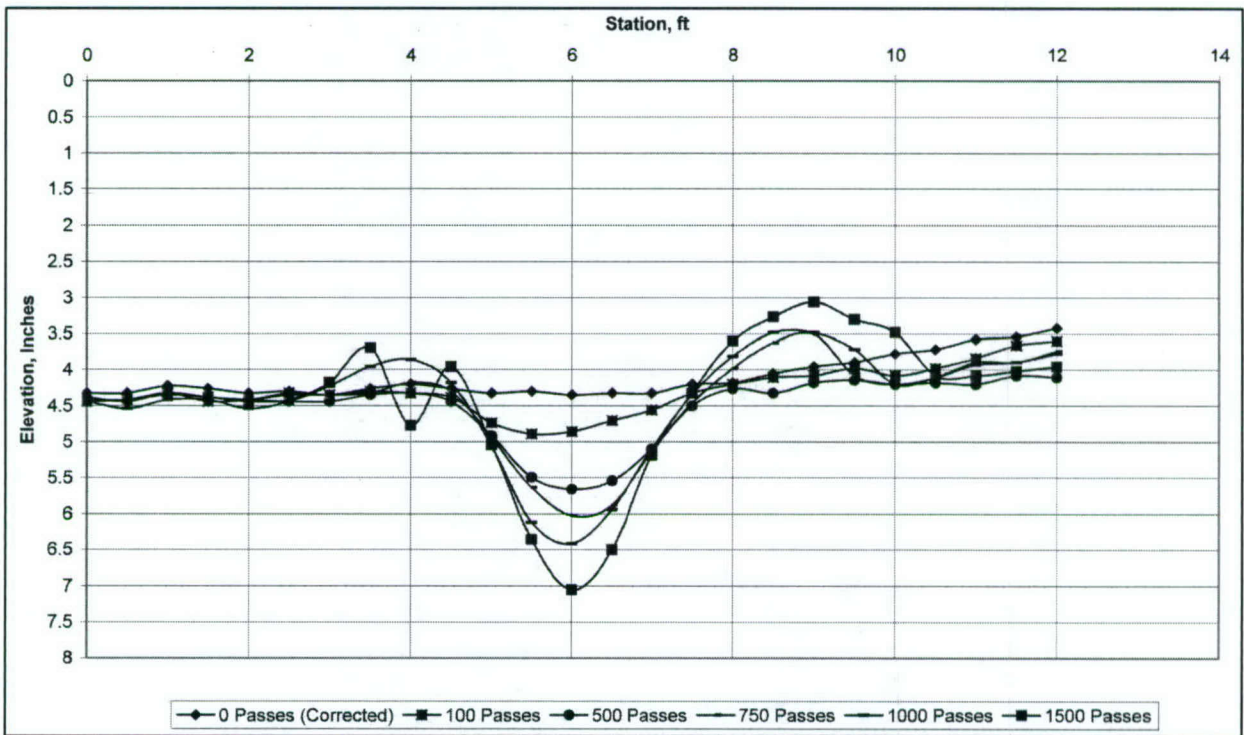
Figure 11. Permanent surface deformation cross section for Rapid Mat on high-strength subgrade (40 to 50 CBR)

Rapid Mat (FFM) tested poorly during this evaluation, reaching the failure criteria of 76.2 mm (3 in.) in 1,010 passes during the high-strength subgrade testing. Because it performed so poorly, it was not evaluated on medium- or low-strength subgrades. The mats offered little or no structural support and did not improve the soil strength condition for heavy aircraft traffic. During trafficking, deep rutting under the mats caused the outer sections of the mats to exhibit large deflections or bow-wave action. These mats are not recommended for use in MOG enhancement activities but should be used only for FOD prevention.

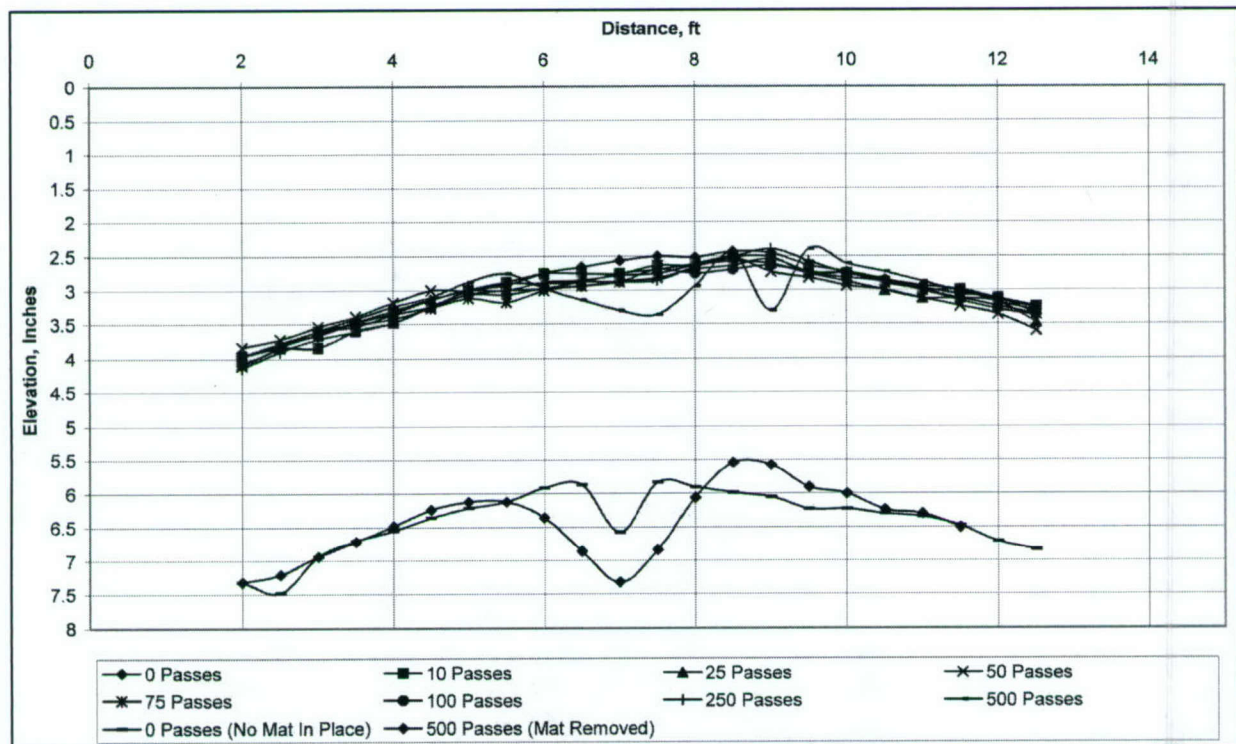
Figure 13. Permanent surface deformation cross section for SP-12 mat on high-strength soil (40 to 50 CBR)

The SP-12 Mat appeared to perform well on the high-strength subgrade (40 to 50 CBR), allowing 500 passes with only 25.4 mm (1 in.) of rut. The mat tested was a prototype model developed and trial-produced by the manufacturer and shipped to ERDC specifically for this test. This mat is still in the developmental phases, and during testing it was found that the welding between the "skin" and "ribbing" or "core" of the mat was faulty, and contact between the two pieces was less than 20 percent. These flaws caused the mat to fail mechanically before failure due to rutting occurred. It is therefore not appropriate at this time to pass final judgment on this product. The initial testing of this product indicates a mat system with much potential, but the flaws with the manufacturing process must be resolved before further testing and conclusions can be formed.

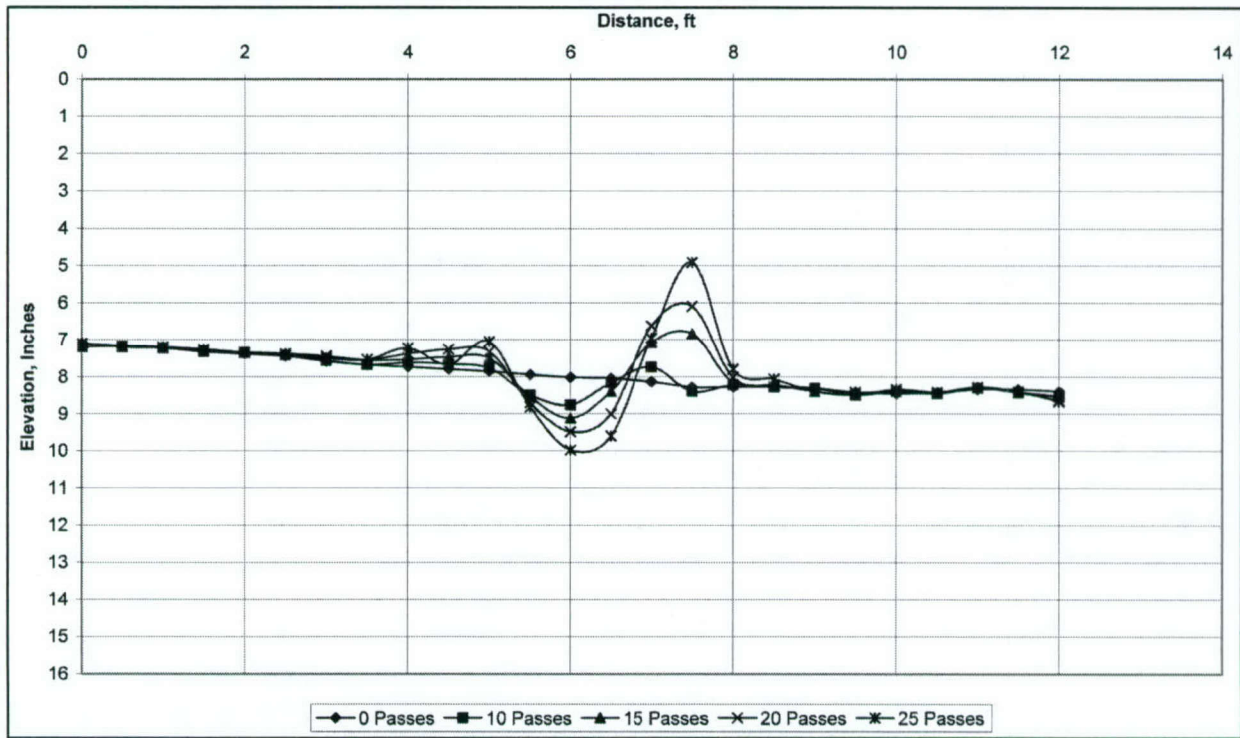
Figure 14. Permanent surface deformation cross section for control (no mat) on medium-strength soil (8 to 10 CBR)

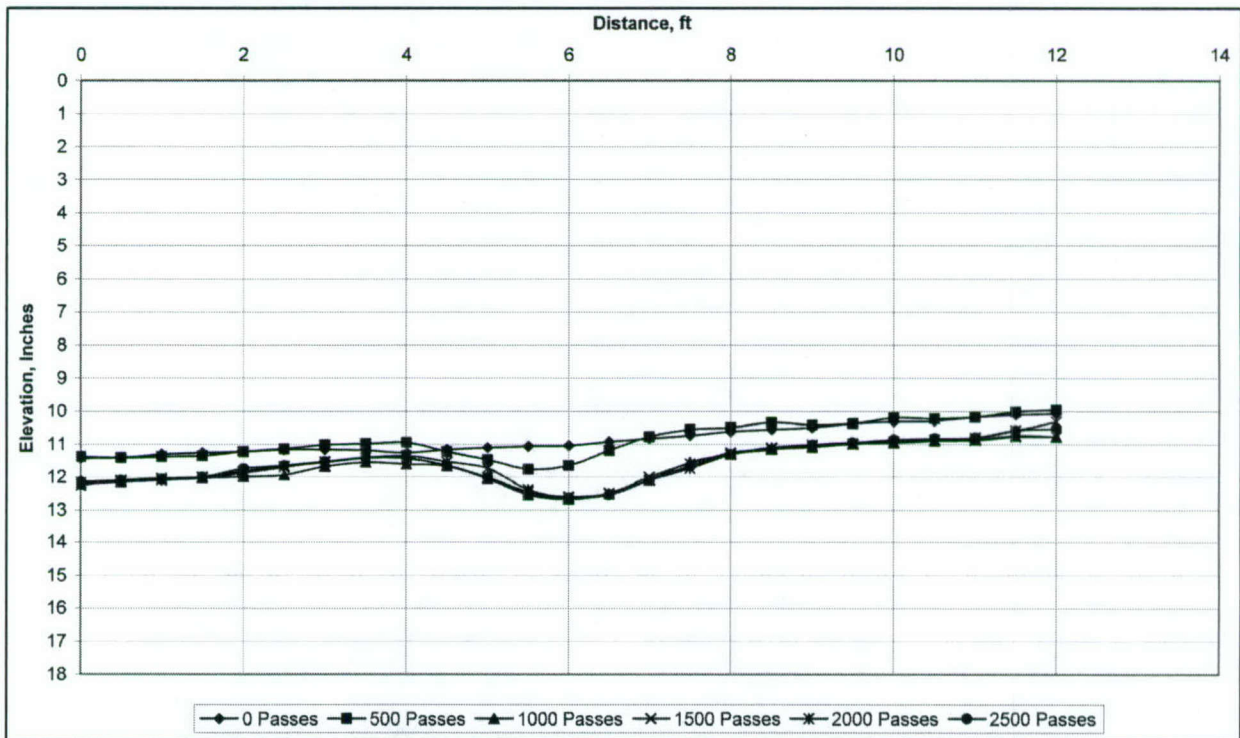
Figure 15. Permanent surface deformation cross section for DURA-BASE on medium-strength soil (8 to 10 CBR)

The DURA-BASE matting system performed very well, allowing well over 2,000 passes of the load cart under all the soil conditions investigated with less than 76.2 mm (3 in.) of mat deflection. The mat surface did show signs of traffic and wear by the end of the investigation, but even with this wear, the surface still offered ample traction. The only major sign of failure was some permanent deformation in the mat's midsection during the final stages of testing. The mats exhibited no tears, ruptures, or pin connection failures during the entire investigation.

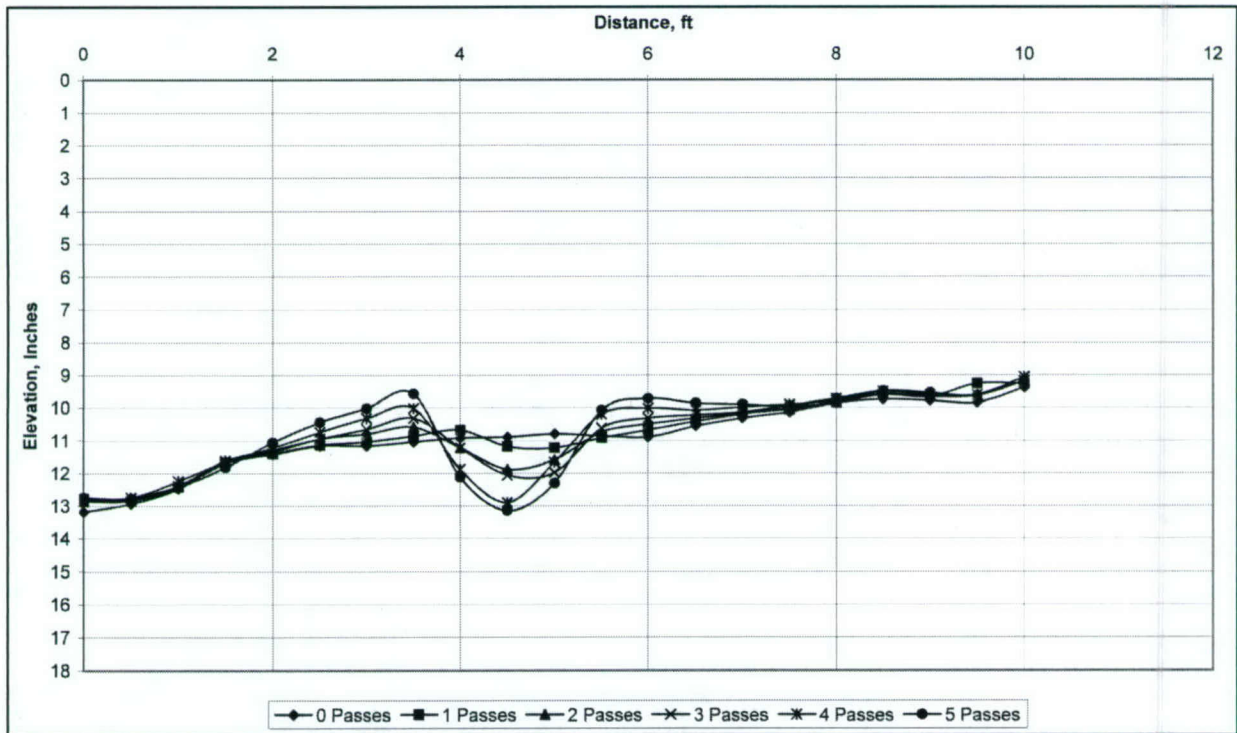
Figure 17. Permanent surface deformation cross section for control (no mat) on low-strength soil (3 to 5 CBR)

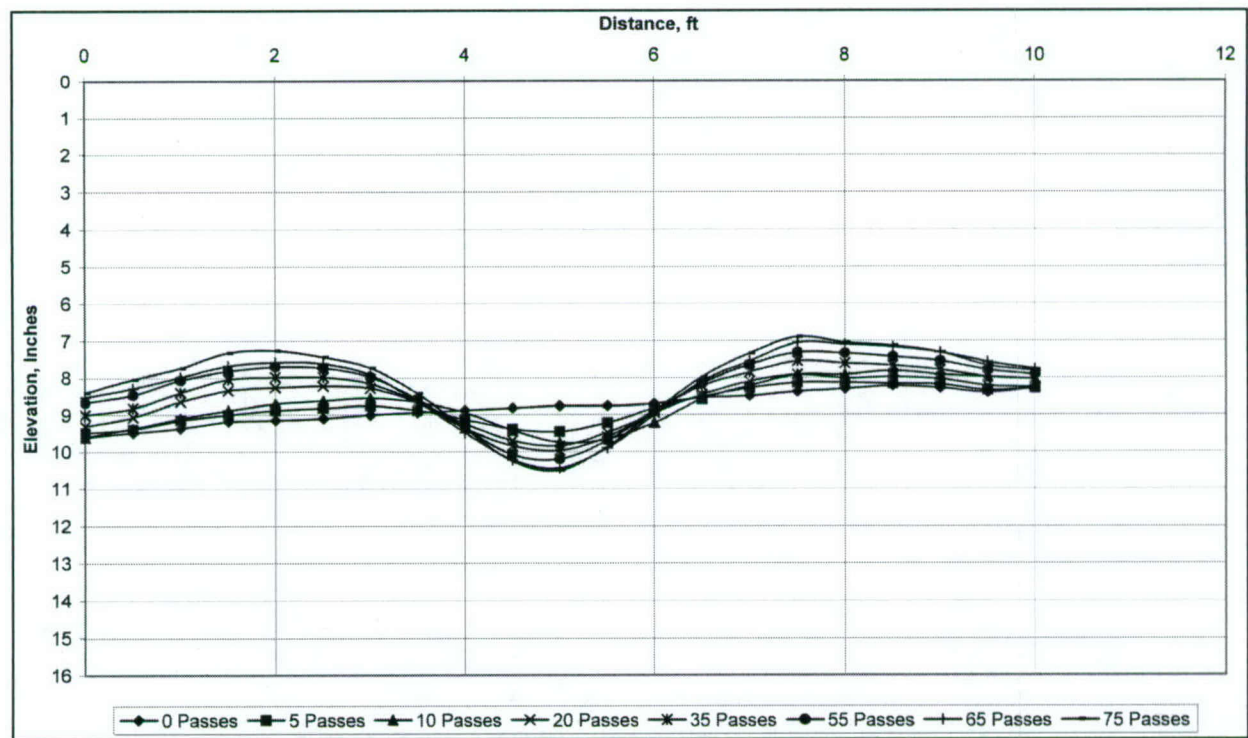
Figure 19. Permanent surface deformation cross section for MP Mat on low-strength soil (3 to 5 CBR)

The MP Mat, although not as resilient as the DURA-BASE, performed well during the test section evaluations. This matting system was able to withstand the minimum 2,000 passes with less than 76.2 mm (3 in.) of mat deflection for the 40 to 50 CBR soil subgrade (high-strength subgrade). The mats did show some large secondary deflections (away from the traffic path) once the point of deflection failure was approaching. This reaction to the progressive rutting of the weak soil beneath the mat caused minor pin problems during the second and third stages of testing (8 to 10 CBR and 3 to 5 CBR, respectively) in which pin popouts occurred (see Photo 37). These popouts totaled less than 10 percent of the total pins installed, and the failure of this small number of pins did not constitute failure of the mat in the test section. In addition, there were several pins within the system that showed signs of minor movement within the connection, but none of these pins failed prior to test completion (see Photo 38). MP Mat allowed 330 passes before reaching the failure criteria during the medium-strength (8 to 10 CBR) subgrade testing and sustained 55 passes before failure during the low-strength (3 to 5 CBR) subgrade testing.

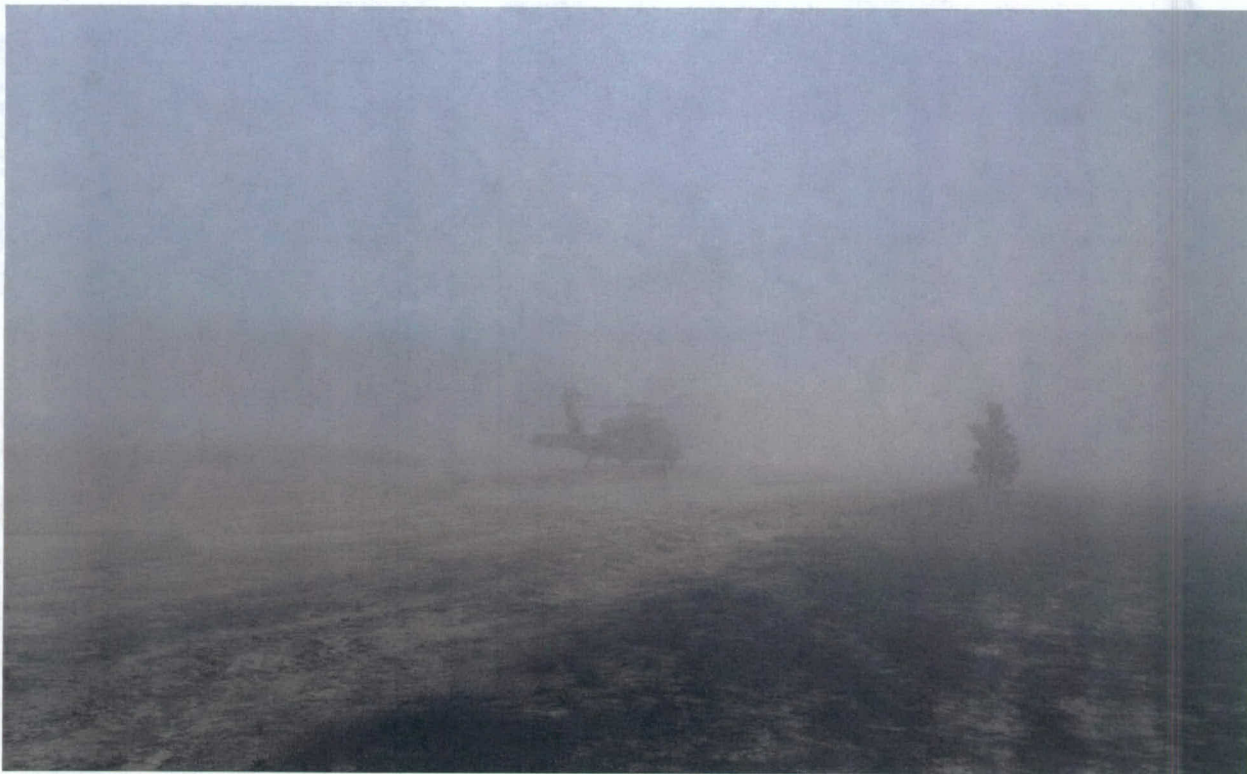
Photo 1. Brownout conditions resulting from helicopter operations in dusty environment

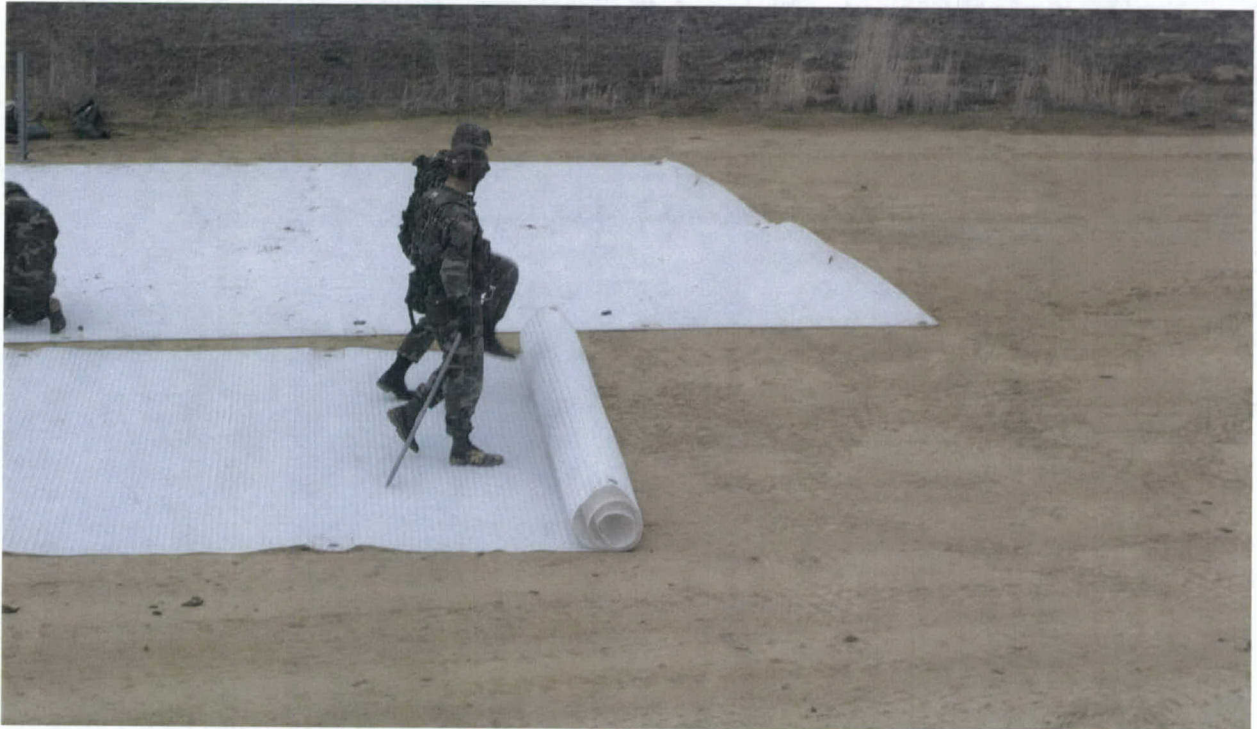
Photo 4. Rolling out Mobi-Mat before anchoring to adjacent panel and staking edges

Mobi-Mat was the simplest system to construct. The soldiers quickly grasped how to assemble the matting system, and site preparation was not needed. The mat was easily locked together with the straps provided, although it was quite labor intensive for the soldiers to install the metal anchoring spikes using sledgehammers. It was noted that the spikes could be substituted with military U-shaped pickets, utilizing the interlocking straps to tie the mat down to the

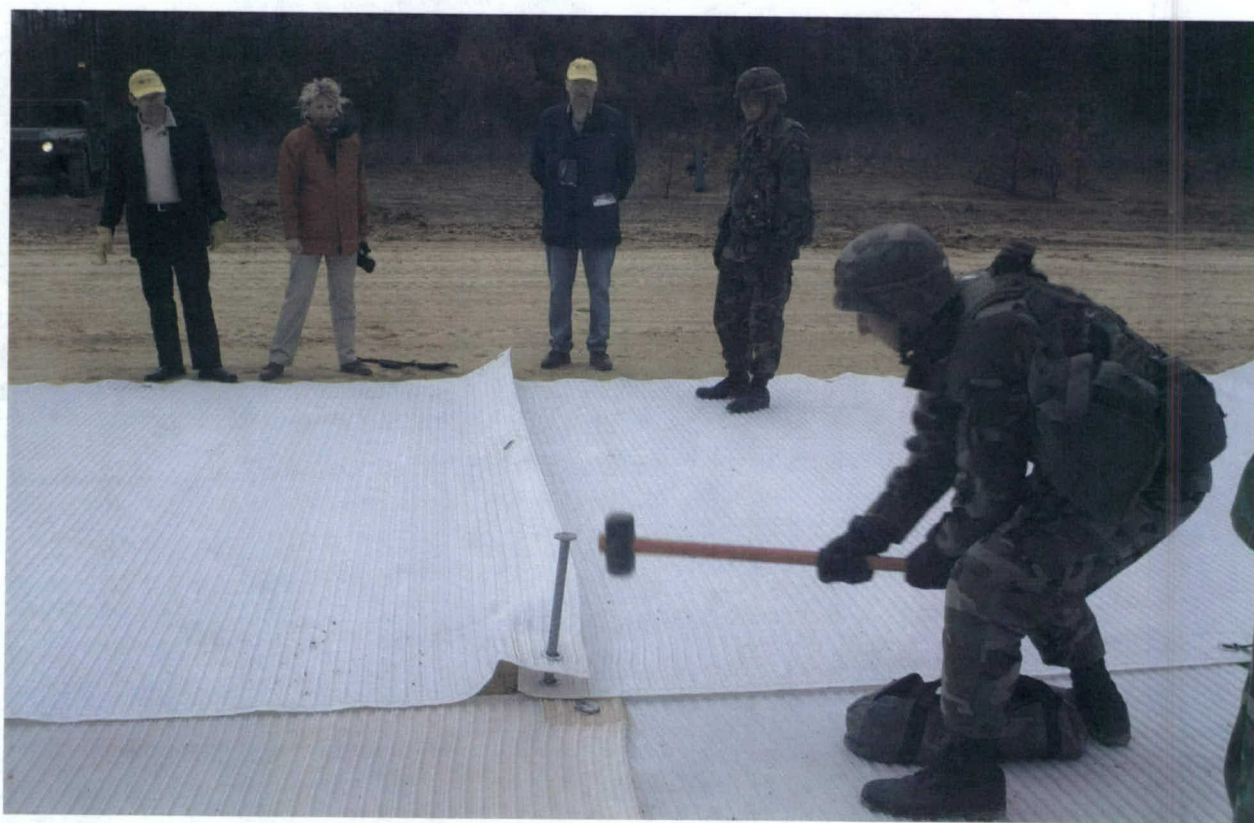
Photo 6. Hammering corner stakes into Mobi-Mat panels

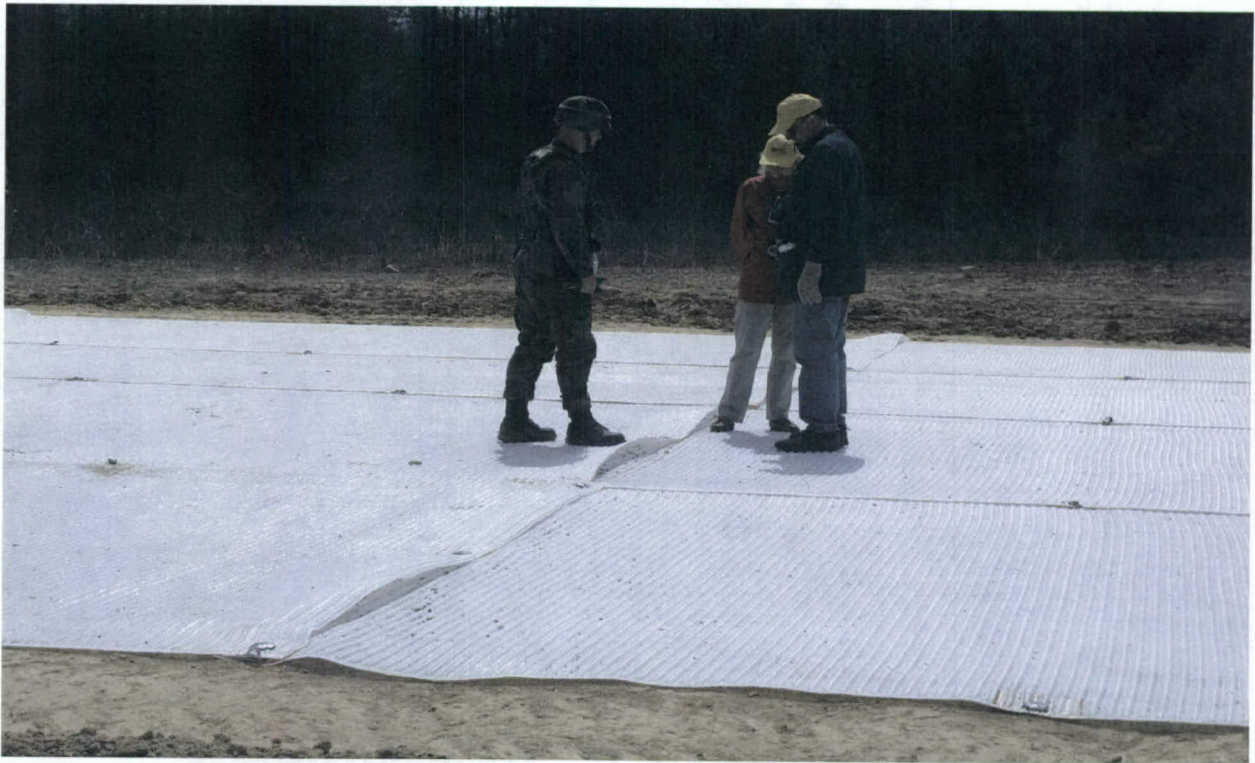
Photo 7. Completed Mobi-Mat helipad. (Note tops of pins used to hold it in place)

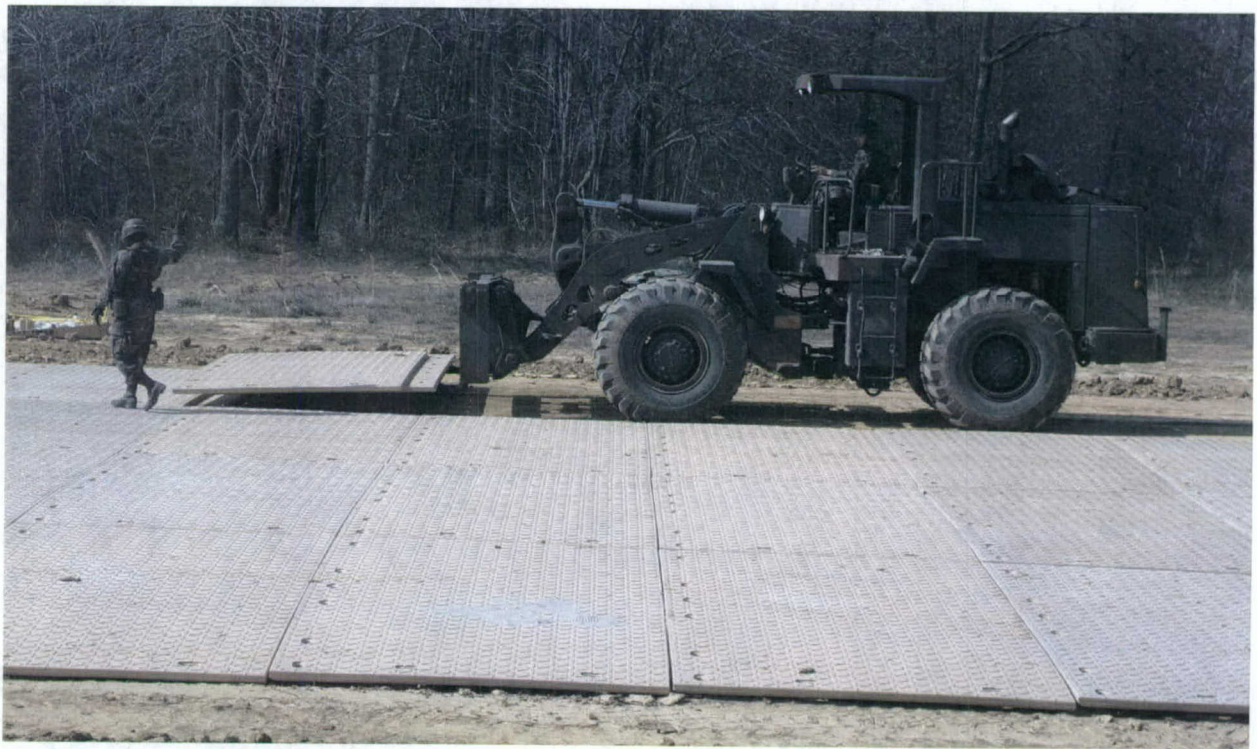
Photo 8. Large forklift used to place each DURA-BASE panel

Only the DURA-BASE system required MHE to assemble. Unless MHE is available to offload and maneuver the mats, this system cannot be emplaced. The weight of the matting limits the amount that could be brought in by airframe or as a secondary load. For these reasons alone, the DURA-BASE system should not be considered for expedient contingency helipads. The SUPA-TRAC system showed signs of wear under limited dynamic and static loads of the helicopters, and the mats do not allow for the helicopter's mooring system to be emplaced without modification. For these reasons, the SUPA-TRAC system was not given further consideration as an expedient contingency helipad system.

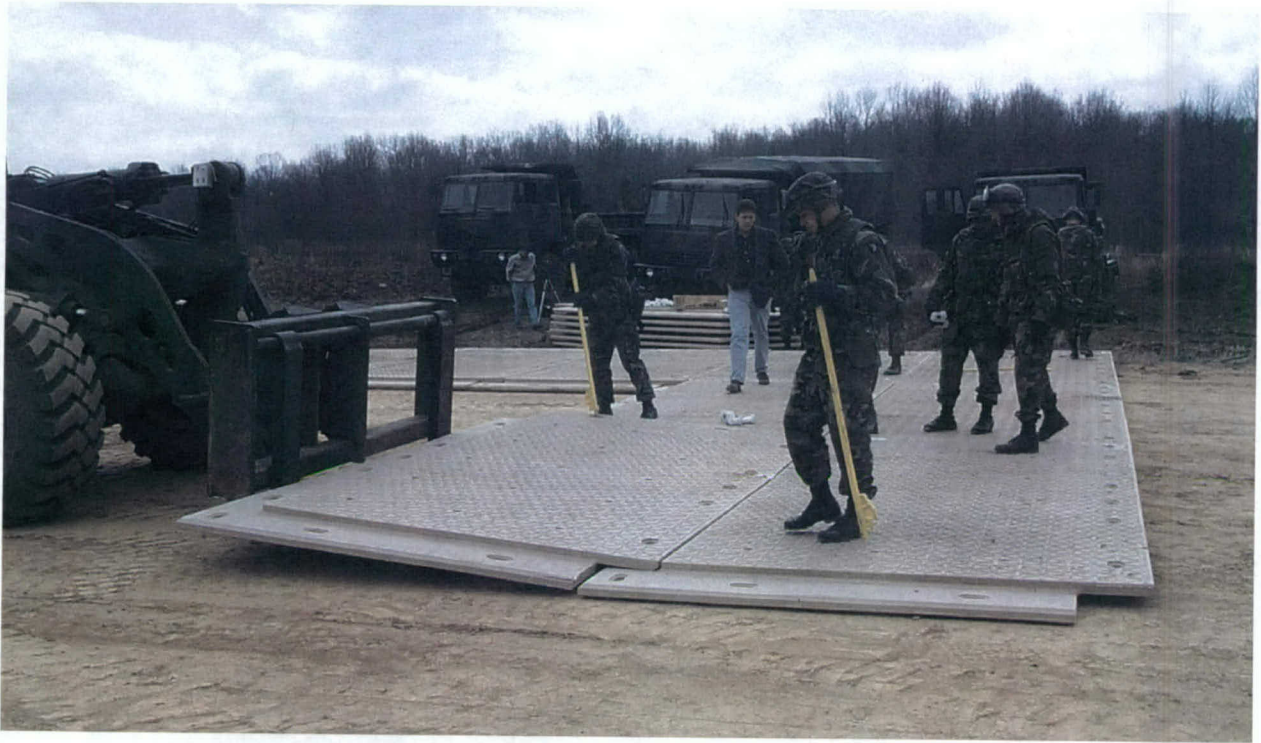
Photo 9. Bar tools used to align connector pinholes during placement

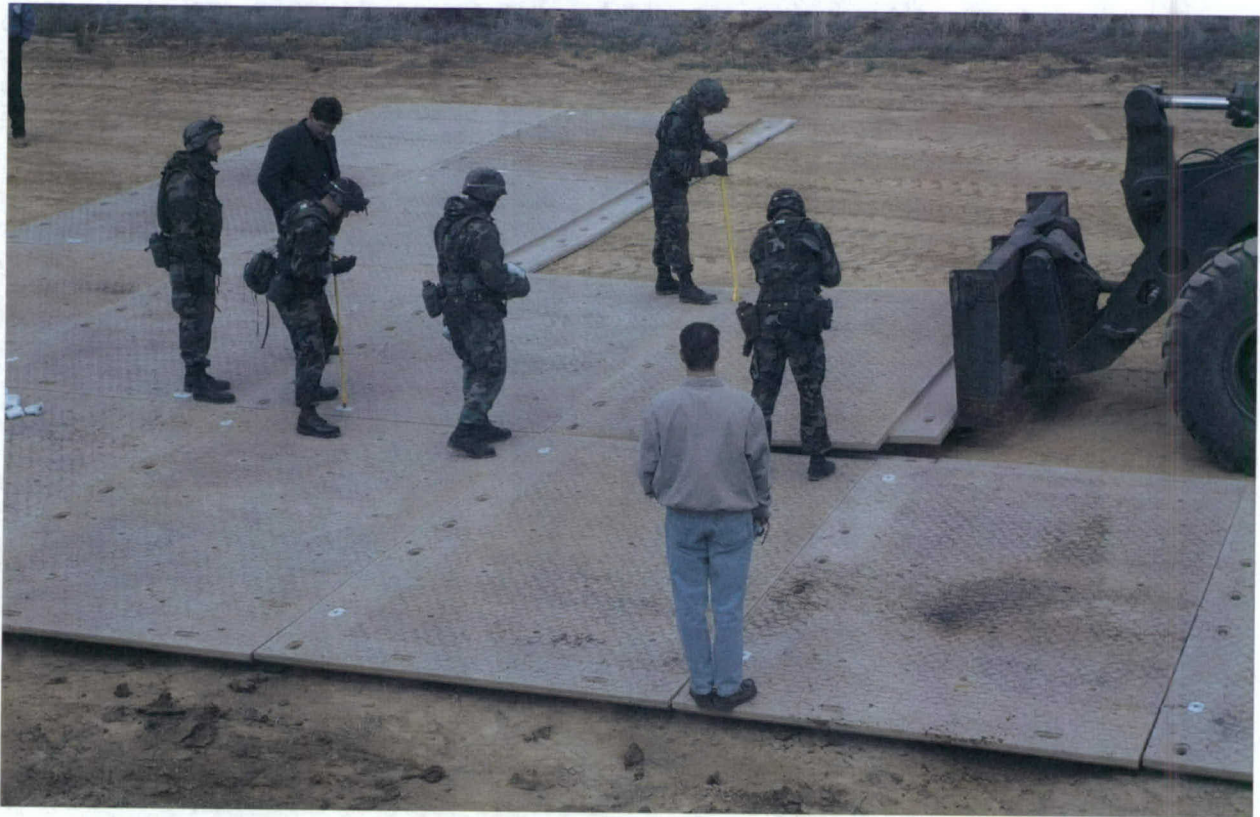
Photo 10. Dual-use bar tool used to align panels and lock in connector pins

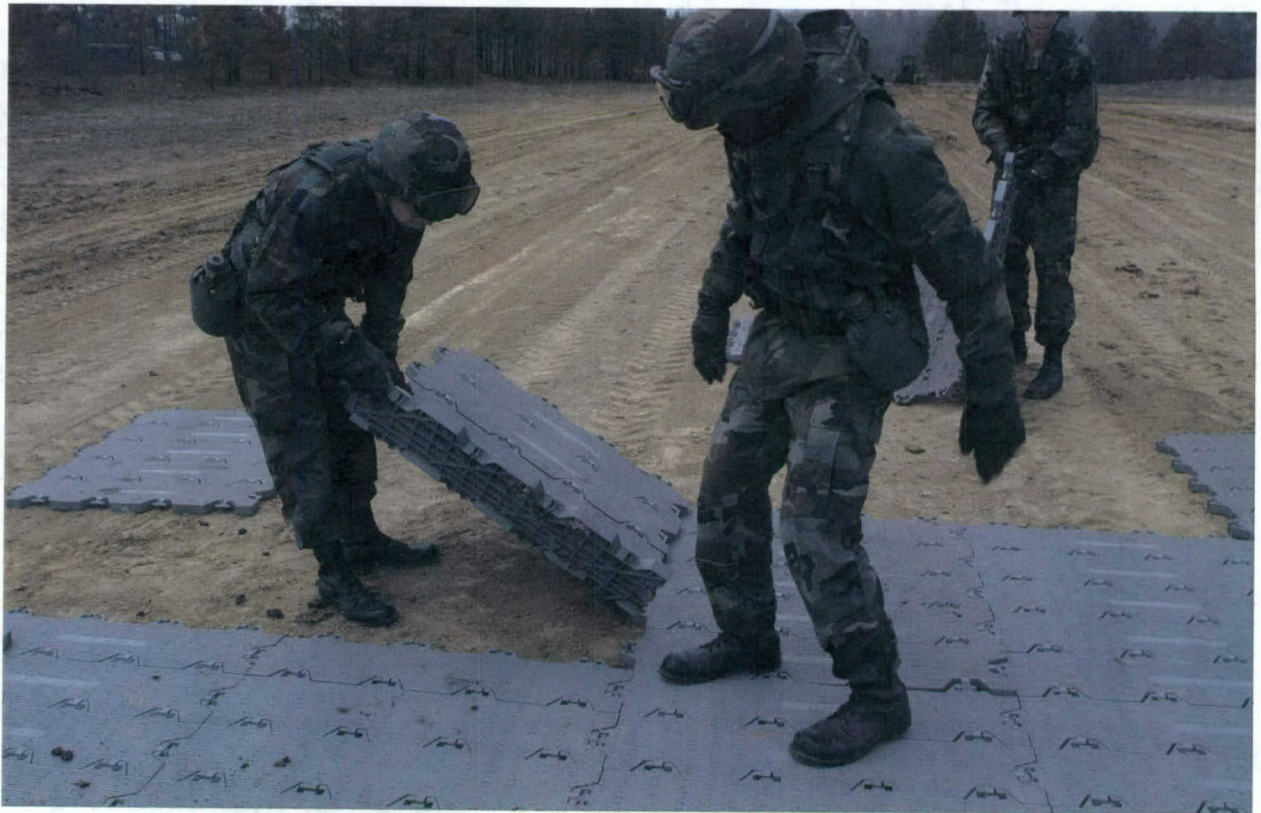
Photo 12. Snapping panels of SUPA-TRAC into place with boot heel

The SUPA-TRAC system was constructed in a short amount of time. The entire system went together smoothly once the soldiers worked out the assembly process. Several of the plastic connecting clips were broken during installation and several of the panels were cracked when soldiers missed the edge spikes with the sledgehammers and hit the mat. This system has ramp pads along the edges with predrilled holes to put the metal anchoring spikes through. This design feature makes it impossible to ground the mat using other means.

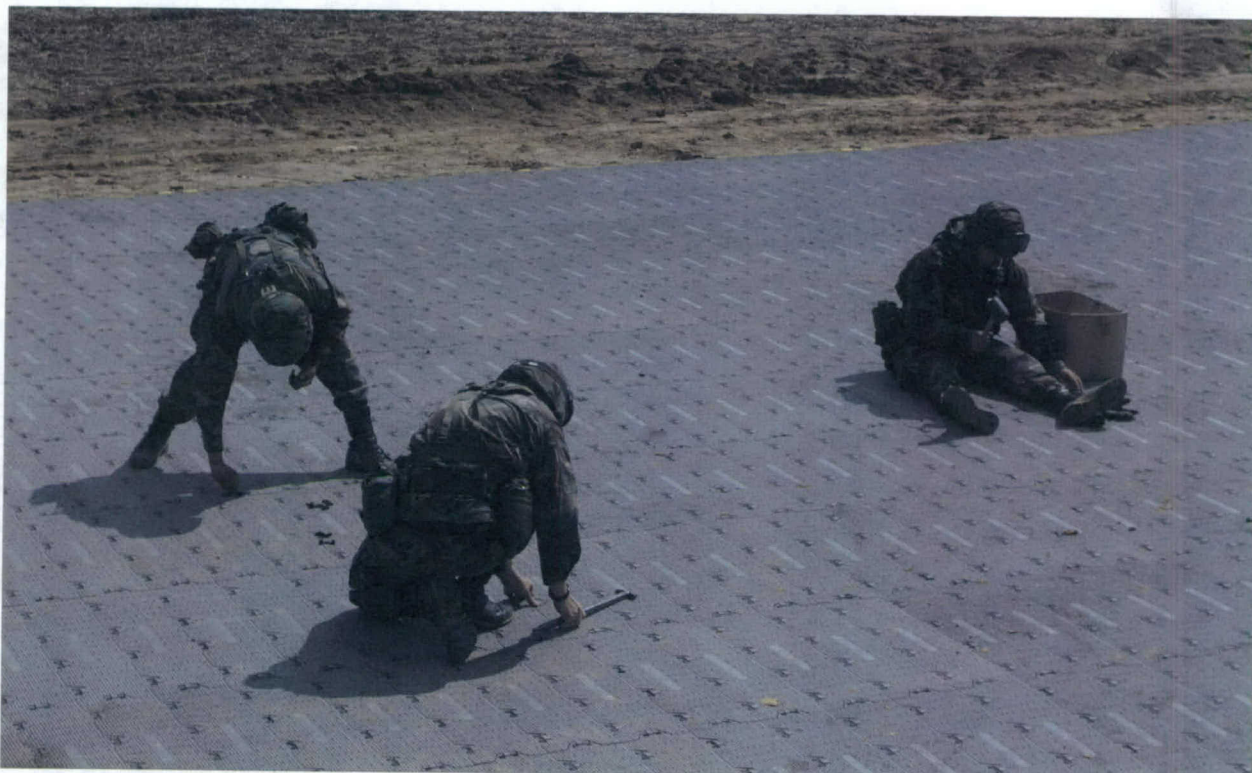
Photo 13. Tapping in SUPA-TRAC connector pins

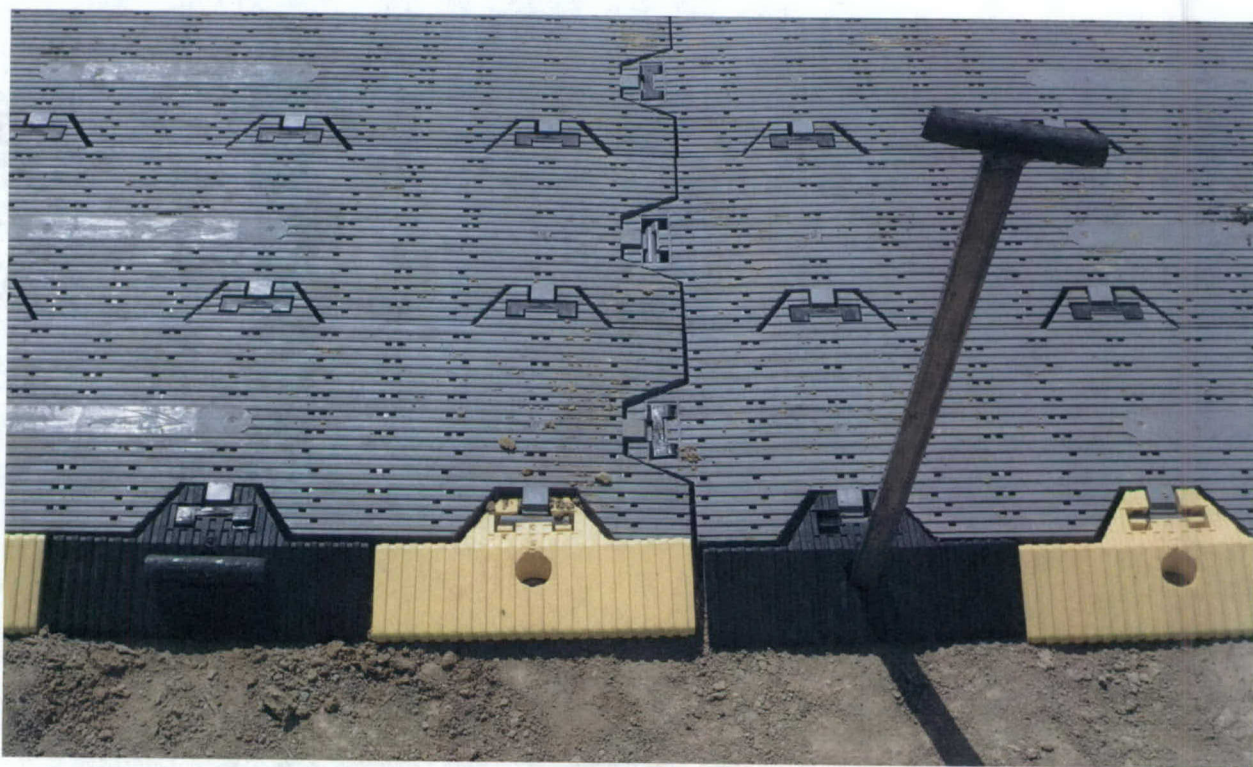
Photo 14. SUPA-TRAC with edge pieces and pins used to tie down the edges
