Rapid Maximum-On-Ground (MOG) Enhancement Technologies

Report 1

Matting Systems for Contingency Helipads and C-130 Test Sections

January 2005

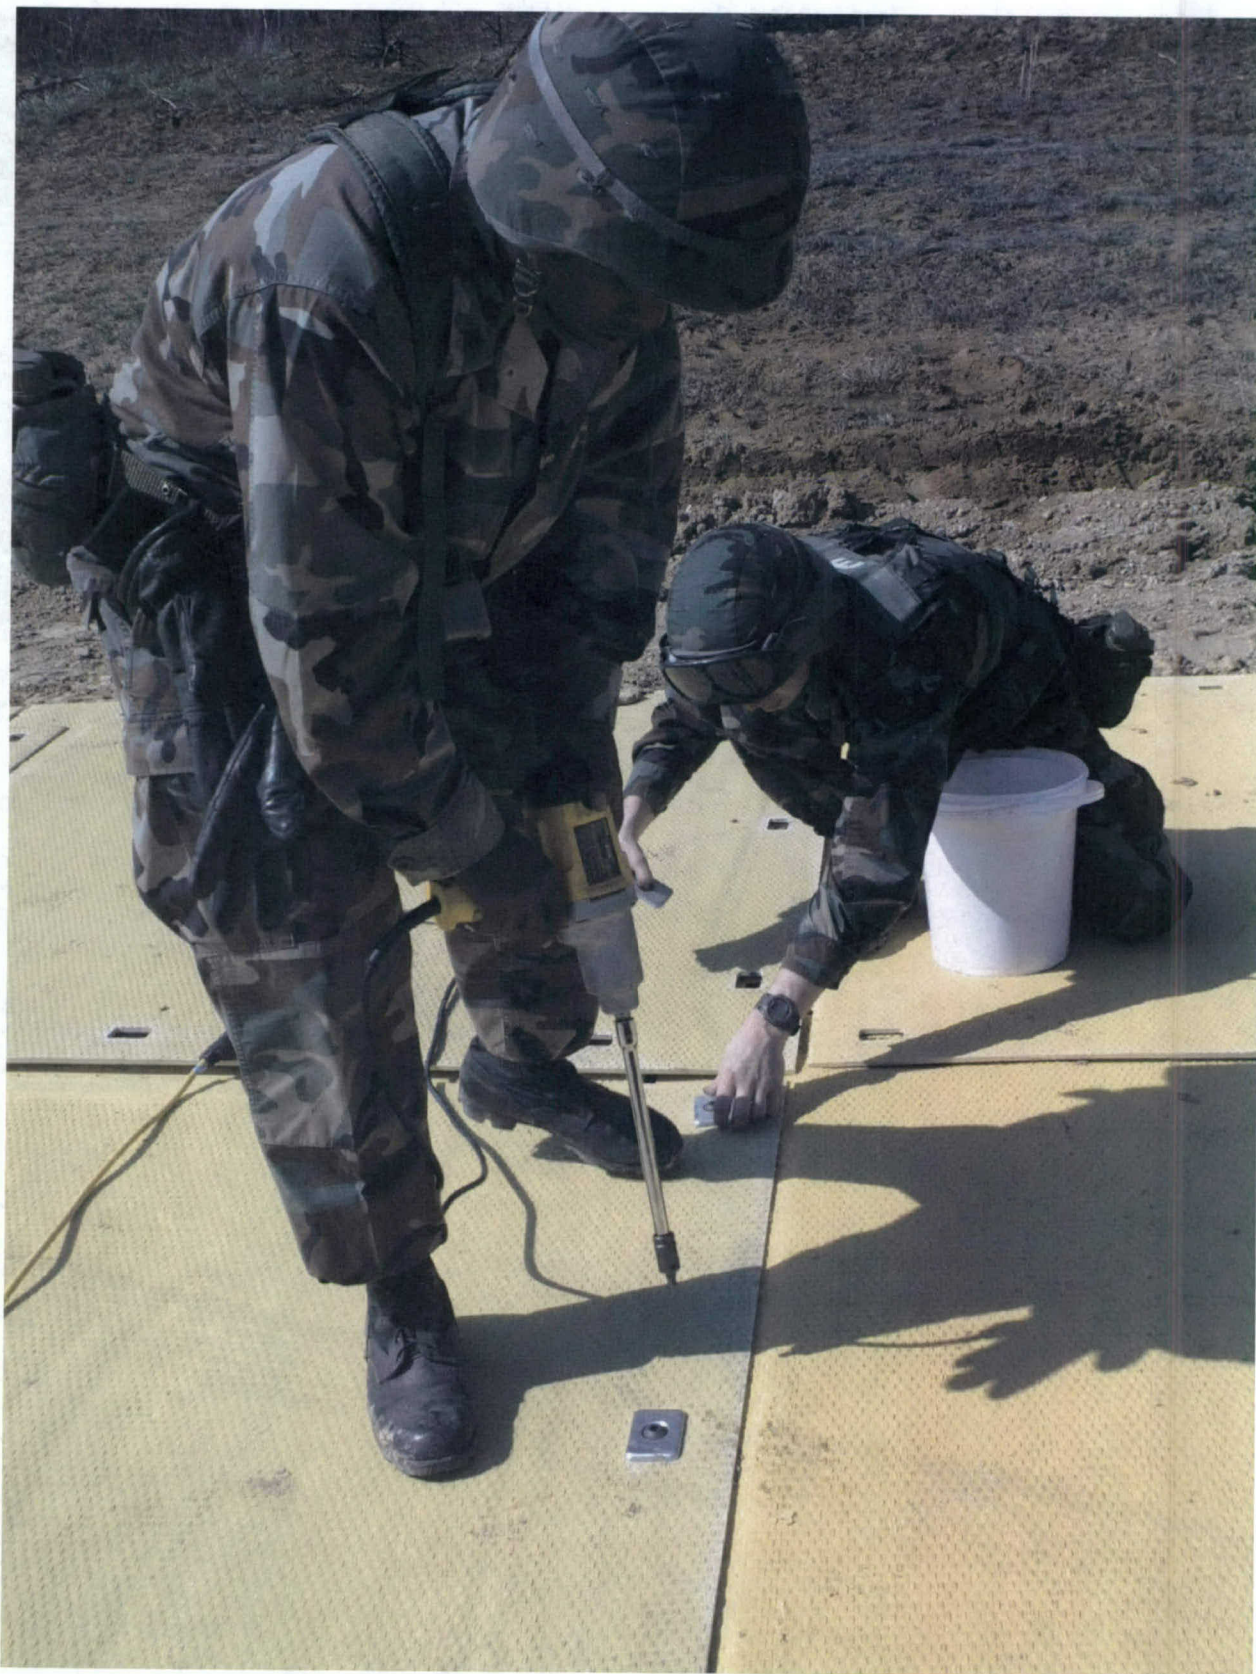
Photo 17. Placing MP Mat connector pins and locking pins with electric impact wrench

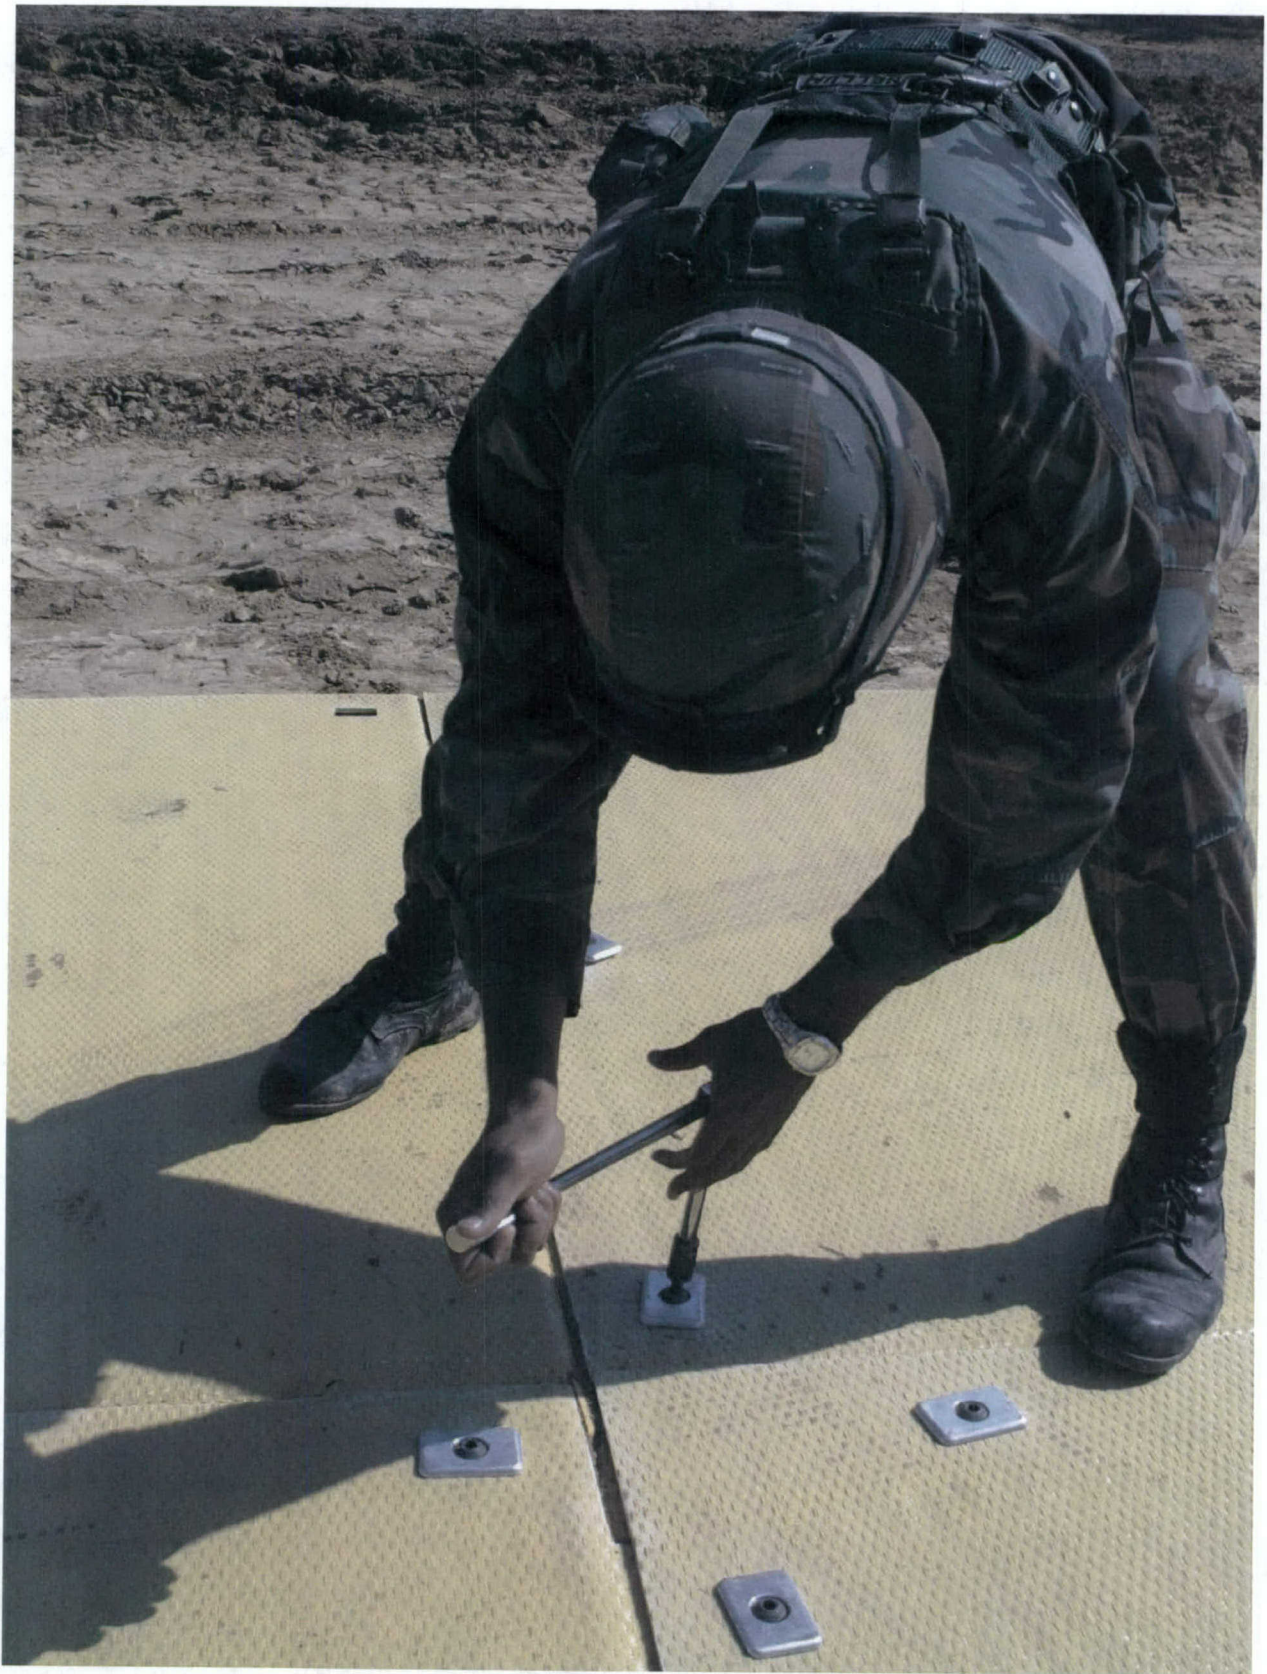
Photo 18. Locking MP Mat connector pins with socket wrench

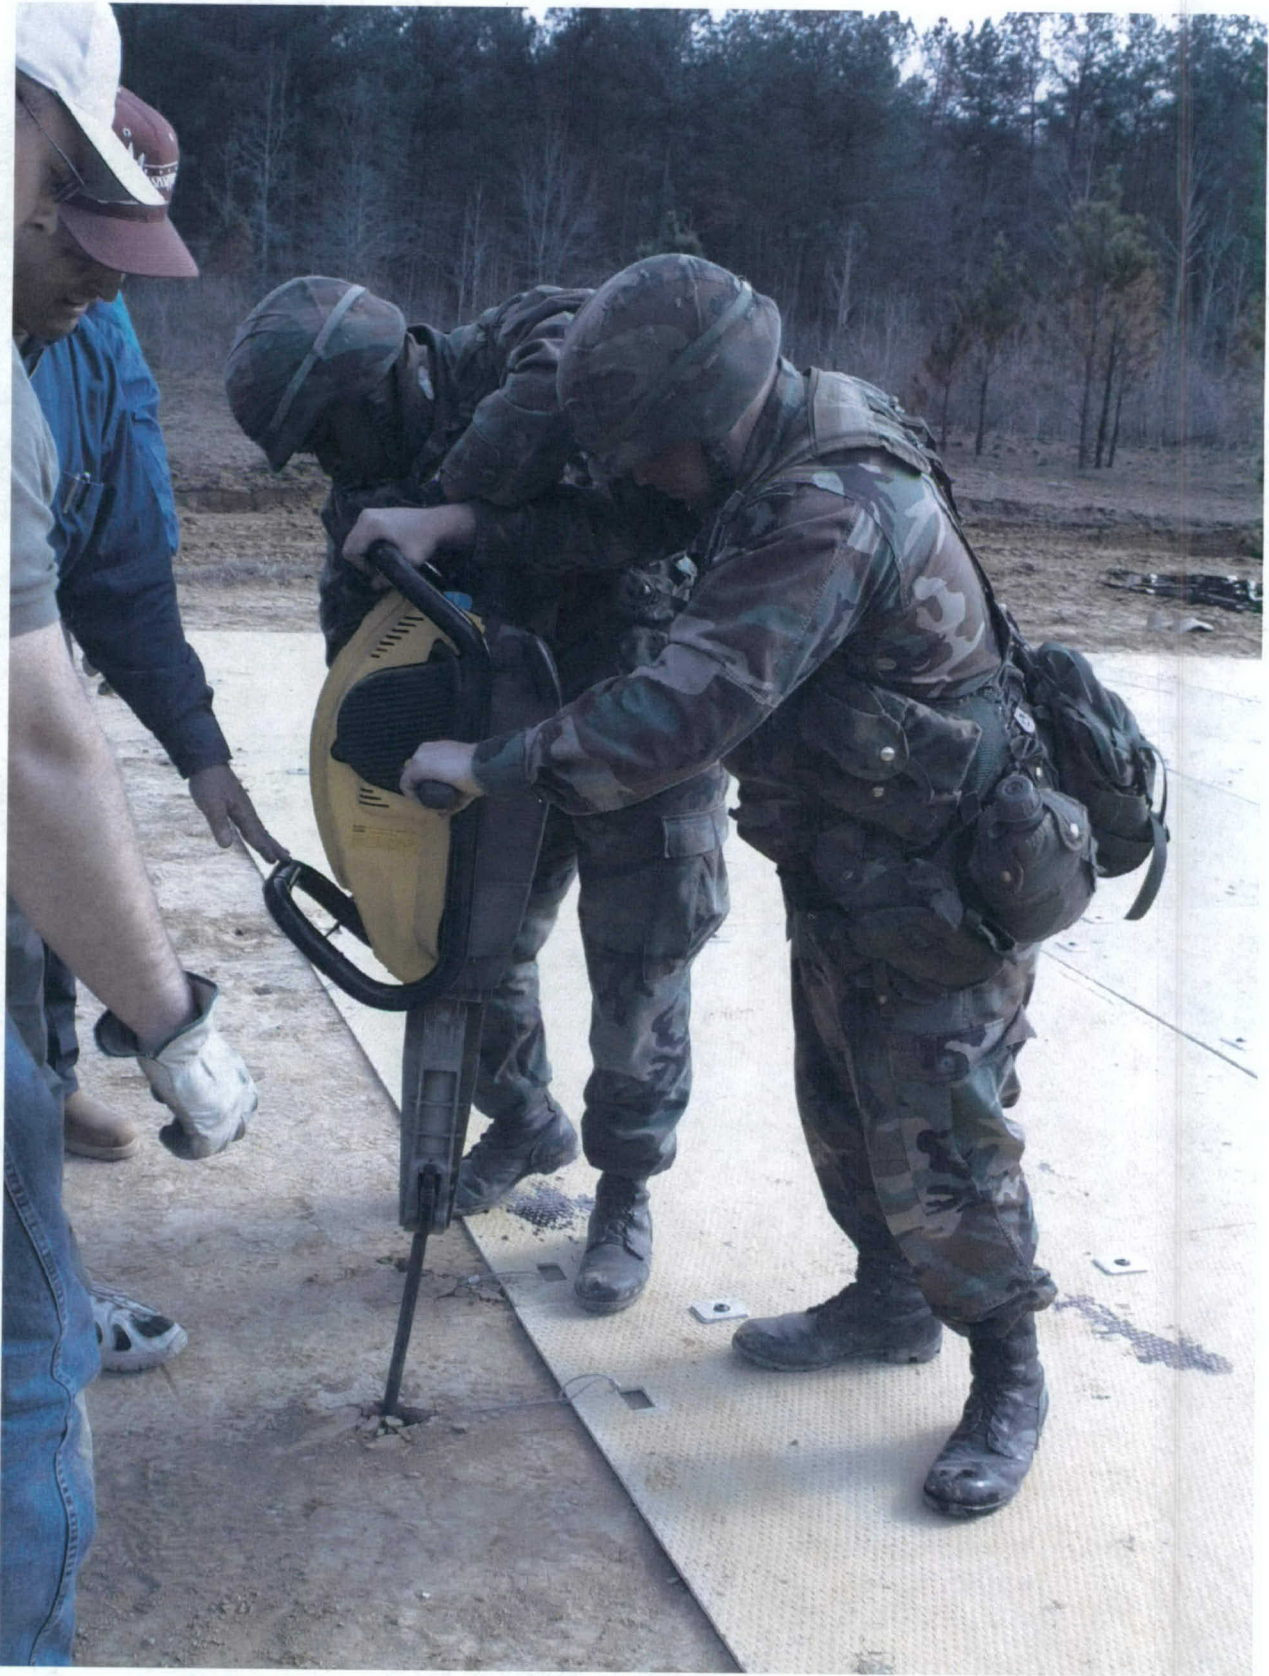
Photo 19. Gasoline-powered jackhammer used to drive duckbill anchors into ground

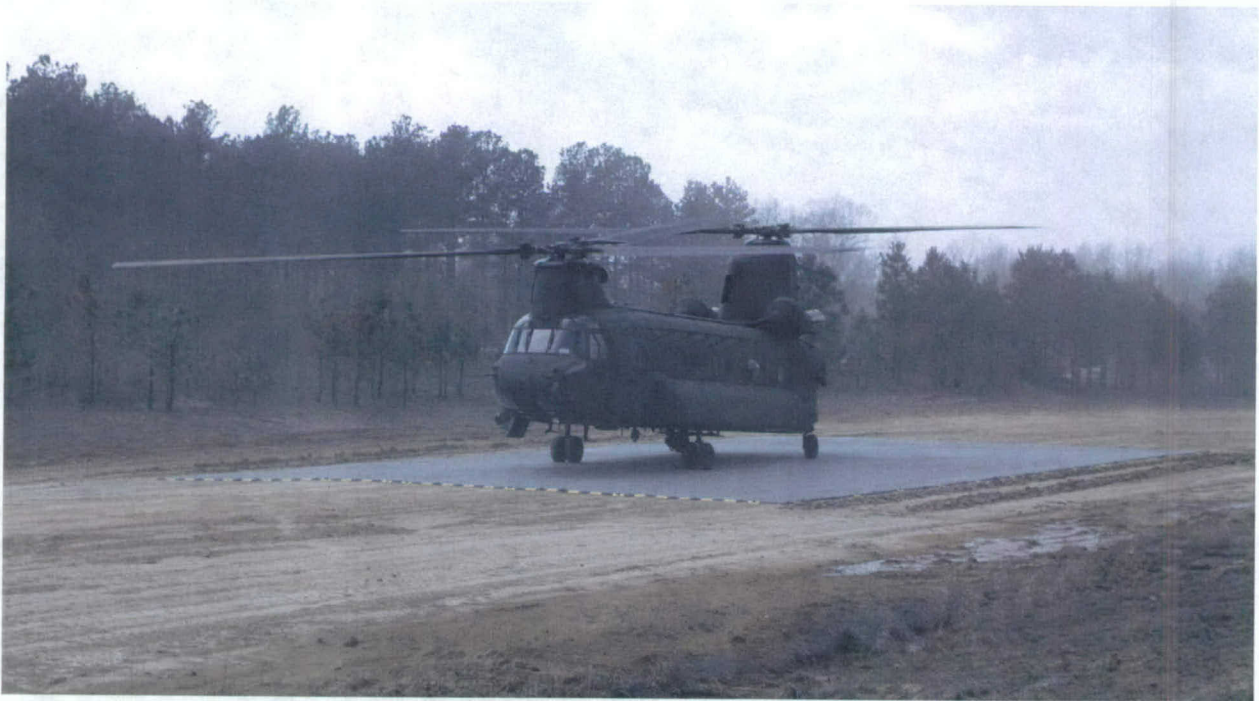
Photo 23. CH-47 Chinook operating on SUPA-TRAC helipad

The SUPA-TRAC system performed reasonably well during the helicopter tests. Excess dust and FOD were reduced while the aircraft were hovering directly above or operating on the matting system itself (Photo 23). Inspection of the mats after the limited helicopter operations showed that the plastic panels did sustain some damage (Photo 24). It was not determined if the limited damage occurred as the result of static or dynamic loads. Also, one edge panel loosened during testing because of rotor wash, but no significant deflection or upheaval resulted from this failure. The SUPA-TRAC system is expected to provide improved load-bearing support, but system component durability is questioned because of the damage noted after the very limited traffic and installation.

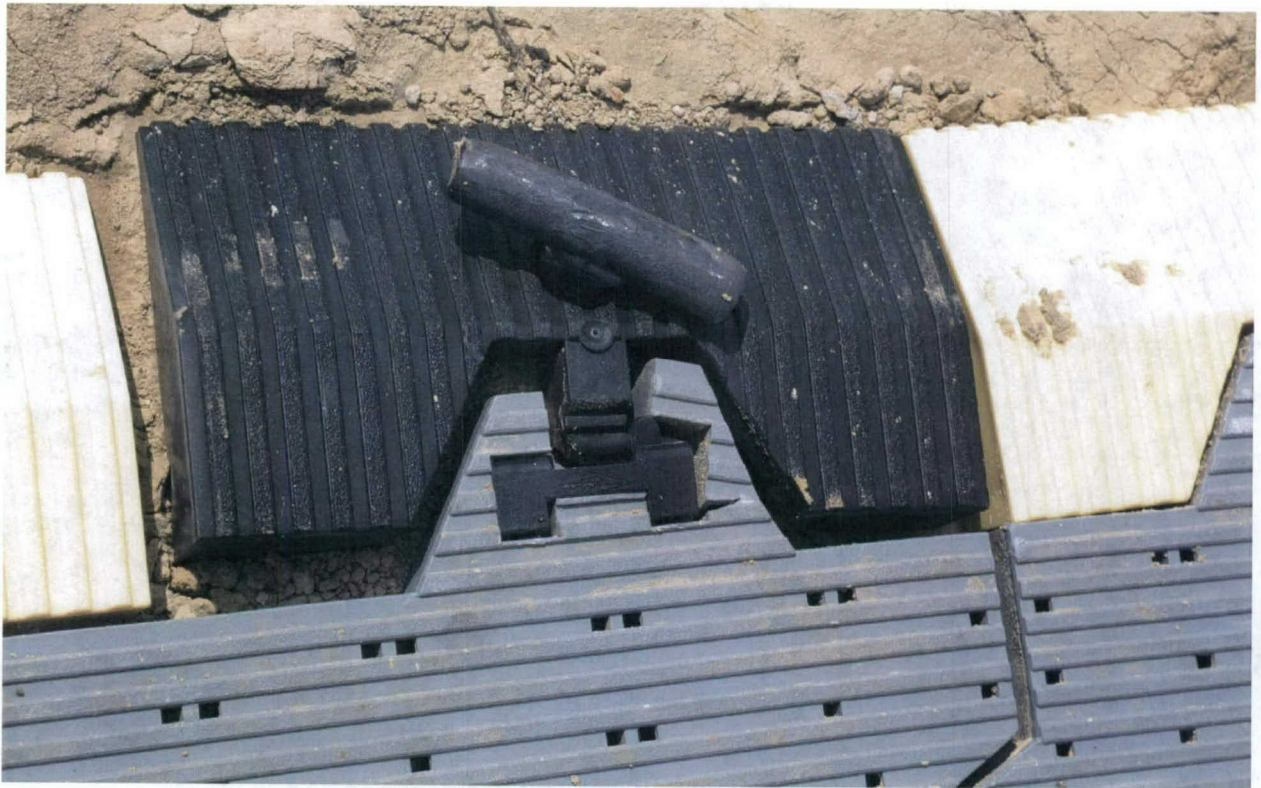
Photo 24. Isolated structural damage to SUPA-TRAC matting system at helipad edge

(1) SUPA-TRAC is a relatively quick and simple matting system to assemble, but it has a potential for structural damage under even a limited number of helicopter operations. This matting system is not recommended for use as a contingency helipad.

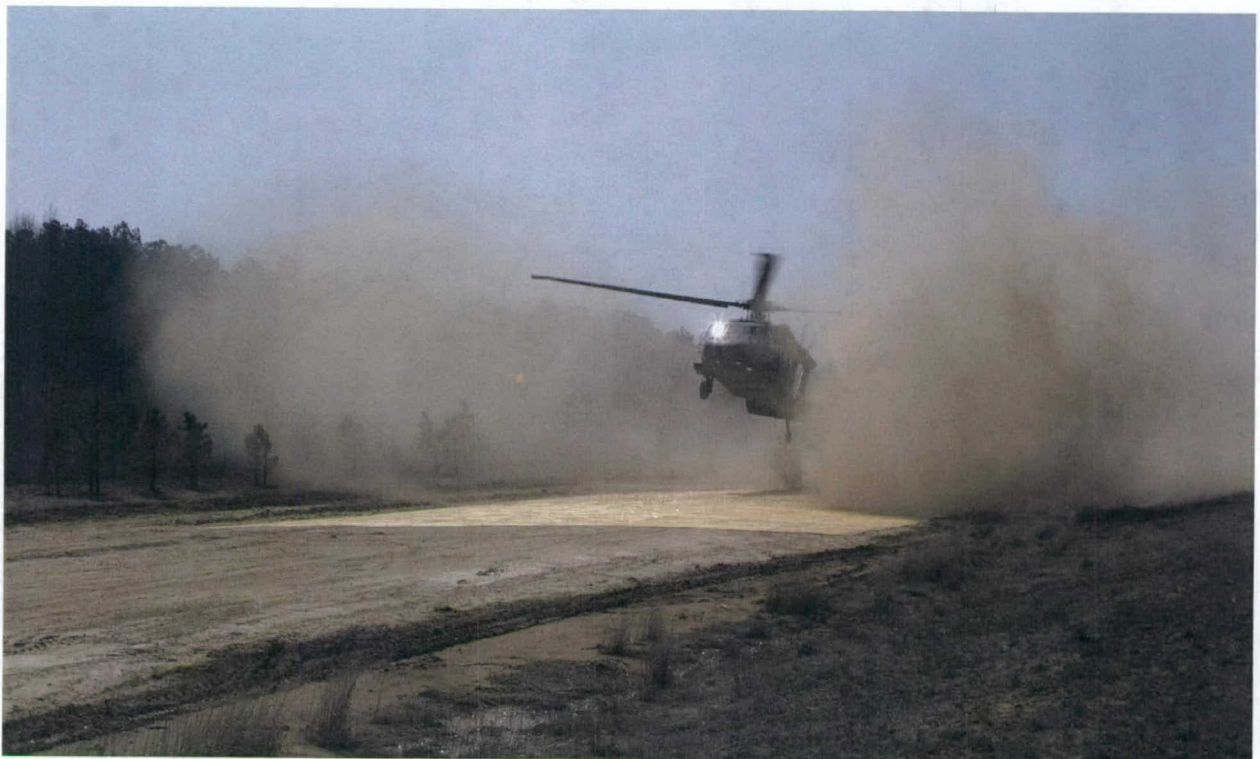
Photo 25. MP Mat helipad diffusing dust cloud as UH-60 Blackhawk approaches helipad

The MP fiberglass reinforced mats performed extremely well under all helicopter tests by significantly reducing dust while providing a firm helipad surfacing for taxiing and static loads. Some minor deflections were noted when the helicopters touched down and rolled, but no damage or dangerous undulations were observed. The helicopter tests suggested that only corner connector pins are actually needed for helicopter loads. Also, it was agreed that the duckbill anchoring system was excessive, and that a simple edge staking system should be more than adequate to resist uplift or other movement from rotor wash. Photo 25

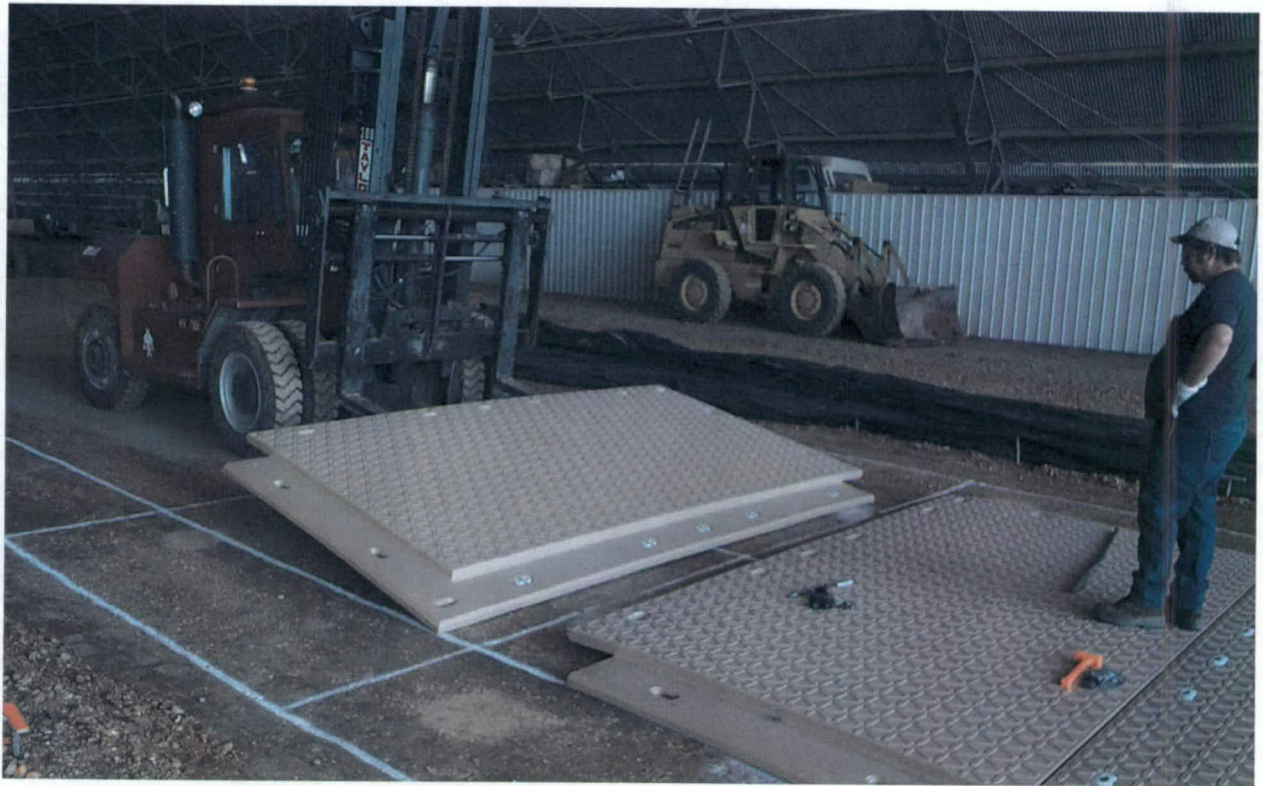
Photo 26. Installing DURA-BASE matting system

This matting system was originally designed and manufactured as a temporary load-bearing work platform system for use on low- and medium-strength soils by the oil-drilling industry. These mats have been found to be durable for the application of heavy truck traffic over soft, low-strength soils. The primary applications would be taxiways and parking aprons for contingency airfields, extensions or temporary additions to existing airfields, temporary helipads, and equipment storage pads. A material description of DURA-BASE is given in the Chapter 2 of this report. Photo 26 shows the installation of DURA-BASE on the test section.

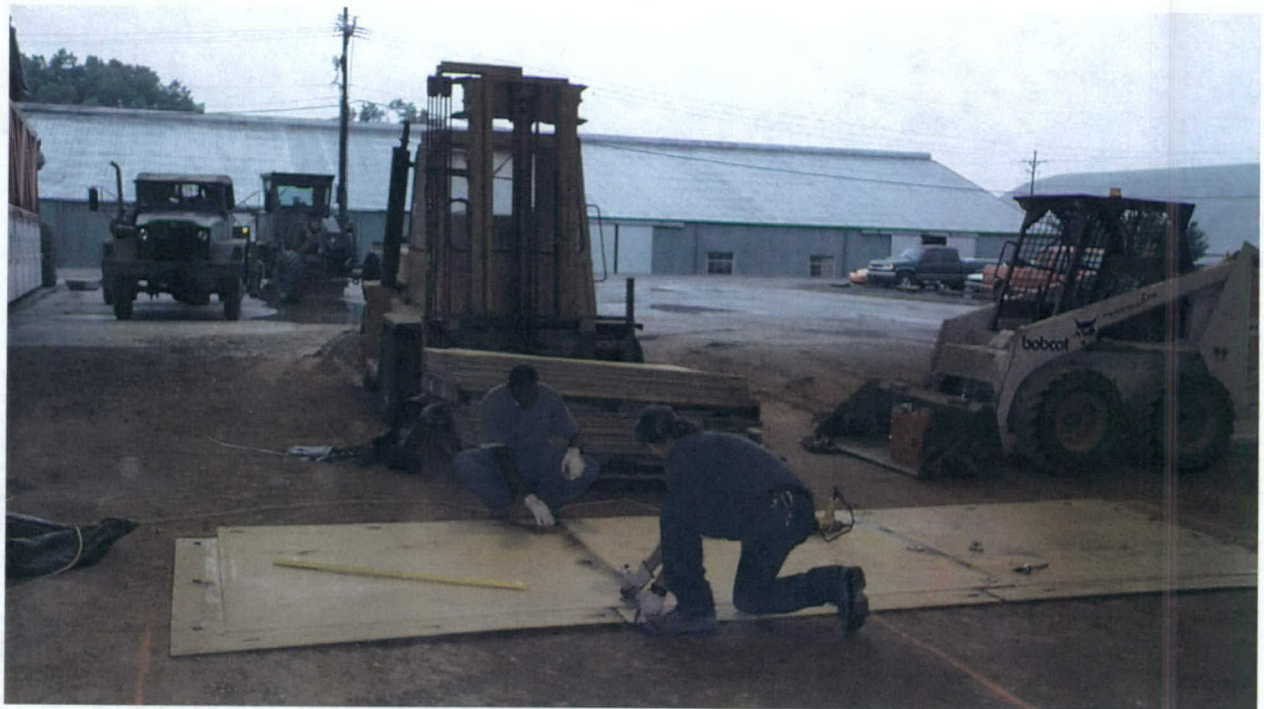
Photo 27. Installing 5-ply MP matting system

This matting system was originally developed for expedient road construction over sandy soils. MP Mats, like the DURA-BASE Mats, have been found to be durable for application of heavy truck traffic over loose, sandy soils. They can also be used in the same applications listed for the DURA-BASE. A material description of MP Mat is given in Chapter 2 of this report. Photo 27 shows the assembly of MP Mat on the test section.

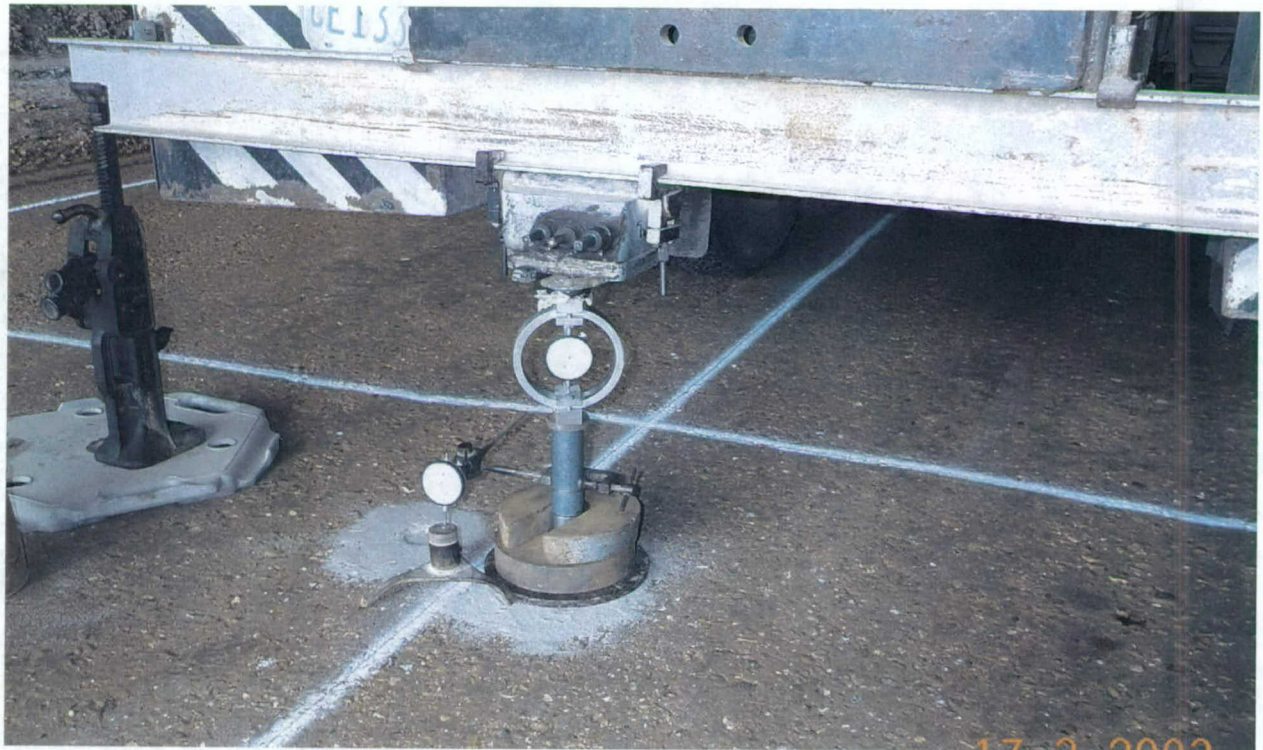
Photo 31. Field CBR test setup

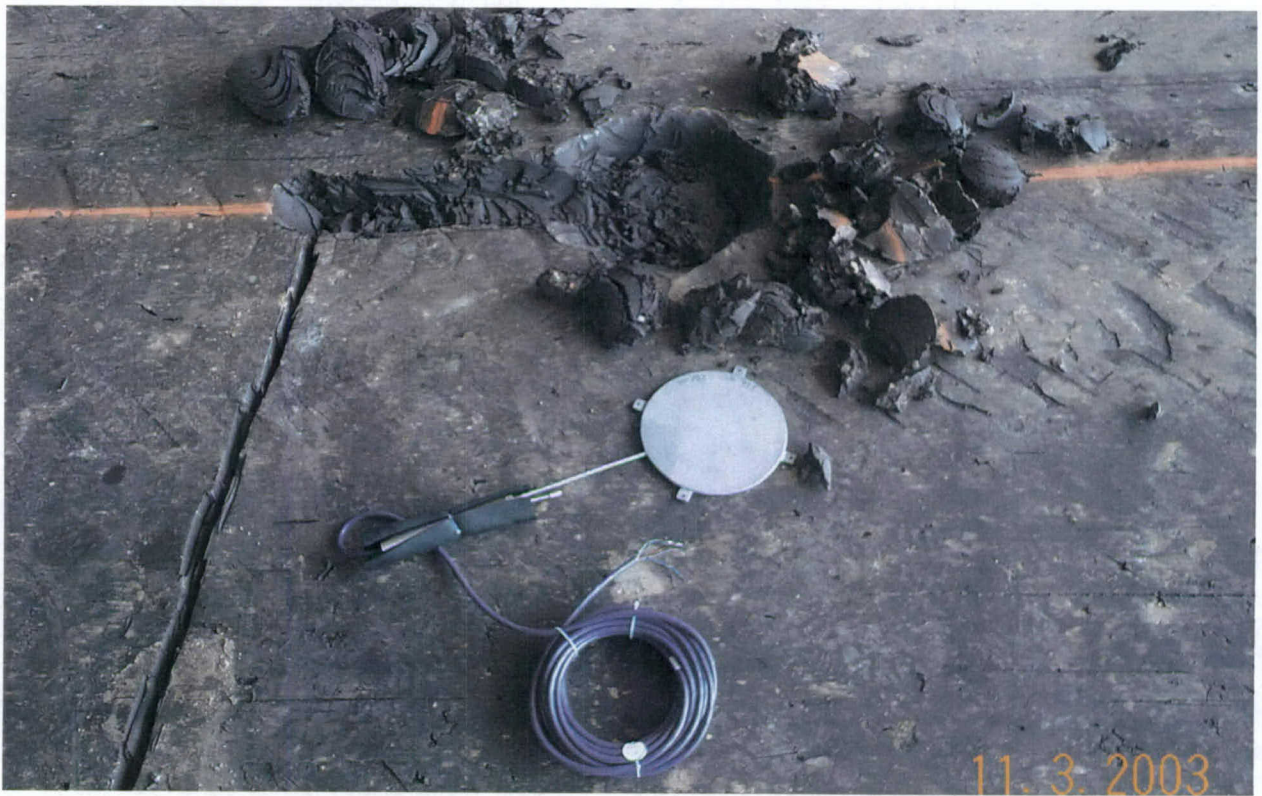
Photo 33. 100-psi GeoKon Pressure Cell awaits placement in CH clay

The instrumentation used for this test section consisted of subsurface pressure sensors. Although failure criteria for this project were limited to rut depths and mat system failure, it was determined that gathering information on soil pressures during trafficking could be useful for this and other projects. The sensors used were GeoKon 0.7-MPa (100-psi) pressure cells that were connected by radio telemetry to a data acquisition system located in Hangar 4. The project began with four of these pressure cells. One of these cells was destroyed during its extraction between the testing of the unsurfaced control and the first mat system. The remaining three cells continued to function with some repairs as the testing progressed. The cells were generally placed at a depth of 6 in. below the surface on which the mats were laid (either clay gravel or CH clay). Photo 33 shows a typical pressure cell and a location excavated in the CH clay where it was installed. The cells were placed such that at least one was located below the center of a mat in the middle of the lane, and another in the middle of the lane and below a joint between two mats. In all cases, the cells were placed farther than 10 ft from one another. The pressure cell data were collected at only specified numbers of passes.

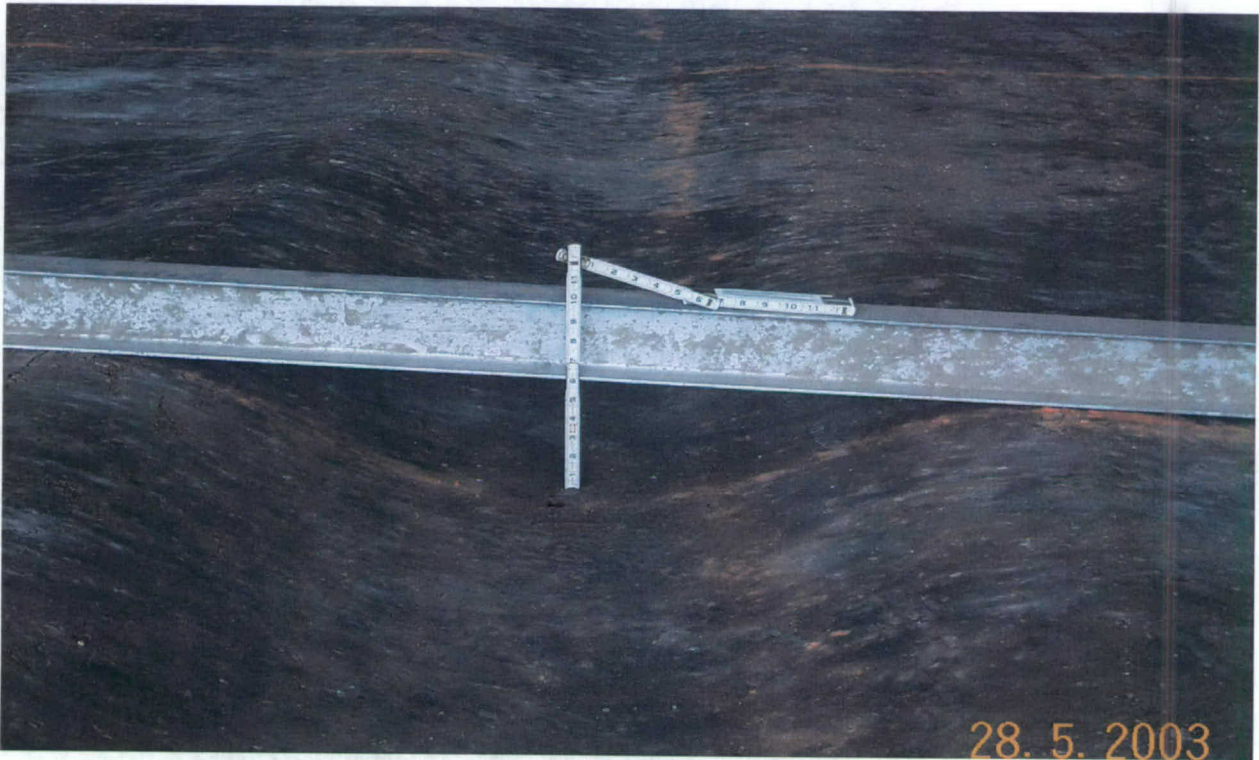
Photo 34. Measuring final rut depth on the Rapid Mat test (mat has been removed)

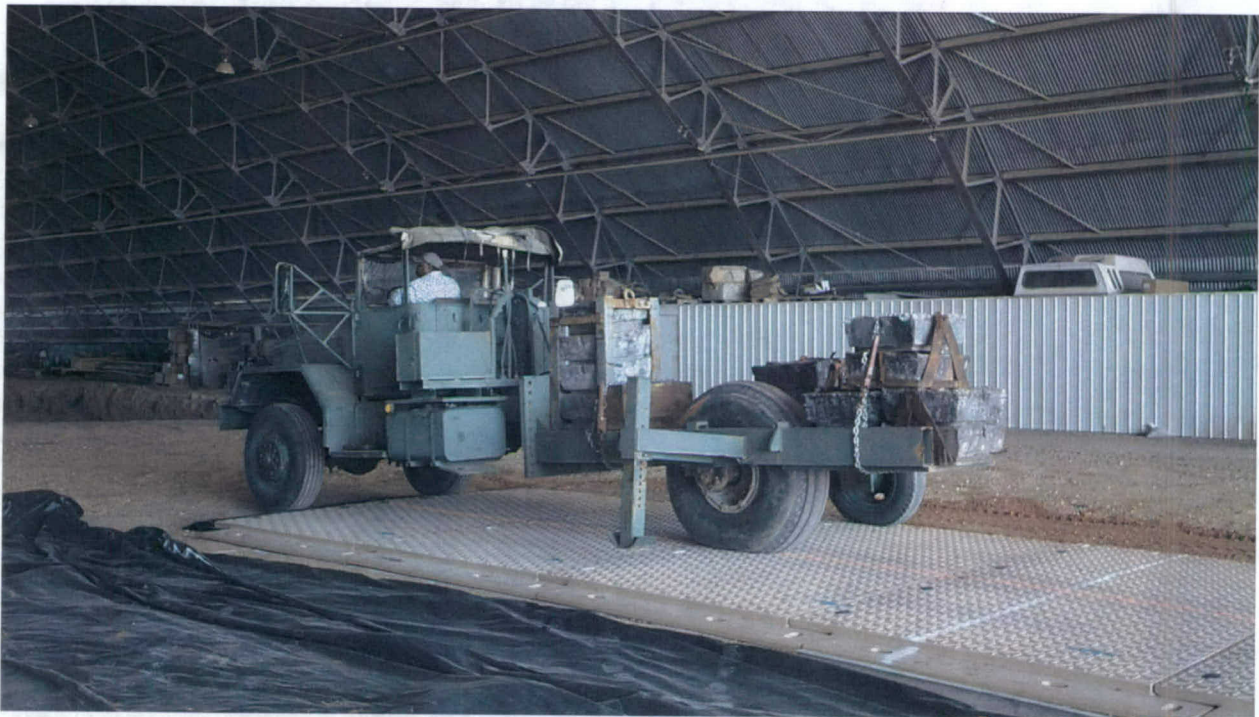
Photo 35. Loaded C-130 load cart performing traffic test on DURA-BASE matting

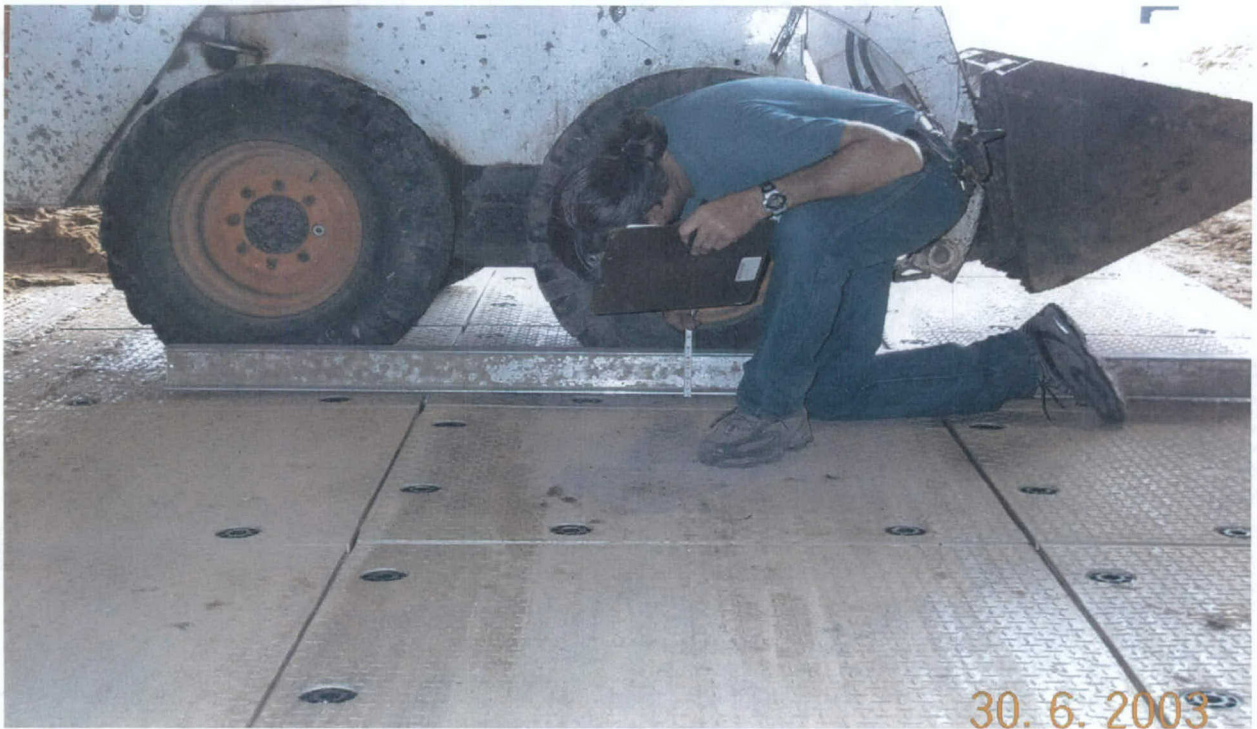
Photo 36. Using the skid-steer multipurpose machine to measure mat in-place rutting

In-place cross sections and rut measurement data were typically collected at traffic pass intervals of 0, 10, 25, 50, 75, 100, 250, 500, 750, 1,000, 1,500, 2,500, 5,000, or at the final failure point. These measurements were observed at three observation stations, typically stations 15, 25, and 35 ft, as measured from the south end of the test section. A rod and level, using a permanent benchmark located in Hangar 4, was used to record total lane-width cross sections at each station. A 10-ft aluminum straight edge was used to obtain measurements of the total rut depth. Measurement intervals were modified as needed based on observations and differences in failure rates and failure modes. Baseline data were recorded prior to the placement of the matting system, and final cross sections and rut measurements were taken after the matting system had failed and was removed from the test section. Rut and cross section data collected during traf-

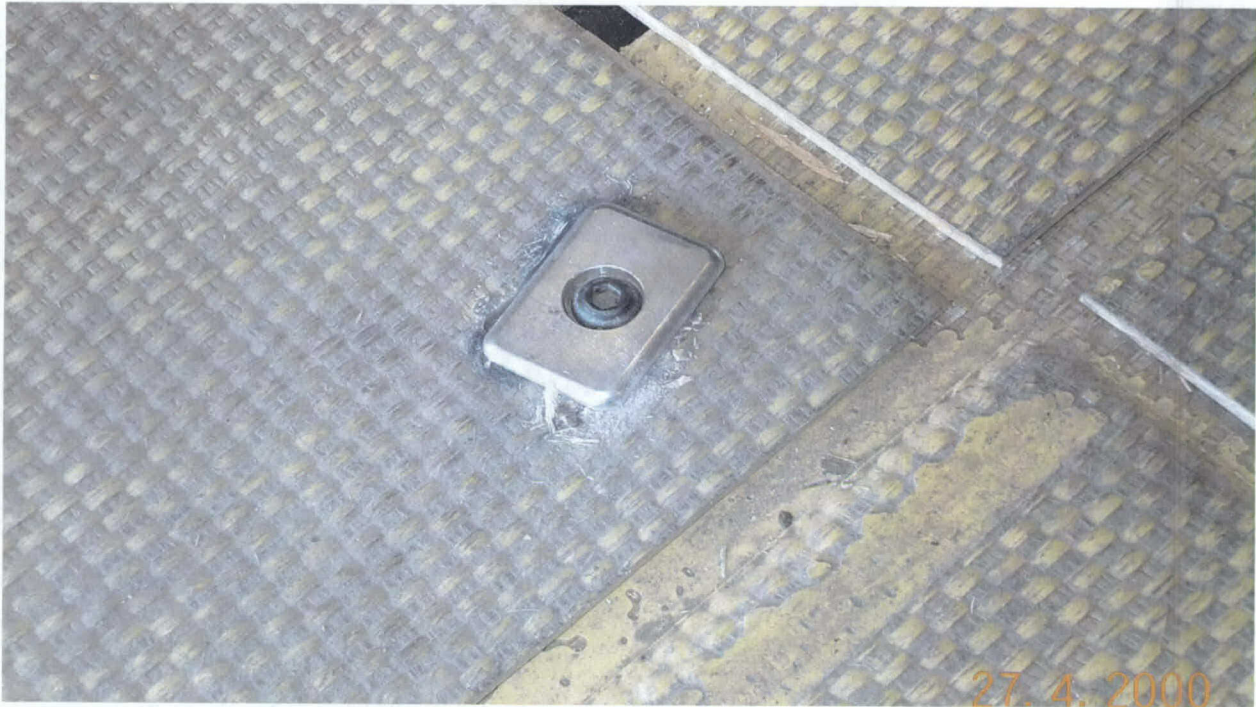
Photo 38. Movement of MP Mat pin within connection. Pin did not fail. (Low-strength soil, 3 to 5 CBR)
